# Characterizing Steel Corrosion in Different Alkali-Activated Mortars

Nina Gartner <sup>\*</sup>, Miha Hren, Tadeja Kosec and Andraž Legat

Slovenian National Building and Civil Engineering Institute, Dimiceva ul. 12, 1000 Ljubljana, Slovenia; miha.hren@zag.si (M.H.); tadeja.kosec@zag.si (T.K.); andraz.legat@zag.si (A.L.)

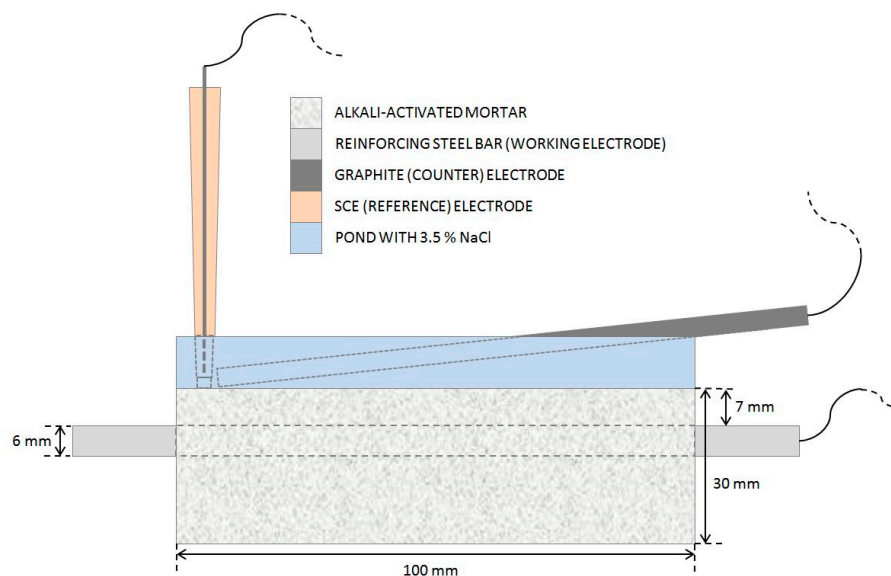
**Figure 1.** A schematic presentation of the experimental setup used for EIS measurements.

Electrochemical impedance spectroscopy (EIS) measurements (Figure 1) were performed once per cycle, on the last day of the wetting period. The steel reinforcing bar embedded in the mortar specimen was used as the working electrode, while a graphite electrode and a saturated calomel electrode (SCE) submerged in the top pool of the specimen served as the counter and reference electrodes, respectively. The EIS measurements were performed using a Gamry Ref600 potentiostat (Gamry Instruments Inc., Warminster, PA, USA). All potentials refer to the SCE scale. EIS measurements were performed at open-circuit potential (OCP) in the frequency range from 65 kHz to 5 mHz, with 11 points per

decade and an amplitude of  $\pm 10$  mV. The total impedance ( $|Z|_{\text{total}}$ ) value was estimated as the impedance ( $|Z|$ ) measured at the lowest measured frequency, less the solution resistance ( $R_s$ ) value.

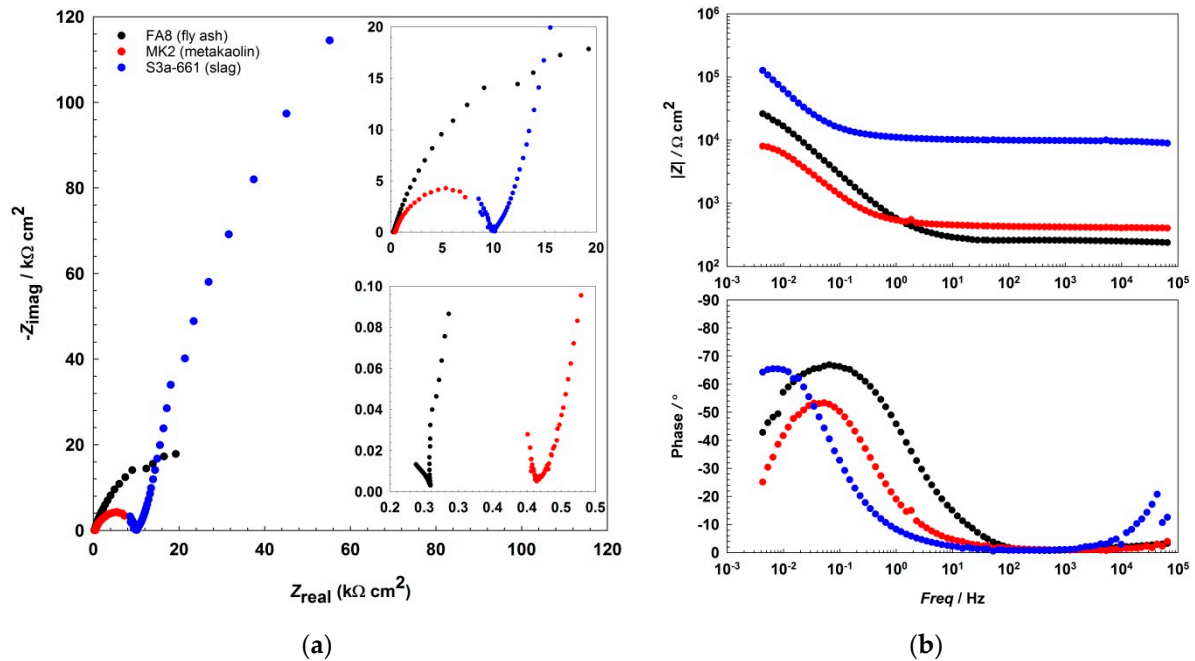
**Figure 2.** Representative EIS spectra, (a) Nyquist, and (b) Bode plots recorded during the 1st wetting/drying cycle (W1) in each of the three different alkali-activated mortars.

The EIS results show that the impedance responses (Figures 2–4) differ between the mortars and also change over the period of exposure. All spectra show an incomplete arc at high frequencies, which is associated with bulk phenomena. The spectra measured in both the fly-ash mortar (FA8) and the metakaolin mortar (MK2) indicate one time constant at the beginning of the exposure (W1, Figure 2), at the point where chlorides were introduced. After several wet/dry cycles of exposure to the chloride solution, an impedance response indicating two time constants became noticeable in these two mortars (FA8 and MK2). The shape measured at W8 (Figure 3) shows two time constants and a straight line at low frequencies, indicating the diffusive properties of the corrosive system investigated, which is more significant at the end of the exposure (W17, Figure 4). The resistance of the exposure media,  $R_s$ , in the FA8 mortar slowly rises during the exposure, with the final

$R_s$  value ( $0.43 \text{ k}\Omega\cdot\text{cm}^2$ ) being 1.8 times higher than its initial value ( $0.24 \text{ k}\Omega\cdot\text{cm}^2$ ). The resistance ( $R_s$ ) of the MK2 mortar is similar to that of the FA8 mortar. The spectra measured in the slag mortar (S3a-661) significantly differ from the spectra measured in FA8 and MK2 mortars; the total impedance ( $|Z|_{\text{total}}$ ) values are much higher, with only one time constant measured, and no diffusive properties of the system were observed. At the end of the exposure, the  $R_s$  value (W17) increases from  $10 \text{ k}\Omega\cdot\text{cm}^2$  (W1) to  $20 \text{ k}\Omega\cdot\text{cm}^2$ .

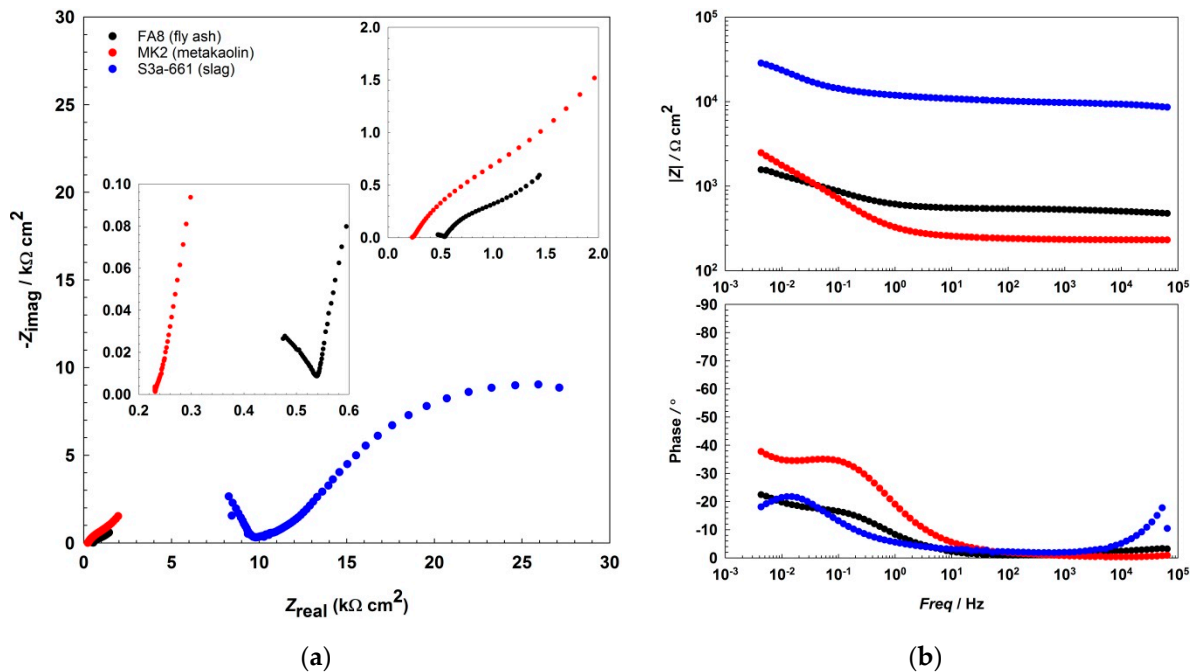
**Figure 3.** Representative EIS spectra, (a) Nyquist, and (b) Bode plots recorded during the 8th wetting/ drying wetting/drying cycle (W8) in each of the three different alkali-activated mortars.

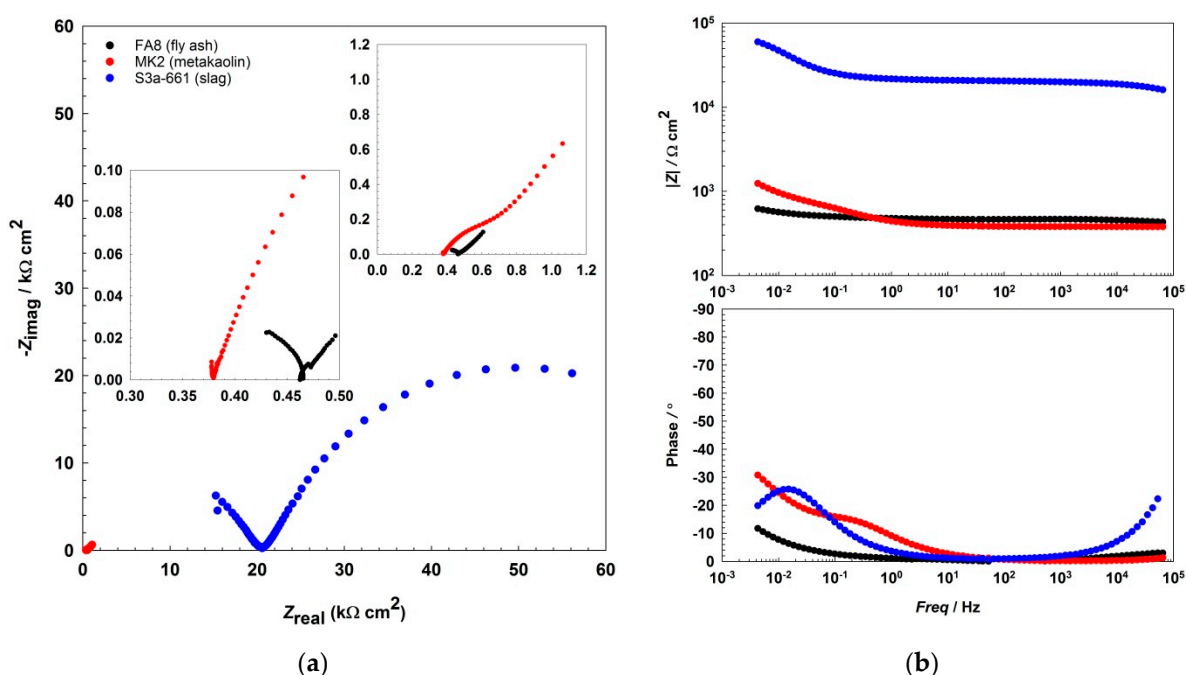
**Figure 4.** Representative EIS spectra, (a) Nyquist, and (b) Bode plots recorded during the 17th wetting/drying cycle in each of the three different alkali-activated mortars.

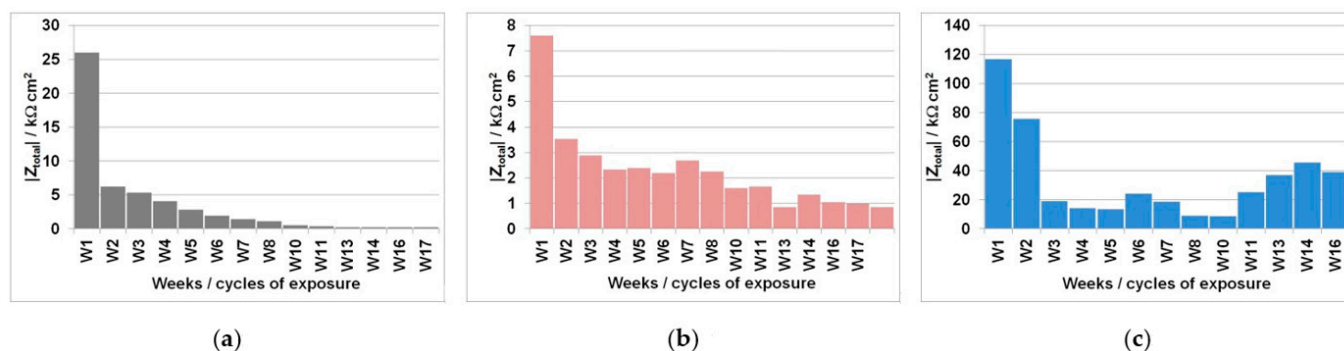
**Figure 5.** Total impedance ( $|Z|_{\text{total}}$ ) values periodically measured by EIS during the wetting/drying cycles in the (a) FA8, (b) MK2, and (c) S3a-661 mortars.

The total impedance values ( $|Z|_{total}$ ) measured in each wet/dry cycle (W1–W17) for each of the three mortars tested are presented in Figure 5. The  $\nu_{corr}$  values calculated from the EIS parameters measured are presented in Table 2.  $j_{corr}$  values were calculated using the Stern–Geary equation (Equation (1)) using an estimated constant of  $B = 0.026$  V [44]. The  $|Z|_{total}$  value, less the solution resistance ( $R_s$ ) value, was used as a near estimation for polarization resistance ( $R_p$ ).  $\nu_{corr}$  values were calculated according to Equation (2) [22], using an atomic mass value of  $AM = 55.85$ , a Faraday constant of  $F = 9.65 \times 10^4$  As, a valence of  $n = 2$ , and a steel density of  $\rho = 7.89$  g/cm<sup>3</sup>.

The corrosion processes intensify as the time of exposure increases, while the total impedance ( $|Z|_{total}$ ) values decrease over time (Figure 5); corrosion rates ( $\nu_{corr}$ ) consequently increase over time (Table 2). This is expected as a result of the increase in Cl<sup>−</sup> concentration in the mortar following each cyclic wetting with the 3.5% NaCl solution. The measured rise in  $\nu_{corr}$  is especially high in the FA8 mortar (Figure 5a), where values gradually increase from 12  $\mu\text{m}/\text{year}$  in the 1st wetting/drying cycle to 270  $\mu\text{m}/\text{year}$  in the 8th cycle, and finally to 1510  $\mu\text{m}/\text{year}$  in the 17th cycle. The equivalent measured increase in  $\nu_{corr}$  values is lower in the MK2 mortar (rising from an initial value of 38  $\mu\text{m}/\text{year}$  to a final value of 340  $\mu\text{m}/\text{year}$  after 17 cycles) but still significant (Figure 5b). On the contrary, the steel embedded in the S3a-661 mortar does not exhibit significant corrosion rates after 17 cycles of exposure, with the  $\nu_{corr}$  reaching 8  $\mu\text{m}/\text{year}$ . However, the  $|Z|_{total}$  values measured on the steel in the S3a-661 mortar do not decrease evenly (Figure 5c), with the highest corrosion rate (35  $\mu\text{m}/\text{year}$ ) measured during the 11th week of exposure (W11).

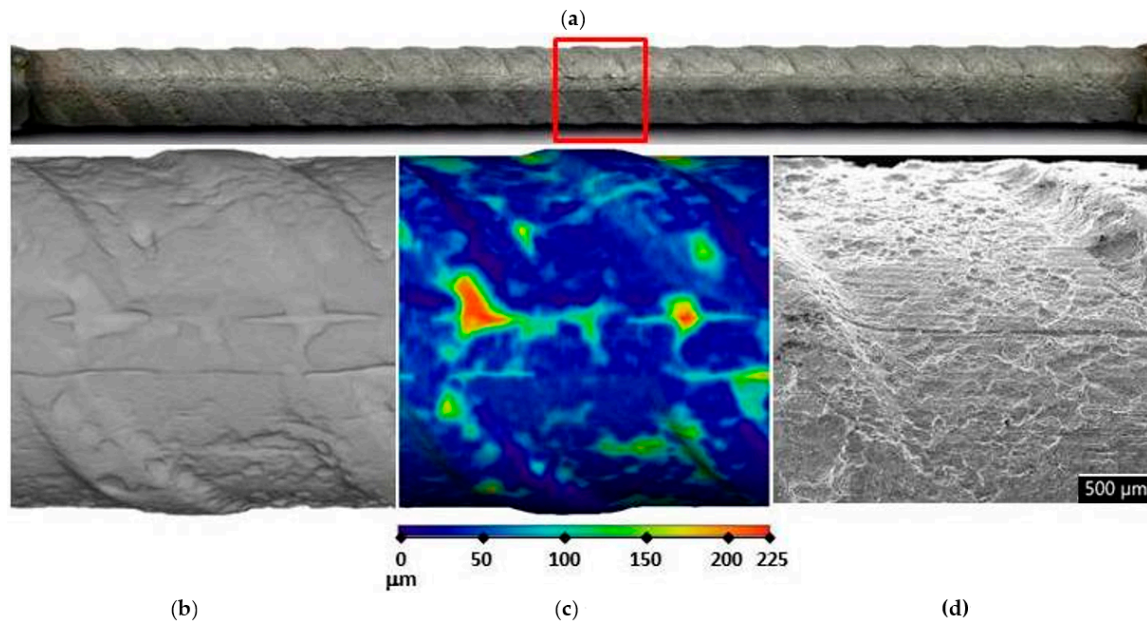
**Figure 6.** Visual assessment of the steel bar embedded in the FA8 mortar after 17 weeks of exposure; (a) photographic image of the steel bar; (b,c)  $\mu$ XCT images of the most severe corrosion damage; (d) SEM image of the representative steel surface (magnitude  $35\times$ ).

In order to assess corrosion damage, visual assessment of the corrosion damage was conducted using photographic analysis,  $\mu\text{XCT}$  scans, and SEM imaging. Before the exposure, there was no visible (mechanical) damage on the surface of the steel bars embedded in the mortars. Following the exposure, visual inspection of the steel bars (Figures 6–8) confirmed the intensity of the corrosion activity measured by electrochemical impedance spectroscopy (EIS). Images of the steel bar embedded in the FA8 mortar (Figure 6) show severe corrosion damage across the entire surface of the bar. The surface is rough due to the merging of several small local pits, resulting in large areas of corrosion damage spanning the entire surface, with a possible reduction in the rebar diameter. Damage to the steel bar embedded in the MK2 mortar (Figure 7) is fairly deep locally and clearly visible, while the surrounding surface remains undamaged. However, the steel bar embedded in the S3a-661 mortar (Figure 8) shows fairly shallow spots of surface corrosion (Figure 8c), which are mainly limited to areas around the edge.

After 17 weeks of exposure to a chloride solution, through periodical wetting and drying, the types and rates of corrosion were evidently different in each material tested, ranging from very dense but relatively small pits in FA8 (Figure 6) to rather large and deep areas of corrosion with undamaged surrounding areas in MK2, (Figure 7) and to very shallow corrosion spots with only a few small pits in S3a-661 (Figure 8).

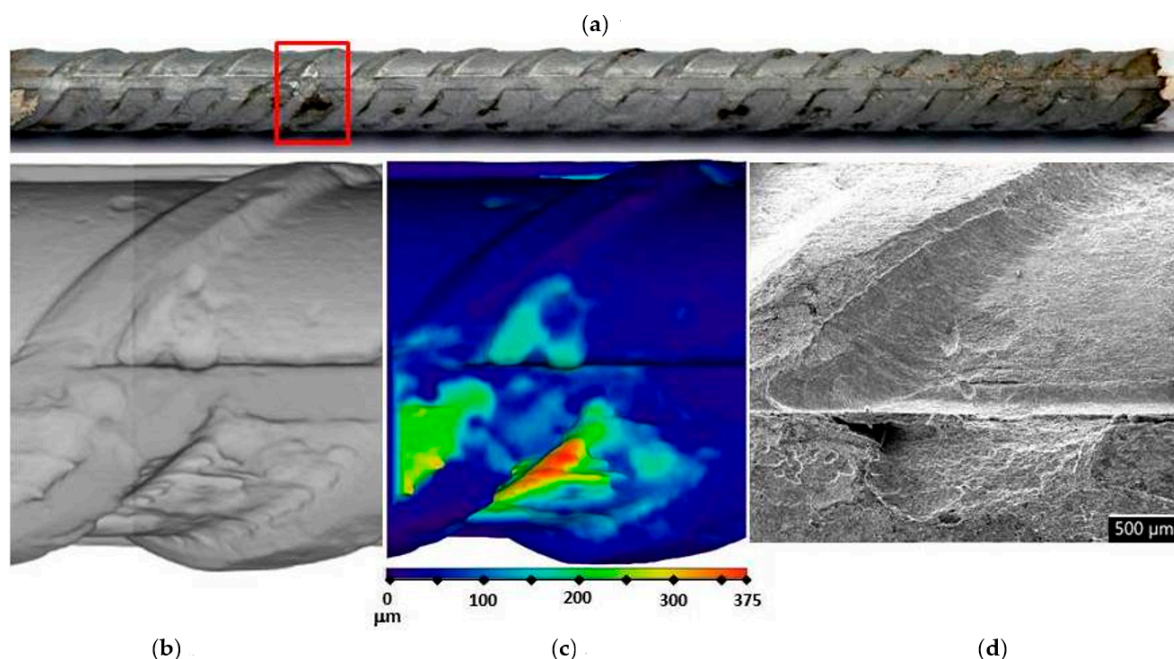
**Figure 7.** Visual assessment of the steel bar embedded in the MK2 mortar after 17 weeks of exposure; (a) photographic image of the steel bar; (b,c)  $\mu$ XCT images of the most severe corrosion damage; (d) SEM image of the representative steel surface (magnitude  $35\times$ ).

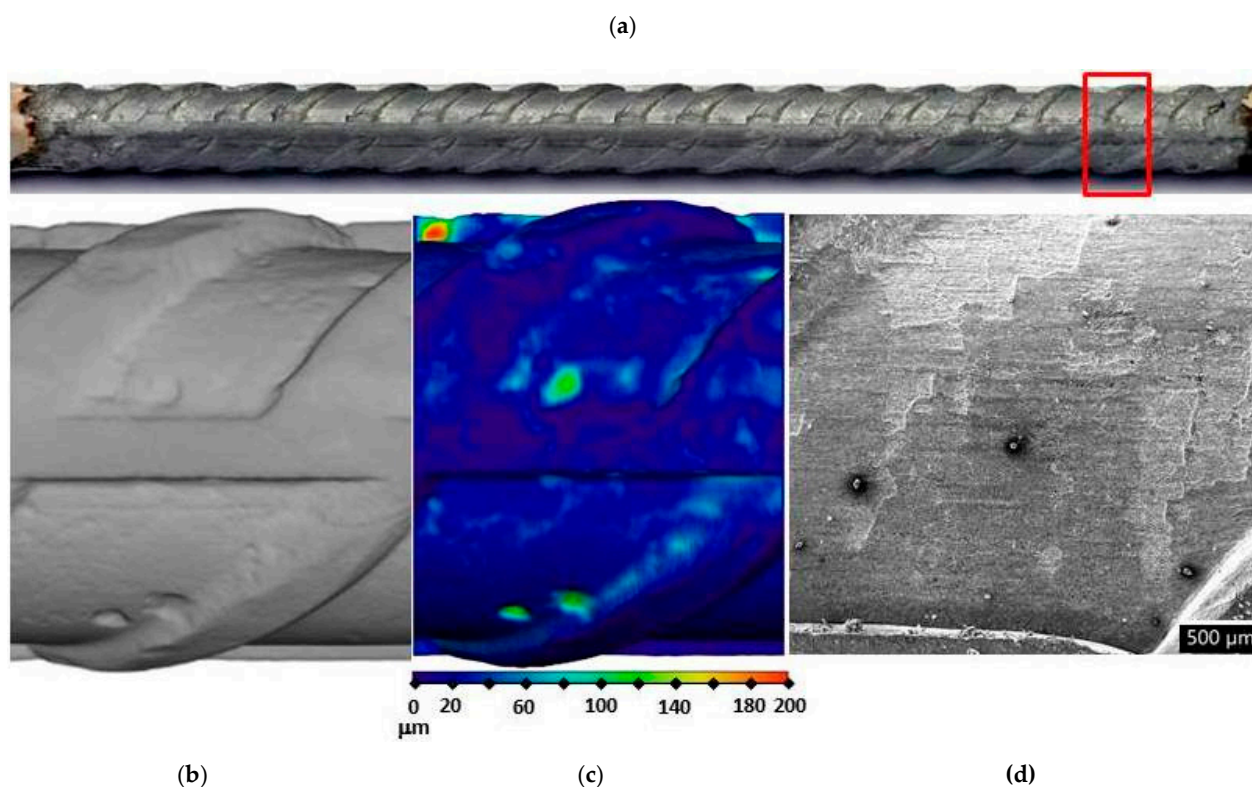
**Figure 8.** Visual assessment of the steel bar embedded in the S3a-661 mortar after 17 weeks of exposure; (a) photographic image of the steel bar; (b,c)  $\mu$ XCT images of the most severe corrosion damage; (d) SEM image of the representative steel surface (magnitude  $35\times$ ).
