Concrete Examination of 100-Year-Old Bridge Structure above the Kłodnica River Flowing through the Agglomeration of Upper Silesia in Gliwice: A Case Study

Abstract: The article analyzes the composition of concrete taken from various elements from a 100-year-old bridge in South Poland, so as to analyze its technical condition. The main methods applied during experimental work were: Designation of pH, free chloride content, salinity, XRD and SEM examinations, as well as metals determination using inductively coupled plasma mass spectrometry (ICPMS), high-performance liquid chromatography (HPLC)-ICP-MS, and cold-vapor atomic absorption spectroscopy (CV-AAS). The concrete of the bridge was strongly carbonated and decalcified with an extremely high content of chlorides. The pH of the concrete was in a range from 10.5 to 12.0. Acid soluble components were between 9.9% and 17.6%. Typical sulfate corrosion phases of concrete were not detected. Friedels' salt was found only at the extremity of an arch. The crown block was corroded to the greatest extent. Various heavy metals were absorbed into the concrete, likely from previous centuries, when environmental protection policy was poor. The

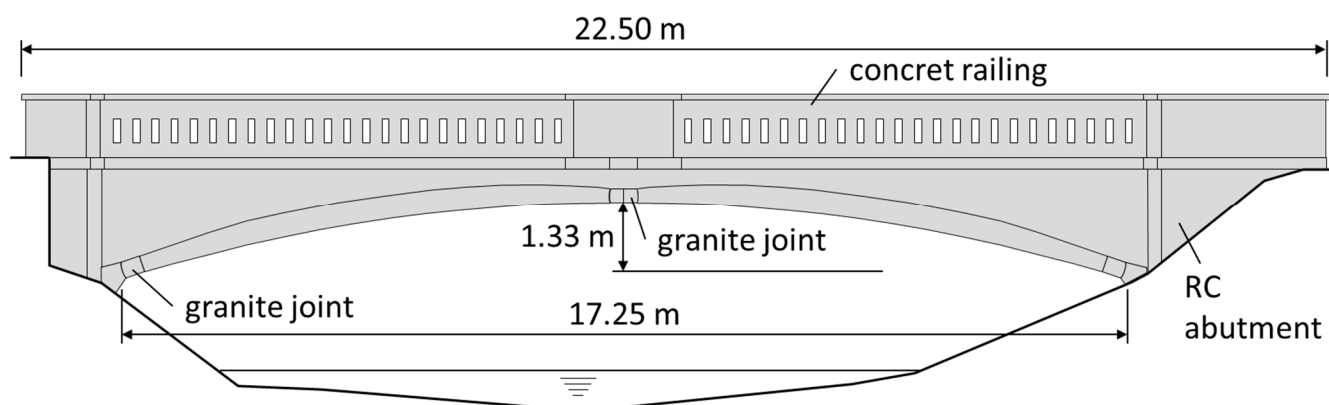
Figure 3 shows a side view of the bridge with its basic dimensions and structural elements. It is a three-joint RC arch with a span of 17.25 m and a width of about 20 m. The thickness of the vault is variable, with a maximum thickness of 40 cm. The reinforcement is placed only on concrete surfaces in the form of a mesh formed of 10 mm plain bars with a spacing of 30×30 cm. The joints are made of hewn granite blocks. The foundations were built of non-reinforced concrete and set in two rows of timber piles with a diameter of ~30 cm.

Figure 3. Side view of the bridge.

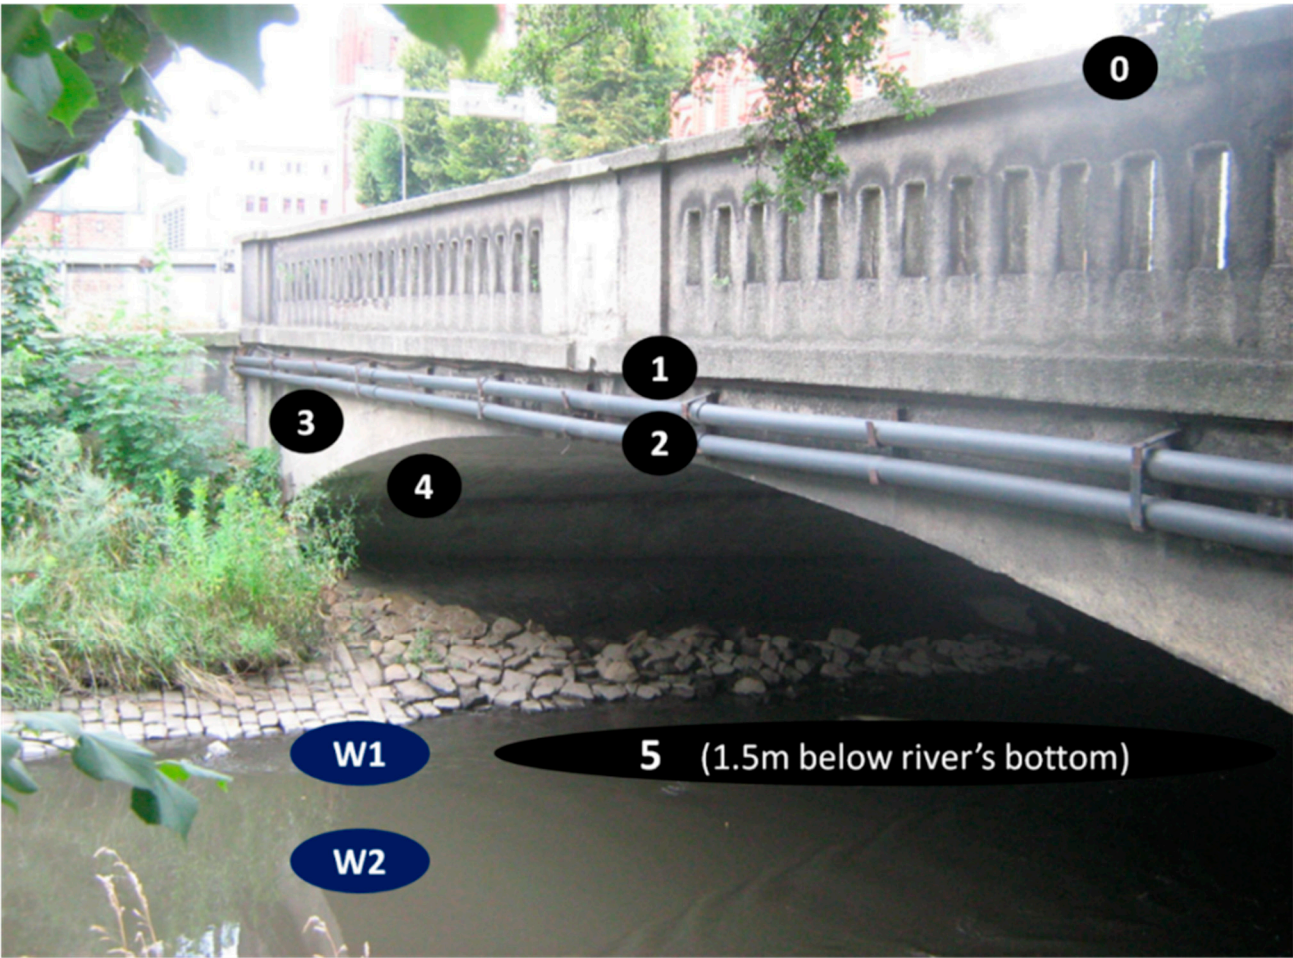
Figure 4. Location of samples of concrete and water shown before demolition of the bridge.

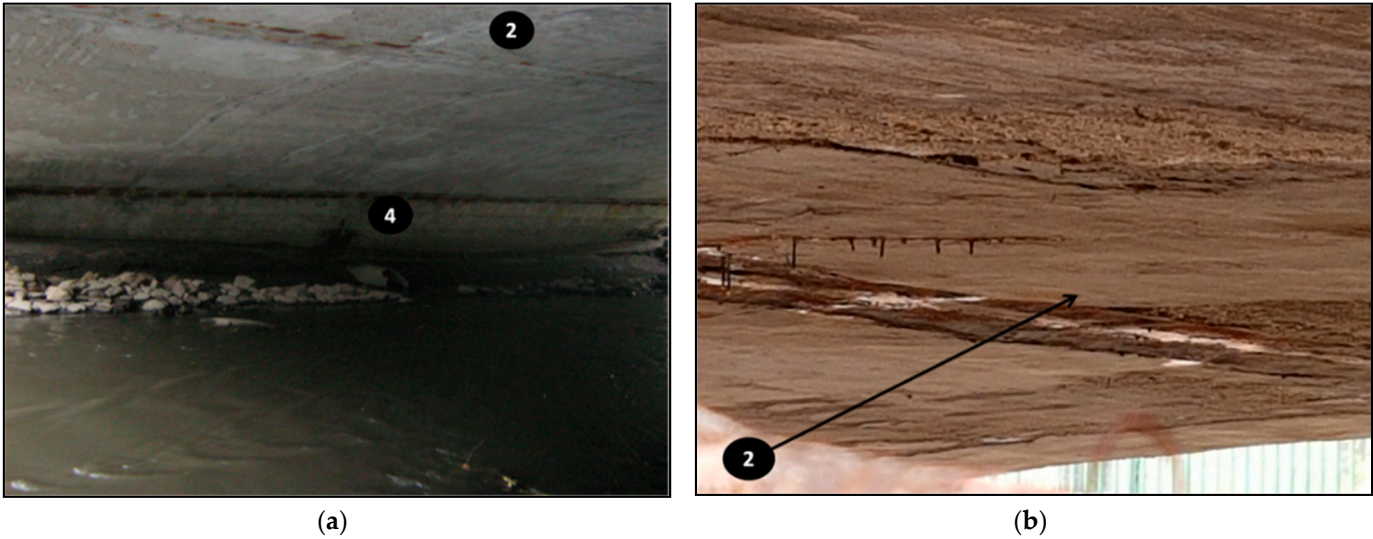
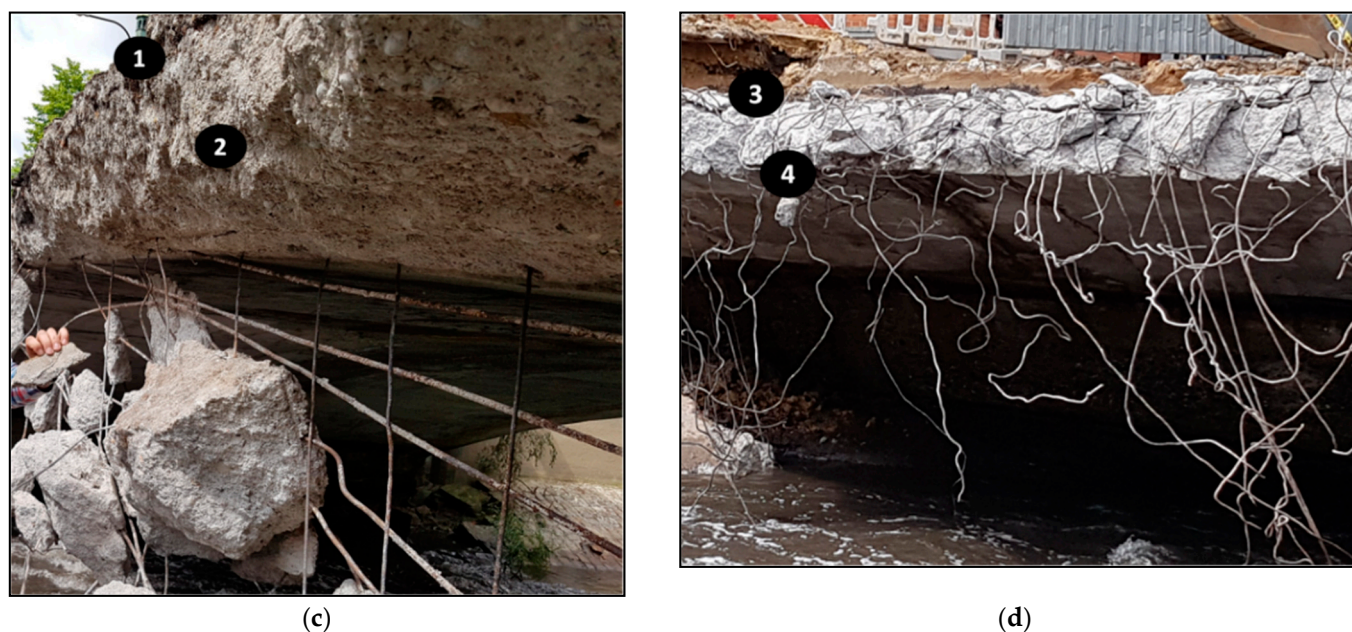
Figure 5. The sampling sites during demolition: Corroded steel mesh and carbonate icicles: (a) location of samples 2 and 4, (b) location of samples 2, (c) location of samples 1 and 2, (d) location of samples 3 and 4.

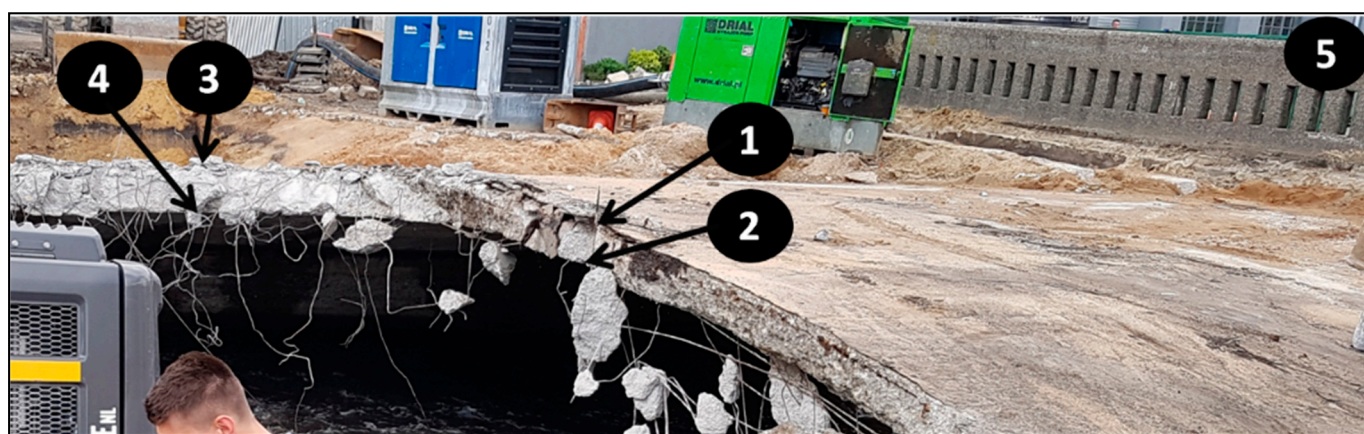
Figure 6. The RC (reinforced concrete) slab after removing the bituminous layer from the bridge.

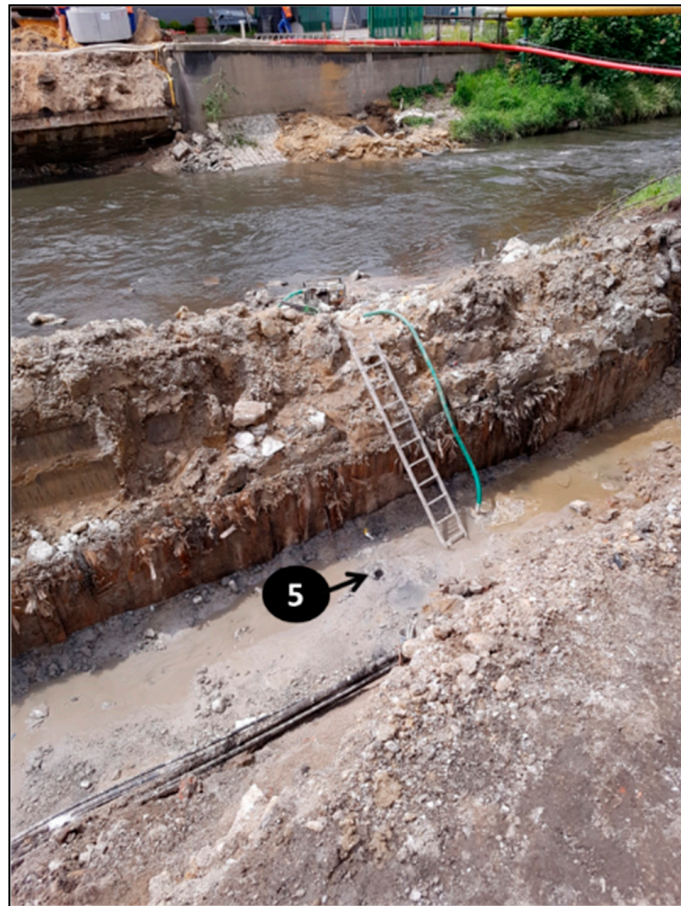
Figure 7. Location of foundation borehole.

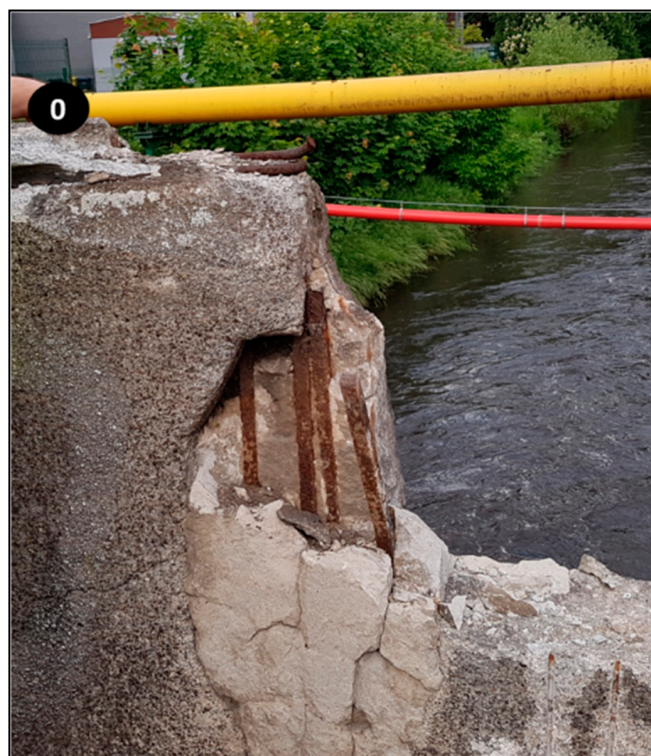
Figure 8. Corroded steel bars in the concrete of the balustrade.

The pH of the concrete railings was lower than that of healthy concrete, and it is explained by the exposure of railings to atmospheric precipitation, chlorides ingress, and carbonation reactions. The pH of this concrete was not sufficient to protect steel reinforcement against corrosion. This is very notable in the image shown in Figure 8, where corroded bars revealed and where the sample “0” is seen, as well.

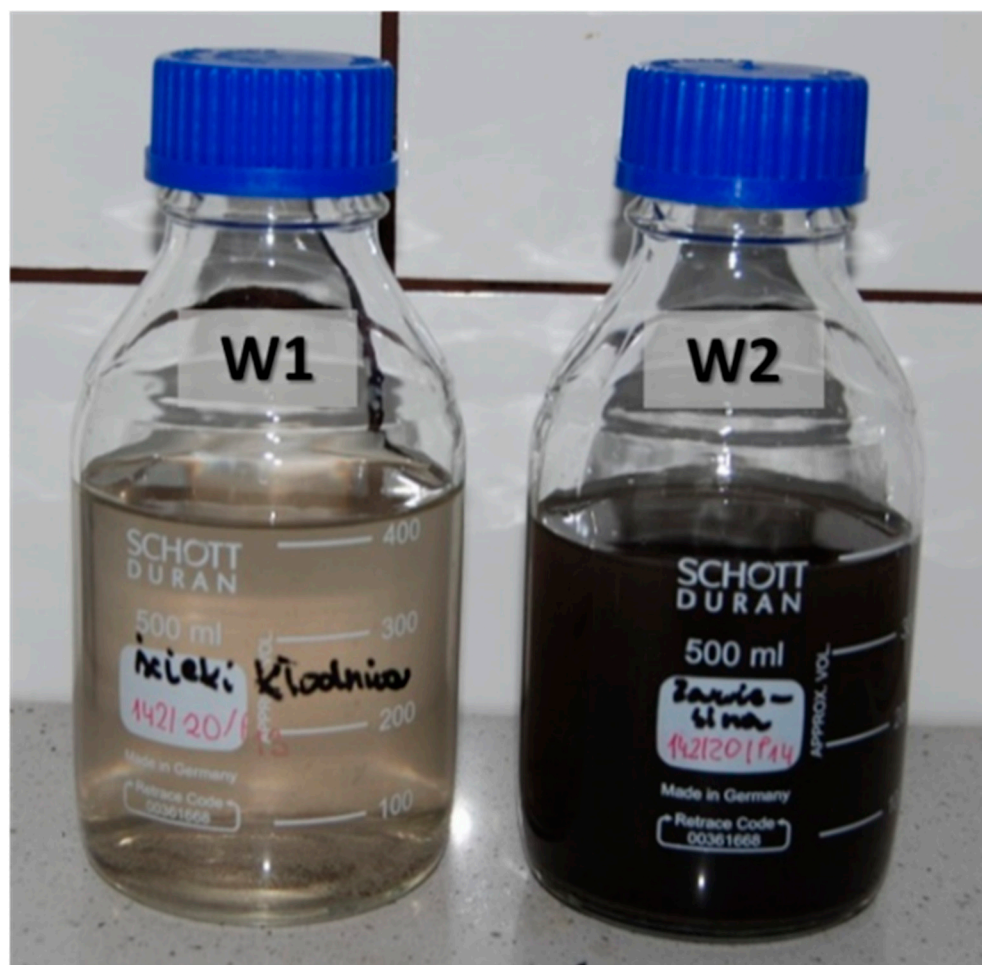
Figure 9. Water and suspension samples taken in March 2020 from the Klodnica river; flowing water (W1) and water collected at the bottom of the river (W2).

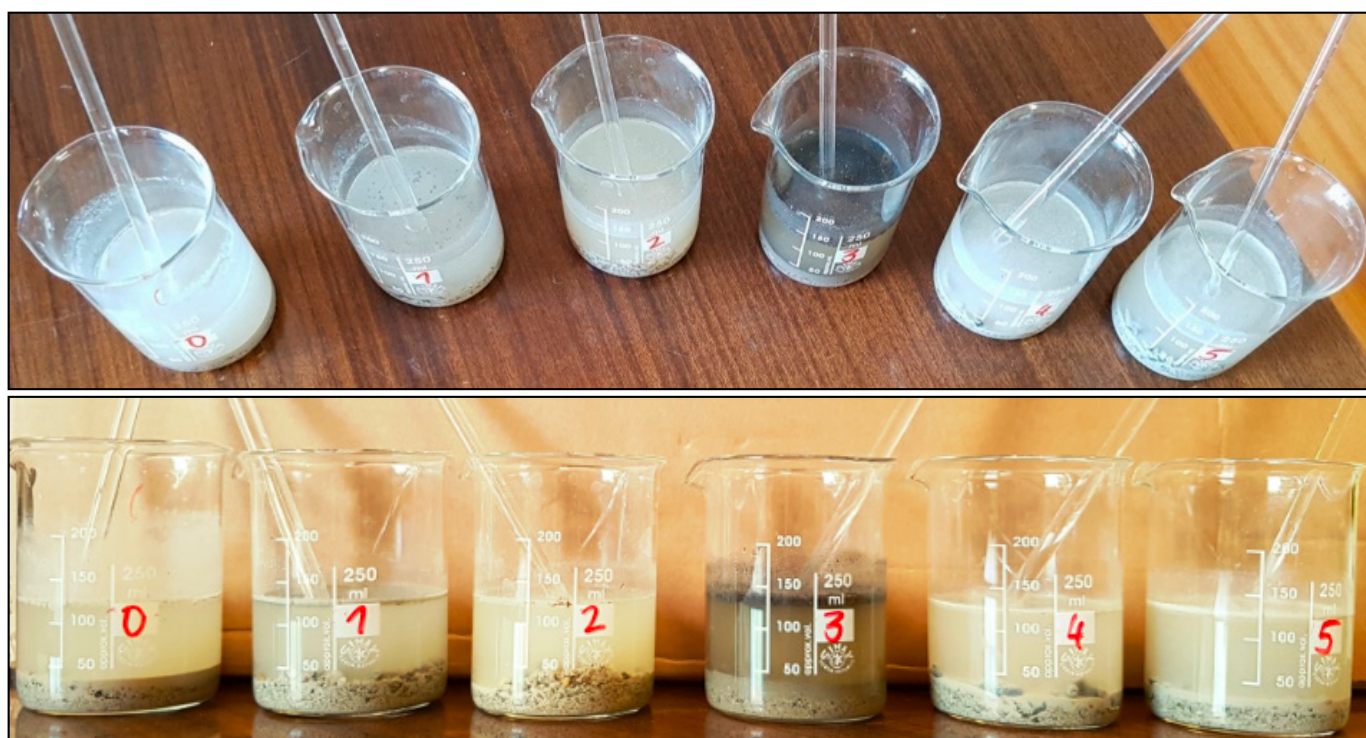
The binder content in healthy concrete is typically about 20% [10,22]. In tested samples, this value is not preserved. The smallest remaining amount of phase digested in HCl was in specimen 1 (9.9%), which was taken from the upper layer of the top part of the crown block. A low amount of soluble phase could be due to a high degree of concrete destruction due to leaching and reactions with de-icing salts. A very small amount of soluble phase was also in concrete taken from the abutment foundation (specimen 5), with approximately 10.5%. It is probable that heavy concrete with a high amount of aggregate was used there or phases of the binder were dissolved, as well. The concrete from the top part of the extreme arch, in specimen 3, was the least affected by the influence of the external environment. However, this concrete was the most contaminated with bituminous material, which was perceptible and visible (see Figure 10). There was less asphalt in specimen 1 than in

specimen 3. Concrete in the location numbered “2” was the most exposed to evaporating water from the river. The condensate water contributed to the dissolution of the cement binder, especially calcium hydroxide. Calcium was washed out from the other hydrates and time. Moreover, carbon dioxide, from the air, bound the leached calcium to calcium carbonates (seen in Figure 5b). The concrete from the railings was made using also some black aggregate (probably basalt), where the content of soluble phases was 16.7% (partially washed off by rainwater).

Figure 10. Suspensions made from deionized water and crushed concrete from the bridge.

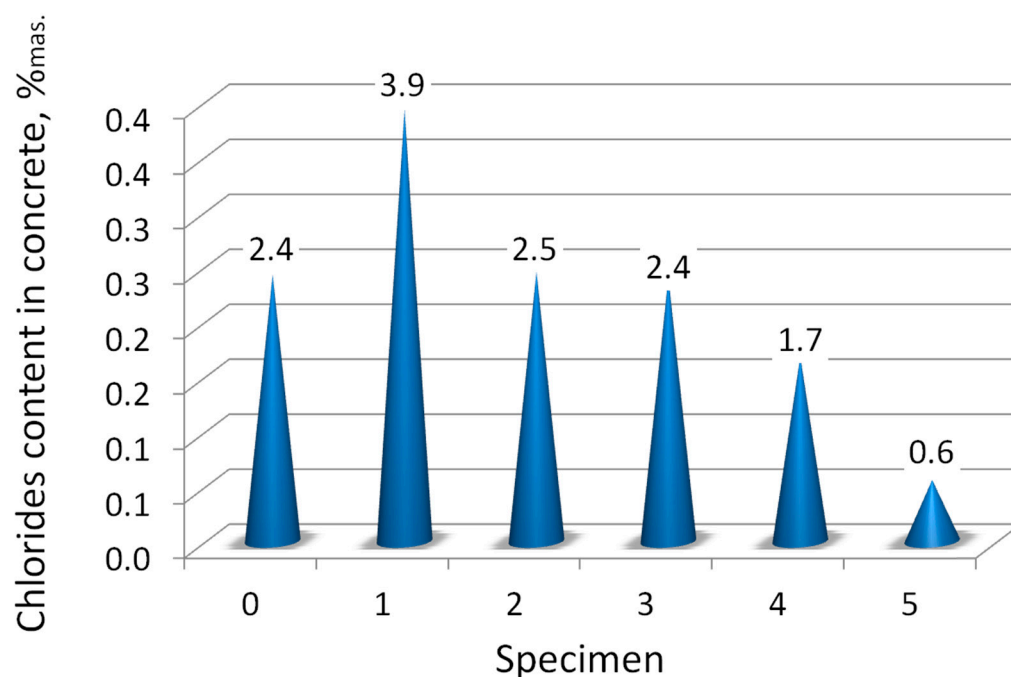
Chlorides from de-icing salts cause corrosion of steel reinforcements and destruction of concrete in a dry climate when they crystallize and cause stress on pores in concrete [88–93]. According to [94], the chloride content in concrete is related to the mass of the cement and should not exceed 1% (when there are no metal elements), 0.20% or 0.40% (concrete with reinforcement and metal elements), and 0.20% (steel prestressing reinforcements). Of course, this standard was not applicable when this bridge was constructed, and are used as an indicator and guide to protect the bridge against steel corrosion and the corrosion process. So, with the consideration of the above PN-EN standard, the chloride content was greatly exceeded in the concrete of the examined bridge structure, see Table 6, Figure 11.

Figure 11. The free chloride ions content in concrete samples from the bridge.

The significant free chloride ions content in the examined concrete is explained by the use of deicing salts over the years after construction, but the high salinity of the river also cannot be omitted. It can also explain the low content of soluble phases in the concrete. The highest mass content of chloride ions was in the specimens found under the bituminous layer sprinkled with deicing salts. In specimen 1, almost 40% of the mass of soluble phases were chlorides. This also explains the very small amount of soluble phases in specimen 1. A large number of chloride ions in sample 2 come from chlorides leaking from the above layer (specimen 1). The lowest content of chlorides was in the concrete of the abutment foundation (specimen 5) because this concrete was probably very dense, not porous, and was not constantly exposed to fresh large amounts of chloride.

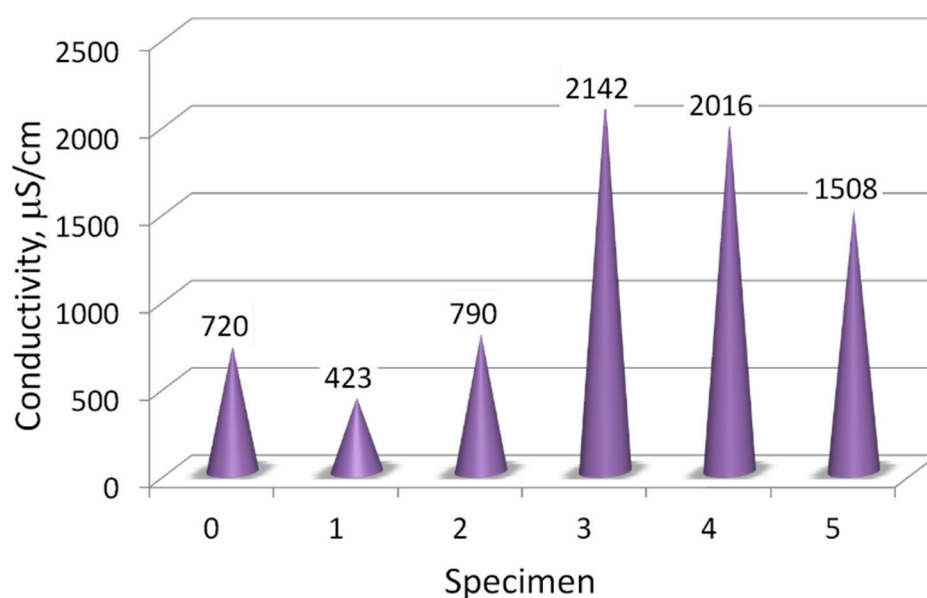
The salinity of the concrete filtrates ranged from 400 to 2200 $\mu\text{S}/\text{cm}$ (Figure 12). However, these results should be considered as qualitative. This measurement aims to indicate the quality of the concrete in given structural elements. That is, whether any of its component can dissolve or concrete is contaminated with ions from the external environment.

**Figure 12.** The conductivity of filtrates made of concrete samples from the bridge.

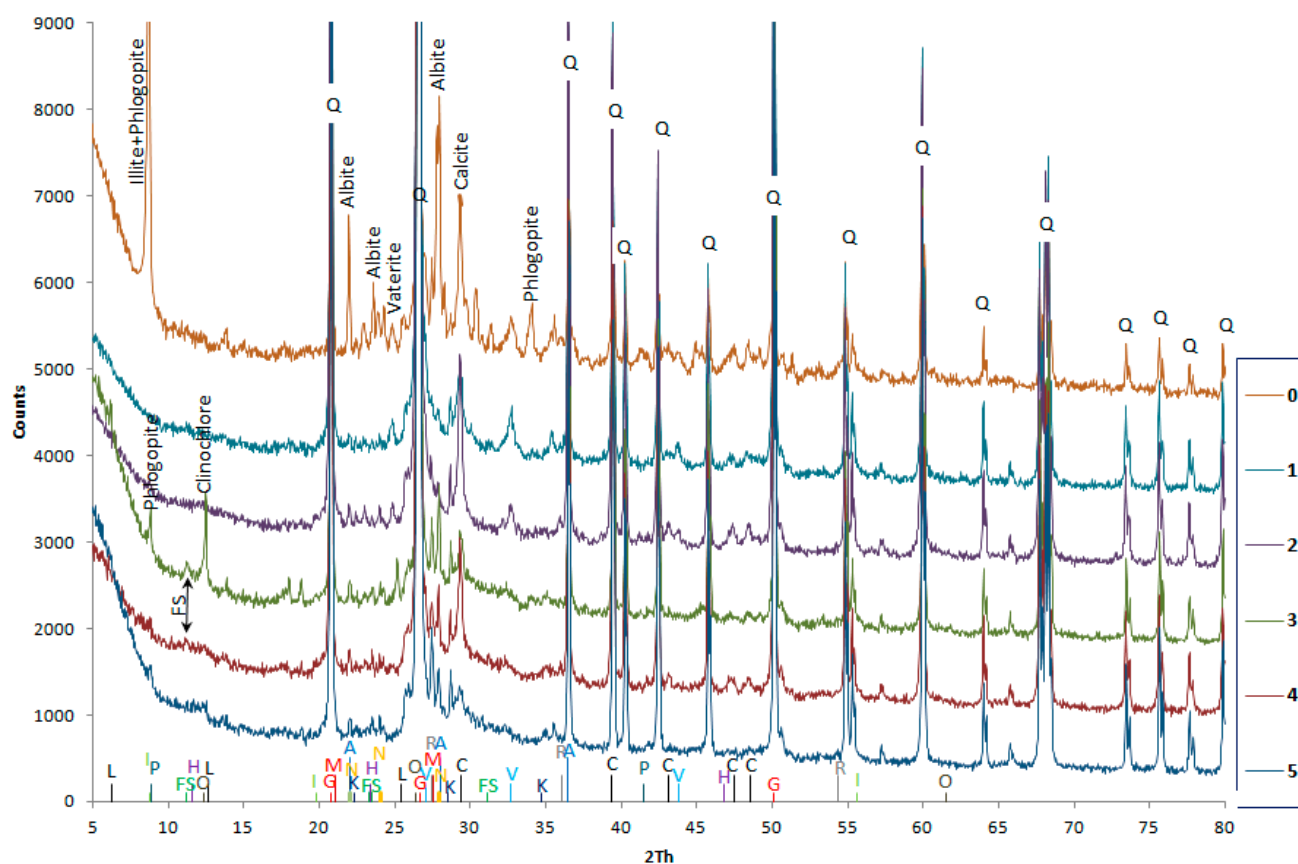
The XRD patterns of specimens 0, 1, 2, 3, 4, and 5 (Figure 13) show the presence of aggregates and calcium carbonates. This means the concrete was heavily carbonized, to the extent that not one cement phase could be detected. The biggest surprise was the lack of sulphate phases indicating corrosion of the concrete. The corrosive phase, in addition to calcium carbonates, was hydrocalumite, present in specimens 3 and 4, called Friedel's salt. This chloride phase is unstable when the pH drops below 12. Among the discovered calcium carbonates: Calcite was present ubiquitously and vaterite was present in specimens 0, 1, 2, and 3—in the upper sections of the construction where carbon dioxide was more available as CO_2 or HCO_3^- ions. Calcite may be a part of the aggregate, but there it was mainly a product of concrete destruction. Vaterite, in turn, recrystallizes to form calcite or aragonite but can also be derived from biochemical sediments [96]. After all, it cannot be ruled out that the concrete has also been biodeteriorated [97]. All the detected phases in the individual samples are summarized in Table 9.

Figure 13. The XRD patterns of specimens 0 to 5.

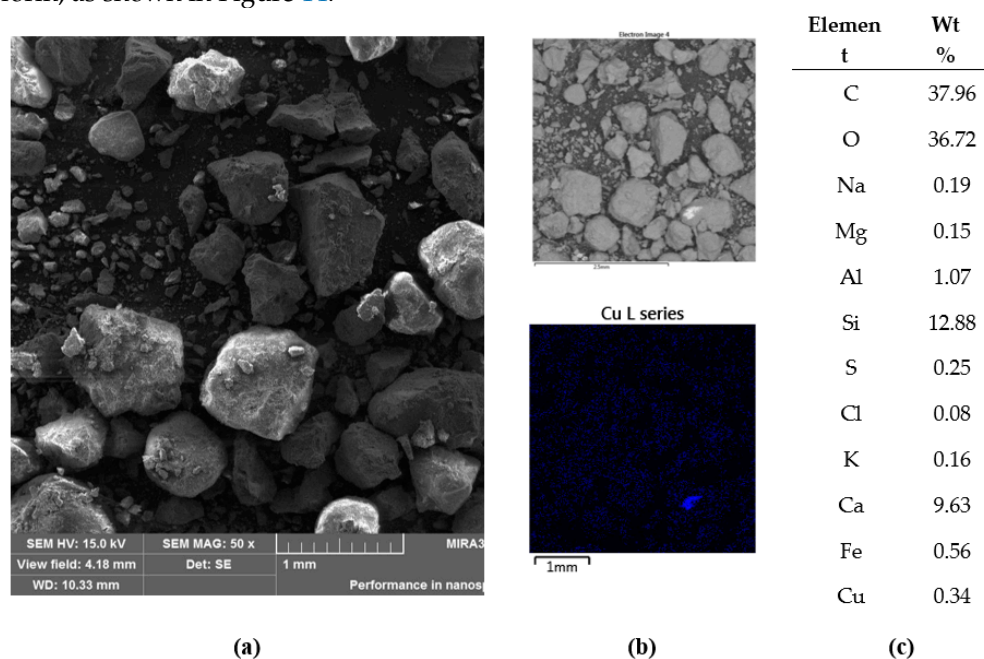
In the crushed concrete, taken from specimen 4, Cu was detected, probably in metallic form, as shown in Figure 14.

Figure 14. Crushed concrete on carbon tape, specimen 4: (a) SEM-SE image; (b) SEM-BSE image, with a map of Cu location, and (c) the elemental content over the whole shown area.

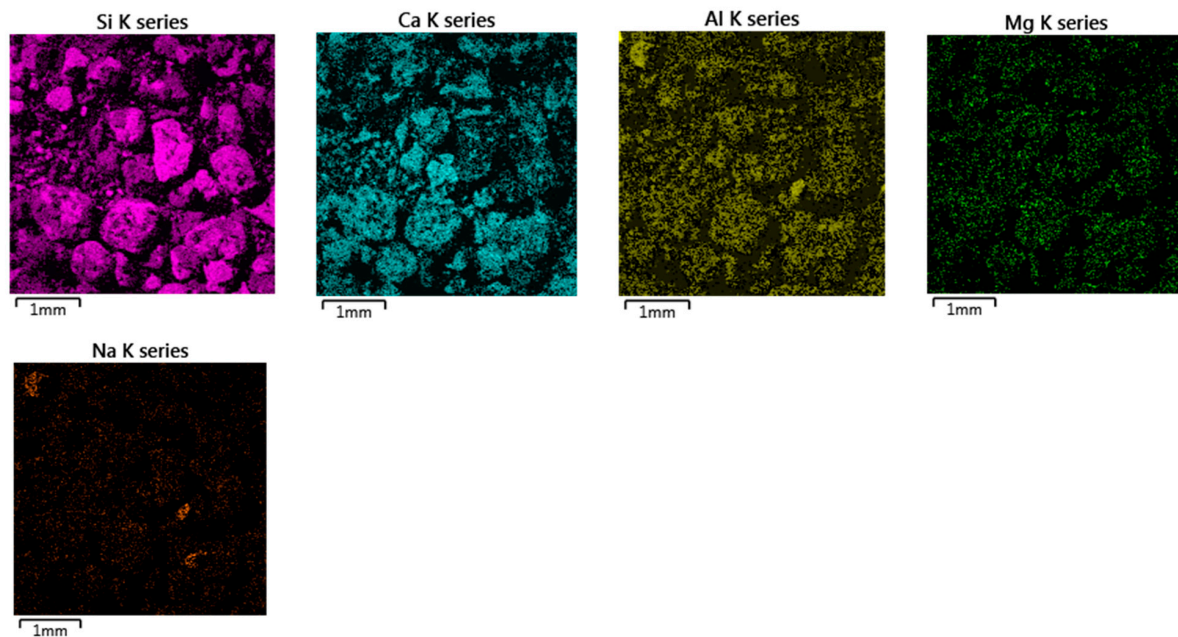
Figure 15. Crushed concrete on carbon tape, specimen 4: Si, Ca, Al, Mg, and Na maps over the analyzed area shown in Figure 14b. Mg is evenly distributed throughout the image, suggesting it is absorbed freely.

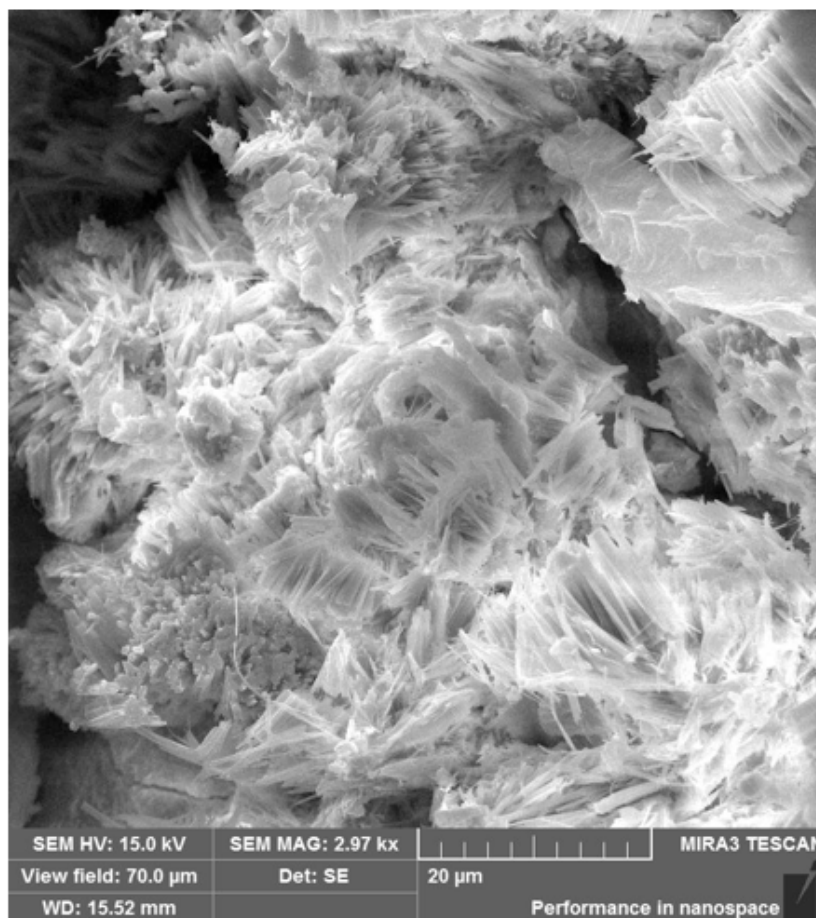
An accumulation of needle-like sulfate salts, possibly ettringite $\text{Ca}_6\text{Al}_2(\text{SO}_4)_3(\text{OH})_{12} \cdot 26\text{H}_2\text{O}$ or even thaumasite: $\text{Ca}_3\text{Si}(\text{OH})_6(\text{CO}_3)(\text{SO}_4) \cdot 12\text{H}_2\text{O}$ phases, were observed in the pores, located here in a small amount, and not detected using diffractometry, however, they are seen in the SEM micrographs in Figure 16.

Figure 16. A crystalline form from inside a pore of the concrete, specimen 4: (a) SEM-SE image and (b) elemental content of the entire shown area.

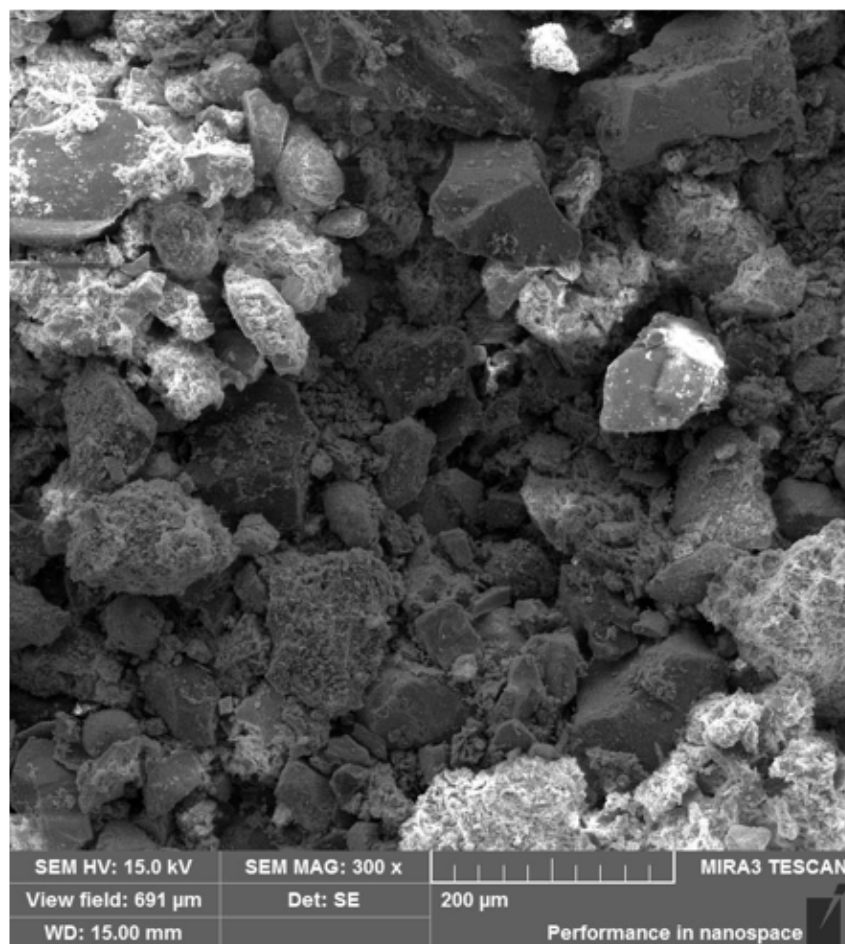
Observation of W2 sediment from the river indicated it was not composed of round gravels nor sands typical for river debris, but it rather formed dust and ashes with both oxidized and hydrated phases, or even slag polluting the river, as shown in Figure 17.

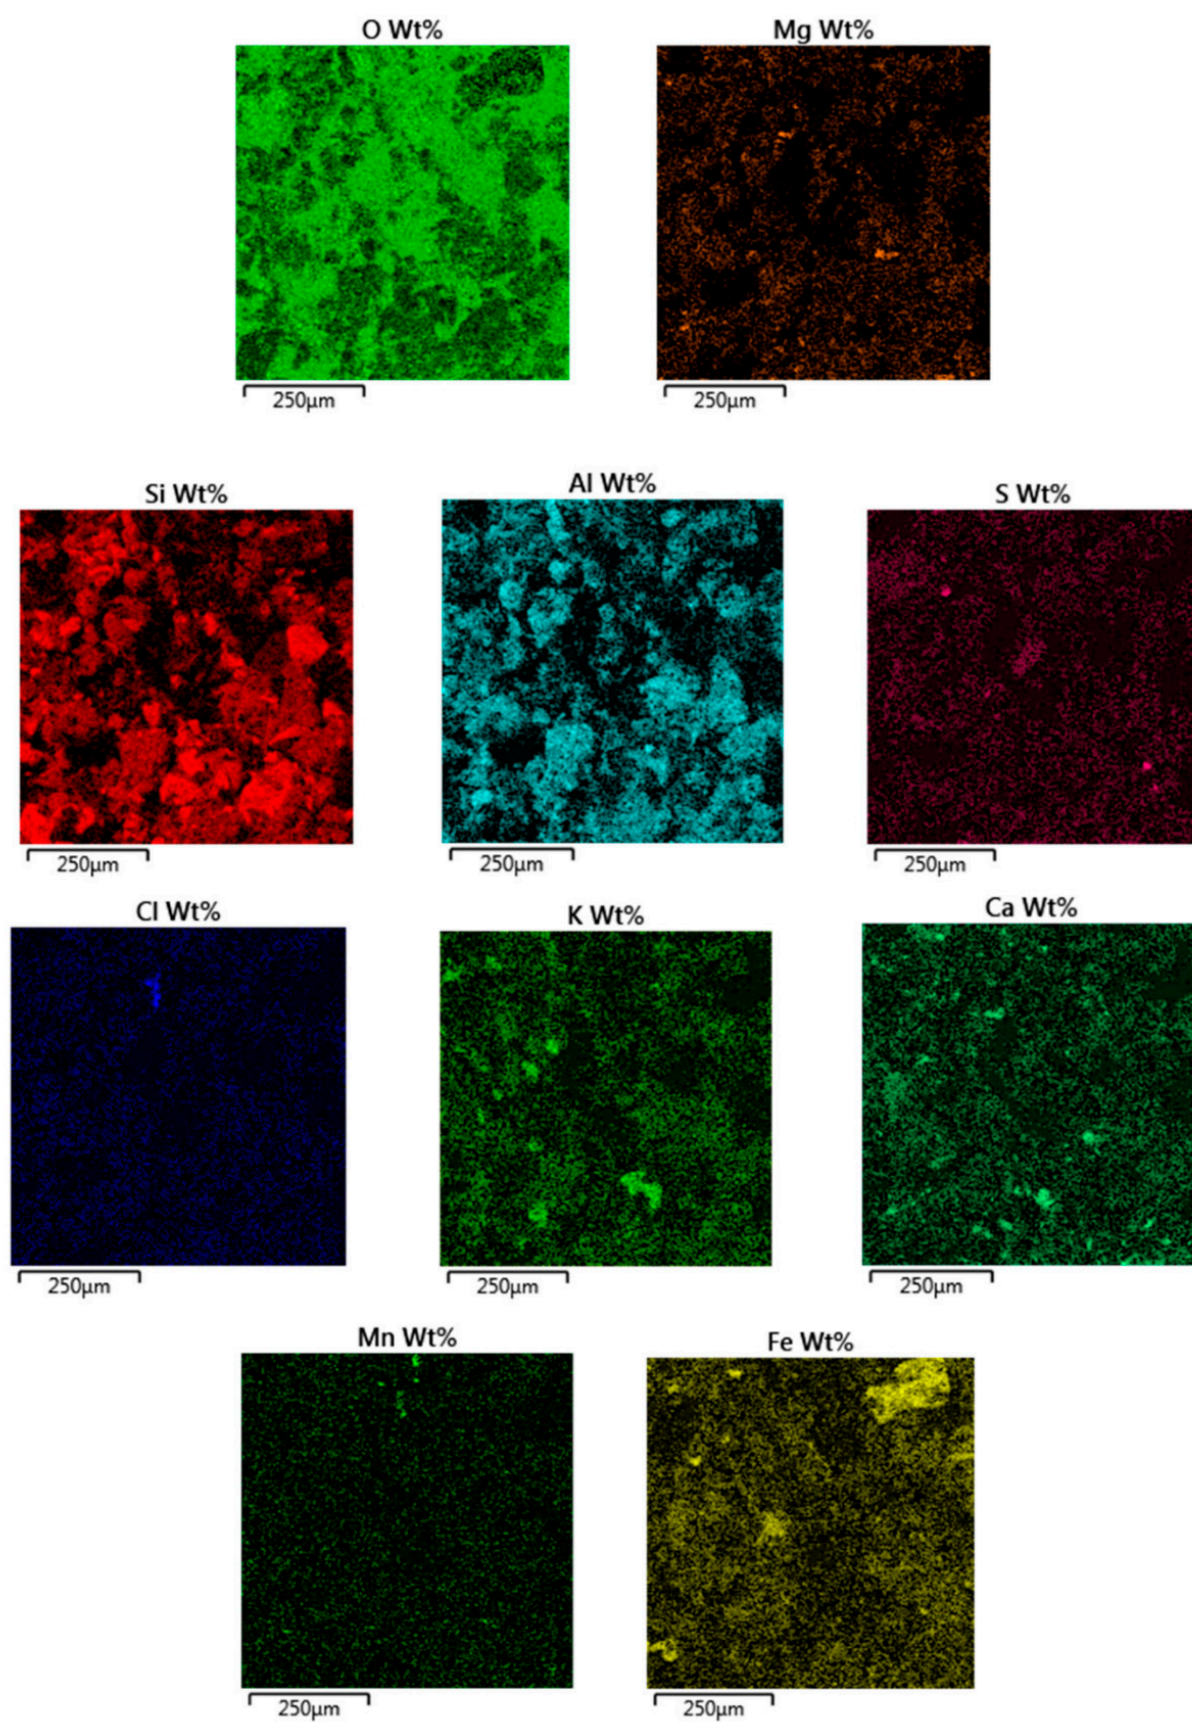
The detected Zn, Co, Cu, Ti, P, and Na elements were uniformly distributed throughout the mass, but the rest of the elements were not uniformly distributed, they formed clusters, interlayered in the minerals, and pointed to mineralogical separateness, as seen in Figure 18.

Inclusions in the sludge may indicate the presence of iron ore but could also correspond to other compositions from the underground mine waters. Moreover, the zinc and lead ore deposits in the Bytom trough co-exist with the ore-bearing dolomite series of the middle Triassic.

Figure 18. Microanalysis of specimen W2 sediment from Kłodnica river: Elemental content maps over the area given in Figure 17a.
