# Active Thermography in Diagnostics of Timber Elements Covered with Polychrome

**Abstract:** The contribution of natural wood defects such as knots is an important factor influencing the strength characteristics of structural timber. This paper discusses the use of active thermography in the timber diagnostics, particularly in the determination of the knot area ratio (KAR) in elements covered with paint coatings. Moreover, on the basis of thermal images, the localization for the subsequent semi-destructive tests (SDTs) was established. Three different sources of external energy supply were used in the studies: laboratory dryer, air heater and halogen lamps. The active thermography tests were performed on elements made of three wood species (fir, pine and spruce). The specimens were covered with varying layers of paint coatings and primers, to reflect the actual condition of the historic structural elements. The obtained thermal images enabled the estimation of the KAR, due to the difference in temperature between solid wood and knots occurring therein. It should be noted that the results were affected by an external energy source and subjective judgement of the operator. Moreover

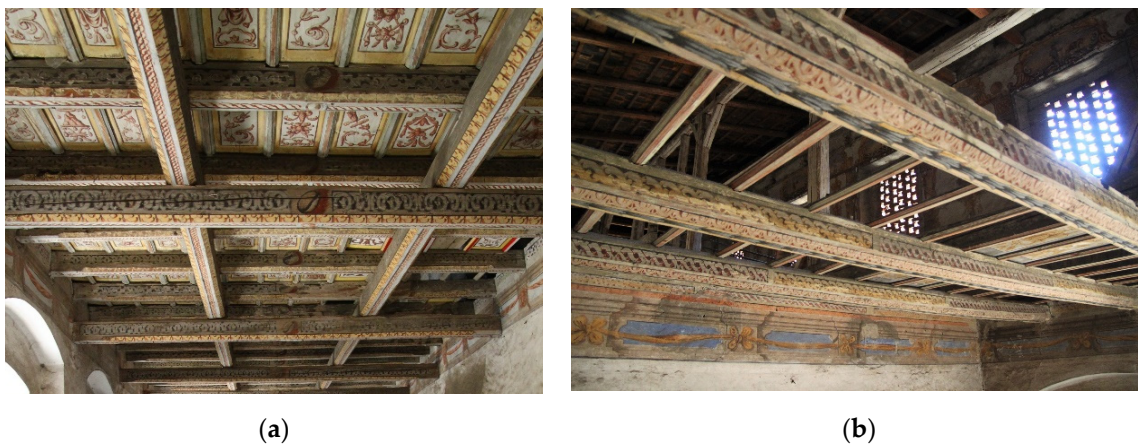
**Figure 1.** Examples of polychrome ceilings requiring technical condition analysis in Gorzanów Palace, 2015: (a) ceiling in a lounge chamber, (b) ceiling in a theatre chamber.

The problem of determining the existing load-bearing capacity of timber structural elements, usually ceilings and roof frames, appears during each restoration or modernization of historical buildings and structures [12]. It should be taken into account that, in such objects, the natural structure of the wood, which enables the proper selection of the location for SDTs or the determination of the knot area index (KAR), is often covered. In particular, this concerns historical polychrome elements, which are of substantial cultural heritage. Figure 1 shows two examples of historical Renaissance wooden ceilings of the Gorzanów Palace, which, before further conservation and subsequent exploitation, required an evaluation of their technical condition, to confirm their satisfactory quality and thus their safety.

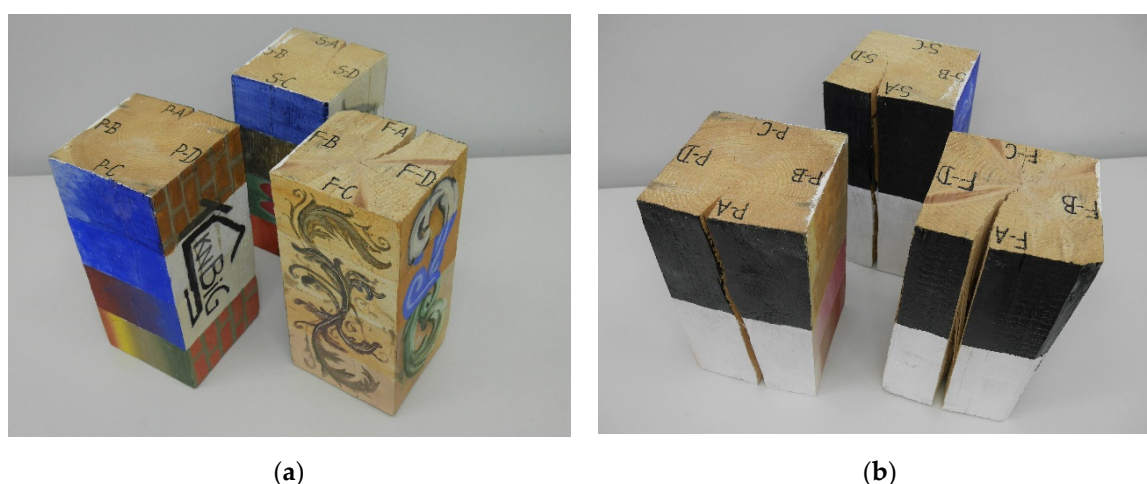
**Figure 2.** Test element with applied paints: (a) front view and (b) back view.

Figure 2 presents the test specimens with applied paint coatings with a visible designation of side surfaces. Table 1 summarizes the primers and layers of paint coatings applied on the respective side surfaces. Such an arrangement was maintained for all wood species used in the research program.
