Article

Microstructures and Mechanical Properties of Deposited Fe-8Cr-3V-2Mo-2W on SCM420 Substrate Using Directed Energy Deposition and Effect of Post-Heat Treatment

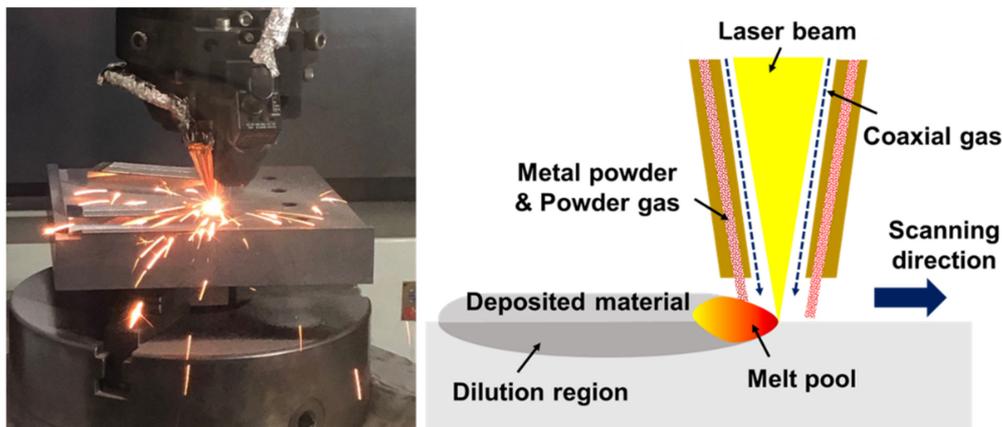
Figure 1. Schematic diagram of the directed energy deposition (DED) process.

Direct metal tooling (DMT) MX3 equipment, which is the DED machine developed by Insstek (Daejeon, South Korea), was used in this study. Figure 1 shows the schematic diagram of the process and a photograph of the equipment. This equipment consists of a 4 kW CO₂ laser that serves as the heat source, a numerical control system, the MX-CAM software, a 5-axis NC machine tool, a powder feed system with three hoppers and a coaxial powder nozzle. The laser beam diameter was 1 mm. The principle of the DED process is similar to that of laser cladding. A melt pool is formed on the substrate surface by locally irradiating a high-power laser beam onto the substrate and metal powder (or wire) is simultaneously supplied to the melt pool in real time through the powder gas from the powder feed system for melting. The melt pool in which the substrate and the metal powder are mixed is rapidly cooled to form a deposited bead with a dense and fine crystalline structure. During the deposition process, argon gas was used to deliver the powder and also, to prevent the oxidation of the supplied powder. The deposited beads form a deposition layer along a specific path and this process is repeated and each layer is deposited in the vertical direction in a crisscrossing path, to form a three-dimensional structure. Table 1 shows the process parameters applied in the experiment.

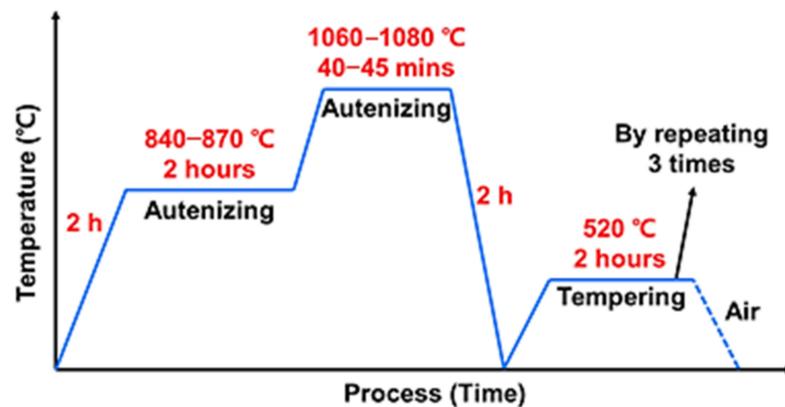
Figure 2. Schematic representation of the heat-treatment process.

To observe the changes in the properties due to heat treatment after the deposition of the Fe-8Cr-3V-2Mo-2W powder, heat treatment was performed through quenching and tempering. As shown in Figure 2, austenizing was performed at 840 $^{\circ}\text{C}$ for two hours and at 1060 $^{\circ}\text{C}$ for 40–45 min in a nitrogen purging chamber, followed by oil quenching at two bars. The tempering process of cooling in the air at 520 $^{\circ}\text{C}$ for two hours was then repeated thrice.

In the carburizing process of SCM420, primary carburizing was performed by maintaining the substrate at 1193 K for 36 min in a 1% carbon atmosphere after degreasing. Secondary carburizing was performed by maintaining the substrate at 1133 K for 22 min and oil quenching was then performed. Finally, tempering was performed at 433 K for 17 min.

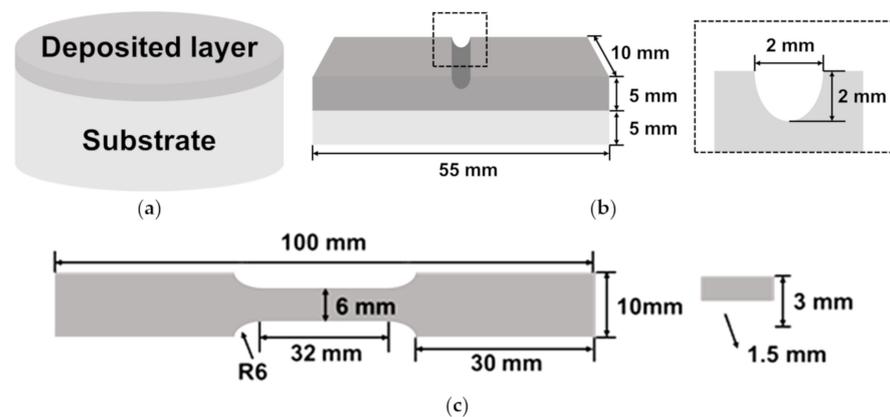
Figure 3. Schematic representation of the specimens for the (a) wear test, (b) U-notch Charpy impact test and (c) tensile test.

The specimen for the wear test was fabricated with a 10 mm height, including the 1 mm deposited region on top of the cylindrical substrate with a 30 mm diameter and a 9 mm height, as shown in Figure 3a. Prior to the wear test, the surfaces of all the specimens were polished and cleaned with ethanol. The test was conducted for an hour at a rate of 60 rpm using an alumina (Al₂O₃) ball (7 mm diameter) with a load of 10 kgf with the help of a ball-on-disc tester. The lost weight and the worn depth were measured to compare the wear resistance and the wear track was observed using a field emission scanning electron microscope (FE-SEM).

The Charpy impact test was conducted to evaluate the fracture toughness and the interfacial bonding between the deposited region and the substrate. As shown in Figure 3b, the specimens were fabricated to include the 5 mm deposited region. The test was repeated thrice under each condition and the average values were extracted. It was conducted at a temperature of $22 \pm 1 \text{ }^\circ\text{C}$ and a humidity of $43 \pm 3\%$, in accordance with the ASTM A370 standard. After the test, the impact absorbed energy was calculated and the fracture surface was observed using SEM.

For the tensile test, specimens with the 1.5 mm deposited region and the 1.5 mm substrate were fabricated in accordance with ASTM E8, as shown in Figure 3c. The test was conducted at a rate of 1 mm/min using a 50 kN tensile tester (MTS, 322.21, Eden Prairie, MN, United States). After repeating the test thrice, the strength and the elongation were extracted through the average values. After the test, the fracture surface was observed using the FE-SEM.

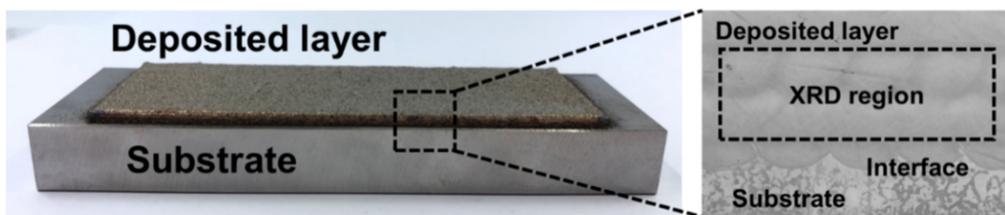
Figure 4. Cross section of deposited specimen for XRD analysis.

Figure 4 shows the morphology of the specimen fabricated by depositing the Fe-8Cr-3V-2Mo-2W powder on the SCM420 substrate. The SEM image of the interface shows that there are no cracks or pores present in the deposited region and near the interface between the deposited region and the substrate. XRD analysis was conducted to examine the phase, the carbide and the microstructure formed in the deposited zone. Figure 5 shows the XRD patterns of the C-SCM420, the as-built (M2), the as-built (FeCrVMoW) and the as-built (FeCrVMoW)-PHT, respectively. Figure 5a shows the ferrite (α), the martensite (α') and the austenite (γ) peaks, but there was no carbide detected. Owing to the high carbon content of the carburized layer, the retained austenite transforms into stable martensite when cooled to room temperature. In addition, a high martensite peak was detected because most of the austenite transformed into martensite during the oil quenching after the carburizing [35]. In contrast, to the other specimens that did not exhibit a carbide peak, the peak of tungsten carbide was observed in the austenite peak in the as-built (M2)(Figure 5b). According to C. Navas [32], the type of carbide detected in Figure 5b is considered the M_6C -type Fe_3W_3C carbide. The M_6C carbide can become a nucleus for the crystallization of the austenite because it is not completely dissolved during the deposition process [36]. This allows for the tungsten carbide detected through the XRD pattern in Figure 5b, to have the same peak as that of austenite. In the as-built (FeCrVMoW) and the as-built (FeCrVMoW)-PHT (Figure 5c,d), only the austenite and martensite peaks were detected. The austenite and martensite structures are formed by the melting and the quenching of the metal powder as well as the high temperature gradient with the substrate. The XRD patterns in Figure 5c,d show that the microstructure was changed by heat treatment after deposition. During the quenching to room temperature in the austenite state, there is not enough time for the diffusion of carbon. Therefore, carbon remains in the austenite. However, through three tempering processes, the retained austenite transforms into martensite and the martensite into tempered martensite. This showed a decrease in the austenite fraction and an increase in the martensite fraction in the matrix.

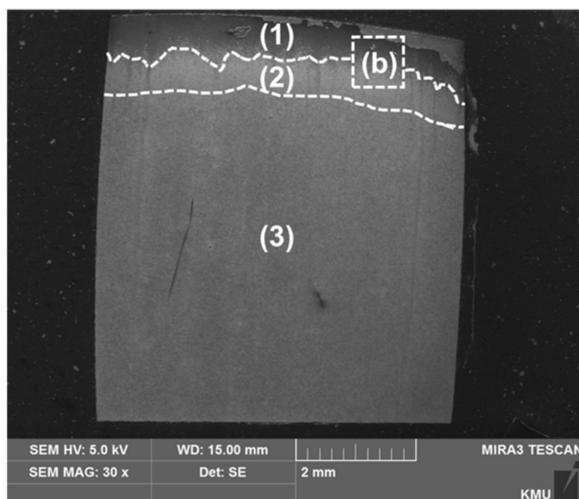
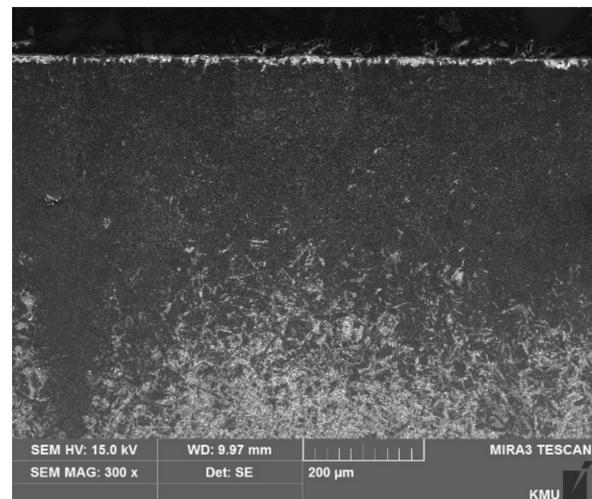
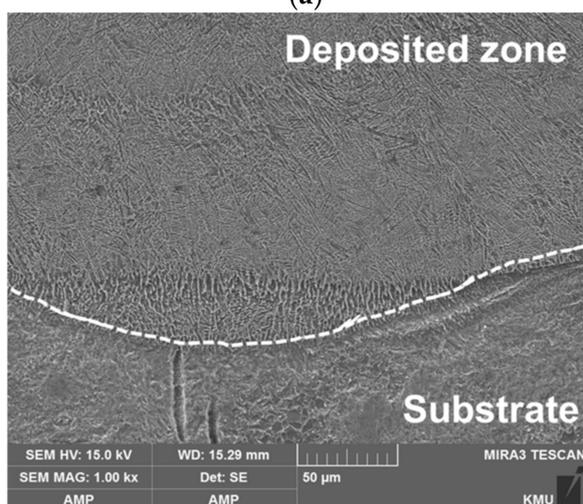
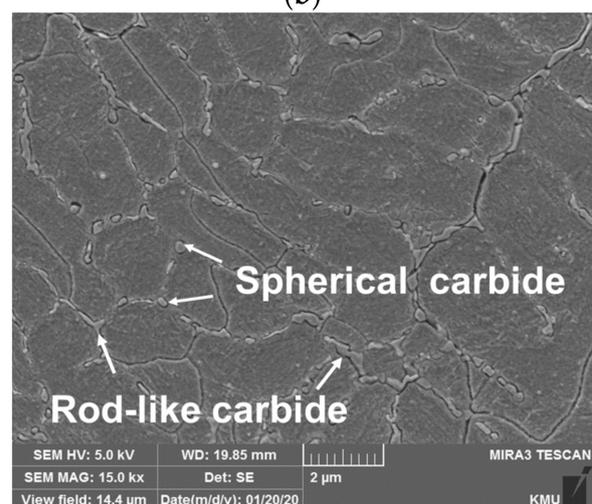
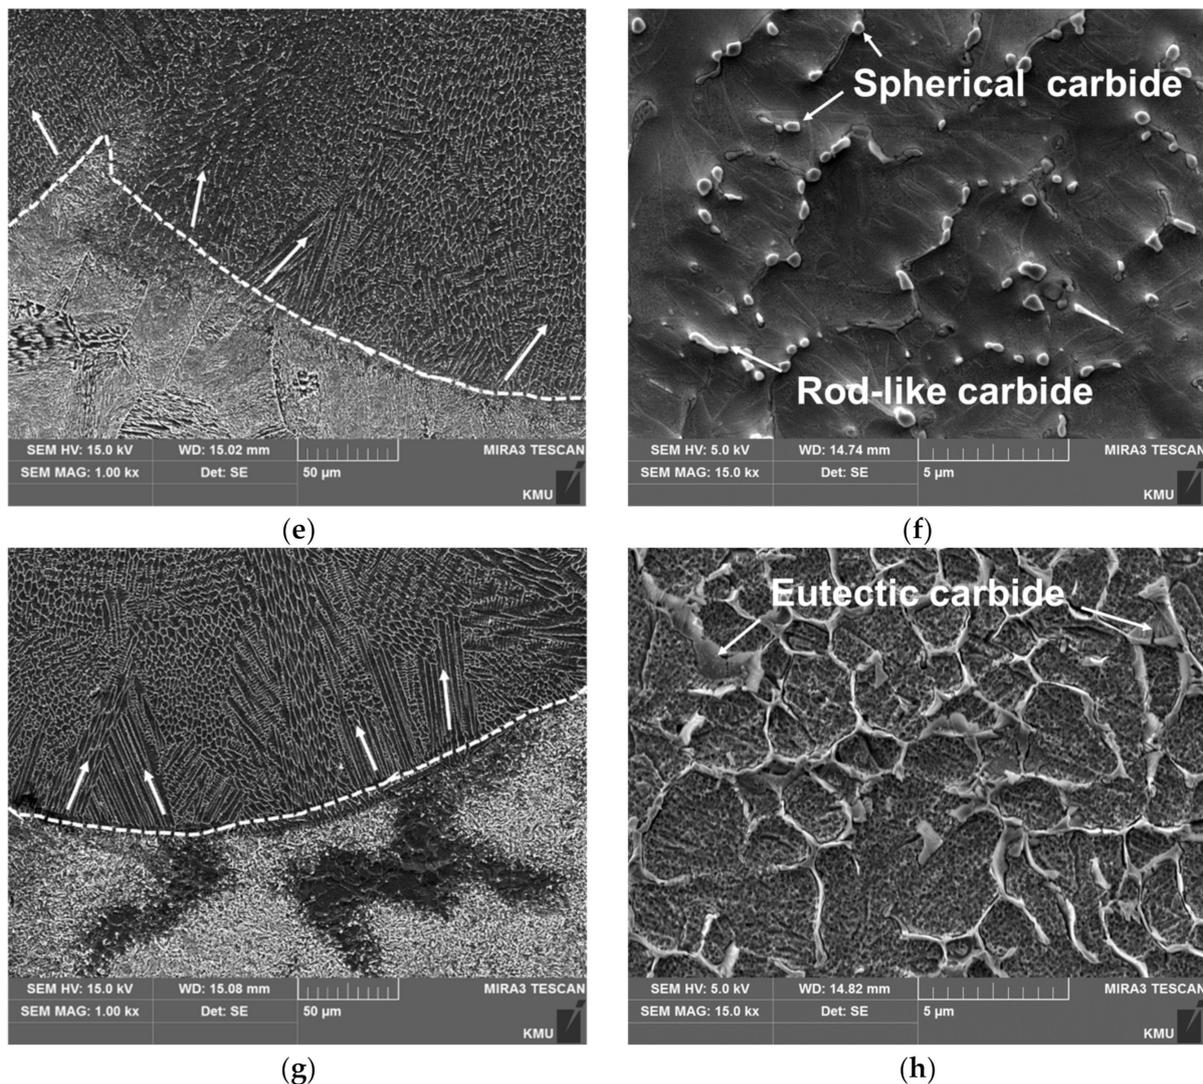
Figure 6 shows the microstructure of the cross-section of each specimen. Figure 6a shows the cross section of the carburized substrate, which is mainly divided into three zones: the carburized layer with the highest carbon content (1), the diffusion zone between the carburized layer and the substrate (2) and the substrate zone with the lowest carbon content (3). In zone (1), a high hardness can be expected. Zones (1) and (2) are difficult to distinguish based on the microstructure, but they can be divided through the hardness of each zone. Figure 6b shows the plate martensite, which is a typical high-carbon martensite, along with some retained austenite. Because the carburized zone has a high carbon content, the microstructure of the C-SCM420 always includes the retained austenite [37].

Figure 6c shows the M2 deposited zone and interface of the as-built (M2). The interface of the bead exhibits a high cooling rate owing to the high thermal gradient between the substrate and the deposited zone. Therefore, columnar dendrites were formed in the

direction of the heat transfer. Equiaxed grains were then formed in the center of the bead, where the cooling was relatively delayed. In the deposited region (Figure 6d), equiaxed grains were observed. A microstructure in which martensite is surrounded by an austenite network was observed and rod-like, as well as spherical carbides, were precipitated at the grain boundaries. Figure 6e shows the deposited region and interface of the as-built (FeCrVMoW). Similarly with the as-built (M2) as shown in Figure 6c, columnar and equiaxed grains were formed at the interface. The grain size in the deposited zone (Figure 6f) is larger than that in Figure 6d and small spherical and rod-like carbides were observed. The interface of the as-built (FeCrVMoW)-PHT shows similar microstructures (Figure 6g). However, the carbide precipitated in the as-built (FeCrVMoW)-PHT (as shown in Figure 6h) has a different shape from that of the one in the as-built (FeCrVMoW). Spherical and rod-like carbides were hardly observed, but agglomerated eutectic carbides were precipitated at the grain boundaries. This indicates that a phase transformation has taken place and a new carbide phase was generated during the heat treatment.

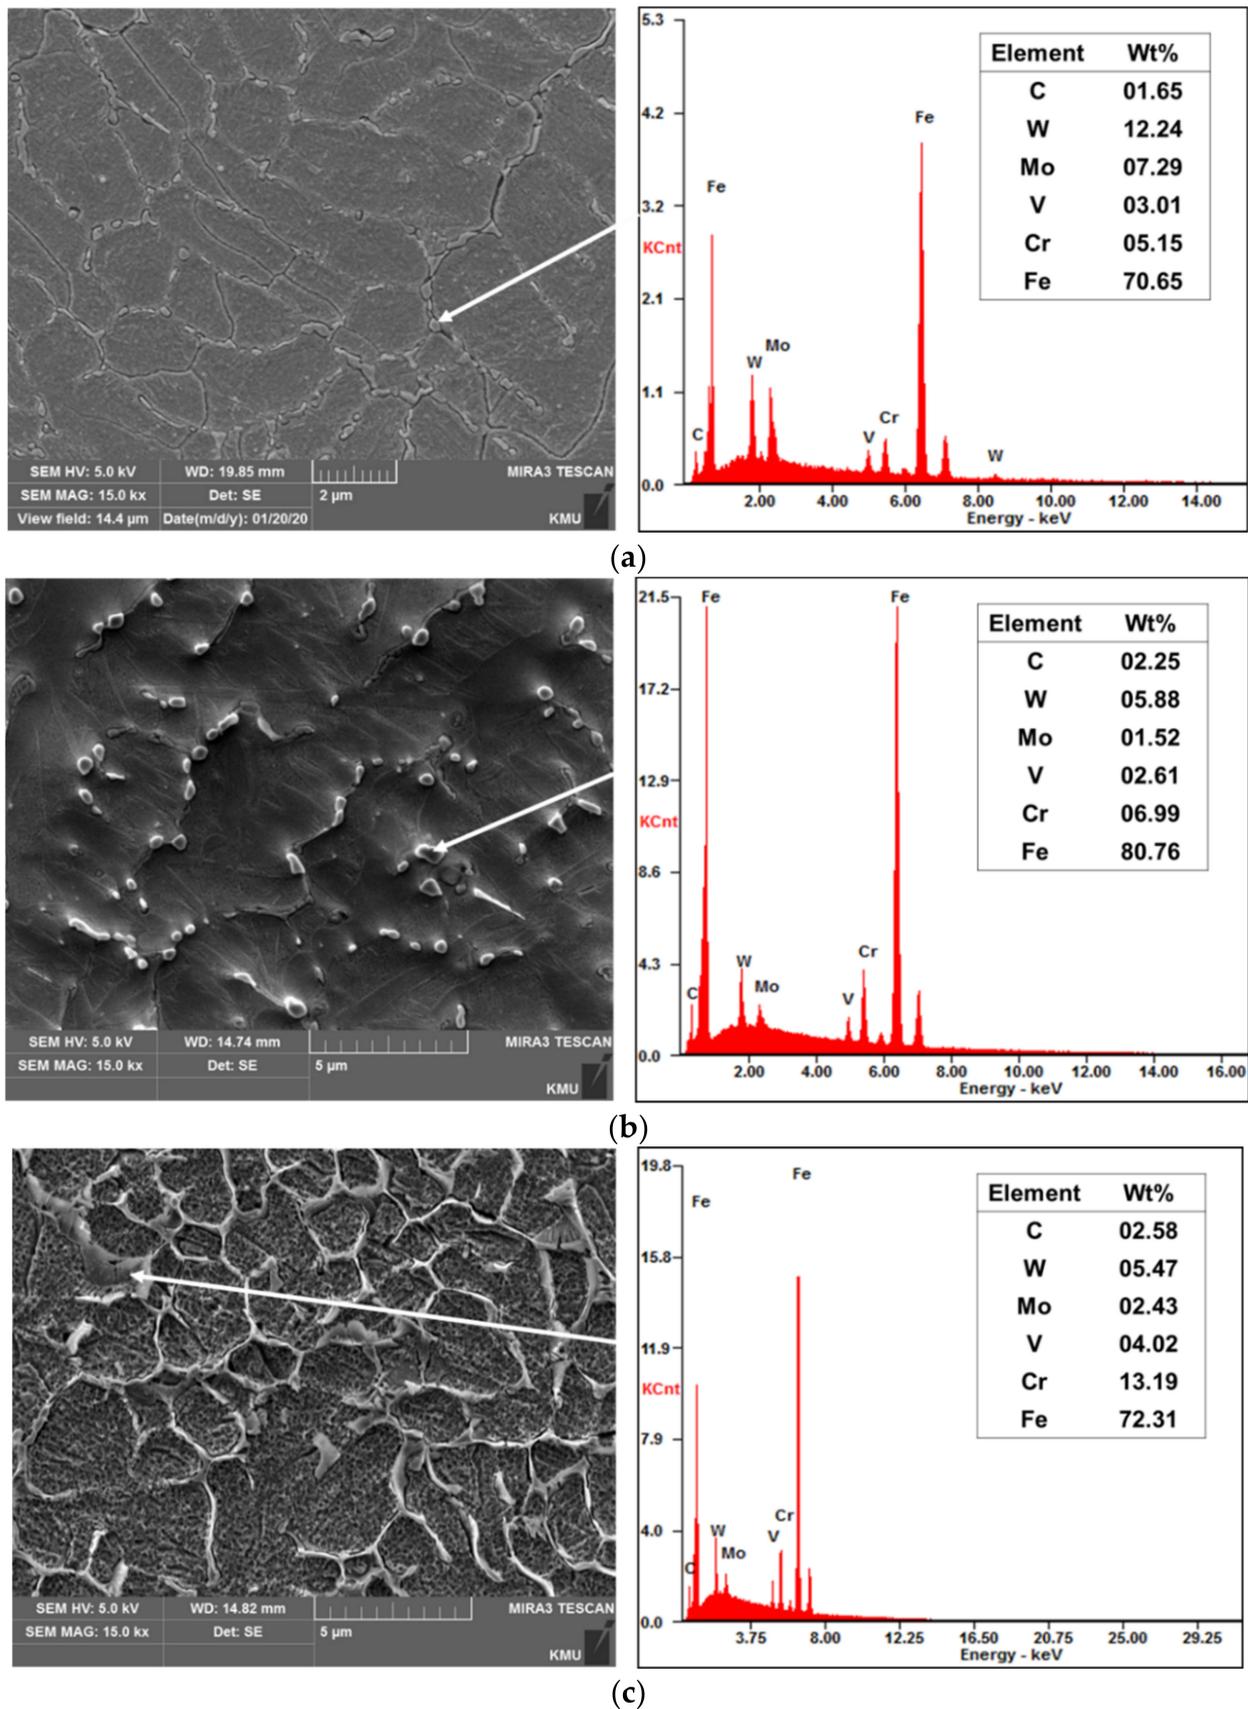
Figure 7. Results of the EDS composition analysis: (a) as-built (M2), (b) as-built (FeCrVMoW) and (c) as-built (FeCrVMoW)-PHT.

Figure 7 shows the EDS observation results for the carbides precipitated in the deposited region of the as-built specimens. Figure 7a shows the carbides of the as-built (M2). The precipitated carbides were composed of chromium, molybdenum, tungsten and vanadium, which are the main elements of carbides that can be generated in tool steel powder. The tungsten content was especially high, which can also be confirmed by the XRD pattern in Figure 5b. According to Kim et al. [38], the carbides in the deposited region of the as-built (M2) are inferred to be W-rich M_6C carbides. As for the carbides in the as-built (FeCrVMoW), Cr-rich carbides were precipitated in contrast to the carbides shown in the as-built (M2). Leunda et al. [39], has stated that the rod-like carbides are Cr-rich carbides. In the as-built (FeCrVMoW)-PHT, the agglomerated eutectic carbides are also Cr-rich carbides. Eutectic carbides that are precipitated in Cr-rich materials are M_7C_3 carbides [40,41]. As chromium carbides precipitated at grain boundaries are agglomerated in a narrow zone as eutectic carbides during the heat treatment process, they exhibit a higher chromium content than the carbides in Figure 7b.

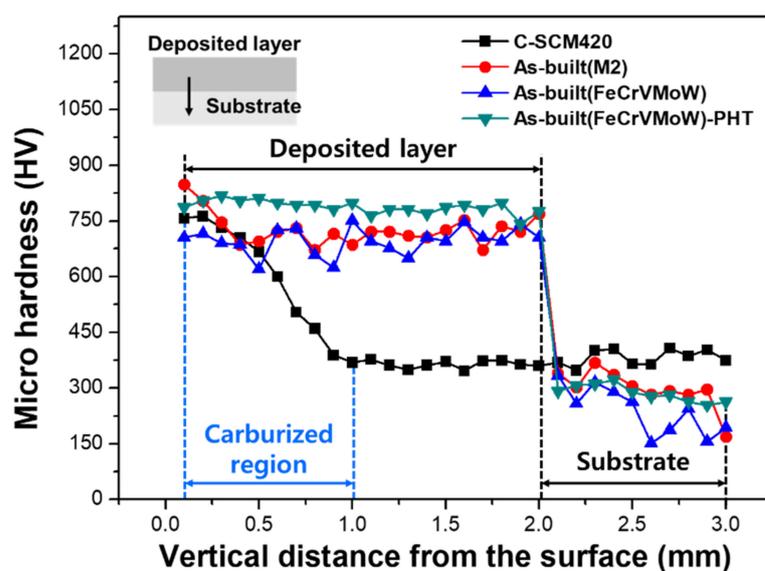
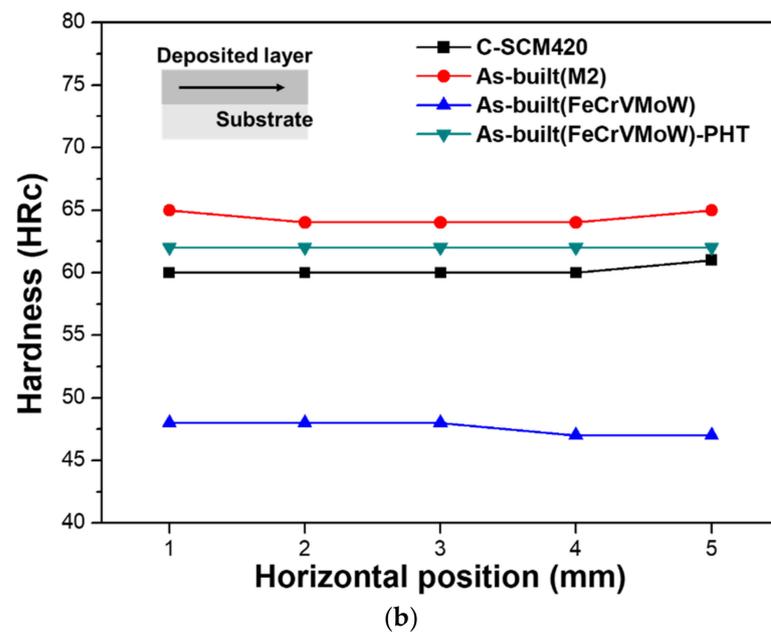
Figure 8. Hardness test profile in the (a) vertical direction and (b) horizontal direction.

Figure 8a shows the micro-hardness values measured along the depth direction from the carburized layer or the deposited region, to the substrate. In the C-SCM420 specimen, as the carbon content decreased from the top surface to the center, the hardness simultaneously decreased towards the center. The specimens fabricated by DED exhibited higher hardness in the deposited region than in the substrate regardless of the powder or heat treatment and the hardness sharply decreased at the interface. The slight difference in the hardness values at each position can be attributed to irregularity in the powder supply and fluctuations in the laser power. In addition, the irregular distribution of carbides in the deposited zone may also cause different hardness values at each position. The decrease in the hardness at the interface is due to the formation of a mixed layer caused by the simultaneous melting of the substrate and the powder. As the substrate has a relatively lower hardness than the deposited powder, the hardness decreases, depending on the mixing ratio of the substrate and deposited powder. The deposited region of the as-built (M2) exhibited a high hardness of 780 HV even though heat treatment was not applied. This could be due to the presence of elements such as V and W, contained in M2, as well as the presence of martensite and the precipitated carbides. The average hardness of the deposited region of the as-built (FeCrVMoW) was 672 HV, but it increased to 780 HV through post heat treatment. Previous studies on the deposition of tool steel [20,39] reported that secondary hardening occurred because the retained austenite transformed into tempered martensite along with the precipitation of secondary carbides. Therefore, the martensite fraction and the concentration of chromium carbides increased by heat treatment after deposition, which were confirmed through XRD analysis, microstructure observation and EDS results, are the causes of the increase in the hardness. Figure 8b shows the Rockwell hardness distribution on the surface of the deposited region. The surface hardness was 60 HRC for carburized C-SCM420 and 64 HRC for the as-built (M2). The as-built (FeCrVMoW) had the lowest surface hardness of 48 HRC, but this increased by 29% to 62 HRC after heat treatment due to the increased martensite fraction. Although the as-built (FeCrVMoW)-PHT had a lower martensite fraction and a smaller amount of carbide alloy elements than the as-built (M2), its hardness was similar to that of the as-built (M2).

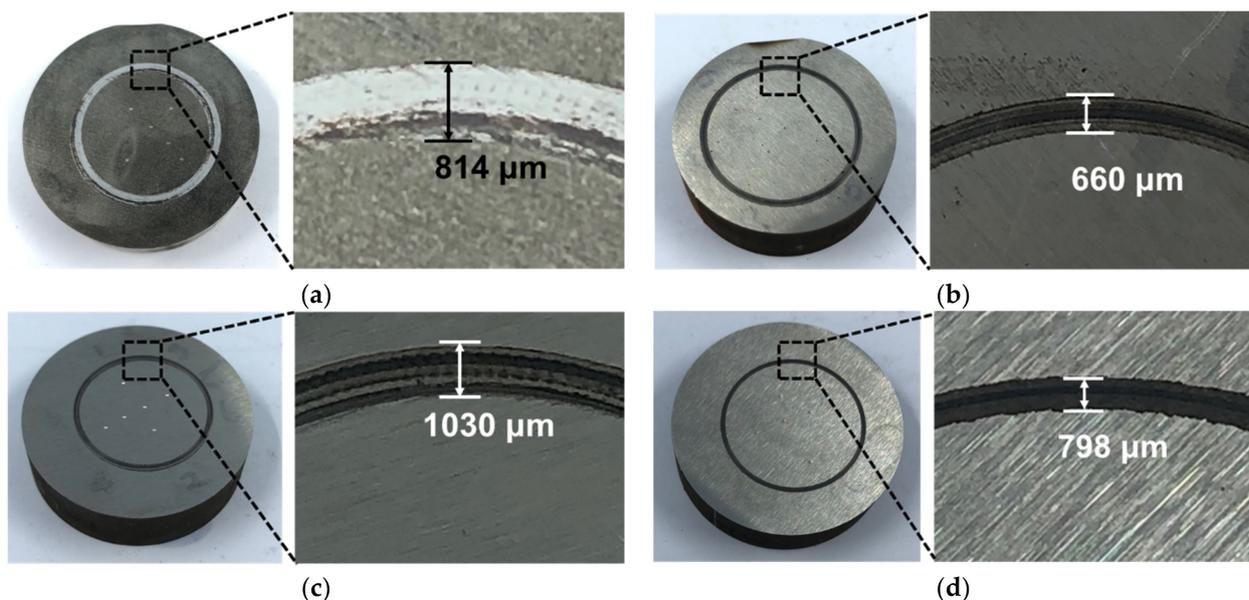
Figure 9. Images of wear scars after ball-on-disc wear test; (a) C-SCM420, (b) as-built (M2), (c) as-built (FeCrVMoW) and (d) as-built (FeCrVMoW)-PHT.

The wear test was conducted to compare the wear resistance under each condition. After the test, the weight of each specimen before and after the test, was compared and the wear rate was examined by observing the width of the wear track generated on the surface. In all the specimens, the wear tracks were generated by the friction between the ball and the surface of each wear specimen, as shown in Figure 9. The wear track of C-SCM420 formed a wear width of 814 μm and that of the as-built (M2) formed the narrowest width of 660 μm . The as-built (FeCrVMoW) formed the widest wear track of 1030 μm , but this decreased to 798 μm after the heat treatment. In other words, the width of the wear track decreased as the surface hardness increased.

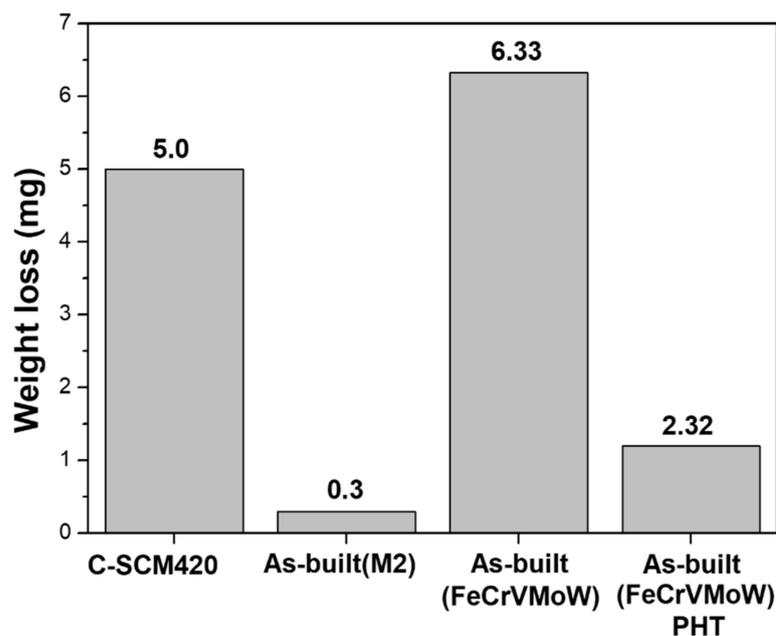
Figure 10. Comparison of weight loss of each specimen.

Figure 10 compares the weight loss of each specimen. The weight loss of C-SCM420 was 5.0 mg, which has an even high surface hardness. The as-built (M2) with the highest surface hardness exhibited the lowest weight loss of 0.3 mg. The weight loss of the as-built (FeCrVMoW) with the lowest surface hardness was 6.33 mg, indicating that it is the most vulnerable to wear. The weight loss of the heat-treated specimen, however, decreased to 2.32 mg. Here, the wear track width and weight loss of the C-SCM420 are notable. The C-SCM420 exhibited a small wear track width due to its high surface hardness, but it showed a relatively large weight loss. This indicates that once the thin carburized layer on the surface is abraded by the ball, the wear rapidly proceeds in the substrate which is less carburized. Conversely, in the deposited specimens, no remarkable loss was observed because of the thick hardened layer (1 mm). These results show that the hardfacing through DED is superior to the conventional carburizing method in terms of wear resistance.

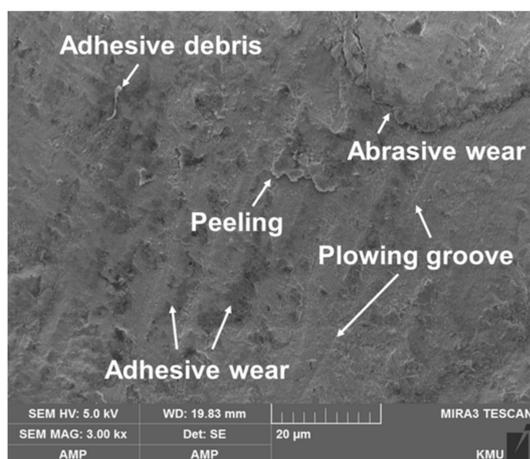
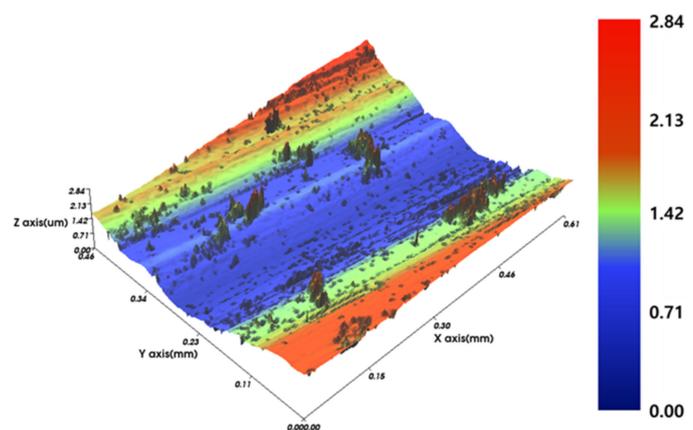
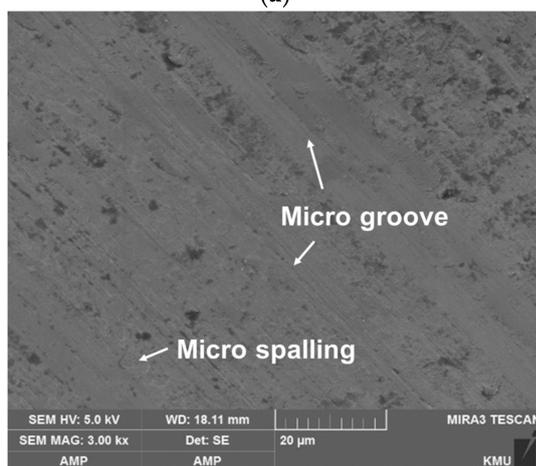
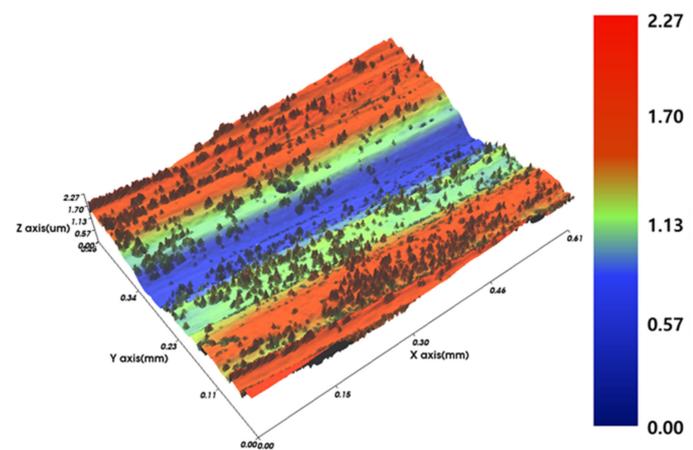
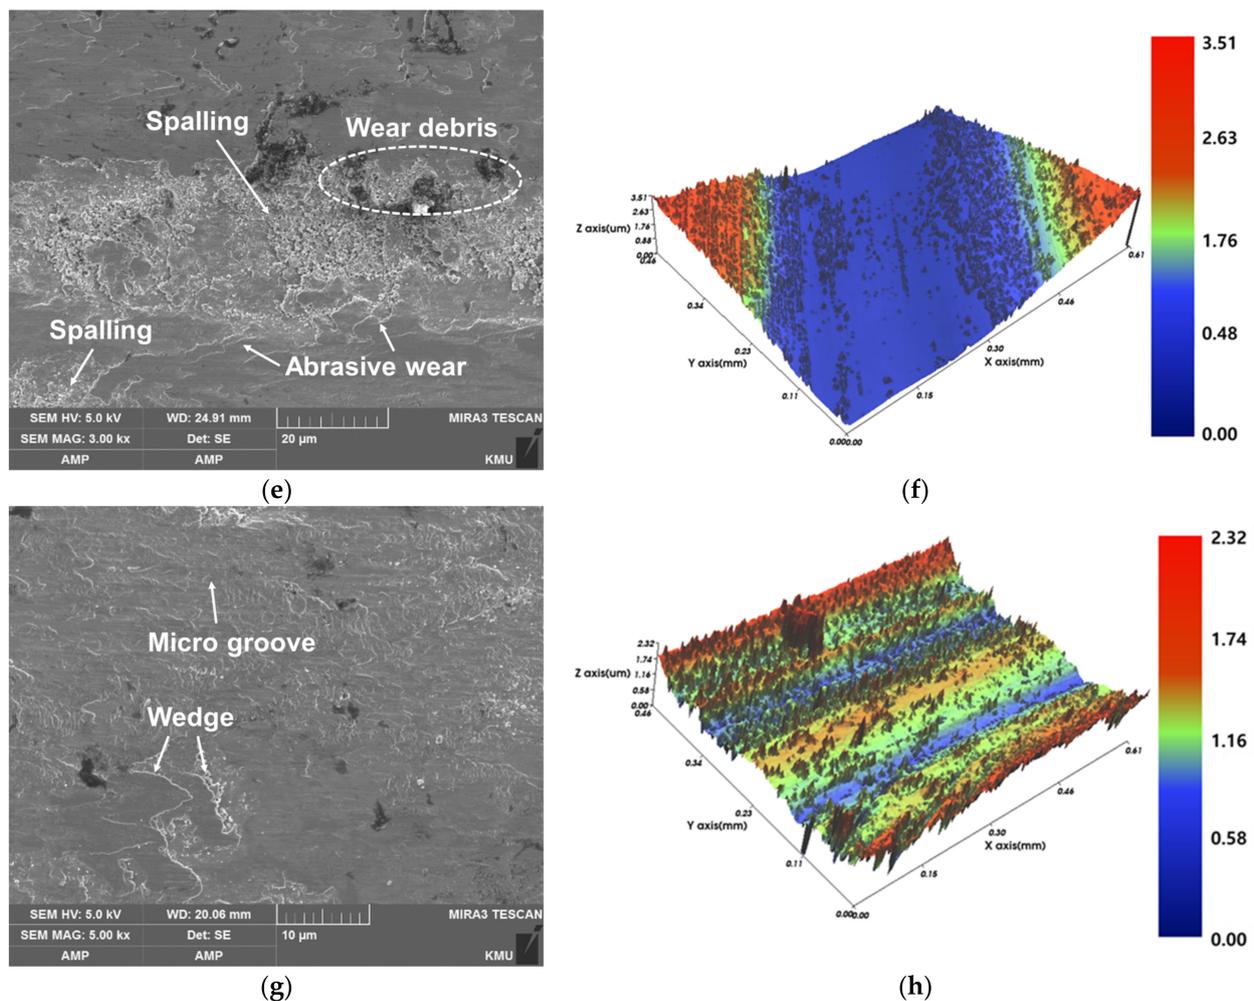
Figure 11. SEM micrographs and 3D topographies of the worn surface: (a,b) C-SCM420, (c,d) as-built (M2), (e,f) as-built (FeCrVMoW), (g,h) as-built (FeCrVMoW)-PHT.

Figure 11 shows the SEM images and the 3D topography of the worn surfaces. The alumina ball used in the wear test begins to slide and applies a load to the surface of each specimen. During the test, elastoplastic deformation occurs at the positions where there is friction, resulting in peeling, grooves and debris. The wear surfaces of the as-built (FeCrVMoW) and the C-SCM420, which exhibited high weight losses after the wear test, were much rougher than those of the as-built (FeCrVMoW)-PHT and the as-built (M2). The C-SCM420 (Figure 11a) shows a combination of abrasive wear and adhesive wear. In addition, micro-carbides were released due to a large and a long load on the surface, resulting in abrasive debris. The released microcarbides generated deep grooves on the surface of the specimen, thereby causing a large loss of weight, due to which, the plowing groove (PG) caused by the tearing and the peeling of the material on the surface were also observed. The wear debris is adhered along the sliding direction on the surface of C-SCM420 due to severe wear. The adhered debris is irregularly distributed in the lowest zone (blue region) in Figure 11b. In contrast, the as-built (M2) specimen shows peeling, slight spalling and microgrooves and the deepest wear track (blue zone in Figure 11d), exhibits the narrowest width. The W-rich and Mo-rich carbides are harder and more resistant to wear than Cr-rich carbides [42]. In addition, the wear resistance of the tool steel containing a high proportion of alloying elements and complex carbides is highly dependent on the composition and the types of the carbides [20]. Therefore, it can be inferred that the as-built (M2), containing carbides mixed with a high composition of

alloying elements, has the highest wear resistance. The as-built (FeCrVMoW) (Figure 11e) shows wide and deep grooves. Additionally, some debris was observed to be adhered to the surface and the spalling. The rod-like carbides which appear to be precipitated at the grain boundaries of the as-built (FeCrVMoW), were released and they deeply eroded the material surface under the continuous load, resulting in spalling and the generated debris was adhered onto the track. Conversely, the as-built (FeCrVMoW)-PHT (Figure 11g), shows spalling at a shallow depth across the image and the generated debris is adhered to the edge of the wear track. It can be observed in Figure 6h, that the surface was not smoothly worn due to the unevenly distributed eutectic carbides. In addition, wedges, which are plastic flows, were observed along with microgrooves. As the abrasive debris generated around the wedges continuously scratch the surface and are pushed out of the matrix, they can cause significant loss of material during the wear test. However, there was no severe wear as the phase transformation of martensite improved the wear resistance [43]. In addition, as the carbides in the microstructure were evenly and widely distributed, they appear to have effectively protected the matrix from repeated friction, thereby increasing the wear resistance.

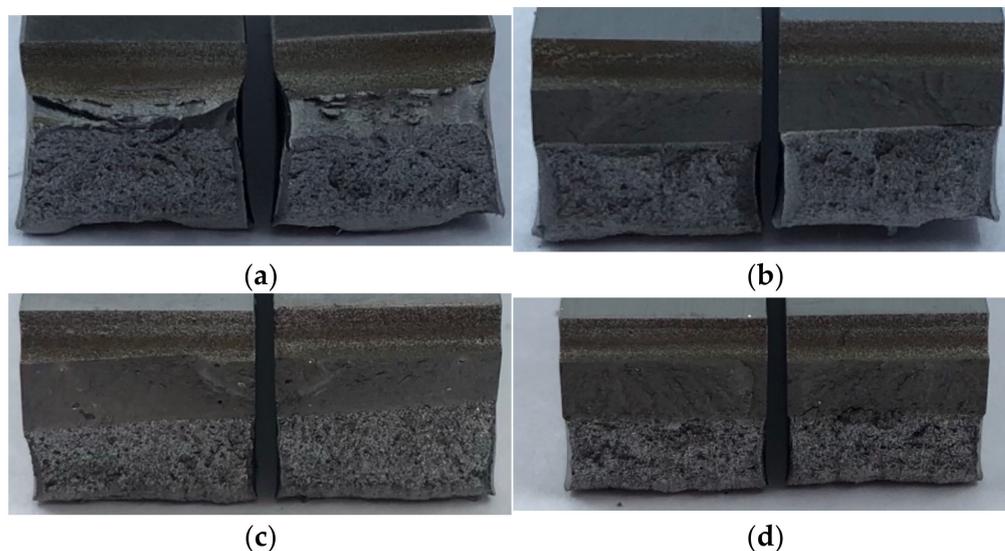
Figure 12. Fracture specimen after the Charpy test: (a) C-SCM420, (b) as-built (M2), (c) as-built (FeCrVMoW) and (d) as-built (FeCrVMoW)-PHT.

The Charpy impact test was conducted to evaluate the fracture toughness of the material. The impact applied to each specimen was allowed to propagate to the substrate by causing a crack in the notch. Figure 12 shows the fractured surfaces of the specimens after the impact test. The crack that initiated at the notch did not propagate along the interface between the deposited layer and the substrate (Figure 12b–d). This indicates that the interface had excellent bonding strength. In C-SCM420, cracks occurred at the interface between the carburized layer and the substrate. The impact energy led to crack propagation towards the interface of the carburized layer. A large amount of impact energy can be absorbed by the substrate, which is relatively ductile when compared to the deposited region or the carburized layer. This can be confirmed by the cross-section (area reduction) of the plastically deformed specimen after the impact test. C-SCM420, which had a larger proportion of the ductile substrate than the deposited specimens, exhibited the largest plastic deformation (largest area reduction). This indicates that the impact energy was absorbed in the form of plastic deformation energy before the final fracture of the specimen. Conversely, the plastic deformation was not large for the deposited specimens. However, among these specimens, the as-built (M2) (Figure 12b) exhibited a larger plastic deformation than the as-built (FeCrVMoW) (Figure 12c) and the as-built (FeCrVMoW)-PHT (Figure 12d). Figure 12d indicates the smallest plastic deformation in the substrate. Significant plastic deformation was not observed due to the increased brittleness of the

substrate and the deposited region, caused by heat treatment after deposition. Therefore, a decrease in the fracture toughness, can be expected after heat treatment.

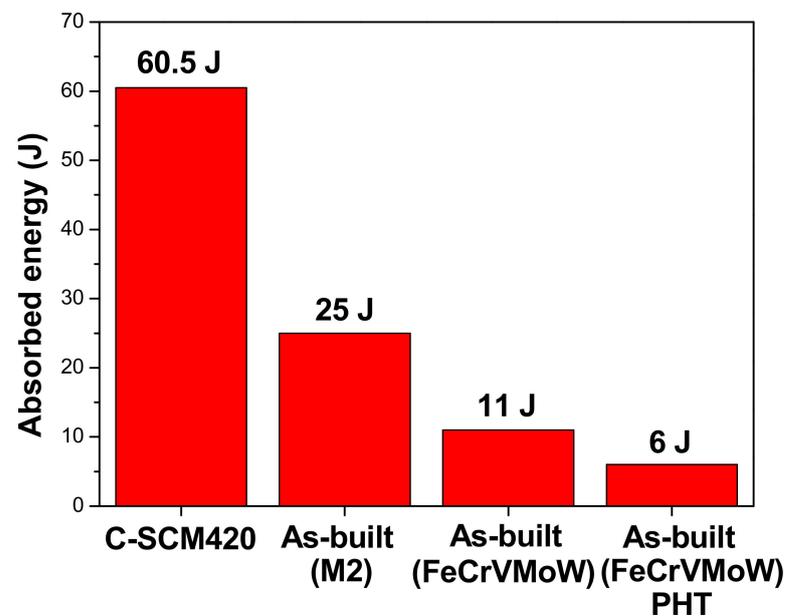
Figure 13. Comparison of average absorbed energies after the Charpy impact test.

Figure 13 shows the absorbed impact energy for each specimen. C-SCM420, which contained the largest region of the un-carburized substrate, exhibited the highest impact absorption energy, of 60.5 J. When an impact load is applied to the C-SCM420, the small carbides and the fine grains can absorb high impact energy as they increase the complexity of the crack propagation path. In the case of the as-built (M2), Figure 6d shows the presence of small grains and carbides. Therefore, it exhibited a high impact energy absorption of 25 J. Conversely, the as-built (FeCrVMoW), with large grains and carbides exhibited a low impact energy absorption of 11 J. Its impact energy absorption decreased by 45% to 6 J after heat treatment. The toughness of the as-built (FeCrVMoW)-PHT decreases due to the increased fraction of the martensite and the eutectic carbides precipitated at the grain boundaries. Particularly, the carbides precipitated at the grain boundaries cause stress concentration, thereby inducing the easy propagation of cracks at the grain boundaries. Therefore, the as-built (FeCrVMoW)-PHT has a lower impact energy absorption than the as-built (FeCrVMoW).

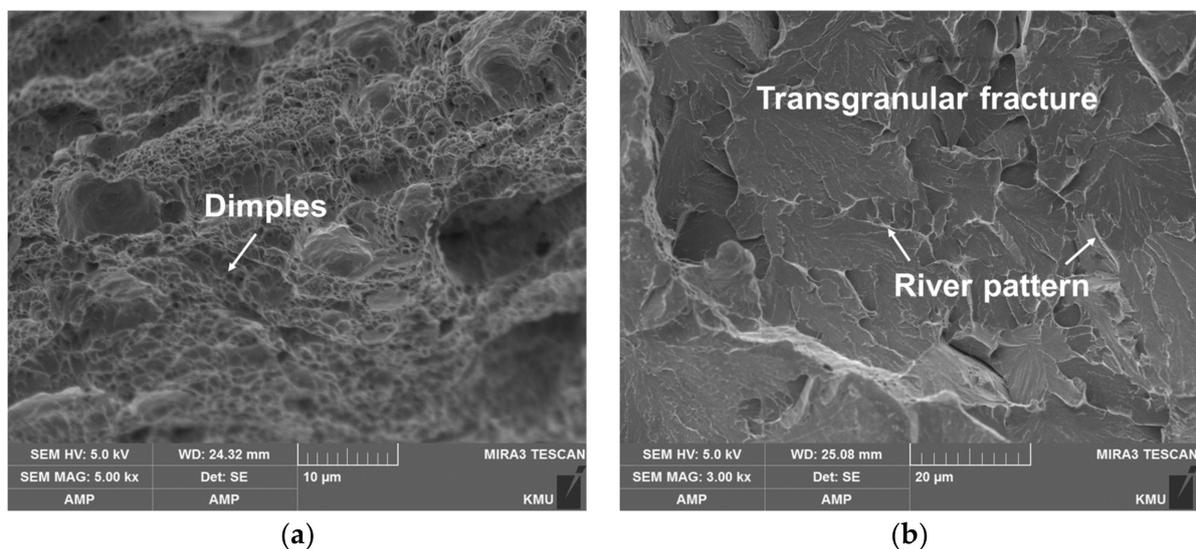
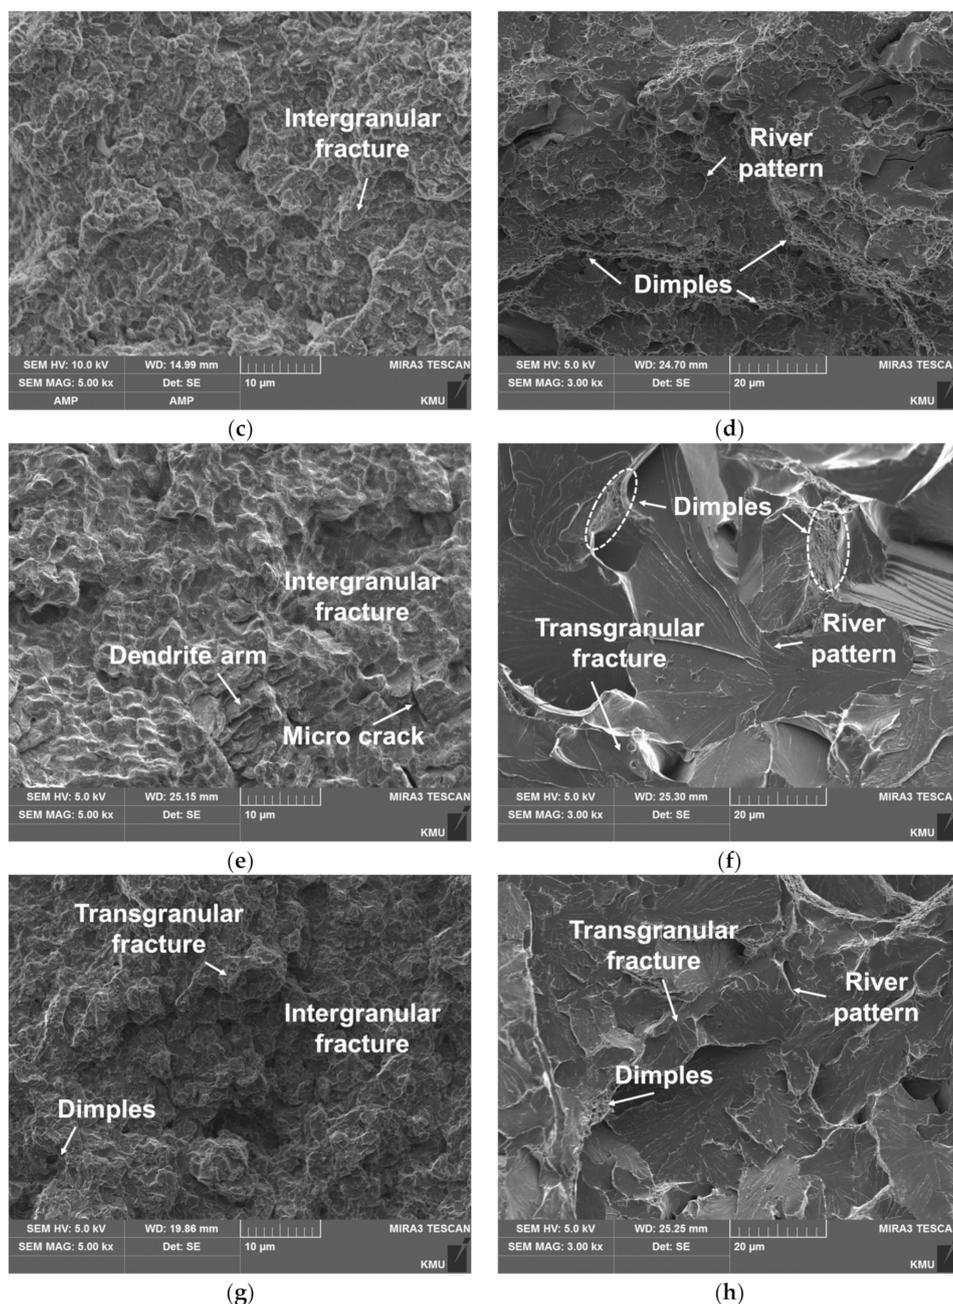
Figure 14 shows the SEM images of the fractured surface. The fractured zone just below the U-notch of C-SCM420 (Figure 14a) was composed of numerous dimples which indicate a ductile fracture. In contrast, since the cracks generated around the U-notch rapidly propagated along the downward direction, a transgranular fracture, a type of brittle fracture, was observed in the center region of C-SCM420 (Figure 14b). The deposited specimens also exhibited similar topography, with slight differences arising from the deposited material. The deposited regions mainly exhibited the geometry of the intergranular fracture. The as-built (M2) shows the geometry of a dense intergranular fracture. The complex fractured surface significantly contributes to the high toughness due to the fine grains and this is one of the mechanisms that can improve the fracture toughness of tool steel [29]. In addition, unlike the other specimens, the agglomerated dimples shown in Figure 14d, are distributed over a large area. Therefore, the specimen had a high toughness because of a ductile fracture caused by the dimples, unlike the substrate of other specimens which exhibited a brittle fracture. For the as-built (FeCrVMoW) (Figure 14e), dendrites with multiple arms were observed along with an intergranular fracture. Microcracks present in some areas reduce the toughness because they lead to a stress concentration. However, the as-built (FeCrVMoW) has a higher toughness than the as-built (FeCrVMoW)-PHT owing to the high fraction of the austenitic matrix. At the interface of the as-built (FeCrVMoW)

(Figure 14f), a transgranular fracture and a local area with concentrated microdimples, were observed. The deposited regions of the as-built (FeCrVMoW) and the as-built (FeCrVMoW)-PHT, have similar fracture surfaces, regardless of heat treatment. Overall, intergranular fractures and transgranular fractures were both observed, with intergranular fractures occurring more frequently. In addition, the deposited region of the as-built (FeCrVMoW)-PHT (Figure 14g), exhibited a greater complexity in the fractures. Brittle fractures and dimples agglomerated in a small area were also observed in the substrate.

also shown in the fractured surface of the impact specimen of the as-built (FeCrVMoW) (Figure 14e). The substrate of the as-built (FeCrVMoW) (Figure 17f) showed a transgranular fracture, which is a rapid brittle fracture, with river patterns. The deposited region of the as-built (FeCrVMoW)-PHT (Figure 17g) exhibited the finest intergranular fracture and its substrate (Figure 17h) showed a quasi-cleavage fracture and river patterns. Its strength was greater when compared to that of the as-built (FeCrVMoW), due to the fine grains.

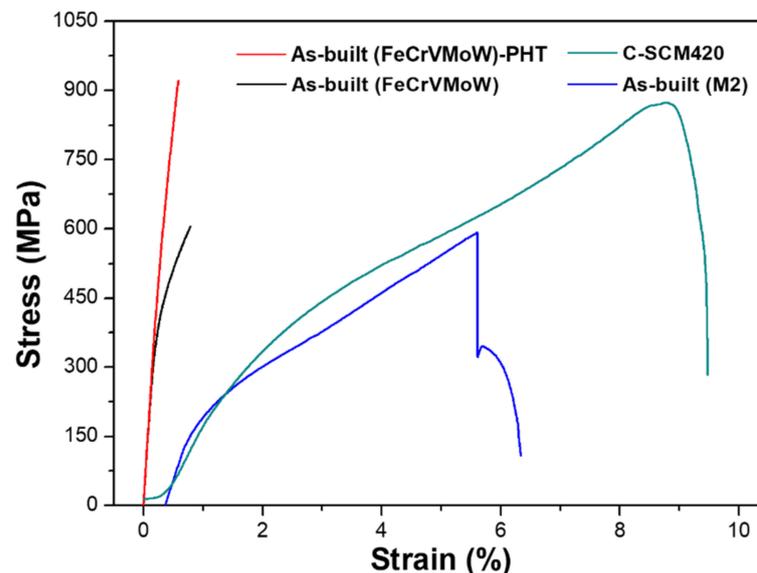
Figure 15. Engineering stress-strain curve of each sample.

Figure 15 shows the tensile test results. C-SCM420 exhibited high tensile strength (877 MPa), owing to the high martensite fraction present in the carburized zone of the surface. It also showed the highest elongation (9.5%) due to the un-carburized substrate. The as-built (M2) exhibited a tensile strength of 592 MPa and an elongation of 6.3%. It had the lowest tensile strength among the deposited specimens but exhibited a high elongation value. As confirmed by the results of the impact test, it exhibited high elongation under a static load along with a high impact toughness. The as-built (M2) appears to have low tensile strength since small carbides cannot be effectively bonded and may cause stress concentration. The cracks generated in the deposited region, which is more brittle than the substrate, propagated to the substrate, thereby causing the final fracture. The tensile

strength of the as-built (FeCrVMoW) was 607 MPa and its elongation was very low, at less than 1%. After the heat treatment, the tensile strength was increased by approximately 52% to 922 MPa, but the elongation decreased.

- (4) The tensile strength increased from 607 to 922 MPa after the post-deposition heat treatment. This is due to the finer grains as well as the decrease in the retained austenite and the increase in the martensite fraction described above.
