Article

Microstructures and Mechanical Properties of Deposited Fe-8Cr-3V-2Mo-2W on SCM420 Substrate Using Directed Energy Deposition and Effect of Post-Heat Treatment

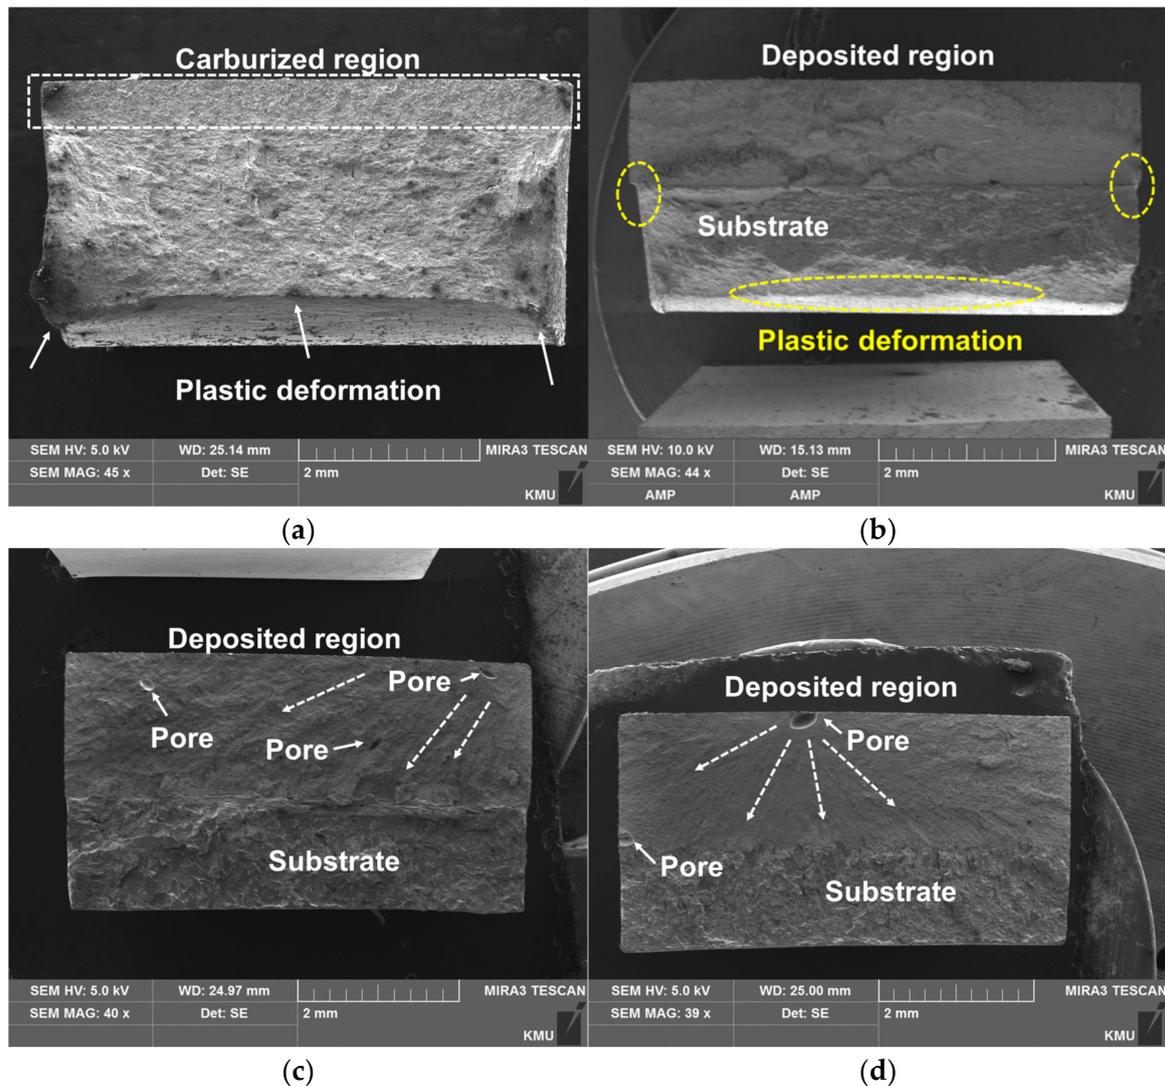
Figure 16. Fracture surfaces of the tensile specimens: (a) C-SCM420, (b) as-built (M2), (c) as-built (FeCrVMoW) and (d) as-built (FeCrVMoW)-PHT.

Figure 16 shows the low-magnification images of the cross section of the fractured specimens. As the carburized zone of C-SCM420 (Figure 16a) was highly brittle, its fractured surface was flat. The specimen, however, had high elongation due to the plastic deformation of the un-carburized substrate. The as-built (M2) (Figure 16b) exhibited necking in the substrate zone, unlike the as-built (FeCrVMoW) (Figure 16c) and the as-built (FeCrVMoW)-PHT (Figure 16d) and defects such as pores and cracks were not observed. The elongation in the substrate was greater when compared to that of the deposited region. In the case of the specimens deposited with FeCrVMoW (Figure 16c,d), the fracture is observed to be caused due to the stress concentration caused by the micropores present in the deposited region. It is estimated that the initial crack originated from the pores present in the deposited region and rapidly propagated to the substrate. Unlike the C-SCM420 and the as-built (M2), no plastic deformation was observed in the substrate or in the deposited region. This indicates that the pores present in the deposited region led to rapid fracture without a distinct elongation for the as-built (FeCrVMoW) and the as-built (FeCrVMoW)-PHT specimens.

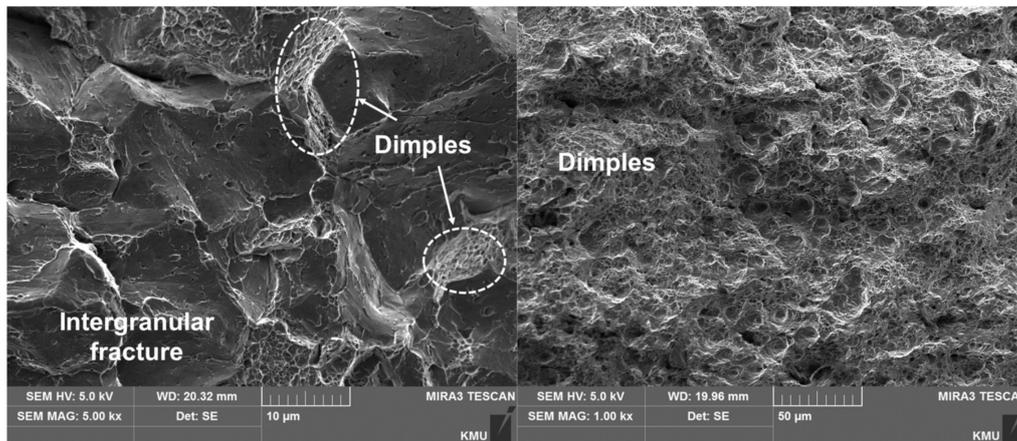
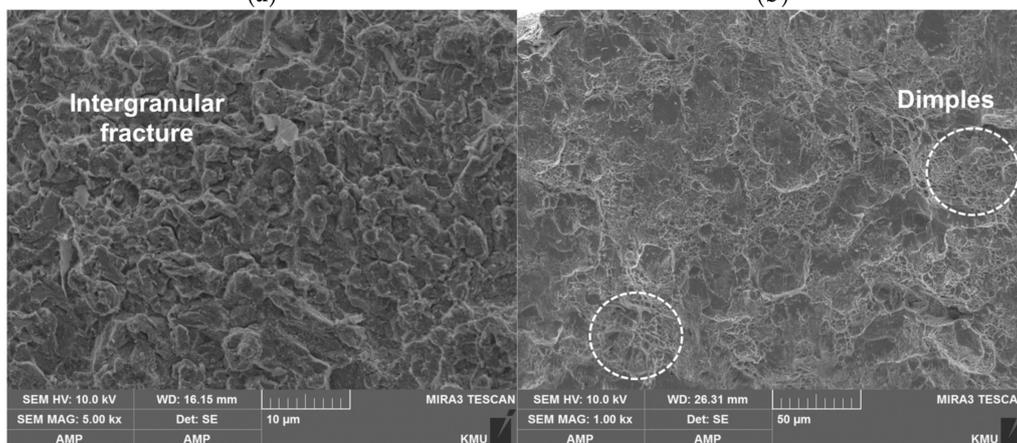
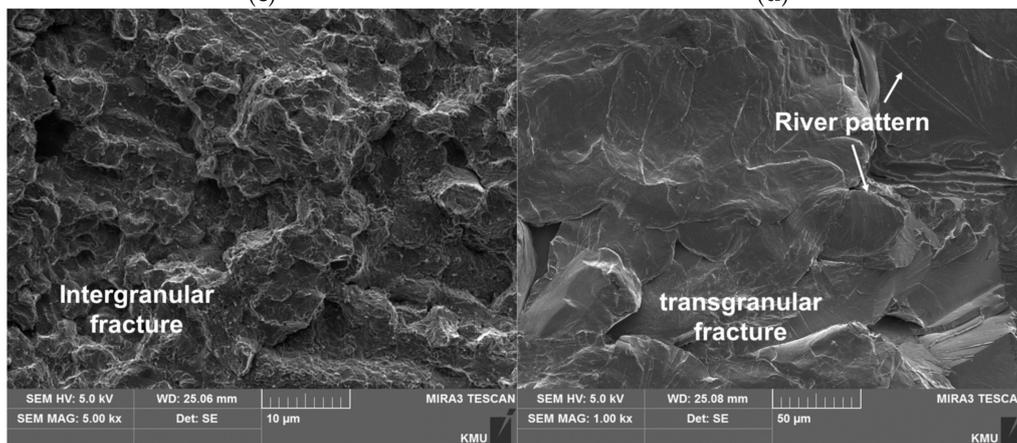
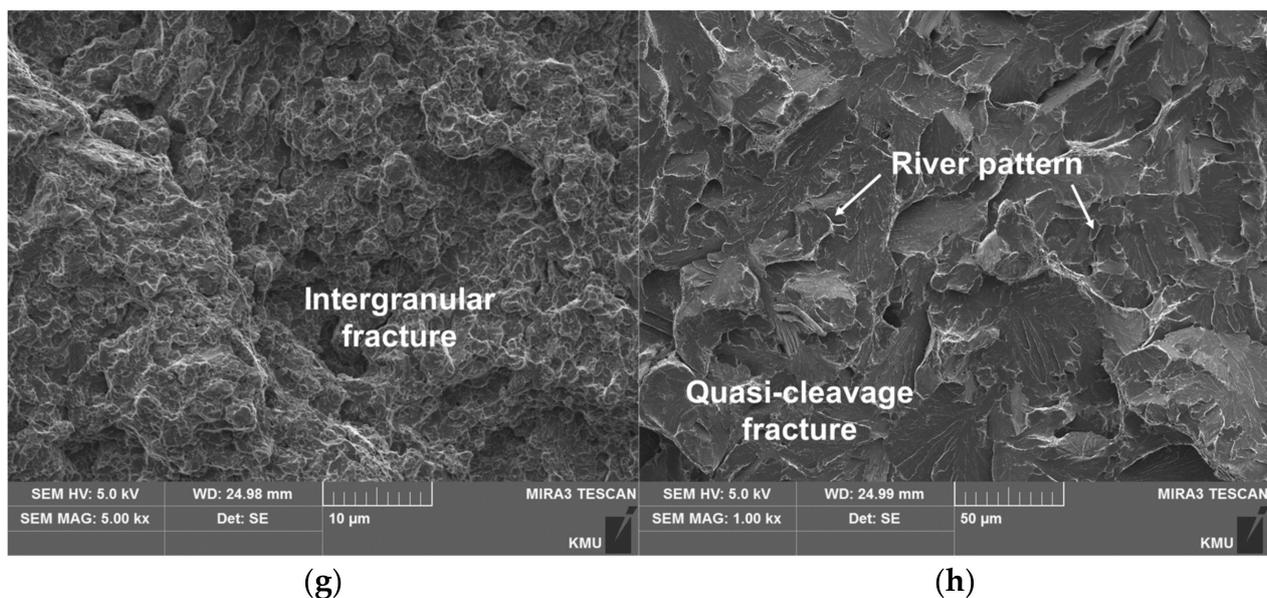
Figure 17 shows the SEM images of the fracture surfaces. In the carburized zone of C-SCM420 (Figure 17a), brittle fractures was observed along with some microdimples, which can be attributed to the high carbon content in the carburized zone. In the non-carburized layer (Figure 17b), however, dimples were observed, indicating ductile fracture. Essentially, for the C-SCM420 specimen, the carburized zone led to the high strength and the un-carburized substrate led to the high elongation. The deposited region of the as-built (M2) (Figure 17c) exhibited a slightly coarser intergranular fracture than that of the as-built (FeCrVMoW)-PHT (Figure 17g) and a finer intergranular fracture surface than that of the as-built (FeCrVMoW) (Figure 17e). The tensile strength was also higher in the same order. The fracture surface of the substrate of the as-built (M2) (Figure 17d), however, exhibited different topograph from the substrate of the as-built (FeCrVMoW) (Figure 17f) and that of the as-built (FeCrVMoW)-PHT (Figure 17h), both of which, exhibited brittle fractures. In Figure 17d, a ductile fracture was observed due to the presence of shallow dimples. In other words, while the substrate was elongated, the specimen was fractured due to the crack propagated from the deposited region. The deposited region of the as-built (FeCrVMoW) (Figure 17e) exhibited an intergranular fracture with large grains as

also shown in the fractured surface of the impact specimen of the as-built (FeCrVMoW) (Figure 14e). The substrate of the as-built (FeCrVMoW) (Figure 17f) showed a transgranular fracture, which is a rapid brittle fracture, with river patterns. The deposited region of the as-built (FeCrVMoW)-PHT (Figure 17g) exhibited the finest intergranular fracture and its substrate (Figure 17h) showed a quasi-cleavage fracture and river patterns. Its strength was greater when compared to that of the as-built (FeCrVMoW), due to the fine grains.
