Article

Effect of Varying Working Distances between Sandblasting Device and Composite Substrate Surface on the Repair Bond Strength

Keywords: composite repair; aluminum oxide sandblasting; working distance; microtensile bond strength

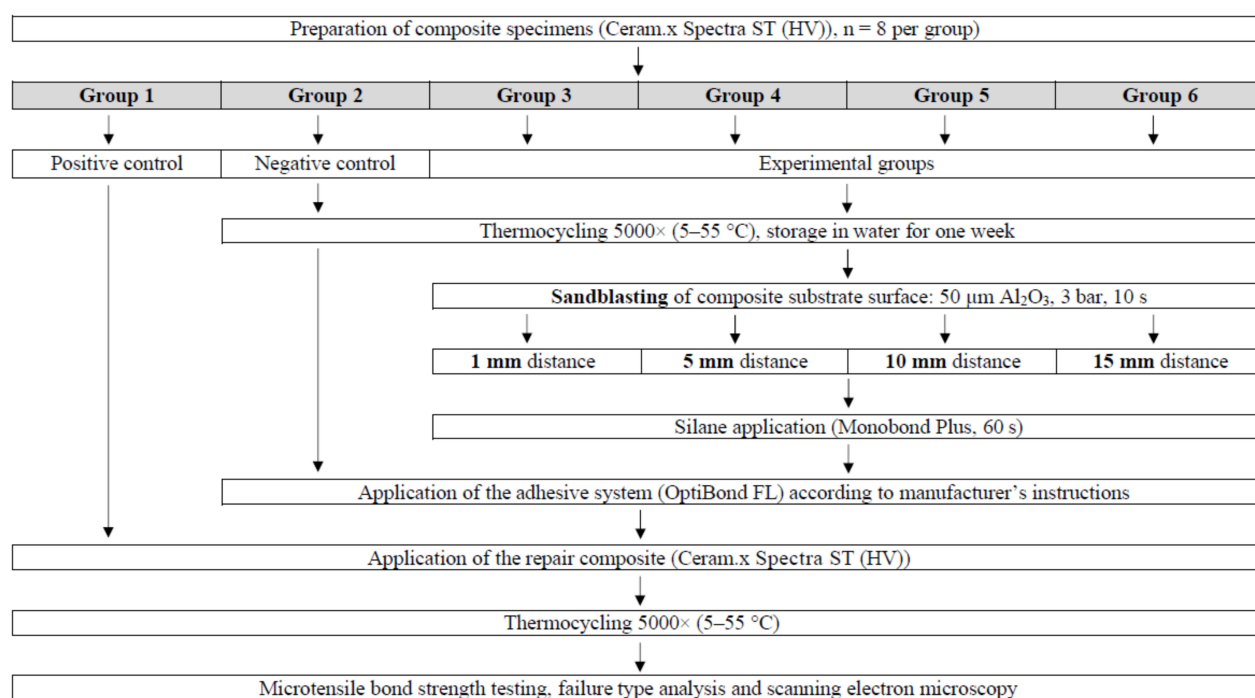
Figure 1. Experimental design.

Figure 1 illustrates the experimental design of the current study. The manufacturer details and the chemical composition of the materials used are provided in Table 1. Forty-eight specimens of a nanohybrid composite with prepolymerized fillers (Ceram.x Spectra ST (HV); Dentsply Sirona, Konstanz, Germany; shade: A4; lot No.: 1907000298) were prepared for this study. This material pertains to contemporary dental resin composites, comprising a modified methacrylate resin matrix filled with ground glass and prepolymerized filler particles. The surfaces of filler particles are typically coated with a silane coupling agent that enables their bonding to the methacrylate resin. The composite material is rendered photosensitive by camphorquinone and tertiary amine, enabling it to set on-demand in clinical work by illumination using blue light [23].

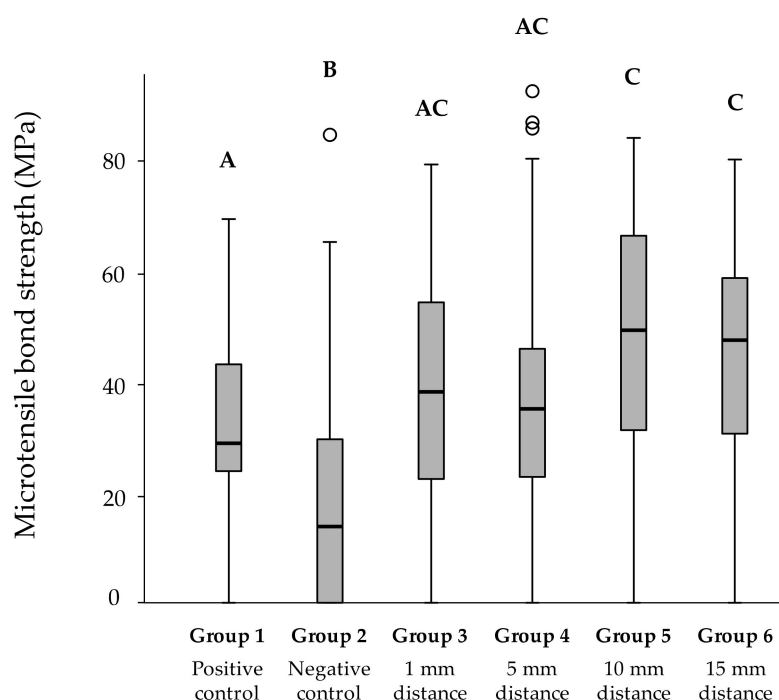
Figure 2. Microtensile repair bond strengths (MPa) of composite surfaces after sandblasting from varying working distances. Significant differences between groups are indicated by different letters ($p < 0.05$). Within each boxplot, the median is represented by a horizontal bold black line. The 25% and 75% data quartiles are shown as boxes, and the whiskers mark the $1.5 \times$ interquartile range (IQR) at the 25th and 75th percentile of each group. The outliers of groups 2 and 4 are shown as circles.

Figure 2 illustrates the microtensile repair bond strengths of the composite substrate surfaces pretreated with aluminum oxide sandblasting from the different working distances. The negative control group (group 2: $19.1\text{ MPa} \pm 13.0$) reached the significantly lowest microtensile bond strength of all groups ($p < 0.05$). Repair bond strength of the positive control group (group 1: $32.2\text{ MPa} \pm 4.8$) did not differ significantly from composite surfaces pretreated with aluminum oxide particles at a distance of 1 mm (group 3: $39.1\text{ MPa} \pm 8.5$) or 5 mm (group 4: $37.8\text{ MPa} \pm 9.5$). However, significantly higher bond strengths were found for group 5 with a sandblasting distance of 10 mm (group 5: $47.5\text{ MPa} \pm 12.1$) and group 6 with a distance of 15 mm (group 6: $43.9\text{ MPa} \pm 10.3$), compared to the positive control group (group 1). No significant differences in repair bond strengths could be observed within the experimental groups (groups 3–6) with working distances from 1 mm to 15 mm between composite substrate surface and tip of the sandblasting device.

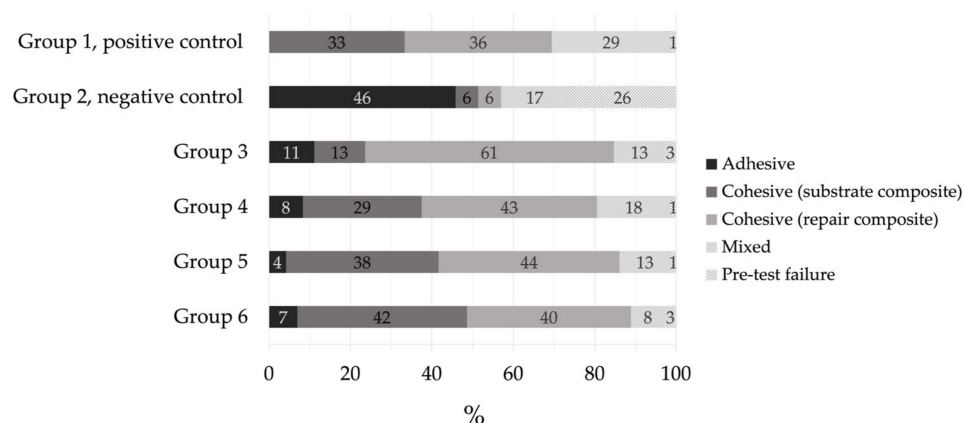
Figure 3. Percentage (%) of failure mode distribution per group.

Figure 3 depicts the failure mode distribution of all groups of the current study assessed at $25\times$ magnification with an optical light microscope. In the majority of groups (groups 1, 3–5), the most frequent failure mode was cohesive within the repair composite. In group 6, however, cohesive failures in the substrate composite were most frequently

observed. The highest percentage of pretest failures was found in the negative control group (group 2).

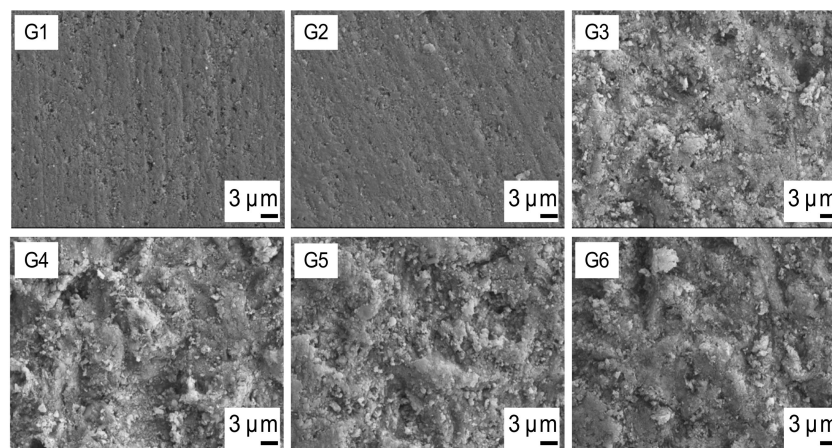
Figure 4. Scanning electron microscopy (SEM) images (5000 \times magnification) of the composite surfaces of all groups. G1: positive control group; G2: negative control group; G3–G6: composite substrate surfaces sandblasted from working distances of 1 mm (G3), 5 mm (G4), 10 mm (G5), and 15 mm (G6).

Micromorphological SEM images of the composite substrate surfaces are shown in Figure 4. In G1, the untreated composite surface is visible, whereas in G2 the aged composite surface without mechanical pretreatment is presented, both showing similar surface topography. G3–G6 of Figure 4 display the aged composite surfaces sandblasted from the varying working distances of 1 mm (G3), 5 mm (G4), 10 mm (G5), and 15 mm (G6). They exhibit similar surface structures among themselves, but they display a more irregular topography than the untreated positive control group (G1) and the solely aged composite surface of the negative control (G2). In addition, analysis by energy dispersive X-ray

Correlating with the achieved repair bond strengths, SEM images showed comparable irregular surfaces after sandblasting, exhibiting similar micro-retentive patterns [21].
