Article

Reduction of Load Capacity of Fiber Cement Board Facade Cladding under the Influence of Fire

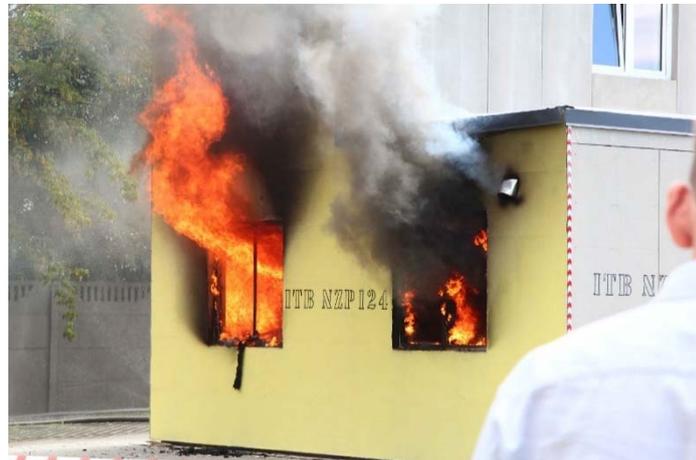
Figure 1. View of flames escaping from a room involved in a fully developed standard fire, during a field test. (Author: E. Kotwica).

the positive effect of using fibers to increase the flexural strength of beams subjected to a normative fire temperature curve is demonstrated. Research shows that, despite the fact that the fibers are subject to destruction at fire temperatures, the voids thus formed allow the material to withstand higher temperatures afterward. The emergency situation of a fire is shown in Figure 1.

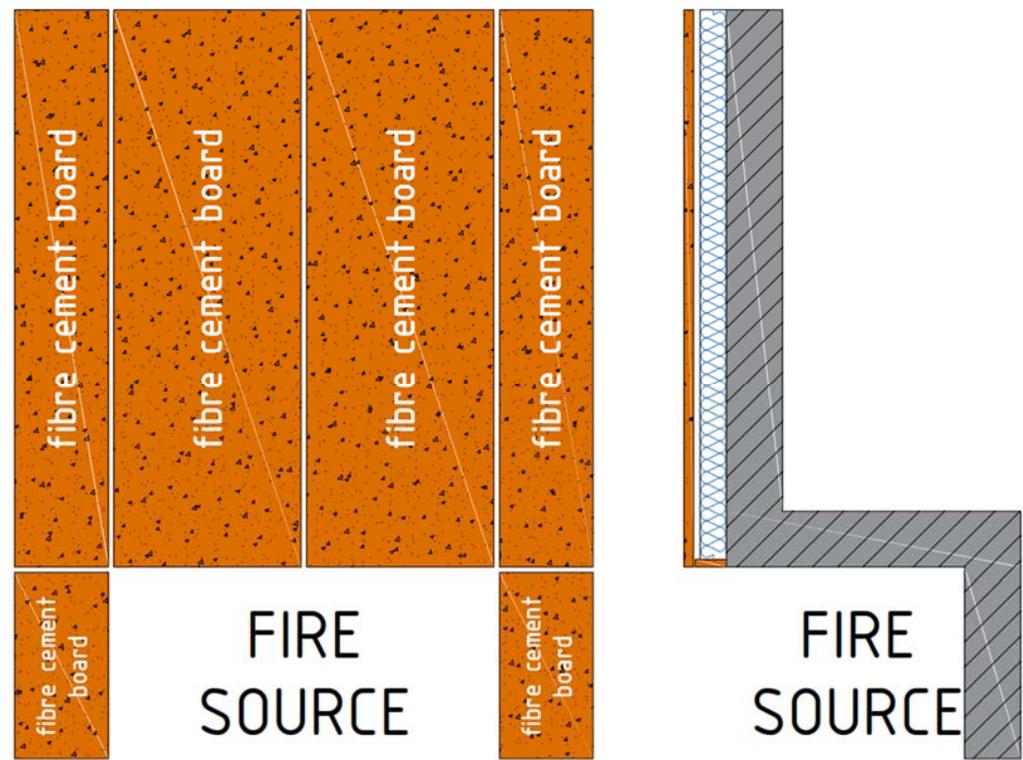
Figure 2. Division of boards on the facade—front and side view.

The facade was made of 8 mm-thick fiber cement boards of natural color—not pigmented. The cladding was fastened using mechanical connections to a galvanized steel

substructure. The substructure was mechanically attached to the platform through consoles. The division of the facade into facade cladding is shown in Figure 2.

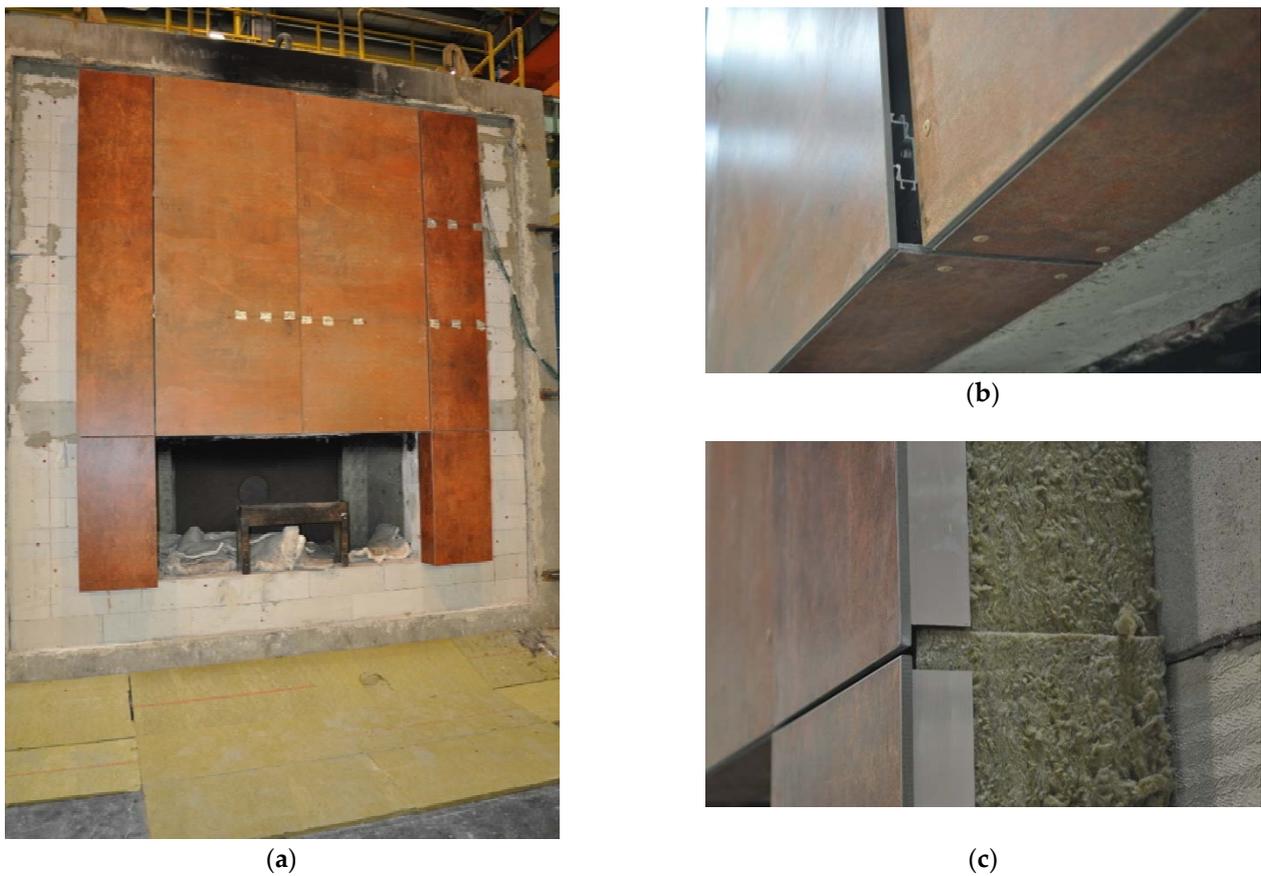
Figure 3. Selected details of the large-scale facade model: (a) actual elevation model view; (b) eaves problem and solution; (c) insulation.

The full view of the large-scale facade model, as it was conducted, is shown in Figure 3a. In addition, the sand burner and the combustion chamber can be seen, through which the fire scenario is implemented. The facade cladding in the left and right part is fixed in a different way, which causes the left part to protrude beyond the face of the plane—this can be seen in Figure 3b. The technical solution for filling and maintaining the stone wool and ventilation space is shown in Figure 3c.

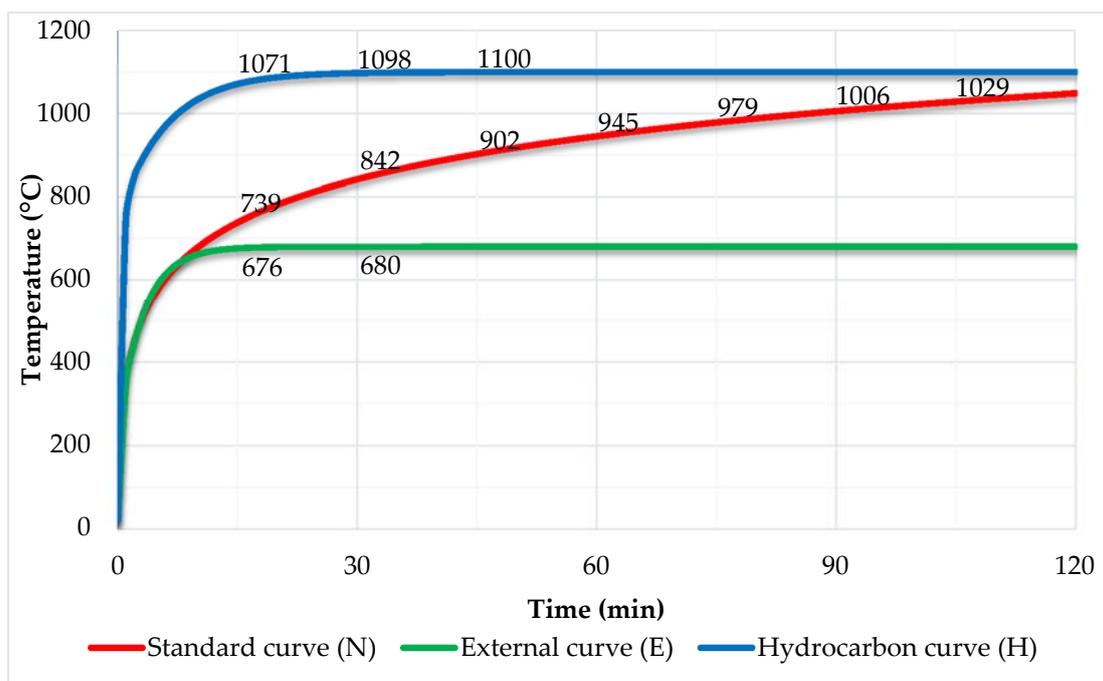
Figure 4. Summary of fire dependencies.

The impact of high temperatures on the facade was tested by means of fire and fire gases escaping from the combustion chamber—the scenario of fire in the room and fire escaping through the window opening onto the facade was carried out. The combustion chamber on the back wall contained a blower, which allowed us to reproduce the real conditions of a fire. The fire source was a sand burner that used gas as fuel—appropriately metered through a mass flow meter. The sand burner used liquid propane of 95% purity (PGNiG Polska) as fuel, with a release rate scaled in such a way that it corresponded to the fire development in accordance with the external curve, which is characteristic for facade fires as cited in EN 13501-2 [27]. International fire curves show the temperature course over time at the source location. The international fire curves, including the external curve, are shown in Figure 4. Laminar air inflow from the side of the room was provided by honeycomb.

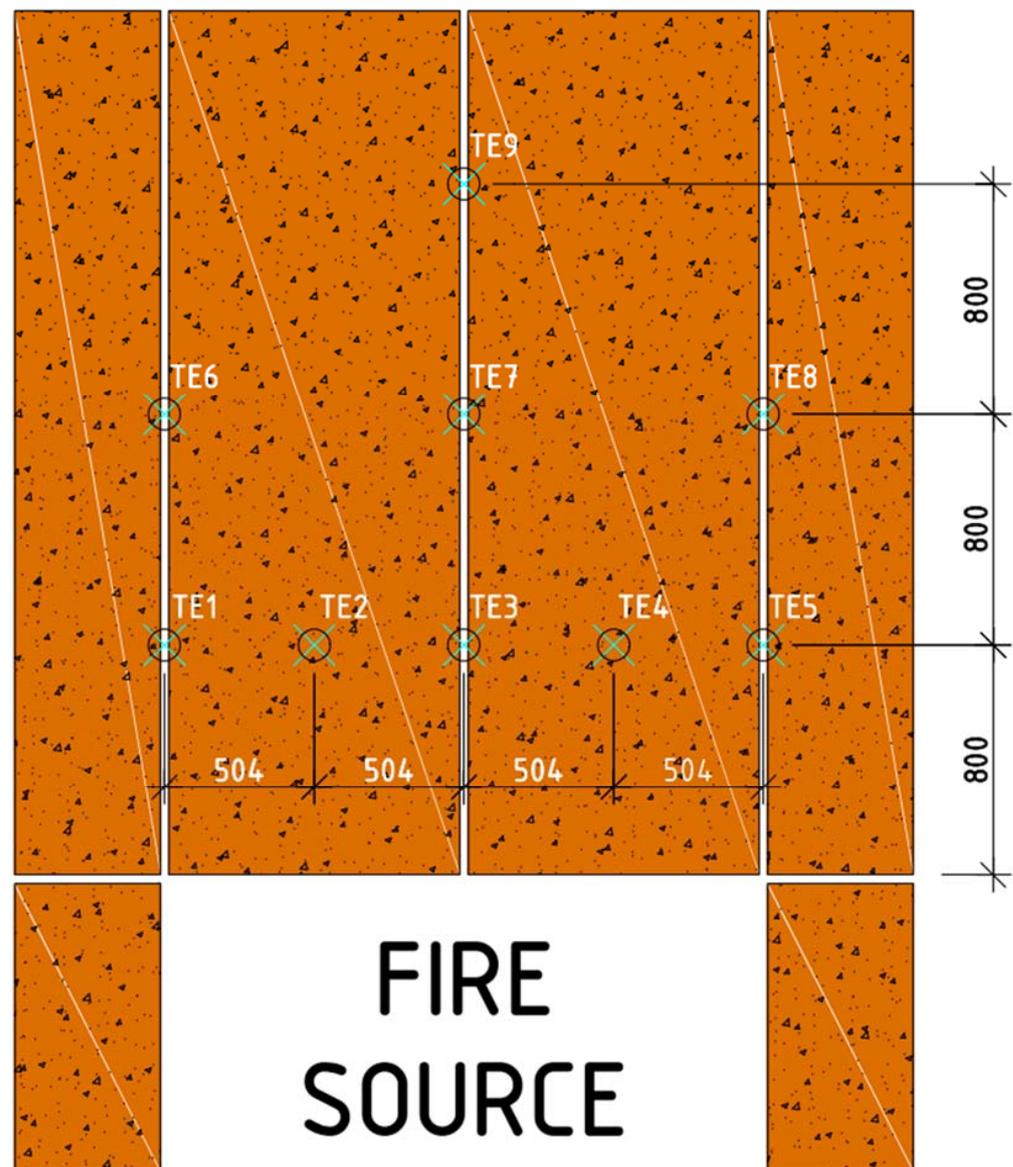
Figure 5. Location of thermocouples on the large-scale facade model—front view.

The large-scale facade model was equipped with a set of thermocouples (named TE1-TE9) to verify and identify the damage to the exterior cladding. They were placed in accordance with the expected development and impact of flames and hot fire gases. Thermocouples were placed on the surface of the board cladding—in 3 rows at heights of 800 mm, 1600 mm and 2500 mm above the combustion chamber. These places were selected due to the expected shape of the flame coming out of the combustion chamber. The exact arrangement of thermocouples and their names are shown in Figure 5.

As shown in Figure 5, the thermocouples recorded the temperature continuously during the test. The results of these tests are shown in Figure 8. It can be observed that the temperatures for TE1 and TE5 thermocouples, and TE6 and TE8 thermocouples, are similar, operating in the low-temperature range—below 100 °C. Such temperatures have no destructive effect on fibers in fiber cement boards. The whole material did not show major signs of wear at these temperatures, either. In the case of TE2, TE3, and TE4 thermocouples a disproportion is visible, i.e., much higher temperatures prevail on the right side of the large-scale facade model—this is due to a smaller protrusion of the cladding beyond the face. Although this difference is minimal (20 mm), it directs all the flames to the right side where the TE4 thermocouple is located. It is also noticeable that the flame source has a

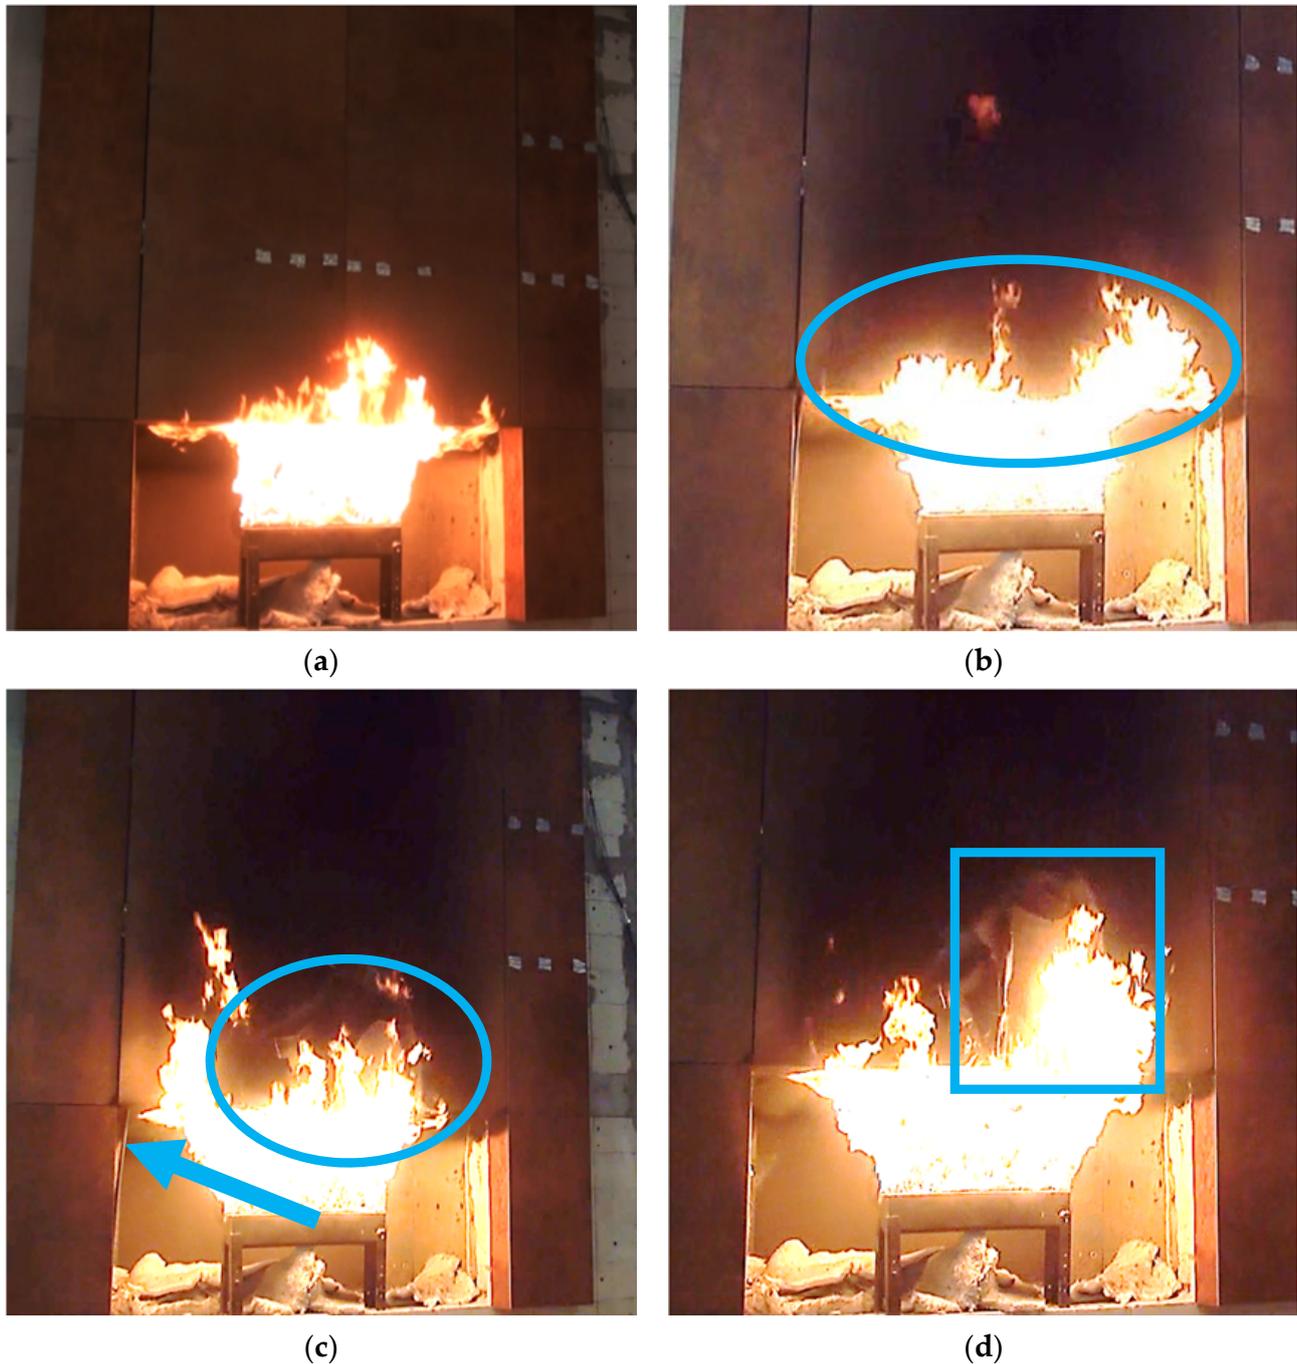
Figure 6. View of the large-scale facade model in successive minutes of the test: (a) start of the test; (b) approximately 11'00"—visible degradations; (c) approximately 17'00"—splay piece falling off; (d) approximately 20'30"—progress of destruction.

The test was conducted at an ambient temperature of 22.3 °C and a relative humidity of 52%. The test began by setting up the burner and properly calibrating the supplied gas. The beginning of the test is shown in Figure 6a—uniform distribution of flames leaning against the splay is noticeable. Such a view is characteristic of the beginning of the test, where the model is not exposed to external winds and the facade cladding is not yet degraded in the initial phase. The first 6-min period of the fire brought smoke/charring of the external facade cladding, and cracks appeared on the upper splays, which are most exposed to high temperatures. Facade cladding mounted on the splays fell off first, after a time range of 9 min to 14 min. During this period, the destruction of the external facade cladding progressed, as shown in Figure 6b, where the continuing degree of destruction is shown on the already targeted facade cladding, within 600 mm of the bottom. In Figure 6c,d, the

progression of facade cladding deterioration under the effect of fire temperatures can be seen; in the minutes that followed, the external facade cladding elements fell off. The side splay boards fell off at about minute 17.

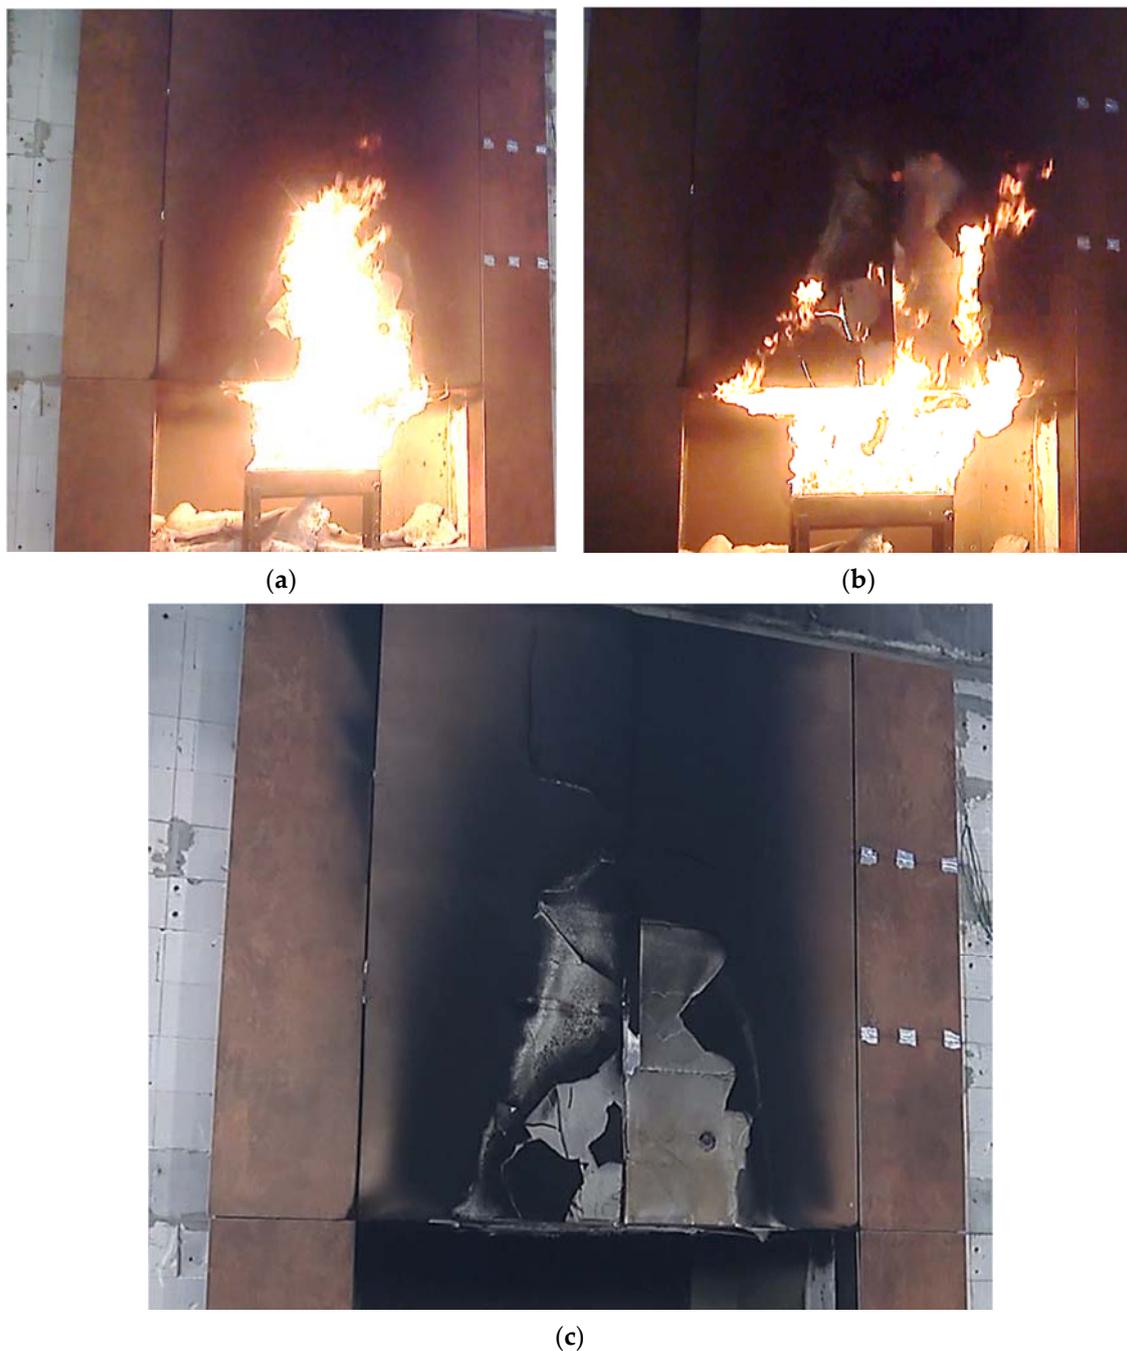
Figure 7. View of the large-scale facade model in the subsequent minutes of the test: (a) approximately 40'00"—high cladding degradation; (b) approximately 55'00"—more elements are falling off; (c) view of facade cladding after testing.

At the end of the test, the load-bearing capacity of the fiber cement boards on the higher elements was progressively exhausted as more and more elements fell off—this is shown in Figure 7a,b. Figure 7c shows the appearance of the cladding after the 60-min test. Significant deterioration of the cladding on the right side of the test model is evident.

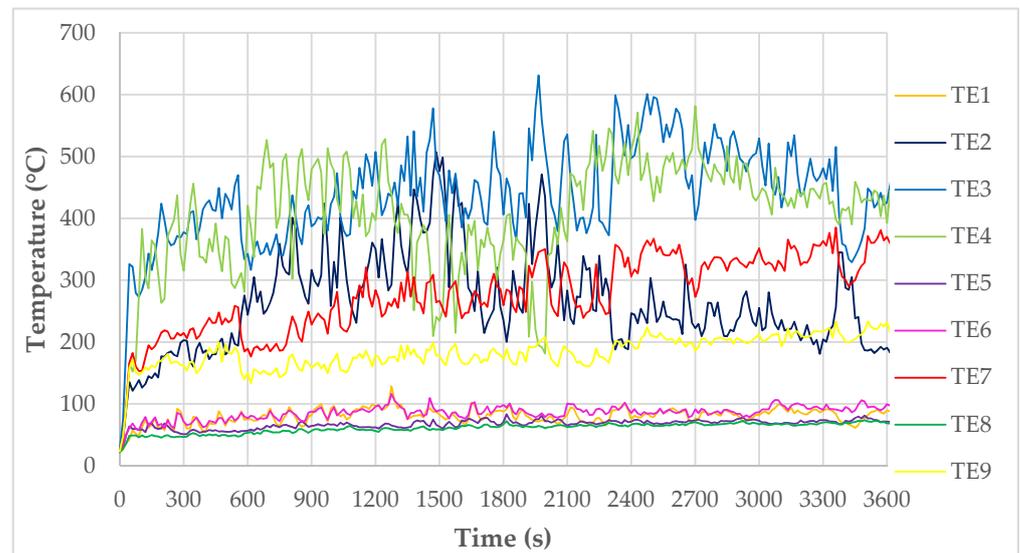
Figure 8. Temperature measurement results for thermocouples on the large-scale facade model.

much greater effect on thermocouples located in a non-central position, such as TE2 and TE4, than on thermocouples located centrally but higher up, such as TE7.

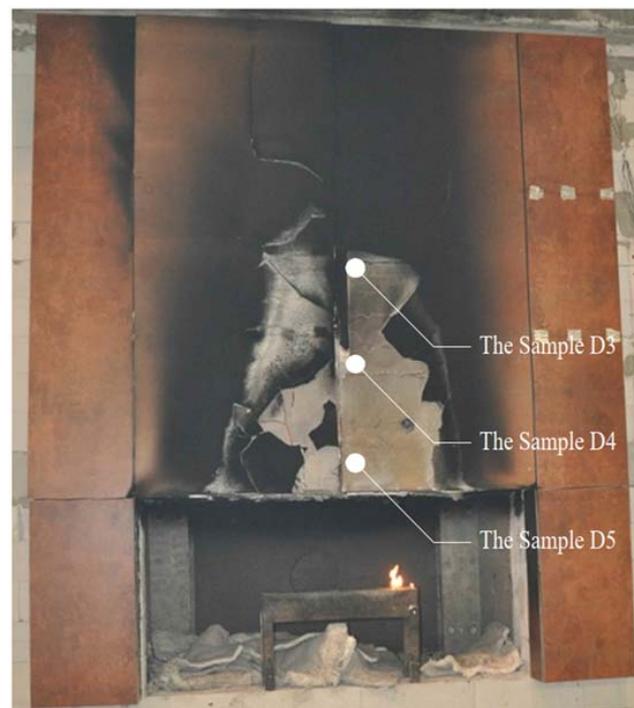
Figure 9. Sampling location.

In order to investigate the scientific issue, which was to verify the reduction in flexural strength of the fiber cement boards during fire impact, samples were taken from the model. Samples were taken directly from the large-scale facade model or from cladding elements that fell off. Samples were taken from 3 locations, shown in Figure 9, and compared to reference samples.

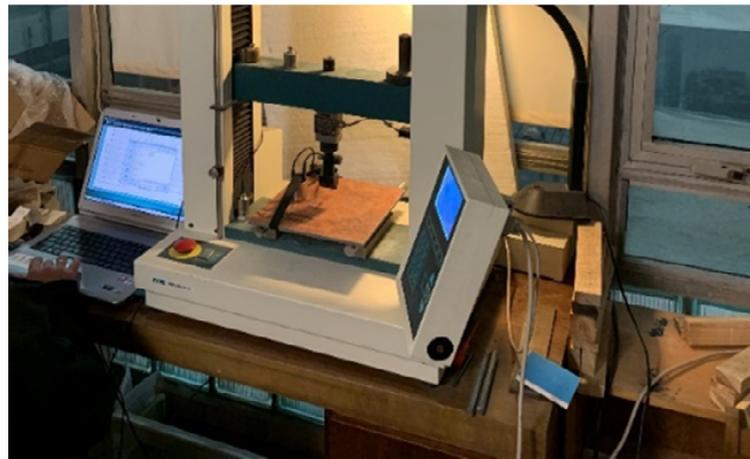
Figure 10. Three-point bending flexural testing machine.

Modulus of rupture (*MOR*) assessment was performed according to PN-EN 12467 [28]. The dimensions of the reference samples were taken as $250 \times 250 \text{ mm}^2$. For the other tested samples, the dimensions recommended by the standard [28] could not be achieved due to the recovery of the samples from the elevation model after the test and the extensive damage to these elements. The three-point bending flexural test stand is shown in Figure 10.

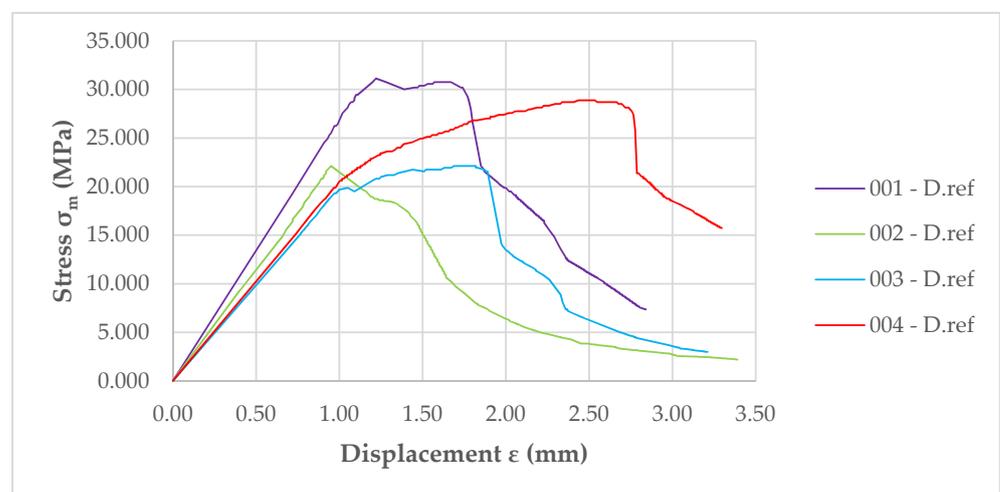
Figure 11. Graph showing the modulus of rupture (*MOR*) of the reference samples.

The results of *MOR* for the reference samples are shown in Figure 11—the significant difference between the courses of the individual graphs for different samples is evident. The direction in which the samples were bent in the test (whether they were cut parallel or perpendicular to the pressing direction) was important for the test results. In the case of bending in the direction perpendicular to the pressing direction of the boards (the samples "001-D.ref" and "002-D.ref" show a much higher flexural strength), the destructive force is higher. In the case of bending in the direction parallel to the pressing direction of the boards, samples "003-D.ref" and "004-D.ref" have lower flexural strength.

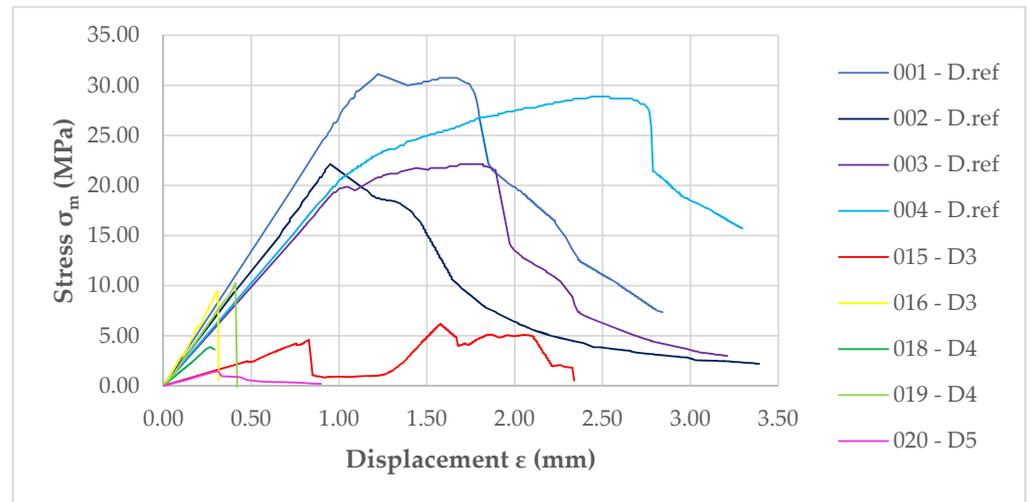
Figure 12. Graph showing MOR of front facade samples compared to reference samples.

A total of 5 samples were taken from the large-scale facade model, and all the results of the strength test course are shown in Figure 12. All the samples are characterized by a significant reduction in strength under the three-point flexural test. In addition, they are characterized by a very rapid and sharp reduction in flexural strength after passing through the point representing the destructive forces.

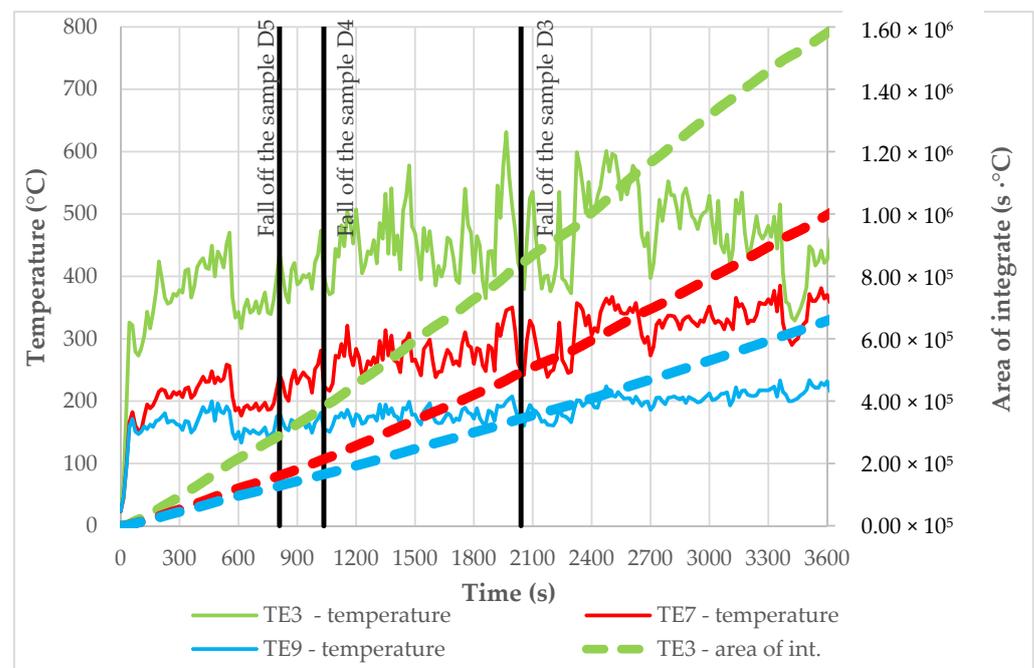
Figure 13. Temperature measurement results for TE3, TE7, and TE9 thermocouples, and the increasing integral for the temperature–time function, along with the determination of the falling-off time of individual elements.

Temperatures as high as 600 °C result in the complete destruction of the sample. Cladding components in this area fall off after about 17'15", which corresponds to an integral of the time-temperature function of about 3.8×10^5 (s·°C). The moment at which the D4 samples fall off along with the integral is shown in Figure 13.

Temperature graphs for TE3, TE7 and TE9 thermocouples with their corresponding time and temperature function integrals (s·°C) are shown in Figure 13; the timeline also shows how long it takes for the individual facade elements sampled to fall off.

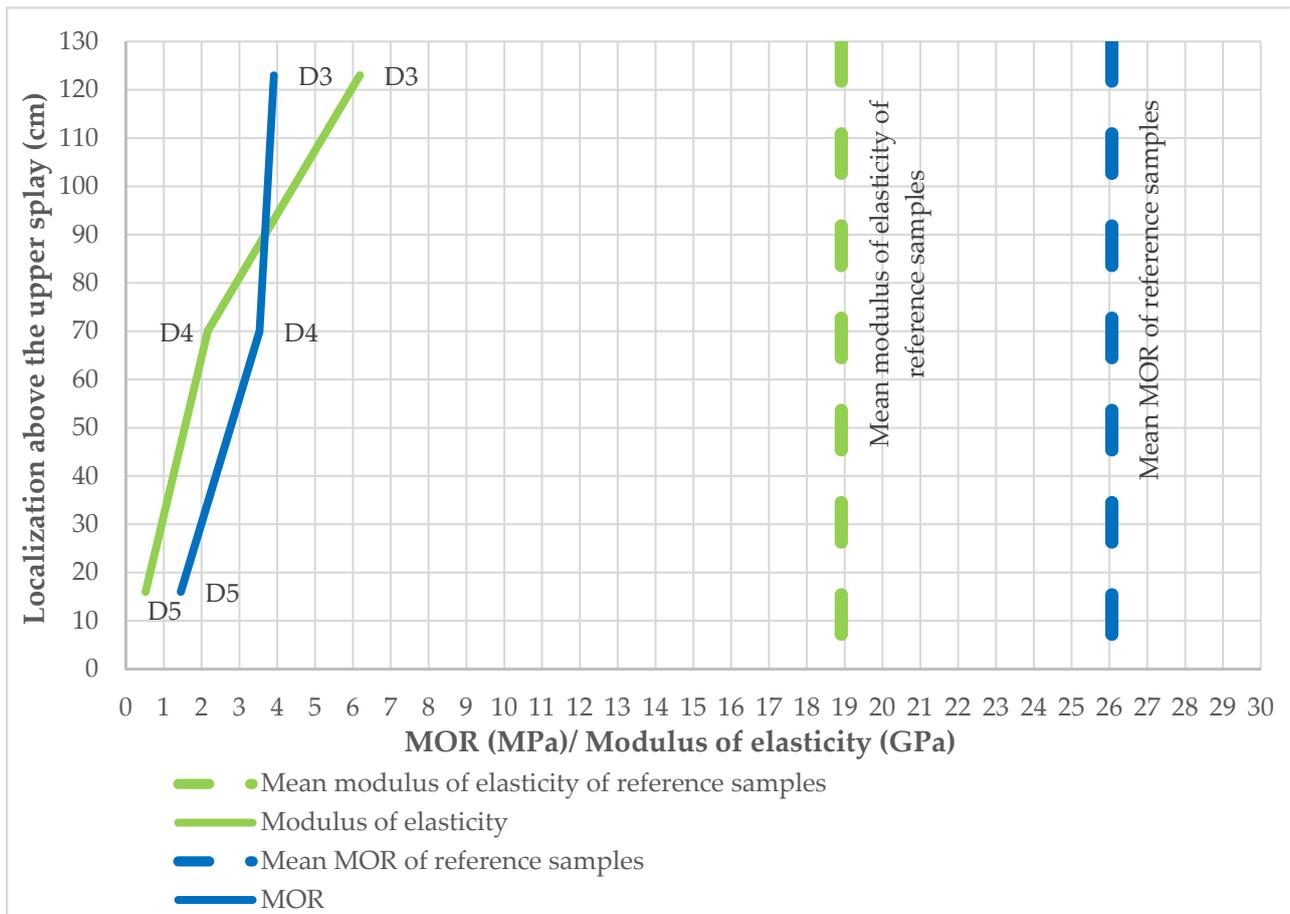
Figure 14. Reduction in MOR of the fiber cement boards depending on the localization above the upper splay.

The results presented in Table 1 were carefully analyzed. As shown in Figure 14, samples subjected to fire, even 1200 mm above the upper splay, do not show sufficient strength, and their modulus of elasticity shows reduced values. A tendency can be noticed that the integral of the temperature and time functions, despite a significantly greater impact on D3 samples, does not show a lower elasticity modulus, and only the flexural strength is reduced. It can therefore be assumed that with such a large impact on this function, the samples remain on the facade only because of their internal predispositions, e.g., the proximity of mechanical fasteners (rivets). The samples taken at a height of approx. 200 mm or approx. 1200 mm above the splay show low flexural strength parameters.
