Review

# A Review of the Use of Titanium for Reinforcement of Masonry Structures

Keywords: titanium alloys; masonry structures; retrofit solutions; earthquake engineering

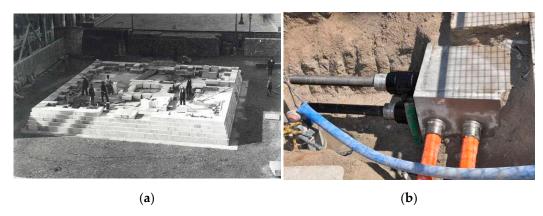
**Figure 9.** (a) Schematic of the bell tower, Venice, Italy; (b) titanium rods installed to confine the brickwork and timber piles at the foundations level (design and calculations G. Macchi and G. Galeazzo).

Titanium ties have been more recently used to stabilize, at the base, the bell tower of the St. Mark cathedral in Venice (Figures 8 and 9) [33]. The bell tower was constructed on wooden piles sunk into the lagoon and has suffered from gradual subsidence, which caused the massive construction (98.6 m in height) to slowly sink and slide downwards into the polluted water. Titanium was found to be an ideal application, given the very aggressive environment due to the continuous flooding with salt water and its filtration

into the bell tower's foundations from the nearby sea. The retrofitting solution consisted of wrapping the wooden piles to prevent lateral buckling and the overlaying brickwork walls using titanium ties.

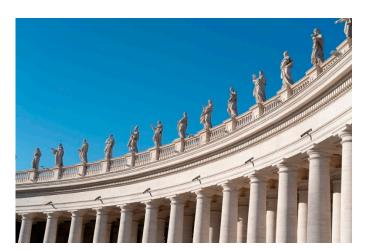
**Figure 12.** 17th century Bernini statues and colonnades, Vatican City. The marble columns are 16 m in height, and the overlying statues are 3.1 m. Cracking was recently detected in several statues and columns, and titanium reinforcements were used for repair.

More recently, consolidation interventions have been carried out on iconic monuments in Rome. Here, we can mention the Bernini's statues and colonnades in St. Peter's square, Vatican City. The colonnade (Figure 12) consists of 284 marble columns having a height of 16 m. The columns were installed in 1655 and were transported by river on the Tiber from the nearby city of Tivoli. Bernini also carved 140 marble statues (3.1 m height) of saints. Several vertical cracks were noted in the columns due to the high compressive stresses, while some extremities of the marble statues tended to detach. The intervention consisted of wrapping the columns with titanium elements and aramidic fibers in the form

of unidirectional sheets. The continuity in the marble material was restored using FRP and titanium rods, inserted in transversal perforations (Figure 13).
