# Effects of Wollastonite Fiber and Styrene–Butadiene Latex Polymer on the Long-Term Durability of Cement-Based Repair Materials

**Citation:** Choo, Y.J.; Lee, G.H.; Lee, S.-J.; Park, C.-G. Effects of Wollastonite Fiber and Styrene–Butadiene Latex Polymer on the Long-Term Durability of Cement-Based Repair Materials. *Materials* **2022**, *15*, 5433. <https://doi.org/10.3390/ma15155433>

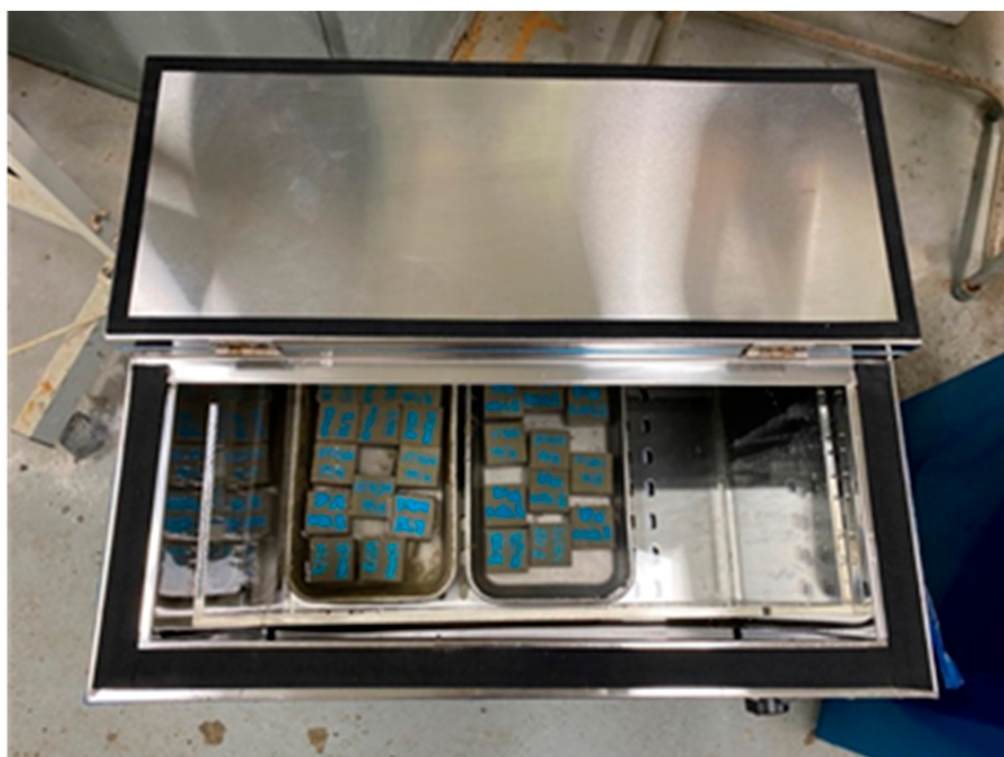
**Figure 2.** Photo of alkali resistance test.

Concrete is strongly alkaline due to the hydration reaction between cement and water. In this study, the effect of the addition of wollastonite fiber and SB latex polymer on the strength characteristics of cement-based repair materials when exposed to an alkaline environment was evaluated. The alkali resistance test was performed to confirm the change in the strength of the mortar in the presence of alkali [13]. A concrete repair material should keep enough strength retention while soaking in saturated hydroxide solution for 28 days (Figure 2). The test was carried out according to KS F 4042. Three cubes sized  $50 \times 50 \times 50$  mm were cured for 28 days and then soaked in saturated calcium hydroxide solution at  $50 \pm 2$  °C for additional 28 days. Then, the specimens were taken out of the solution, wrapped with a wet cloth, and cooled at room temperature for 1 day. The compressive strength was then measured. The alkali resistance test result was presented as an average value after testing three specimens for each mixture.

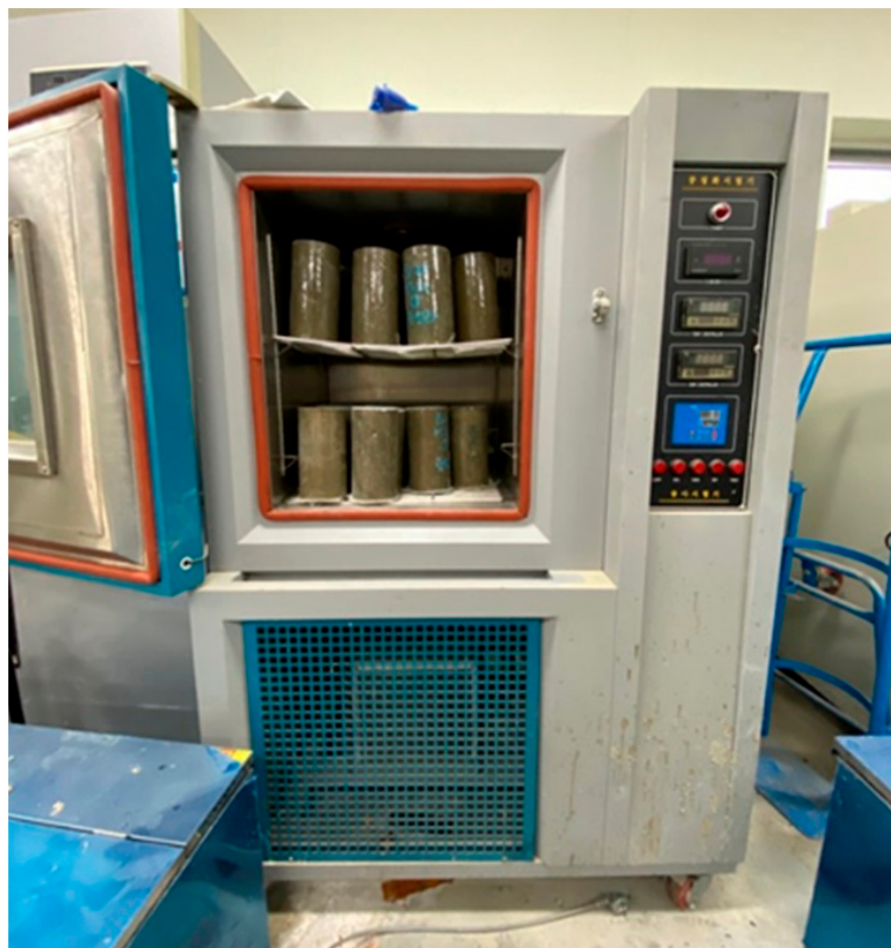
**Figure 3.** Photo of neutralization test device.

The carbonation of concrete is a process through which the alkalinity of the concrete is lost via the action of carbonic acid, acidic gases, and salts present in air or water. Carbonation is one of the major causes of degraded concrete durability, such that the resistance to carbonation is an important performance metric for repair material [14]. In this study, the effect of the addition of wollastonite fiber and SB latex polymer on the improvement of carbonation resistance of cement-based repair materials was evaluated. In the test, the depth where carbonation occurs is measured after the repair material has been placed in the carbonation-accelerating environment. Three cylindrical test specimens with dimensions of  $\text{Ø}100 \times 200$  mm were prepared and cured for 28 days at  $20 \pm 2$  °C and  $65 \pm 10\%$  RH (Figure 3). For the test, epoxy was applied to all surfaces except the top surface. The carbonation depth was measured after exposing the specimens to the 5% carbon dioxide concentration in the test chamber for 28 days, as follows: 1% phenolphthalein solution was sprayed on a cut surface of a specimen and the color change in the surface was observed. The length from the edge to where the color is no longer red is referred to as the carbonized

part. The depths at three locations on each side edge of the carbonized part were measured using a Vernier caliper, for a total of six measurements. The resistance to carbonation was considered excellent if the depth at which carbonation proceeded was 20 mm or less. The carbonation test result was presented as an average value after testing three specimens for each mixture.
