# Experimental Investigation of the Deformed Stagger-Jointed Segmental Tunnel Linings Strengthened by Epoxy-Bonded Filament Wound Profiles

Lei Zhang and Xian Liu \*

College of Civil Engineering, Tongji University, Shanghai 200092, China

**Citation:** Zhang, L.; Liu, X.Experimental Investigation of the Deformed Stagger-Jointed Segmental Tunnel Linings Strengthened by Epoxy-Bonded Filament Wound Profiles. *Materials* **2022**, *15*, 6862. <https://doi.org/10.3390/ma15196862>

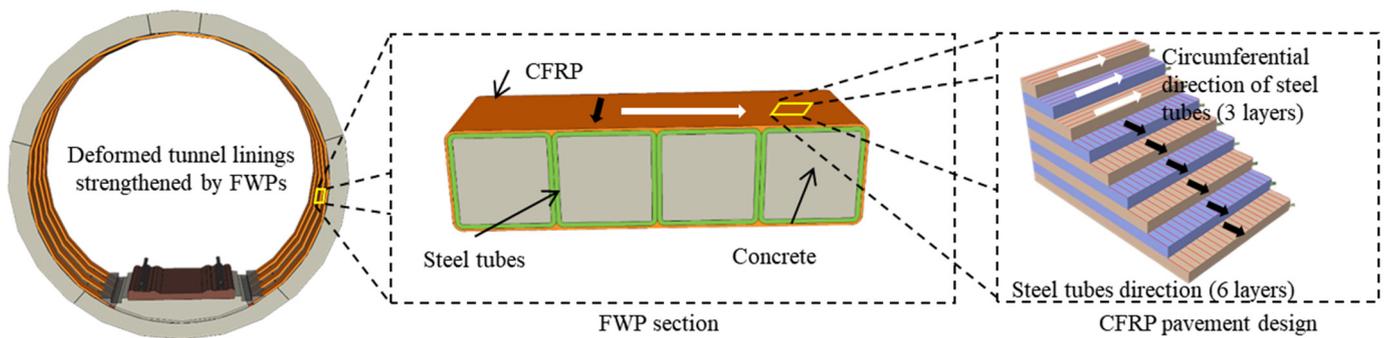
For the FWPs that are used in this full-scale test, the CFRP layer is designed conceptually. As shown in Figure 1, the steel tubes are wrapped with six layers along the steel tube direction and three layers along the circumferential direction. The CFRP along the circumferential direction of the steel tubes can effectively limit the local buckling effect and the bulging deformation of the steel tubes when the FWPs are compressed. The longitudinal CFRP can work together with the steel tubes to bear the tensile stress when the FWPs are subjected to bending or tension. The test was carried out and mechanical properties of the FWPs were obtained [15].

Figure 1. The CFRP pavement design of FWP.

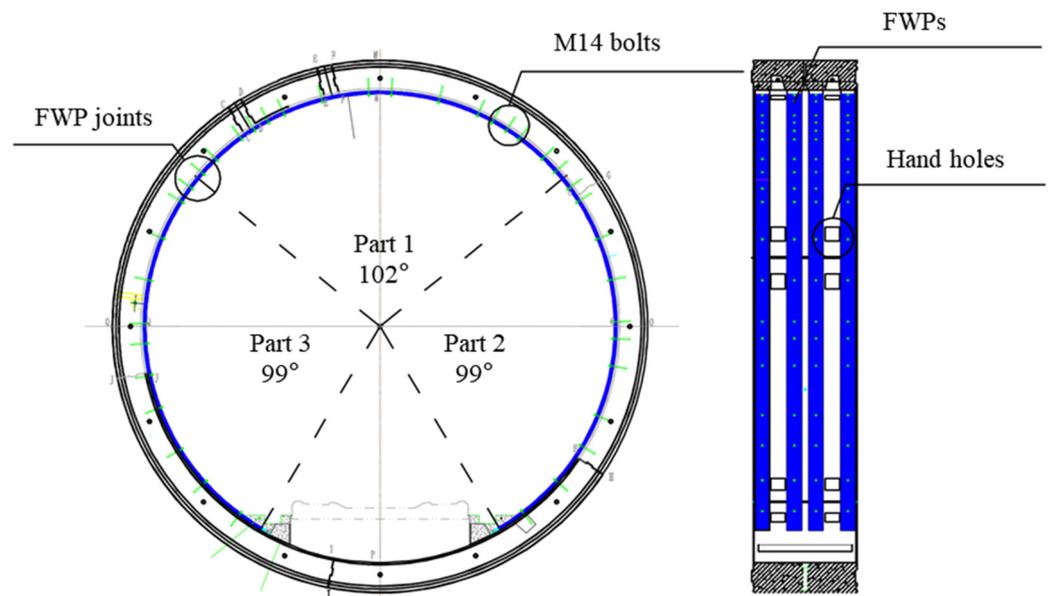
The epoxy-bonded FWP strengthening method is illustrated in Figure 2. The FWPs are added to the intrados of the deformed lining. The strengthening components are comprised of three parts. The central angles of parts 1, 2 and 3 are  $102^\circ$ ,  $99^\circ$  and  $99^\circ$ , respectively. There are four FWPs which are deployed along the width direction of the tunnel lining, avoiding the hand holes of the segments. The strengthening procedure consists of the following steps: firstly, holes are drilled for someone to place bolts on the segments and the intrados concrete are carved to increase the contact area for the epoxy; secondly, the plug bolts are employed to fix the FWPs onto the surface of the tunnel linings; thirdly, the gap between the FWPs and the tunnel lining is injected with structural adhesive; lastly, concrete is grouted into the cavity of FWPs under a pressure condition.

Figure 2. Filament wound profile strengthening method.

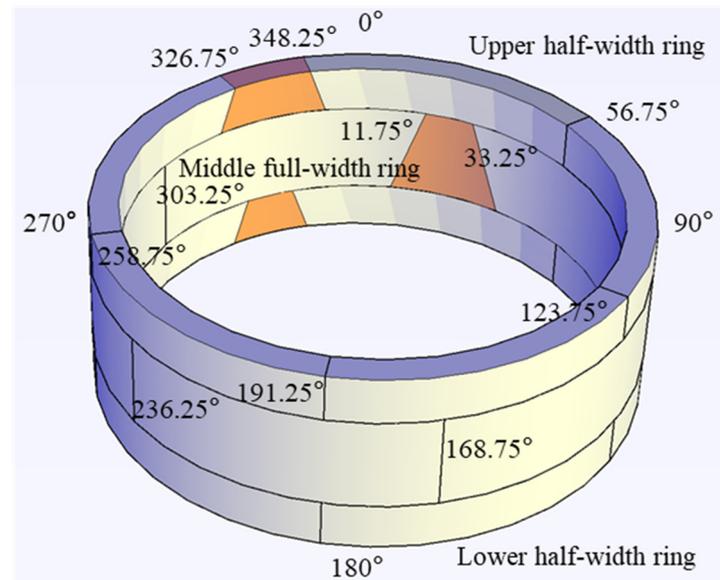
As shown in the Figure 3, the specimen consists of a full ring and two half-width rings. The key segment of the half-width ring is located at  $337.5^\circ$ , while the key segment of the full-width ring is located at  $22.5^\circ$ . The outer diameter of the full-width ring is 6.2 m, the inner diameter is 5.5 m, the segment thickness is 0.35 m and the ring width is 1.2 m. The full-width ring is comprised of a key segment (K), two adjacent segments (B1 and B2), and three standard segments (A1, A2 and A3), whose central angles are  $10.75^\circ$ ,  $68.5^\circ$  and  $67.5^\circ$ ,

respectively. The concrete grade is C50, and the steel bar grade is HRB335. The adjacent segments are connected with M30 bolts. A tongue and groove structure is used for the longitudinal joints, while a plain joint is used for the circumferential joints.

**Figure 3.** Stagger-jointed segmental tunnel lining specimen.

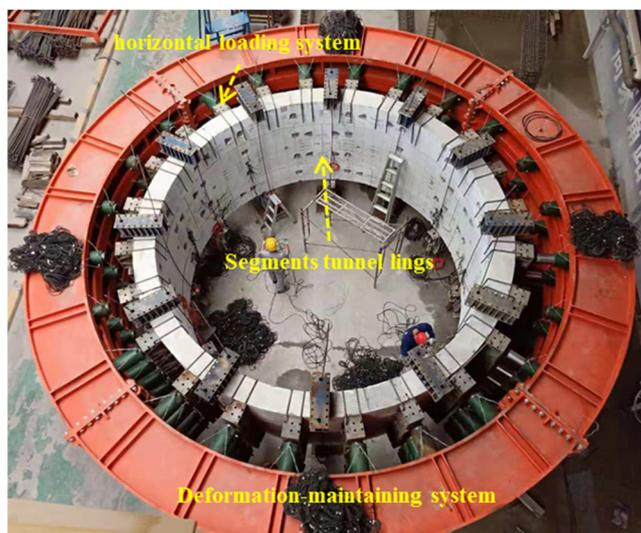
The loading facility consists of a horizontal loading system, a vertical loading system and a deformation-maintaining system, as shown in Figure 4. The horizontal loading system simulates the water and earth pressure, the strata resistance and the ground overload. It includes 24 loading points, and every loading point has four jacks, four distribution beams and one oil pump. For each jack, the maximal horizontal load is 1000 kN and the maximum displacement is 400 mm. The 24 jacks are controlled by the central host to apply and change the load. During the FWP construction process, the jacks keep working, simulating the earth pressure, while the load fluctuation of the jack is controlled to be within a certain range. The vertical loading system simulates the residual jacking force after the thrust of the shield-tunneling machine. It includes 12 pairs of symmetrical tensile loading points. Each loading points consists of two tensile jacks (200 kN) and two distribution beams. In order to reduce the friction resistance between the segments and the ground that is caused by the self-weight, a steel plate is evenly arranged at the bottom of the whole specimen to ensure the flatness of the ground, and an oil pad is arranged between the bottom of the test specimen and the steel plate to form the sliding support conditions.

**Figure 4.** Loading facility.

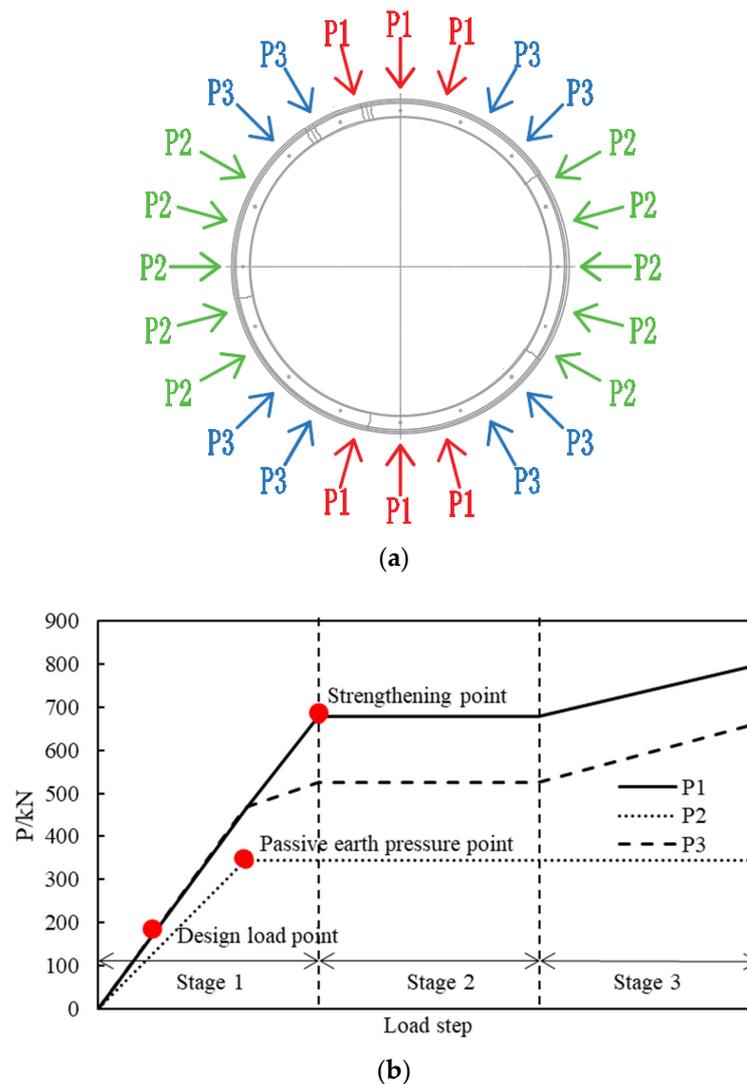
The 24 point loads are divided into three groups, as shown in Figure 5a, i.e., six P1s, ten P2s, and eight P3s. P1 simulates the vertical earth pressure, P2 simulates the horizontal earth pressure, and P3 simulates the load on the shoulder of the structure.

Figure 5b illustrates the loading process of the test, which is divided into three stages. In stage one, P1, P2 and P3 increase simultaneously, in which  $P2 = 0.65 \times P1$  and  $P3 = 0.5 \times (P1 + P2)$ . When the soil resistance reaches the passive earth pressure, it cannot continue to increase with the increase of the soil displacement and the value of P2 is the product of the passive earth pressure and the area which one jack is responsible for. When P2 reaches the passive earth pressure point, P2 is kept constant while P1 increases continuously,  $P3 = 0.5 \times (P1 + P2)$ . The second stage starts when the structural vertical convergence reaches 83 mm (the strengthening point), the structural deformation is maintained by the deformation maintaining system and the construction of the FWPs is conducted. In

stage three, P2 is kept constant, while P1 increases continuously, and  $P3 = 0.5 \times (P1 + P2)$ . This stage ends when the strengthened lining fails.

**Figure 5.** (a) Load groups; (b) Loading scheme.

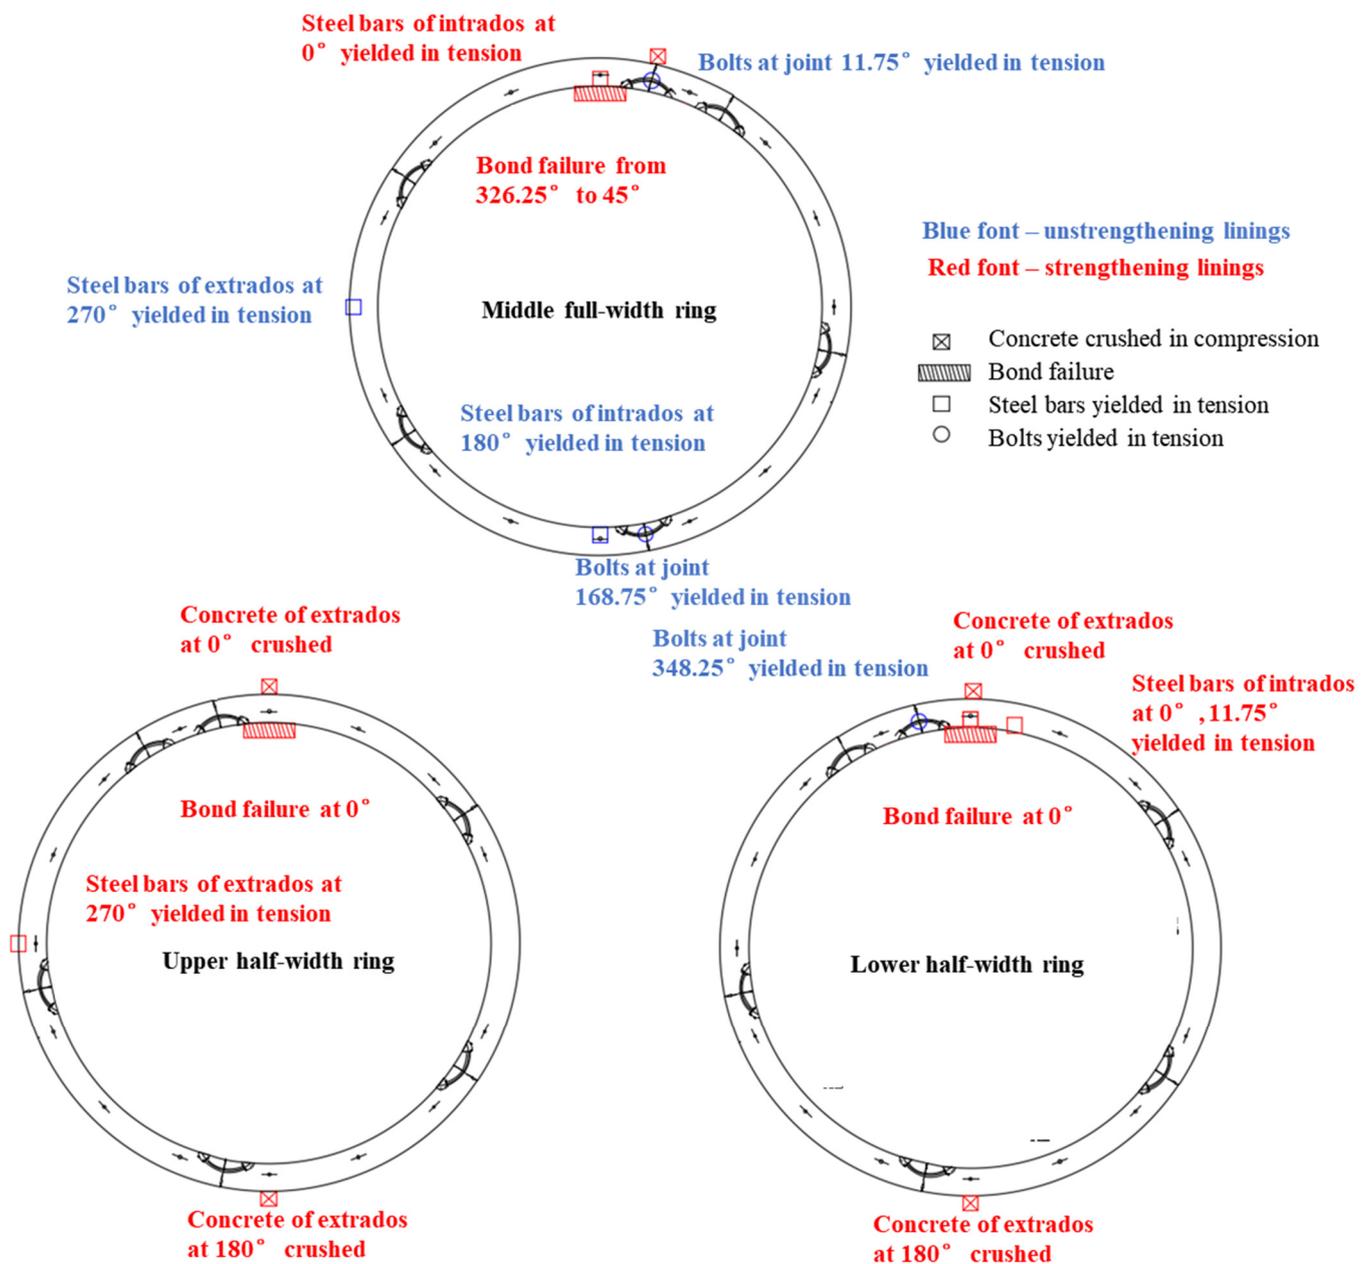
The failure state of the strengthened lining is shown in Figure 6. The debonding failure between the FWPs and the segments occurs in the areas ranging from  $326.25^\circ$  to  $45^\circ$ , peeling from both the clockwise and counterclockwise directions. The longitudinal joint at  $11.25^\circ$  of the middle full-width ring is subjected to a sagging moment, while the extrados concrete of this joint is compressed and crushed. The extrados concrete of the upper half-width ring and the lower half-width ring at  $0^\circ$  and  $168.75^\circ$  are crushed because of compression.

**Figure 6.** Failure state of the segmental tunnel lining that is strengthened by the FWPs.

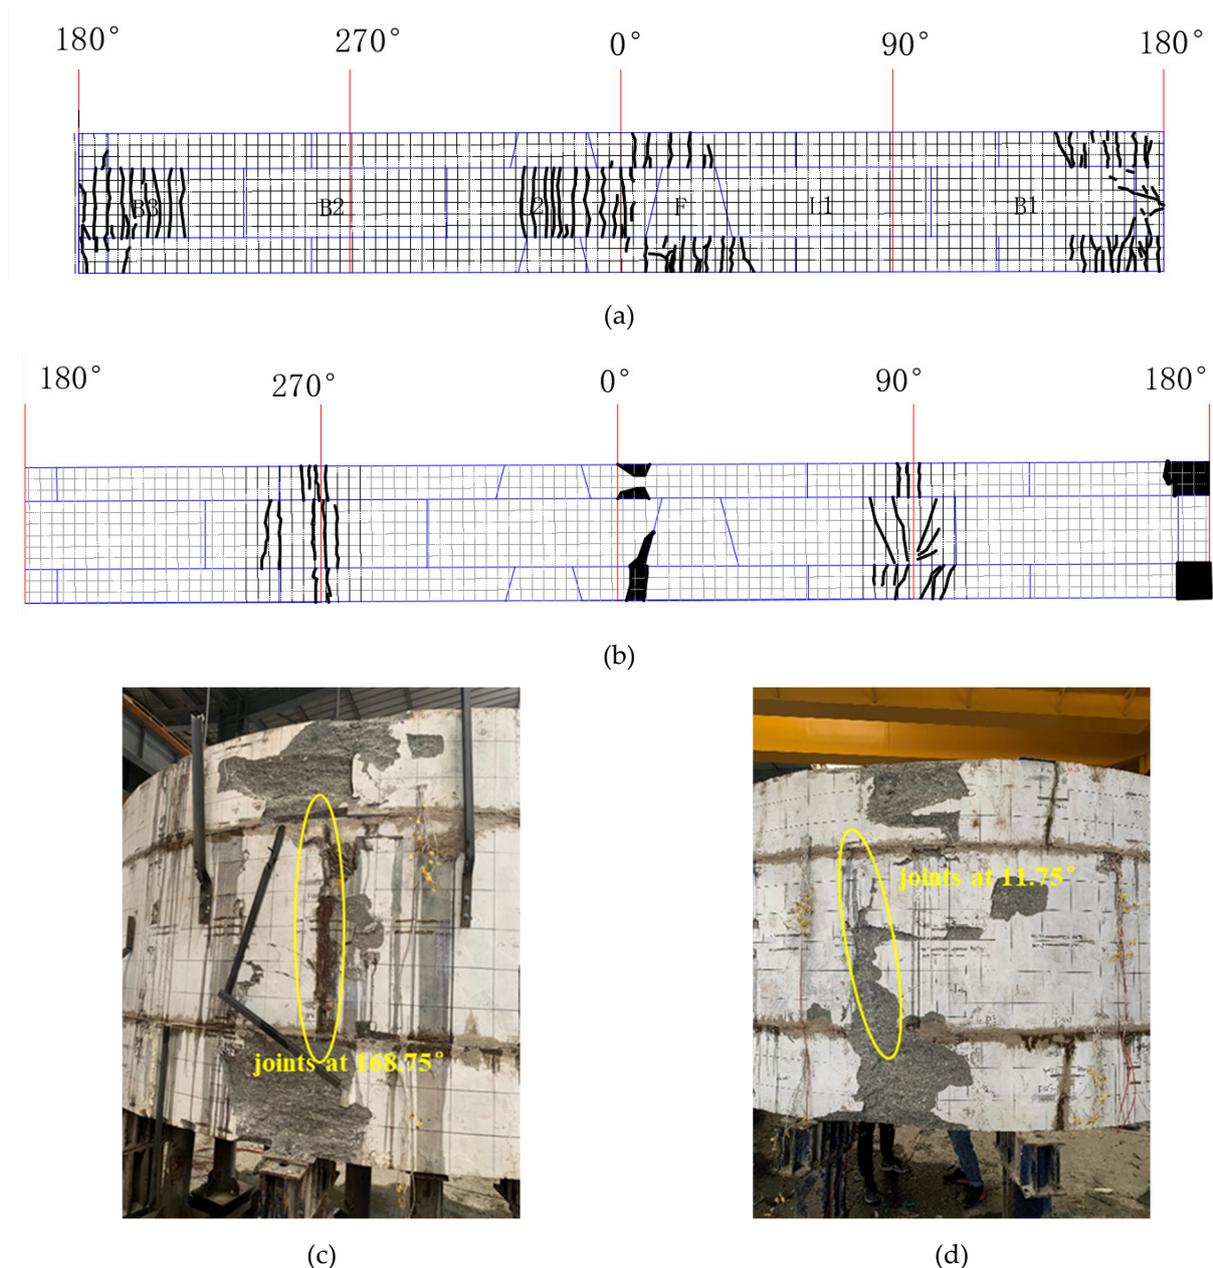
There are two kinds of phenomena in concrete segment, one is the tensile cracking of it and the other is the crushing of it under compression. The layout of the cracks and the crush zones is shown in Figure 6c,d. The black solid line represents the cracks, and the shadow represents the position of the crushing zones. The intrados cracks are filled with epoxy resin after the construction of the FWPs, which can improve the durability of the cracked lining.

In the unstrengthened linings, the segments underwent no compression damage, and only tensile cracking occurred. The cracks are on the crown and bottom of the lining intrados, the waist of the lining extrados, and the corresponding positions of the longitudinal joints of the adjacent rings. The maximum width of the crack is near 0° of the lower half-width ring and the maximum width is 0.37 mm. The cracks on the intrados of the middle full-width ring are fully developed, and the average distance between the cracks is about 200 mm.

In the strengthened linings, the cracks on the intrados of the segmental tunnel lining could not be observed because of them being hidden by the FWP's, and the extrados has no new cracks, but only the width of the existing cracks keep increasing. The maximum width of the extrados crack is located at  $90^\circ$  of the lower half-width ring, and the width is 5 mm. As shown in Figure 7a,b, when  $P1 = 802.5$  kN, the extrados concrete at  $168.75^\circ$  of upper and lower half-width rings are crushed by compression forces; whereas when  $P1 = 835$  kN, the extrados concrete at  $0^\circ$  of the upper and lower half-width rings are crushed by compression forces, and the extrados concrete of joint at  $11.75^\circ$  of the middle full-width ring is crushed by compression forces.

**Figure 7.** (a) Layout of cracks and crushing of intrados concrete; (b) layout of cracks and crushing of extrados concrete; (c) concrete crushed at  $168.75^\circ$ ; (d) concrete crushed at  $0^\circ$ .

After strengthening, the extrados concrete of the joints near the crown and the bottom of the lining is crushed. As shown in Figure 7a,b, the sagging moment is large enough to make the bolts yield under tension and the extrados concrete of the joint crush. After the bonding between the segments and the FWP is intensified, the initial failure of the strengthened lining changed from the bonding failure at the crown to the crush of the 352° zone of the extrados surface joint concrete [17]. Therefore, the extrados concrete of the joints near the crown and the bottom of the tunnel are the weak sections of the FWP-reinforced lining.

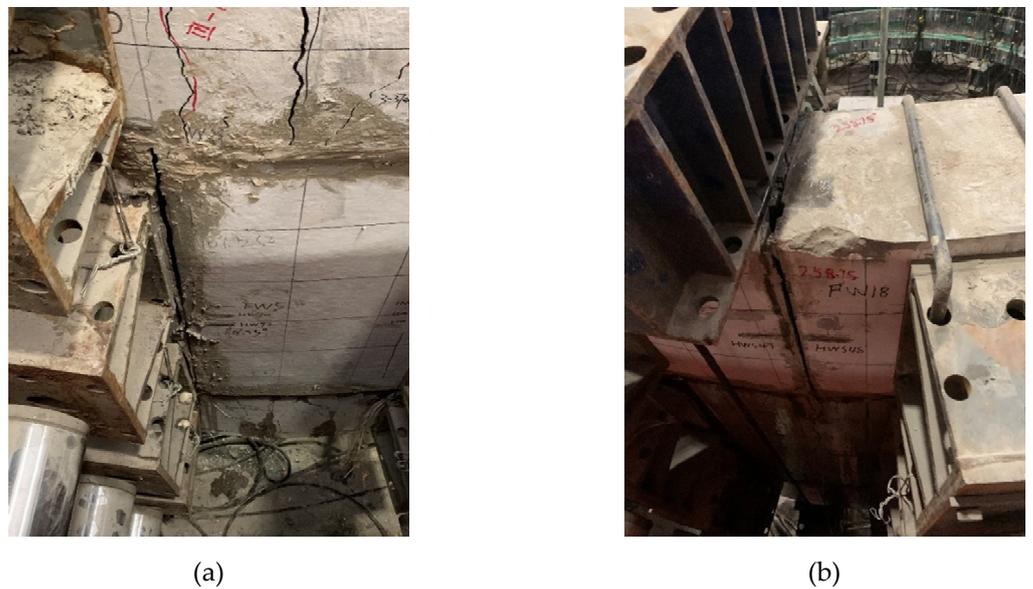
As shown in Figure 8, when the loads that are acting at  $P1$  reach 723.6 kN, the joint at  $101.25^\circ$  of the full-width ring and the joint at  $258.75^\circ$  of the upper half-width ring are under the coupling action of axial forces and hogging moments. Therefore, the intrados of the

first joint is compressed, while the extrados of the second joint is pulled, which makes the sealing mortar that is filled into the joints break.

Figure 8. (a) Joint 101.25° of full-width ring; (b) joint 258.75° of upper half-width ring.

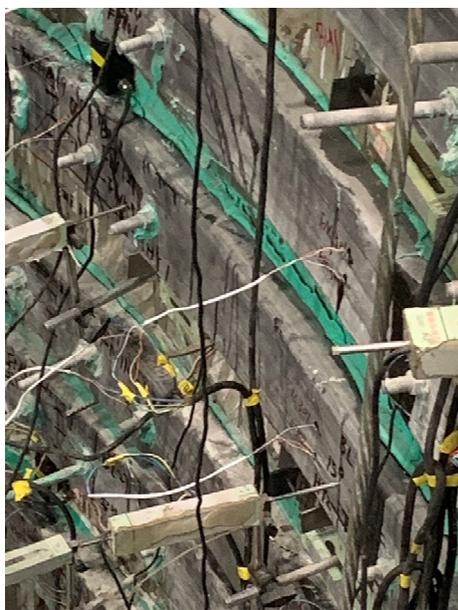
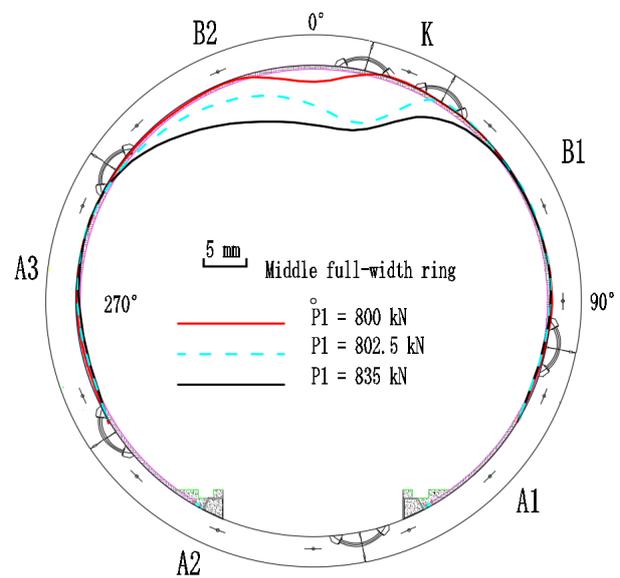
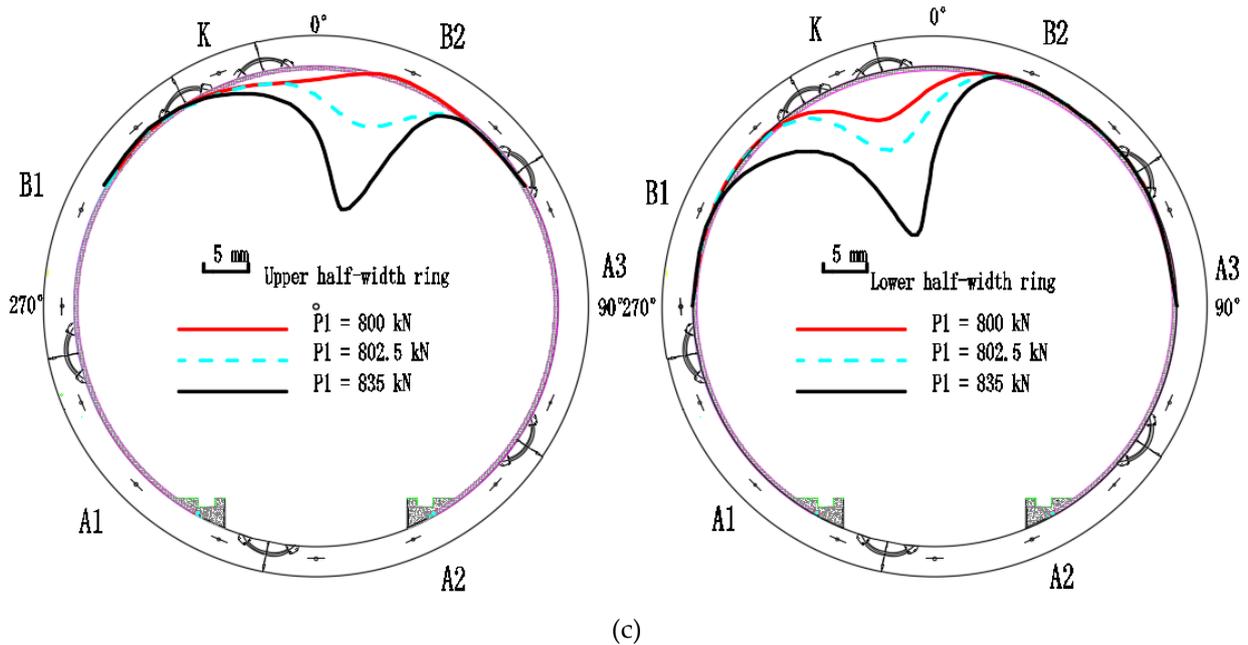
As shown in Figure 9a, when the loads that are acting on P1 reach 800 kN, the bond failure between the FWPs and the full-width ring occurs at 0°. The stripping value of the bond at the failure state is shown in Figure 9b,c.

Figure 9. (a) Bond failure of middle full-width ring; (b) stripping value of middle full-width ring; (c) stripping value of half-width ring.

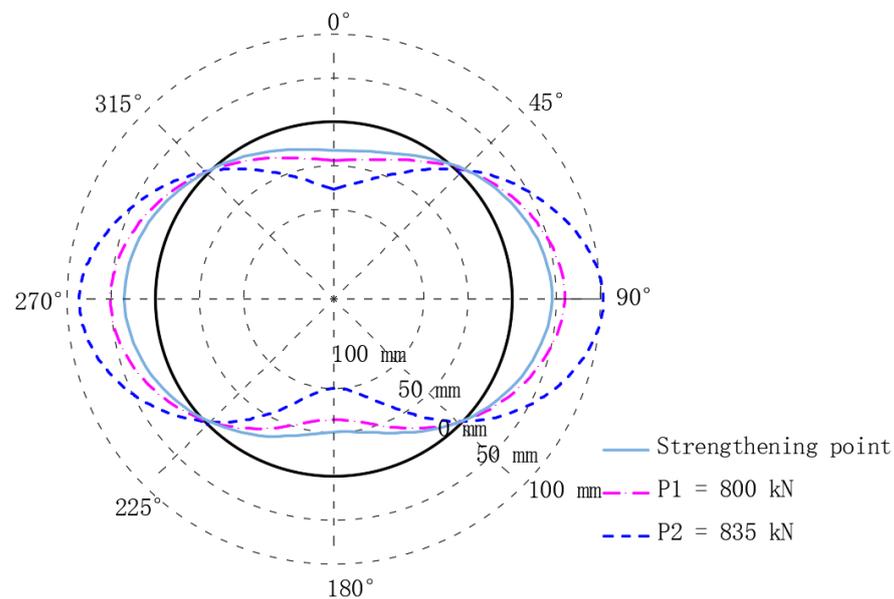
As shown in Figure 10, the crown and the bottom of the strengthened linings deform inward, and the waist of the linings deform outward.

Figure 10. Structural deformation.

At the strengthening point, the vertical convergence is 84.66 mm, and the horizontal convergence is 82.55 mm. When the loads that are acting at P1 reach 800 kN, the vertical and the horizontal convergences are 111.41 mm and 112.37 mm, respectively. When the loads that are acting at P1 reach 835 kN, the vertical and the horizontal convergences are 181.00 mm and 194.13 mm, respectively.

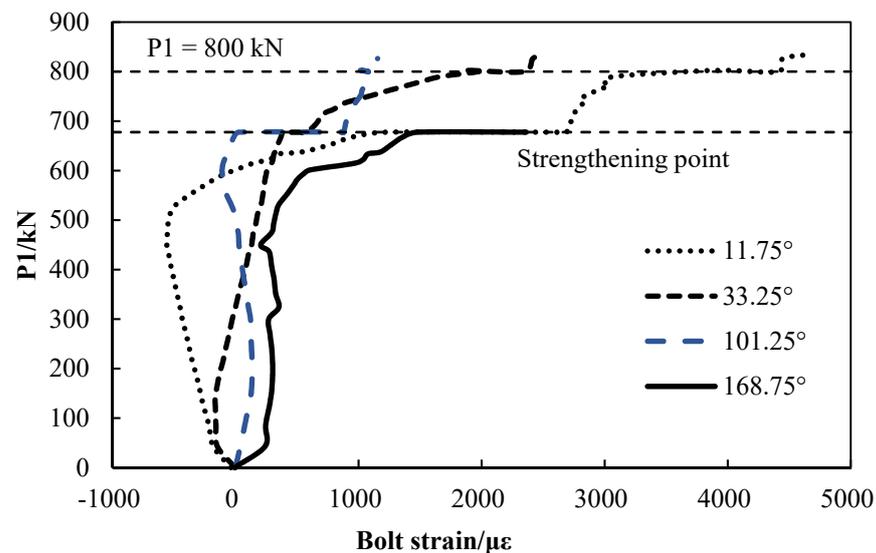
As shown in Figure 11, the bolts of the joints at  $11.75^\circ$  and  $168.75^\circ$  yield strains that exceeds  $2000 \mu\epsilon$ . As the load increasing, the bolt strains at the joint at  $33.25^\circ$  and the joint at  $101.25^\circ$  keep increasing after the FWP strengthening construction procedure is performed. The bolt at the joint at  $33.25^\circ$  yields when the P1 equals 800 kN. The strain gauges of the bolts of the joints at  $236.25^\circ$  and  $303.25^\circ$  in the middle full-width ring are damaged during loading.

Figure 11. The load–bolt strain diagram.

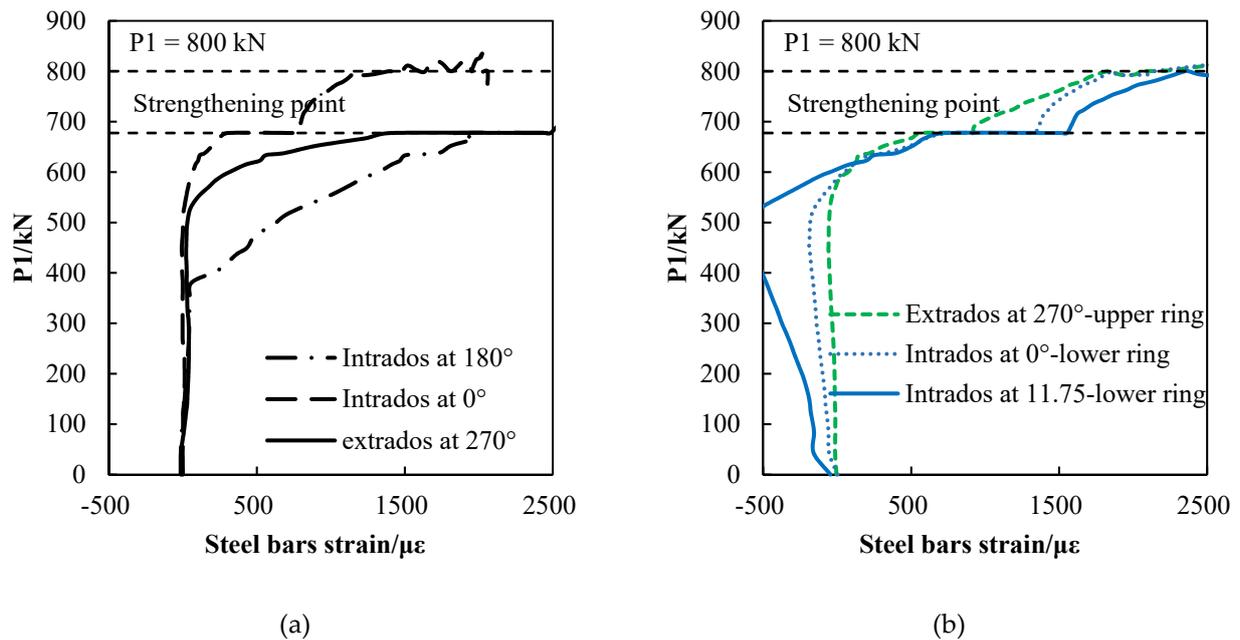
The main reinforcing steel bar of the segment is HRB335, and its elastic strain limit is  $2000 \mu\epsilon$ . The crown and the bottom of the linings are subjected to hogging moments, so the intrados steel bars are subjected to tension, and the extrados steel bars are compressed. The waist of the linings, however, is subjected to sagging moments, so the extrados steel bars are subjected to tension and the intrados steel bars are compressed. When the loads that are acting on P1 reach 677.5 kN, the extras steel bars at  $270^\circ$  are tensioned, and the strain of the steel bars rapidly increases to  $2000 \mu\epsilon$ , thereby reaching a yielding state. As shown in the Figure 12, when the loads that are acting on P1 reach 800 kN, the strain of the intrados steel bars at  $0^\circ$  increase to  $2000 \mu\epsilon$ , thereby reaching a yielding state.

Figure 12. The development of steel bars strains: (a) the steel strain of full-width ring; (b) the steel strain of half-width rings.

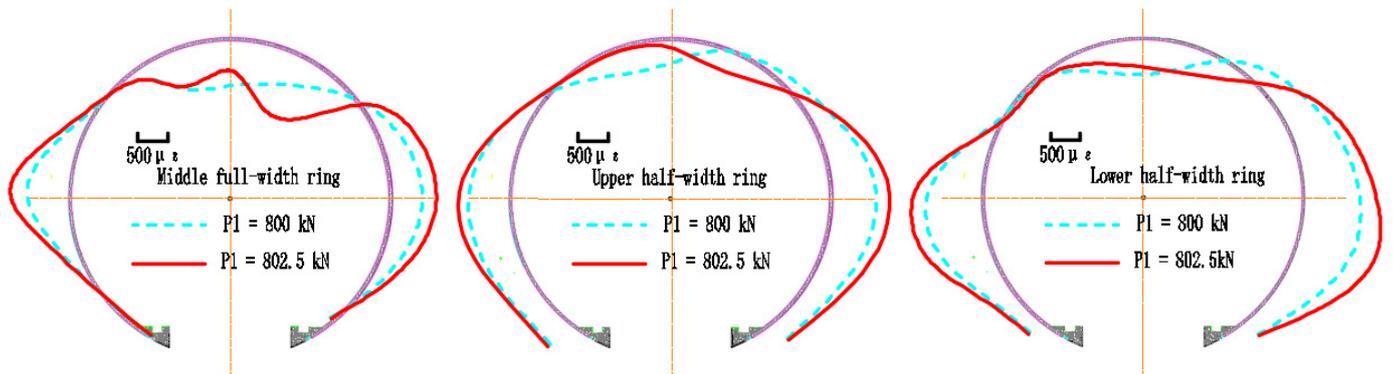
The strain of the FWP is shown in Figure 13, and the strain gauges measure the surface strain of the CFRP in the FWPs. When the loads that are acting at points P1 reach 800 kN, the distribution of the strain of the FWP is symmetrical along the vertical axis. The FWPs at the crown of the linings are subjected to tensile stress, and the FWPs at the waist are subjected to compressive stress. When the loads that are acting at points P1 are equal to 802.5 kN, the FWPs at  $0^\circ$  have separated from the segment. At the same time, the strain of the FWPs at  $0^\circ$  suddenly decrease, as shown in Figure 13.

As a result of the stripping failure, the superimposition effect between the FWPs at the crown and the segments are weakened. The internal force is redistributed, leading to the strain of the FWPs at the crown decreasing, while the strain of the FWPs at the other positions increases.

Figure 13. The distribution of FWP's strain.

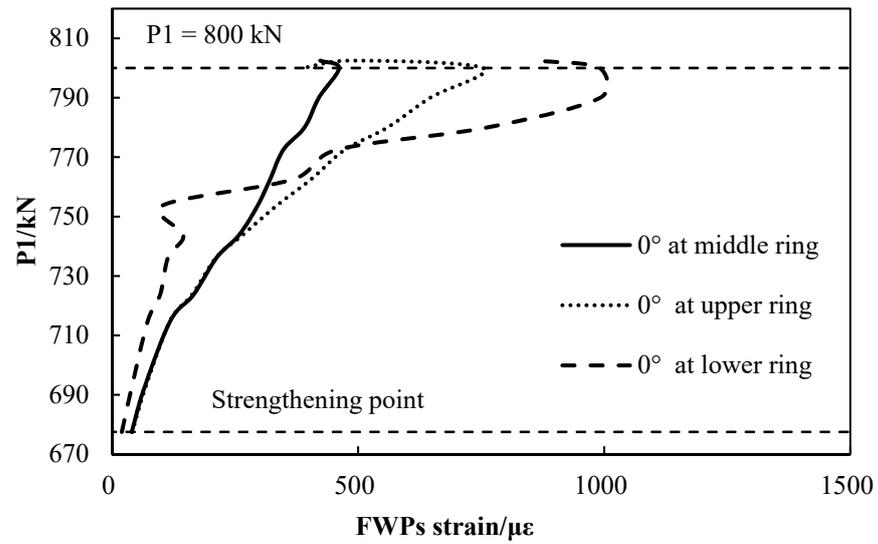
When the loads that are acting at P1 are equal to 800 kN, the strain of the FWPs at  $0^\circ$  has a sudden decrease, which indicates that the bond between the FWPs and the segment fails, as illustrated in Figure 14.

Figure 14. Load-strain curves of FWP's beginning at the strengthening point.

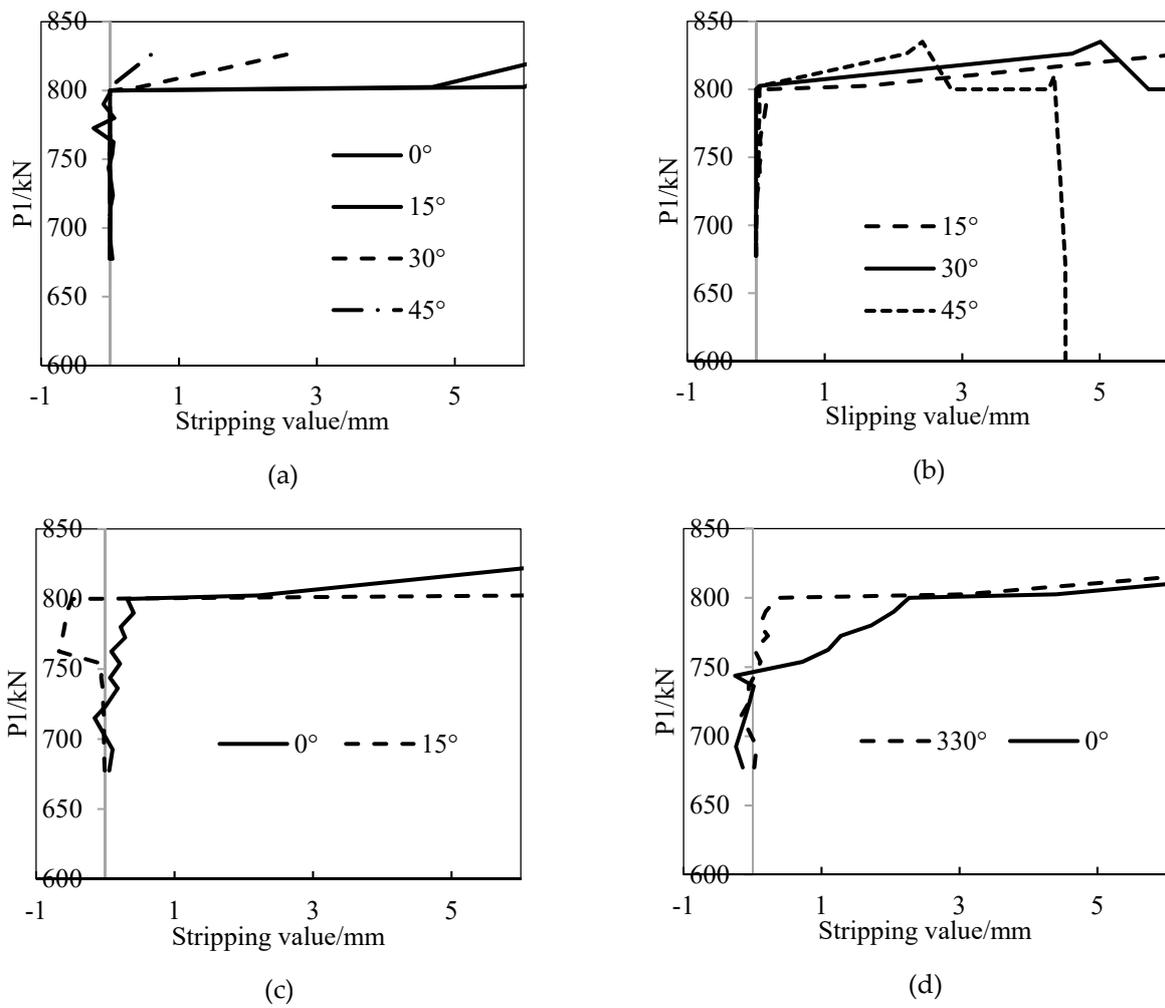
The slippage and stripping of the bond between the FWPs and the linings are tested. As shown in Figure 15, the debonding failure happens almost at the same time when the loads that are acting at P1 are equal to 800 kN, which is same as that of the experimental phenomena.

Figure 15. Load-displacement curves of the bond: (a) stripping of the middle ring; (b) slipping of the middle ring; (c) stripping of the upper ring; (d) stripping of the lower ring.

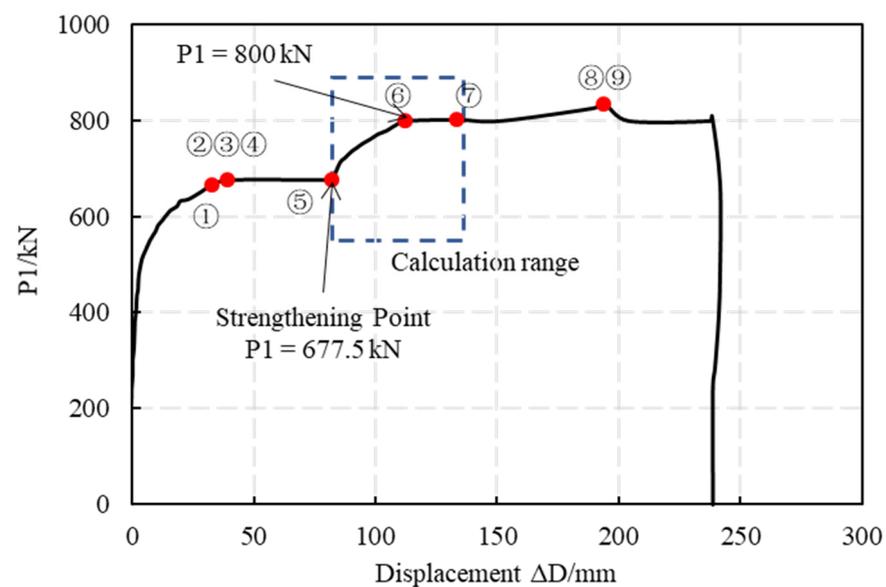
The internal force of the FWPs is calculated in this section and the calculation range is shown in Figure 16. The following assumptions are considered:

**Figure 16.** Load-displacement curves for stagger-jointed tunnel lining strengthened by FWPs.

The experimental load-displacement curves of the deformed stagger-jointed segmental tunnel linings that are strengthened by the epoxy-bonded filament wound profiles is illustrated in Figure 16, and the load levels of P1, which are associated with the progressive failure of the specimen, are listed in Table 4.

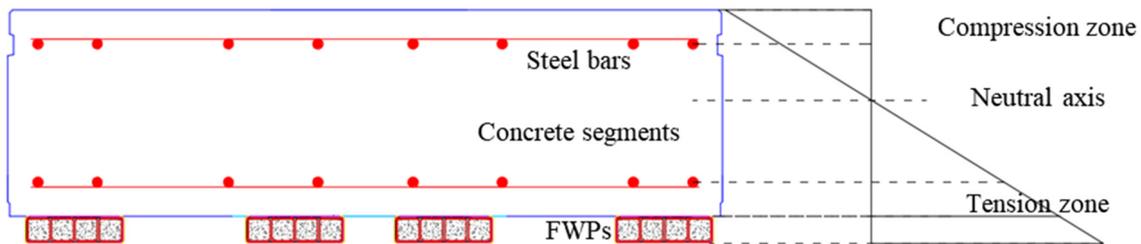
For example, as shown in Figure 17, when  $P_1 = 800$  kN, the strain curve of  $0^\circ$  is obtained by the linear fitting of the strain of the concrete, steel and FWPs. According to the stress development of the unstrengthened linings, the steel bars at the intrados at  $0^\circ$  have yielded, so the stress of intrados steel bars at  $0^\circ$  keeps yield strength as loads increasing. The stresses of the concrete and the CFRP are obtained according to the material assumptions that are made. According to the layered strain of each material in the FWPs, the axial force and bending moment of the FWPs can be obtained by integrating the stress. The calculation result is shown in Table 2. The axial force of the total section is  $-308.14$  kN, and the bending moment of the total section is  $356.23$  kNm. The FWPs bear  $471.02$  kN

tensile force and contribute 103.81 kNm to the bending moment. The FWP's are subjected to an axial tension of 471.02 kN and a bending moment of 0.5 kNm, which means that they are in a tension bending state.

Figure 17. The strain curve of 0°.

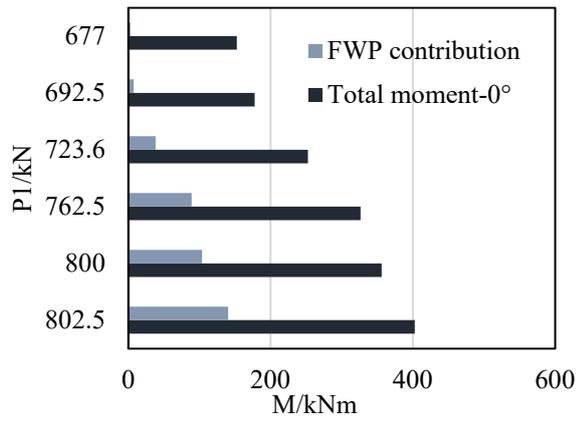
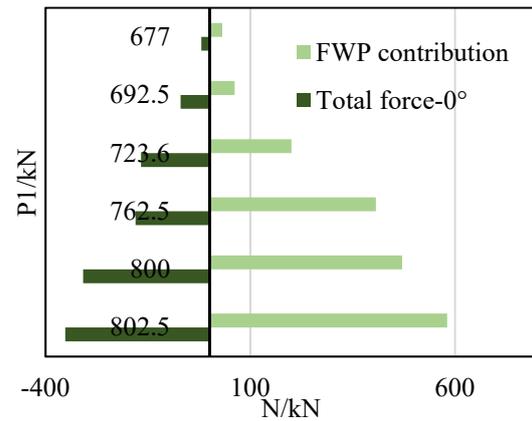
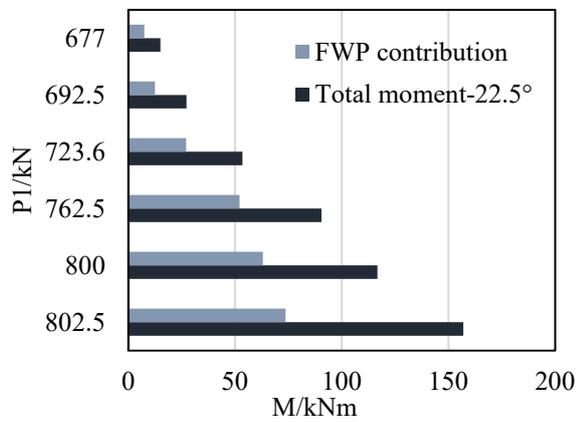
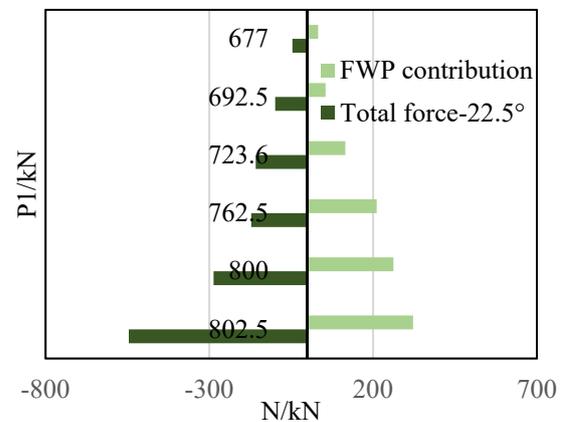
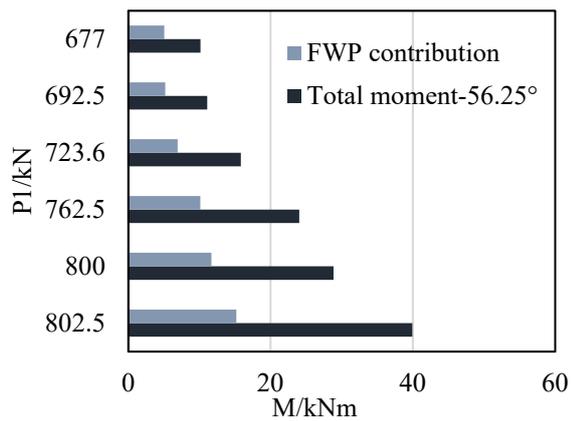
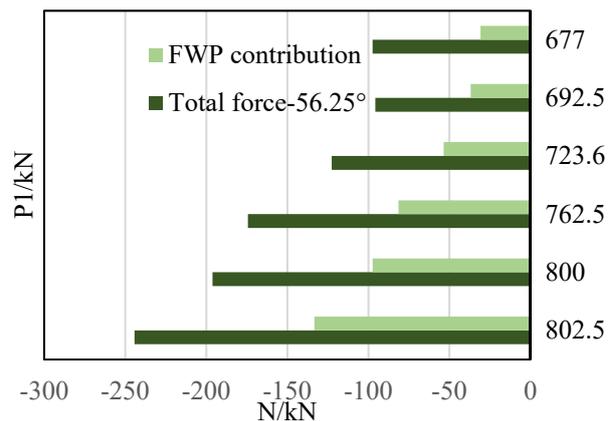
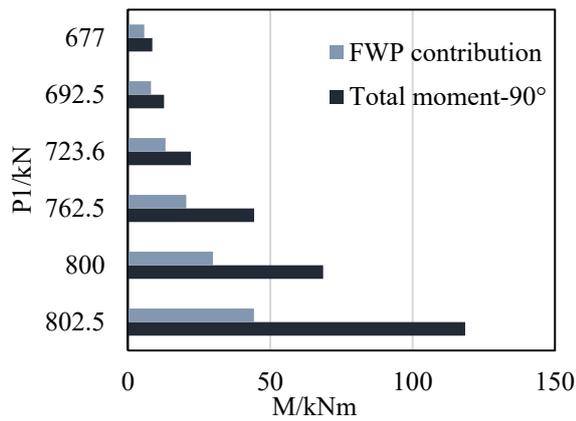
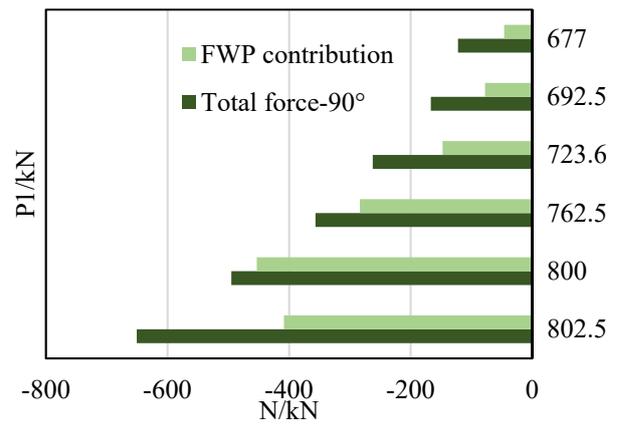
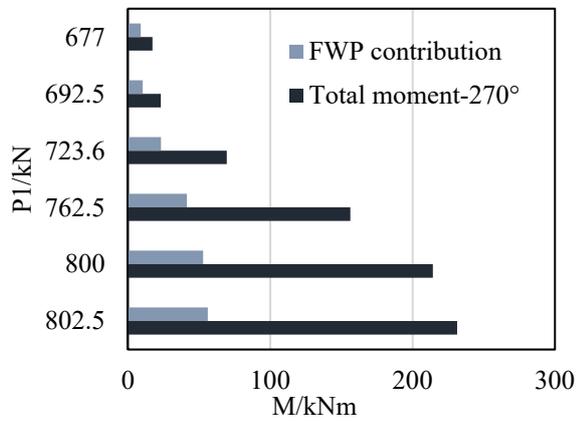
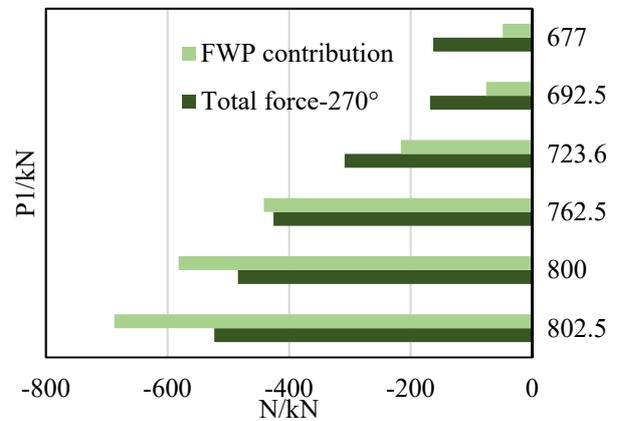
With an incremental load, the internal forces of the segments and the FWP's are shown in Figure 18. The FWP's bear tensile force and bending moments at 0° and 22.5°, while at 56.25°, 90° and 270°, the FWP's bear compressive force and bending moments. With the load increasing, the FWP's and the concrete segments work together in the elastic stage, and the internal forces gradually increase.

**Figure 18.** The internal force of segments and FWPs contribution: (a) moment at 0°; (b) axial force at 0°; (c) moment at 22.5°; (d) axial force at 22.5°; (e) moment at 56.25°; (f) axial force at 56.25°; (g) moment at 90°; (h) axial force at 90°; (i) moment at 270°; (j) axial force at 270°.

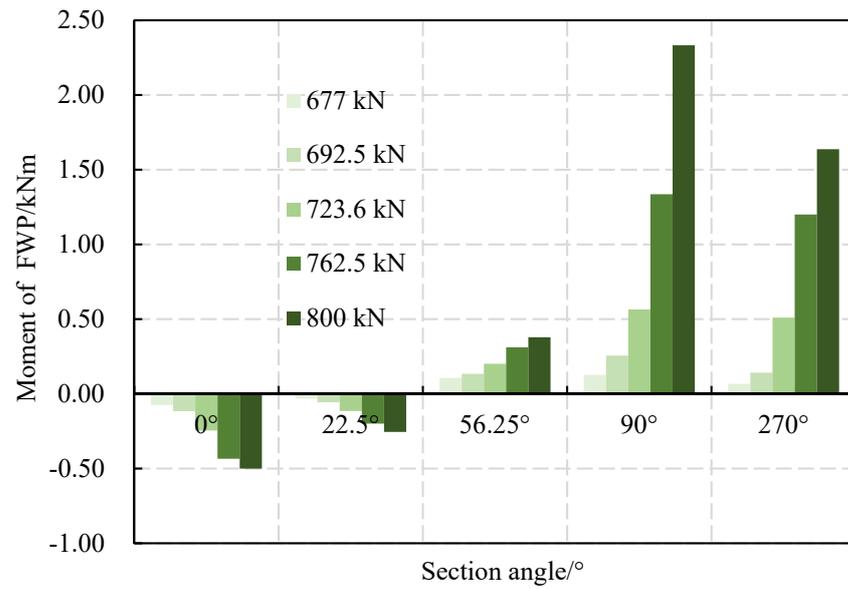
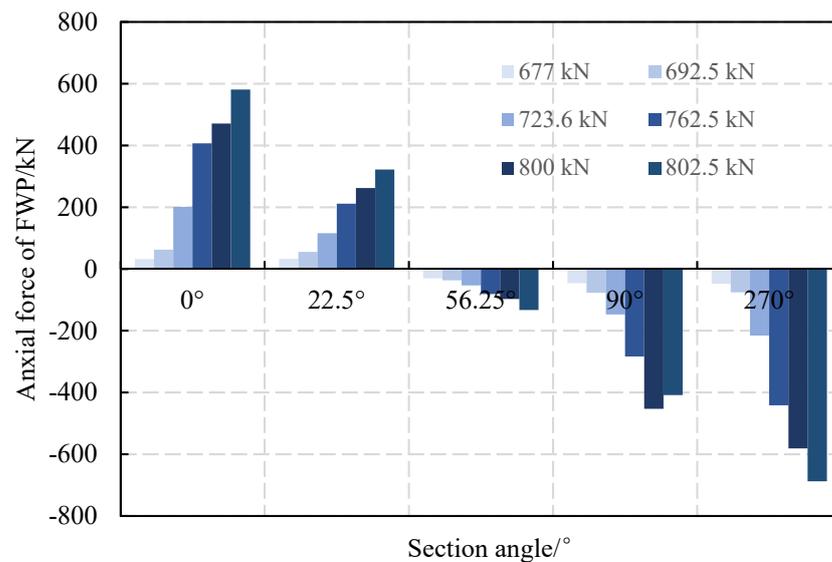
The internal forces of the FWP's are shown in Figure 19. The FWP's at 0° and 22.5° are in bending and tension states. The FWP's of the 56.25°, 90° and 270° sections are in bending and compression states. When the strengthened linings are in the elastic stage, the internal force of the FWP's increases with the increase of the load. The hogging moment indicates that the surface strain of the FWP's that are not bonded with the segments is greater than that of the FWP's that are bonded with the lining, and the sagging moment indicates the that the opposite is true.

**Figure 19.** The internal force of FWPs: (a) the moments of FWPs; (b) the axial force of FWPs.

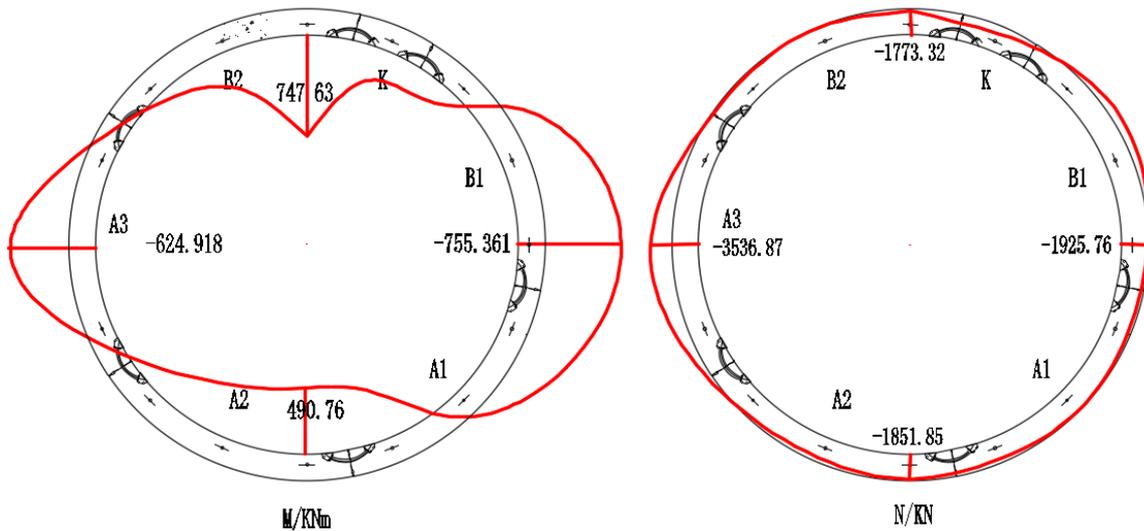
The steel bars of the intrados at the crown and bottom of the lining and the steel bars of extrados at the waist are prone to yield failure. The internal force distribution of the unstrengthened lining is shown in Figure 20. For the calculation method and the

assumption of the internal force, refer to Section 4.1.1. As shown in Figure 20, the peak values of the sagging moment are at the crown and the bottom of the lining, while the peak value of the hogging moment is at the waist. At this load level, the steel bars of the intrados at the crown and the bottom bear the tensile stress, and the steel bars of the extrados at the waist bear the tensile stress.

Figure 20. The internal force distribution of unstrengthened middle full-width ring.
