Article

Application of Biomineralization Technology to Self-Healing of Fiber-Reinforced Lightweight Concrete after Exposure to High Temperatures

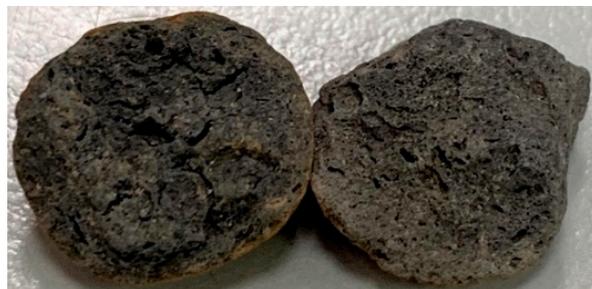
Figure 1. Appearance of lightweight expanded shale aggregates.

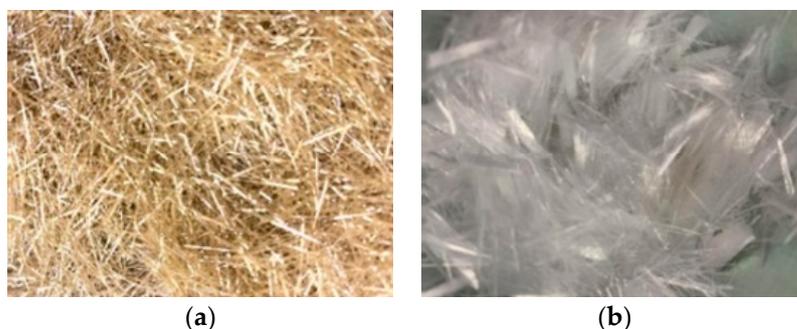
Figure 2. Fibers used in this study: (a) short micro-steel fibers; (b) polypropylene fibers.

- **Fibers:** These were the products of Guli Li Co., Ltd. We used short microsteel fibers (according to ASTM A820) and polypropylene fibers, as shown in Figure 2. The basic properties of the two fibers is shown in Table 1.

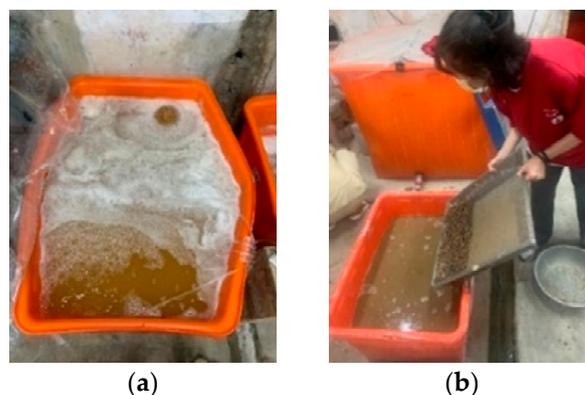
Figure 3. Strain implanted in lightweight aggregate: (a) bacterial spore solution; (b) lightweight aggregate dipped in bacterial spore solution.

- (a) The lightweight aggregates were immersed in a nutrient source solution containing calcium lactate (80 g/L) and yeast extract (1 g/L) for 30 min, as shown in Figure 3.
- (b) Drain the lightweight aggregates that were soaked in the nutrient-source solution, and then put them into an oven at 37 °C to dry for 5 days, as shown in Figure 4.
- (c) Repeat the previous two steps once; then, immerse the nutrient-containing lightweight aggregate in the bacterial spore solution for 30 min; and
- (d) Drain the lightweight aggregates soaked in the bacteria-spore solution and place them in an oven at 37 °C for 5 days. After that, the preparations for the implantation of the strains in the lightweight aggregates were completed.

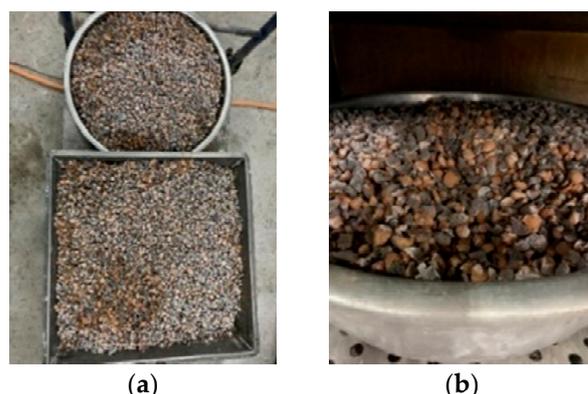
Figure 4. Draining and drying of lightweight aggregates: (a) draining; (b) drying.

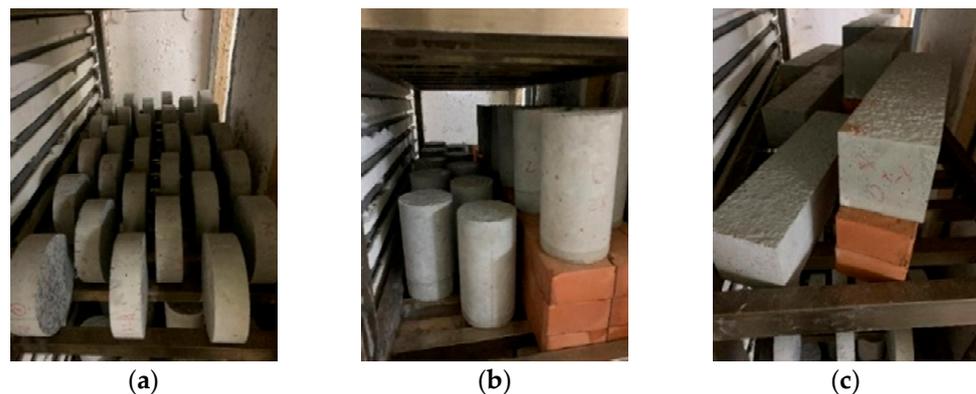
Figure 5. Configurations of specimens in high-temperature furnace: (a) water-penetration-test specimens; (b) compressive-strength-test specimens; (c) flexural-strength-test specimens.

The target temperature of the high temperature test was 500 °C. The concrete specimens were placed in a high-temperature furnace with a gap of 20 mm between the specimens, as shown in Figure 5. During the high temperature test, the furnace temperature heating rate was 2 °C/min. After reaching the target temperature of 500 °C, this temperature was continued for one hour, as shown in Figure 6. After that, the specimens were naturally cooled in the high-temperature furnace to a normal temperature of 23 °C, and then the subsequent related tests were carried out. In terms of the microscopic observation, the whole crack was taken out with a cutting machine. The specimens were split along the cracks, and one of the crack sections was taken and placed under a scanning electron microscope to observe the distribution of the generated substances along the crack-depth direction. Then, another section was taken and grounded into the matrix along the fracture surface with a file, and the ground powder was collected and subjected to XRD analysis to understand its composition.

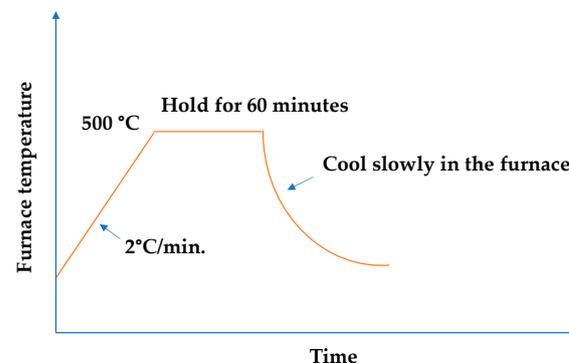
Figure 6. Heating process of the high-temperature test.

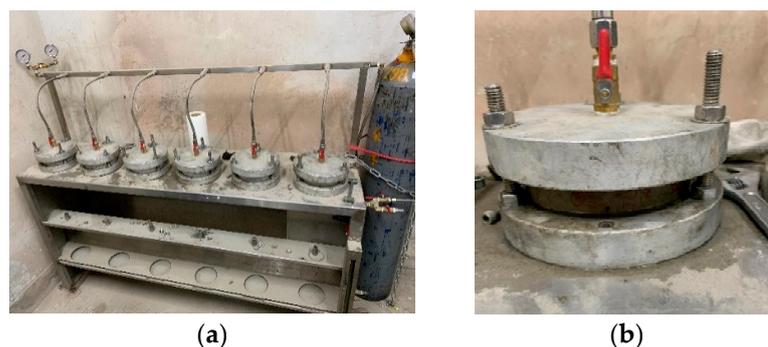
Figure 7. Water penetration test setup: (a) the case of six specimens; (b) the case of a single specimen.

Each group of concrete was subjected to a water penetration test, according to CNS 3763, before and after exposure to a high temperature. The test configuration is shown in Figure 7. The test steps are as follows:

- (a) After cutting the upper and lower sections of the specimen by 7 cm with a cutting machine, take the remaining middle section and cut it into three pieces, making each section 4 cm;
- (b) Put the sheet specimen in an oven and dry it at 80 °C for three days;
- (c) One hour before the water-penetration test, take the specimen out of the oven and measure the weight before the water penetration;
- (d) Dry the water-penetration-test mold up and down, and apply oil on the rubber pad;
- (e) Put the specimen into the mold, lock the bolt, open the pressure valve, and apply 3 kgf/cm² of water pressure for three hours;
- (f) Remove the specimen, wipe the surface-water stains dry, and record the weight after the water penetration.

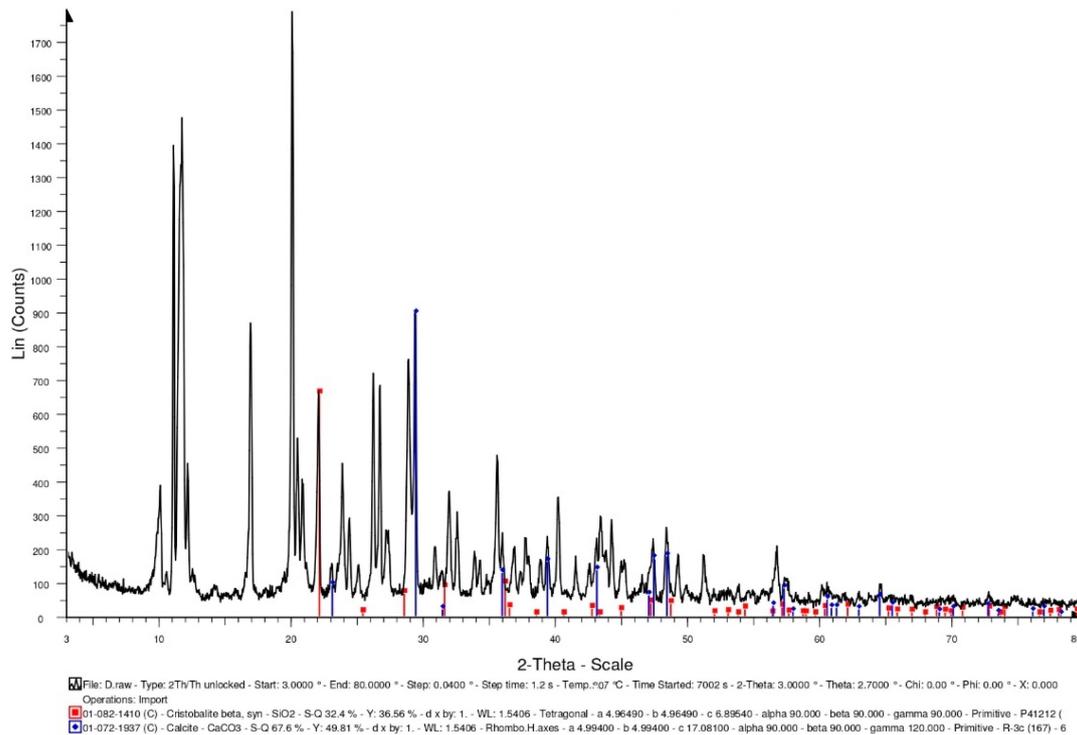
Figure 8. XRD-analysis results of the bacteria powders not subjected to high temperature.

Generally speaking, bacterial cells do not easily survive in high-temperature environments (above 135 °C). In the concrete specimens of the experimental group, the light aggregates carried the bacterial cells. The survival of the bacteria needs to be explored after 500 °C. In this study, the bacterial solution was added to the calcium source solution (calcium lactate: 80 g/L; urea: 20.02 g/L). After the complete reaction, it was dried in an oven (50 °C) until powdery. The intensity of the X-ray-reflected energy of the calcium carbonate in the bacterial powder not subjected to a high temperature was 900 (unit: counts) at 2-theta of 29.4° (Figure 8).

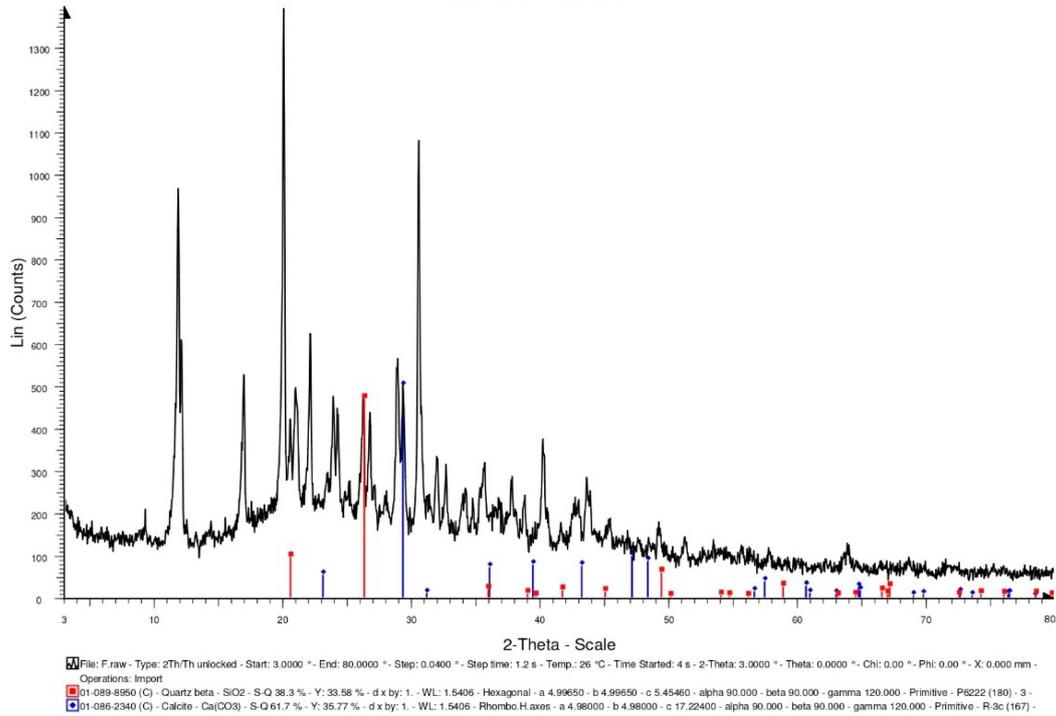
Figure 9. XRD-analysis results of the bacteria powders subjected to high temperature.

Furthermore, some of the bacterial liquids were taken out separately and placed in a high temperature furnace. At a heating rate of 2 °C/min, the temperature was raised to 500 °C, and the temperature was maintained for one hour. After the high temperature test was completed and the temperature was lowered to room temperature, the bacteria liquid subjected to a high temperature was recultivated. The cultured bacterial solution contained the calcium source solution (calcium lactate: 80 g/L; urea: 20.02 g/L). After the complete reaction, it was dried in an oven (50 °C) until powdery. The intensity of the X-ray-reflected energy of the calcium carbonate in the bacterial powder subjected to a high temperature was 510 (unit: counts) at 2-theta of 29.4° (Figure 9). According to this result, there was a reduction in the viable bacterial cells after the exposure to 500 °C, which may have resulted in less pronounced mineralization. On the other hand, the lightweight aggregates were soaked in the bacterial liquid. After the lightweight aggregates were drained, they were placed in a high-temperature furnace. At a heating rate of 2 °C/min, the temperature was raised to 500 °C, and the temperature was maintained for one hour. After the high temperature test was completed and the temperature was lowered to room temperature, the bacteria liquid subjected to the high temperature was recultivated. The cultured bacterial solution contained the calcium source solution (calcium lactate: 80 g/L; urea: 20.02 g/L). After the complete reaction, it was dried in an oven (50 °C) until powdery. When using the lightweight aggregates as carriers, the intensity of the X-ray-reflected energy of the calcium carbonate in the bacterial powder subjected to the high temperature was 1220 (unit: counts)

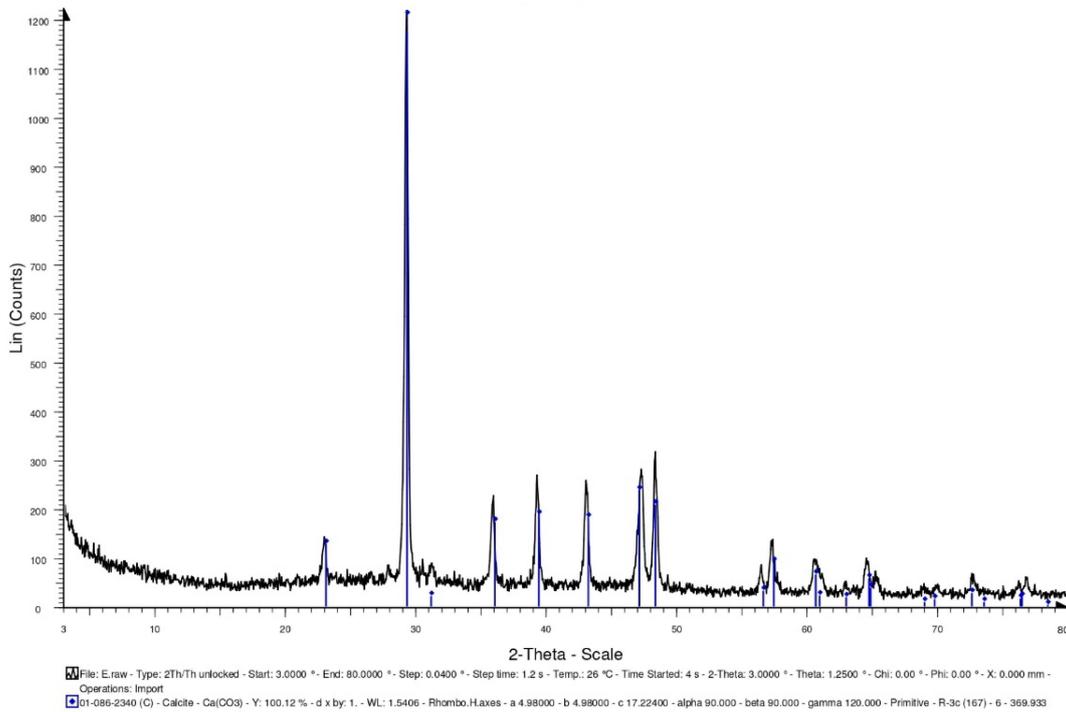
Figure 10. XRD-analysis results of the bacteria powders subjected to high temperature (using lightweight aggregates as a carrier).

at 29.4° (Figure 10). According to the results, using lightweight aggregates as carriers, after exposure to 500 °C, the bacterial solution was recultivated, and its mineralization was still significant.

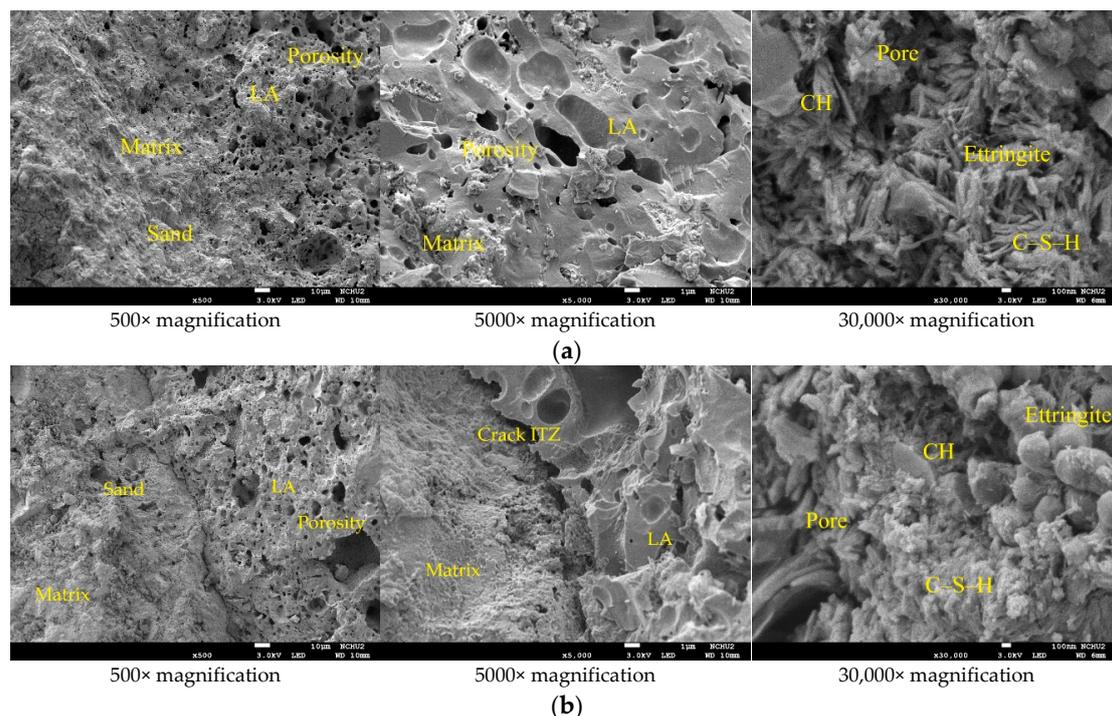
Figure 11. SEM micrographs of the concrete specimens after self-healing for 14 days: (a) control group; (b) experimental group.

The FESEM micrographs of the concrete specimens after self-healing for 14 days is shown in Figure 11, which reveal information about the pore structures, cracks, and mineral phases of the specimens. In Figure 11, the unhydrated cement particles, matrix, light aggregates (LAs), fine aggregates, and the interface transition zone (ITZ) between the matrix and LAs could be observed. In addition, irregular particles, micropores, and microcracks were also observed in each group of specimens. The higher magnification of Figure 11 revealed a more or less connected network of needle-like and platelet-like crystals, with the elongated hexagonal needles being Ettringite (AFt), and the hexagonal platelets being calcium hydroxide (CH). In addition, the network floccs were calcium-silicate-hydrate (C-S-H) colloids, and the black parts were the pores of the substrate, lightweight aggregates, and ITZ. Among them, C-S-H colloids are the main hydration product of Portland cement, accounting for about 2/3 of the total hydration product in hardened cement slurry, and dominating the macroscopic properties of cement-based materials [2]. Furthermore, many microscopic pores were found inside the lightweight aggregates. In particular, the porosity and pore size distribution are the main factors that control the strength of concrete [2]. In the concrete specimens, the unhydrated silicate was hydrated into calcite. In other words, in the presence of moisture, the carbonation process produced smaller rehydration products [24]. These products reduced the porosity of the concrete and restored some of its strength.

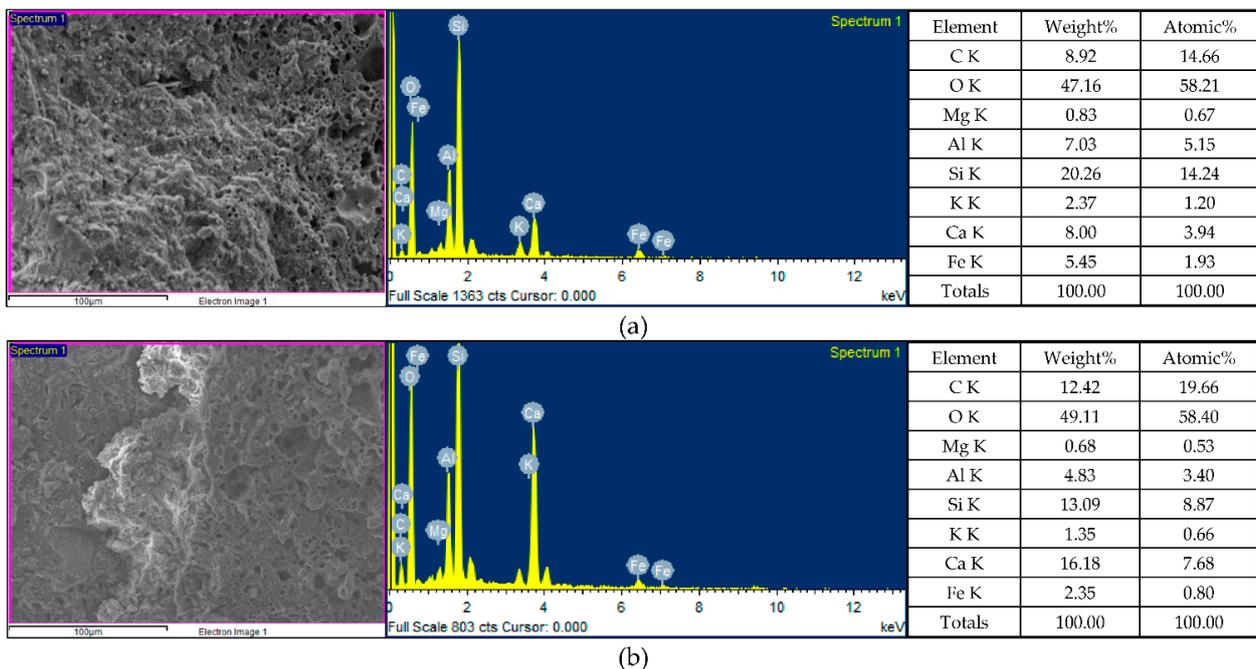
Figure 12. EDS analysis of the concrete specimens after self-healing for 14 days: (a) control group; (b) experimental group.

After self-healing for 14 days, the concrete specimens were analyzed by EDS for the weight percentages of the various chemical elements. The EDS spectra of the concrete specimens are shown in Figure 12, in which the y-axis describes the number of X-rays, and the x-axis describes the energies of the X-rays. In addition, the position of the peak is the identification of the element, and the peak height helps to quantify the content of each element in the specimens. According to the EDS analysis of the control-group specimens, they contained the elements C, O, Mg, Al, Si, K, Ca, and Fe (Figure 12a), of

which the main elements (weight percentage) were O (47.16%), Si (20.26%), C (8.92%), and Ca (8.0%). According to the EDS analysis of the experimental-group specimens, they contained the elements C, O, Mg, Al, Si, K, Ca, and Fe (Figure 12b), of which the main elements (weight percentage) were O (49.11%), Ca (16.18%), Si (13.09%), and C (12.42%). According to the EDS analysis (Figure 12), bacterial CaCO_3 crystals were present in the experimental-group specimens. In other words, the EDS verified the formation of calcium carbonate in the experimental-group specimens. Moreover, it was found that a higher percentage of elemental calcium in the experimental-group specimens. This may be caused by the mineralization of bacteria. An important stoichiometric parameter that defines the C-S-H phase is the atomic ratio of CaO to SiO_2 (C/S ratio) in its structure, which can be used to reflect the changes in the chemical composition of the C-S-H colloids in the ITZ and cement pastes. The C/S ratio is also an important indicator to distinguish the rich phases of hydration products [25,26]. According to some studies [27,28], a lower C/S ratio of the ITZ generally indicates a higher content of C-S-H colloids and a lower content of CH in the cement matrix. As for the vicinity of the aggregate, the C/S ratio increases due to the presence of large CH crystals [29]. In general, C/S ratios between 0.8 and 2.5 can be considered as C-S-H-colloid-rich hydrates, C/S ratios higher than 4 are considered to be rich in monosulfates (AFm), and C/S ratios higher than 10 are considered to be rich in calcium hydroxide (CH) [25]. When the C/S ratio is decreased below 1.0, the BET (Brunauer–Emmett–Teller) surface area of the C-S-H substantially increases, and these properties have been shown to affect the physicochemical behavior of C-S-H [30]. In the experimental-group specimens, the C/S ratio was 0.87, which indicates that it was rich in the hydrates of C-S-H colloids.

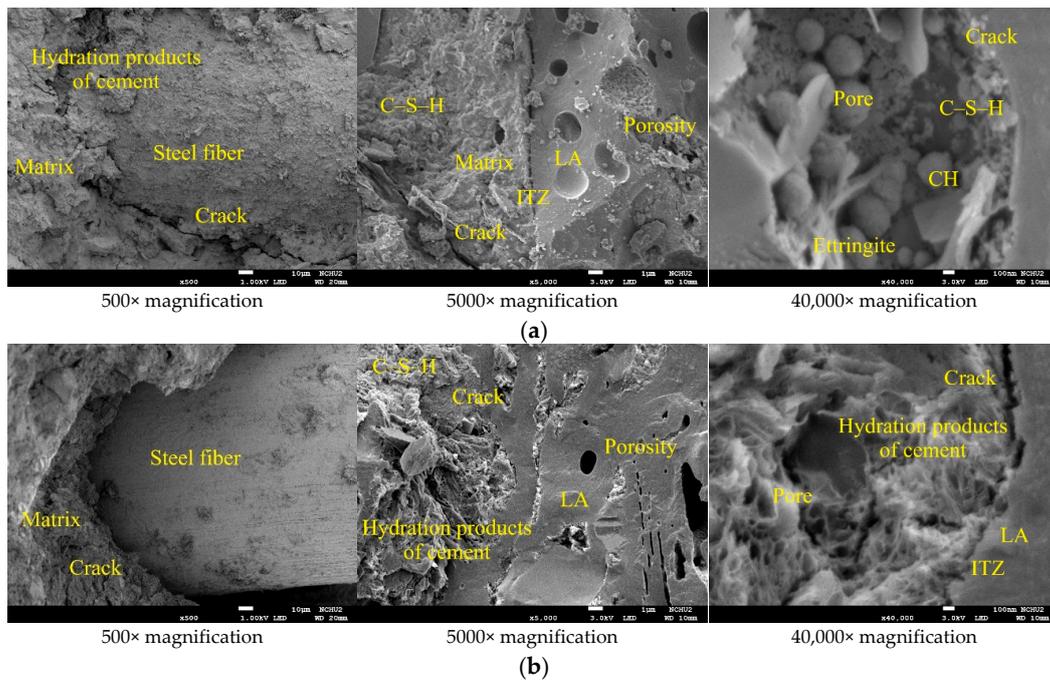
Figure 13. SEM micrographs of the concrete specimens after self-healing for 28 days: (a) control group; (b) experimental group.

After 28 days of self-healing, the FESEM micrographs of the concrete specimens revealed information on their morphological changes and the formation of rehydration products, as shown in Figure 13. Compared with the specimens cured for 14 days, the micropores of the concrete specimens were reduced and the microstructures appeared denser due to the continuous rehydration of the uncemented cement. In other words, the longer the self-healing period of concrete, the more substantial its strength recovery. It

can observe that the interface between the matrix and steel fiber in Figure 13. The higher magnification of Figure 13 revealed the ITZ between the matrix and lightweight aggregate, as well as the cement-hydration products. The elongated hexagonal needles were ettringite, the hexagonal flakes were calcium hydroxide, and the network floccs were C-S-H colloids (the black parts were the voids of the filler). In addition, many fine pores were observed inside the light aggregates. After self-healing for 28 days, the EDS spectra of the concrete specimen are shown in Figure 14.

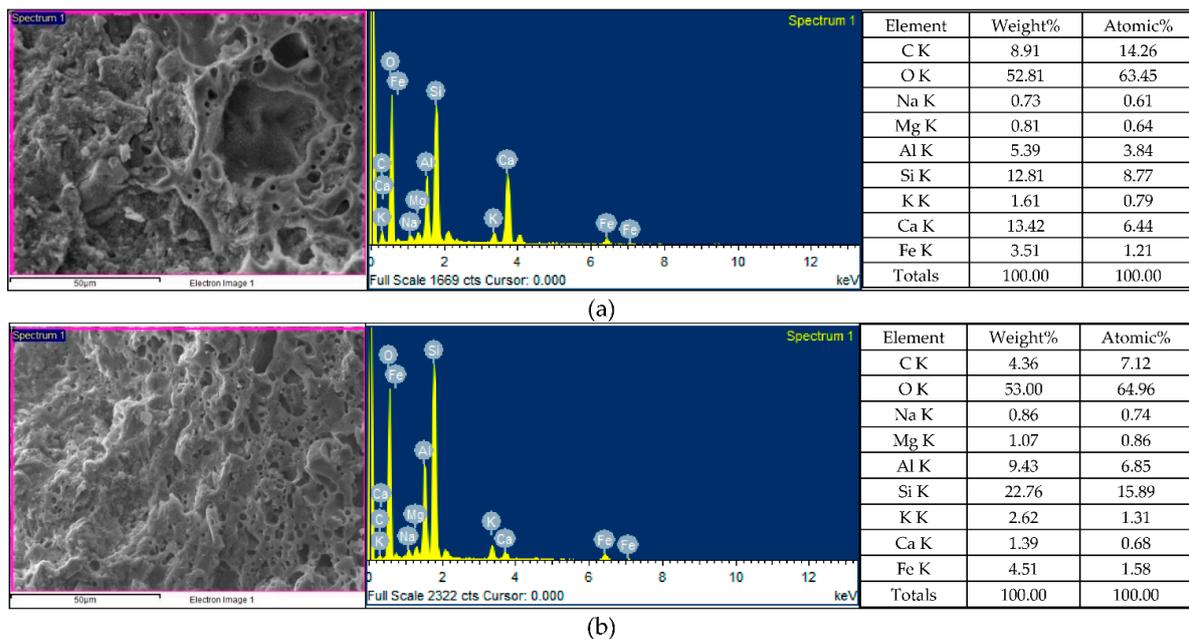
Figure 14. EDS analysis of the concrete specimens after self-healing for 28 days: (a) control group; (b) experimental group.

According to the EDS analysis of the control-group specimens (Figure 14a), they contained the following nine elements—C, O, Na, Mg, Al, Si, K, Ca, and Fe—among which the main elements (the percentage by weight) were O (52.81%), Ca (13.42%), Si (12.81%), and C (8.91%). According to the EDS analysis of the experimental-group specimens (Figure 14b), they contained the following nine elements: C, O, Na, Mg, Al, Si, K, Ca, and Fe, among which the main elements (the percentage by weight) were O (53.0%), Si (22.76%), Al (9.43%), and Fe (4.51%). It was found that a higher percentage of elemental silicon in the experimental-group specimens. In general, the C/S ratio is an important parameter for the microstructure and mechanical properties of C-S-H. The C/S ratio of the concrete specimens changed with the increase in the curing age and the degree of the hydration. In the control group, the C/S ratio was 0.73. In the experimental group, the C/S ratio was 0.04.

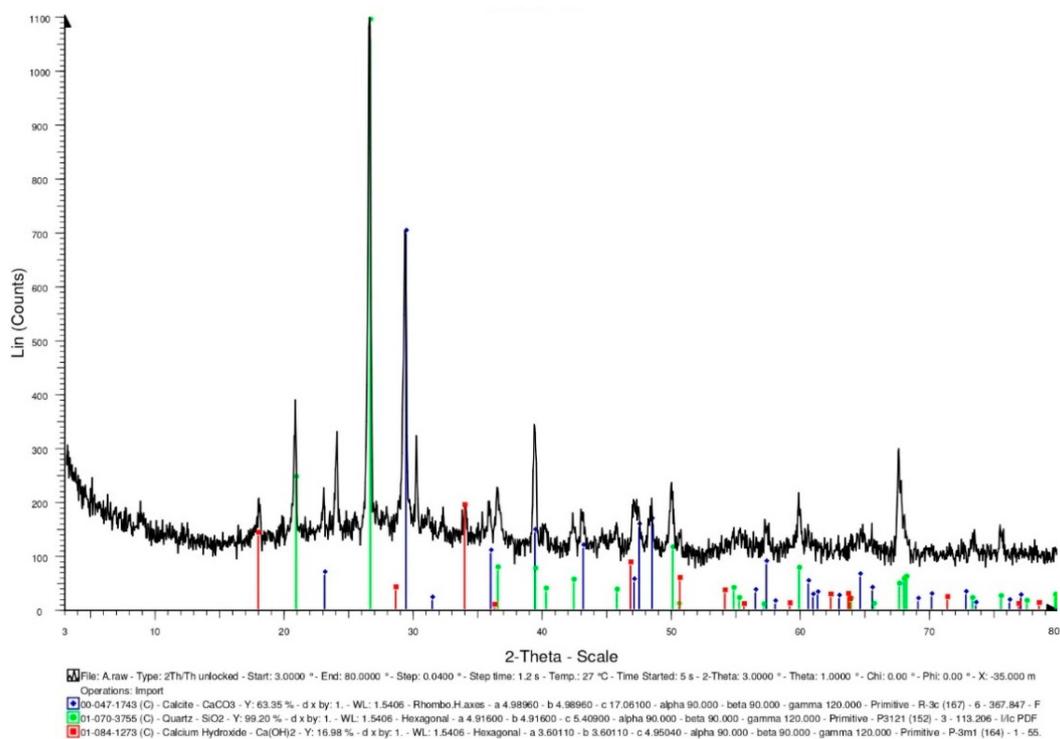
Figure 15. XRD-analysis results of the control group specimen.

XRD-analysis results can provide information about the phases and compounds that are present in specimens. Therefore, XRD analysis was performed on the control group and experimental group specimens to determine the mineral compositions. In the control group specimen, it was able to confirm the presence of calcite crystals (observed at 2-theta of 29.4°), and its X-ray-reflection-energy intensity was 708 (unit: counts), as shown in Figure 15. In addition, the XRD spectra revealed the presence of quartz with hydrated calcium silicate and calcium hydroxide. In the experimental-group specimen, it was also observed a prominent crystalline peak of CaCO_3 at 2-theta of 29.4° , and its X-ray-reflection-energy intensity was 629 (unit: counts), as shown in Figure 16. Moreover, the XRD spectra revealed the presence of quartz alpha and calcium hydroxide. According to the above results, due to the further hydration of the unhydrated cement particles and the precipitation of calcium carbonate crystals at the smaller-width cracks, a small amount of healing product was formed, which allowed the concrete to spontaneously heal.

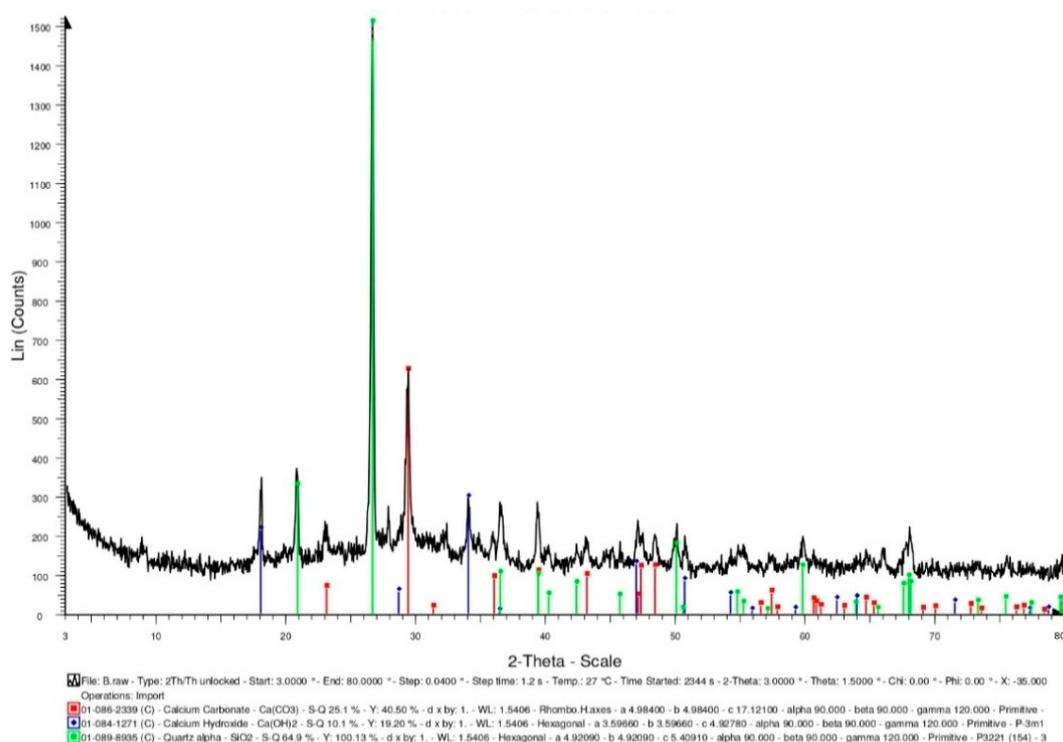
Figure 16. XRD-analysis results of the experimental group specimen.

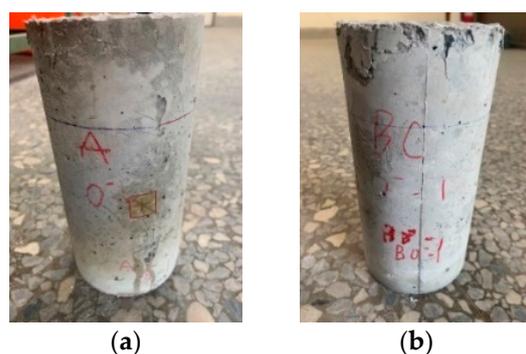
Figure 17. Destruction appearance of the concrete after compressive test at room temperature: (a) control group specimens; (b) experimental group specimen.

During the compressive test, the two groups of concrete specimens did not burst when subjected to the ultimate load due to the hooking or bridging effect of the steel fibers. Therefore, the specimens in the control group and experimental group still maintained the original cylindrical shape after being destroyed, as shown in Figure 17.

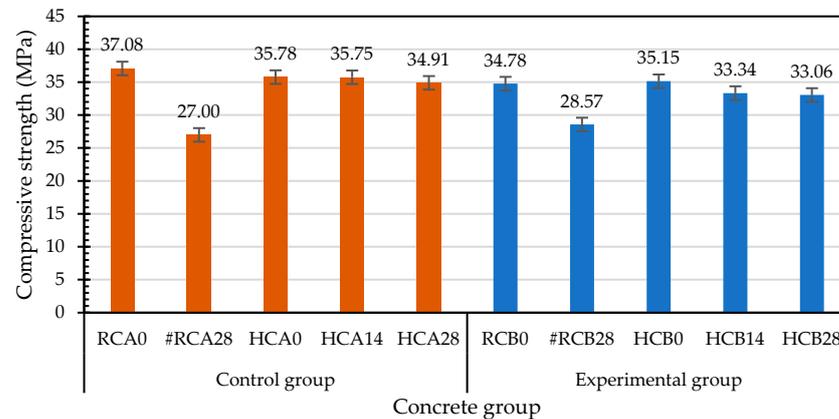
Figure 18. Effects of different test parameters on the compressive strengths of concrete.

The overall performance of concrete is the result of the combination of its mechanical properties and durability, which is closely related to the way the concrete is cured [34,35]. The curing efficiency of concrete is related to the humidity and temperature of the environment, as well as the exposure time of the concrete in the early stage of composite hydration [36]. The compressive strengths of each group of concrete were different under different test parameters, as shown in Figure 18. The results of the second compressive-strength test after self-healing for 28 days for each group of compressive-failure specimens were substantially lower. For each group of concrete exposed to high temperature, the residual compressive strength after self-healing was greater than 33 MPa, which indicates that curing in water has a certain effect. In fact, concrete exposed to high temperatures can recover a large proportion of the original strength of fire-damaged concrete without repair [24,37–40]. The specimens of the control group and experimental group were immersed in the curing tank of the laboratory for self-healing, and the calcium oxide and unhydrated cement particles in the specimens could absorb the water from the surrounding medium for rehydration. The residual compressive strengths of these two groups of

specimens could maintain a certain strength due to the filling of the micropores by the rehydration product [38]. Pan et al. [24] proposed that high temperatures open capillaries that were initially blocked by hydration products. During the self-healing process, these capillaries were refilled with hydration products. These hydration products were smaller in size than the original hydration products, resulting in a finer pore structure that helped the concrete regain its strength and durability.

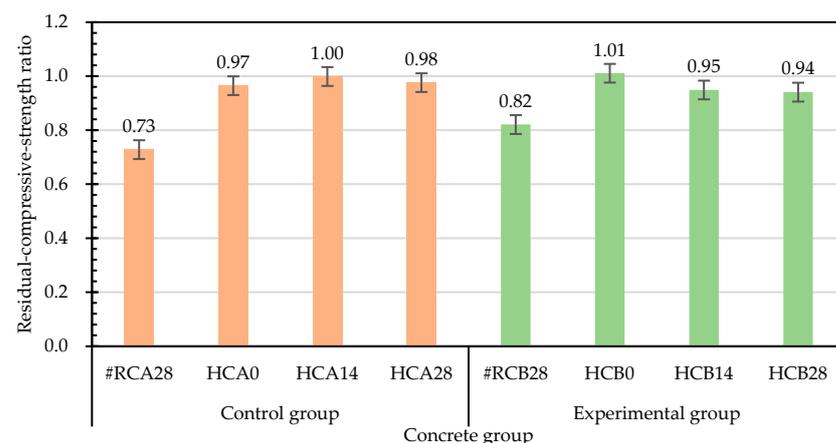
Figure 19. Effects of different test parameters on the relative-compressive-strength ratios of concrete.

The relative-compressive-strength ratios of each group of concrete cured before and after the exposure to 500 °C are shown in Figure 19. The relative-compressive-strength ratios of the compressive-failure specimens of each group after self-healing for 28 days were significantly lower. As for the specimens exposed to 500 °C, the relative-compressive-strength ratios of the control group and experimental group at different self-healing ages ranged from 0.97 to 1.0 and from 0.94 to 1.01, respectively. Specimens from the control and experimental groups were immersed in a laboratory curing tank. This type of curing avoids the loss of the internal mixing water and optimizes the cement hydration to form a hydrated-calcium-silicate network to provide the concrete strength. This is consistent with the findings of Cremonese et al. [41].

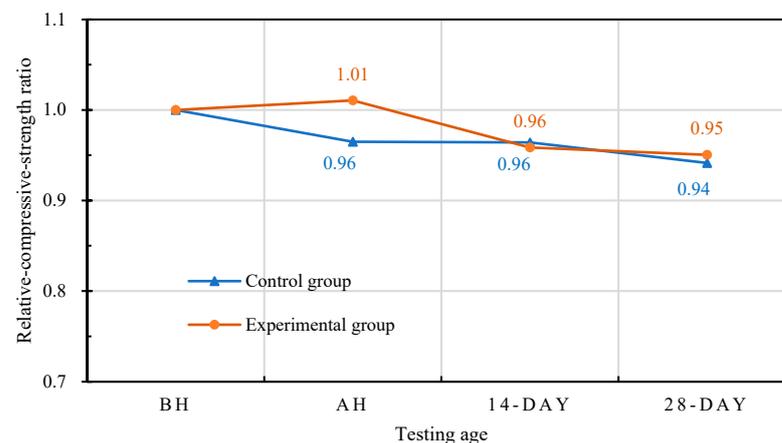
Figure 20. Effects of different self-healing ages on the relative-compressive-strength ratios of concrete.

Taking the 28-day-old compressive strength (before high temperature (BH)) at room temperature as the benchmark for comparison, the relative-compressive-strength ratios of each group of concrete at different self-healing ages are shown in Figure 20. The residual compressive strengths (after high temperature (AH)) of the specimens in the experimental group were higher than the compressive strengths at room temperature. However, with the increase in the self-healing age, the relative-compressive-strength ratios decreased. The

residual compressive strength of the control group after the exposure to high temperature was lower than the compressive strength at normal temperature. With the increase in the self-healing age, the relative-compressive-strength ratios slowly decreased. During curing, the initial decrease in the strength at 14 days of self-healing may have been due to the relative expansion of the wetted outer layer of the concrete, and the subsequent recovery at 28 days of self-healing was due to the regeneration of the C-S-H bonds after rehydration [42]. Each group of concrete specimens showed a certain degree of compressive-strength recovery after self-healing. According to this result, the compressive-strength recovery depends on the self-healing of the concrete. When the fire-damaged concrete was in contact with water after cooling, the micropores could be filled due to the regeneration of the C-S-H and carbonate phases, and the cracks could be healed and the strength of the concrete recovered, which is consistent with the results of Poon et al. [24]. However, water recuring is a controversial approach, as some researchers have found that water recuring is detrimental to concrete [24,43]. For example, CaO in concrete rehydrates it, causing it to disintegrate and further deteriorate. Lin et al. [38] pointed out that $\text{Ca}(\text{OH})_2$ was produced at the end of rehydration, and its volume was 44% higher than that of CaO. This expansion led to an increase in the size and number of existing cracks in the concrete, which further reduced its mechanical properties upon cooling [25].

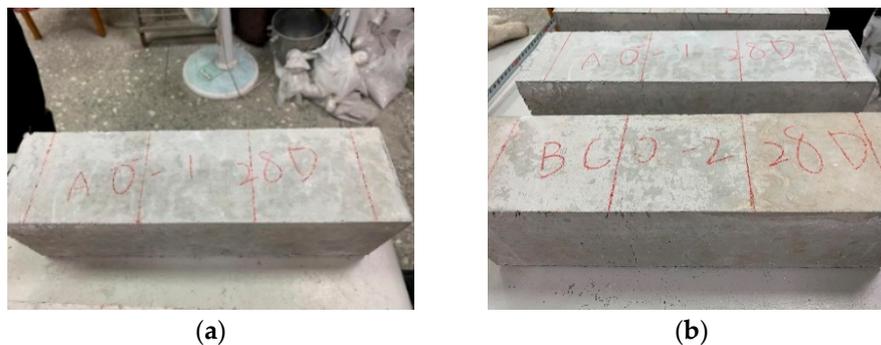
**Figure 21.** Destruction appearance of the concrete specimens after flexural test at room temperature: (a) control group; (b) experimental group.

The results of the 28-day flexural test of each group of concrete at room temperature are shown in Table 17. The flexural strengths of the control group and experimental group were 4.50 MPa and 4.36 MPa, respectively. In addition, the deflections at the midspans of the control group and experimental group were 0.419 mm and 0.428 mm, respectively. Figure 21 shows the failure of each group of specimens after the flexural test. The specimens of the control group and experimental group could still maintain their original appearance and exhibited high toughness after the failure. During the test, the load-carrying capacity continued to increase after the formation of the first crack, and all the specimens exhibited deflection hardening properties. When the specimen reached the ultimate flexural load, it could still maintain a certain toughness and strength, which avoided the formation of brittle failure. The reason is that the short steel fibers absorbed the tensile stress to prevent the expansion and coherence of the microcracks, thereby preventing the formation of macrocracks. Under the continuous action of a load, cracks or microcracks will form in concrete. Adding a large number of short steel fibers (0.75% by volume) can form bridging and hook effects with the concrete, avoiding the formation of large local strains.

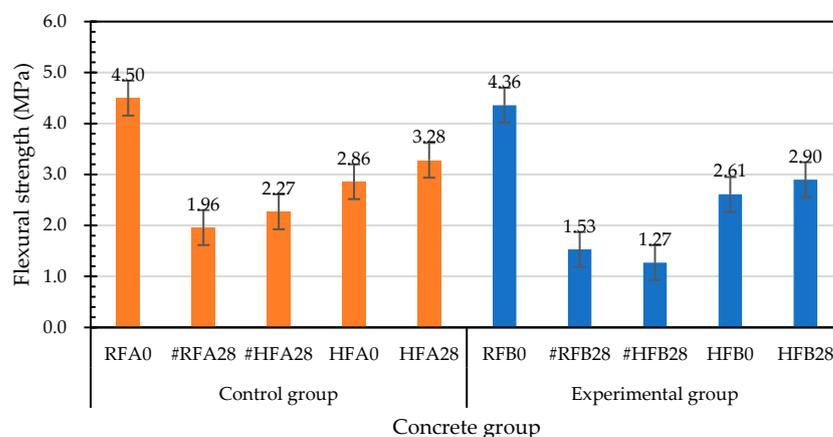
Figure 22. Effects of different test parameters on the flexural strengths of concrete.

Several studies have pointed out that the mechanical properties degradation of concrete exposed to high temperature was caused by a series of physicochemical changes, especially the dehydration and decomposition of hydrated cement paste during heating [25,38]. According to the above analysis, under different test parameters, there were obvious differences in the flexural strengths of each group of concrete. At room temperature, the secondary flexural-strength-test results of each group of flexural-failure specimens after self-healing for 28 days were low (Figure 22). According to the results of the secondary flexural-strength test after self-healing for 28 days, the flexural strengths of the flexural-failure specimens of both the control group and experimental group after exposure to a high temperature substantially decreased. For each group of concrete exposed to high temperatures, the residual flexural strength after self-healing was greater than 2.61 MPa, which indicates that the curing had a certain effect. After the exposure to high temperatures, the recoveries of the flexural strengths of the specimens during curing were due to the rehydration of the decomposed hydration products, and to the further hydration of the initially unhydrated cement particles, which is consistent with the results of Khoury [37].

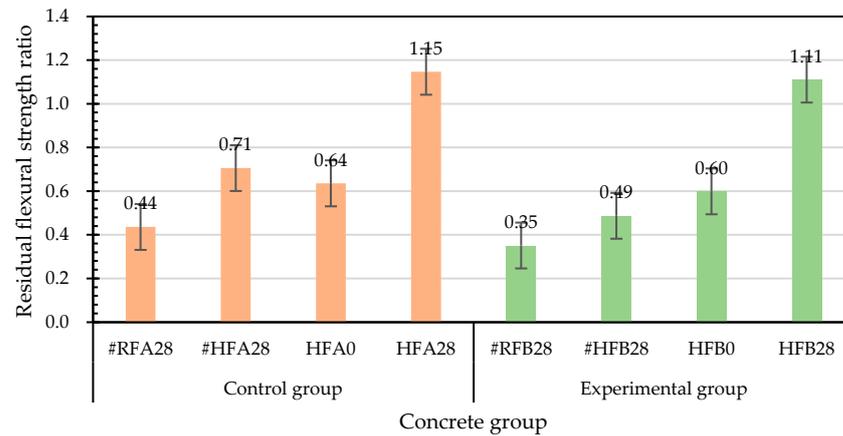
Figure 23. Effects of different test parameters on the relative-flexural-strength ratios of concrete.

The relative-flexural-strength ratios of each group of concrete cured before and after exposure to high temperature are shown in Figure 23. The relative-flexural-strengths

of the flexural-failure specimens of each group after curing for 28 days under normal-temperature conditions were significantly lower. Similarly, the relative-flexural-strength ratios of the flexural-failure specimens of each group after self-healing for 28 days were also significantly lower. The relative-flexural-strength ratios of the cured specimens after exposure to high temperature were 1.15 for the control group, and 1.11 for the experimental group. According to this result, the flexural strength of each group of flexural specimens cured for 28 days after exposure to high temperatures improved.

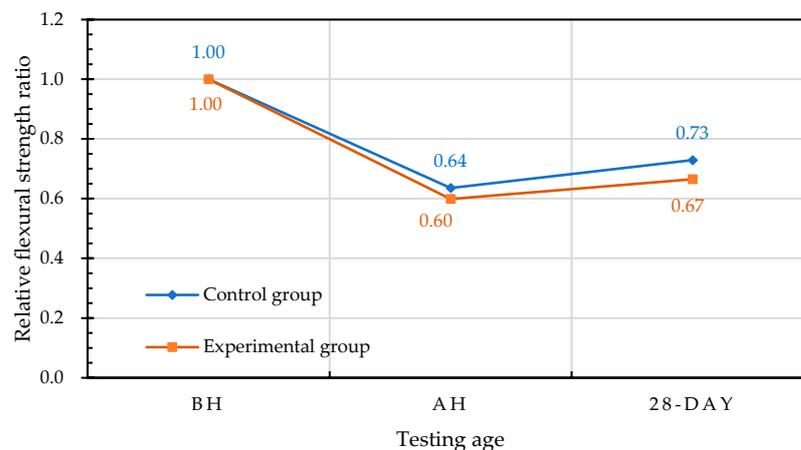
Figure 24. Effects of different curing ages on the relative-flexural-strength ratios of concrete.

Taking the 28-day-old flexural strength (before high temperature (BH)) at room temperature as the benchmark for comparison, the relative-flexural-strength ratios of each group of concrete at different self-healing ages are shown in Figure 24. The residual flexural strength (after high temperature (AH)) of the specimen in the experimental group after the exposure to high temperature was lower than the flexural strength at room temperature, and its relative-flexural-strength ratio was 0.60, whereas the relative-flexural-strength of the specimen after self-healing for 28 days was 0.67. The residual flexural strength of the control group after exposure to 500 °C was lower than the flexural strength at room temperature, and its relative-flexural-strength ratio was 0.64, whereas the relative-flexural-strength ratio of the self-healing for 28 days was 0.73.

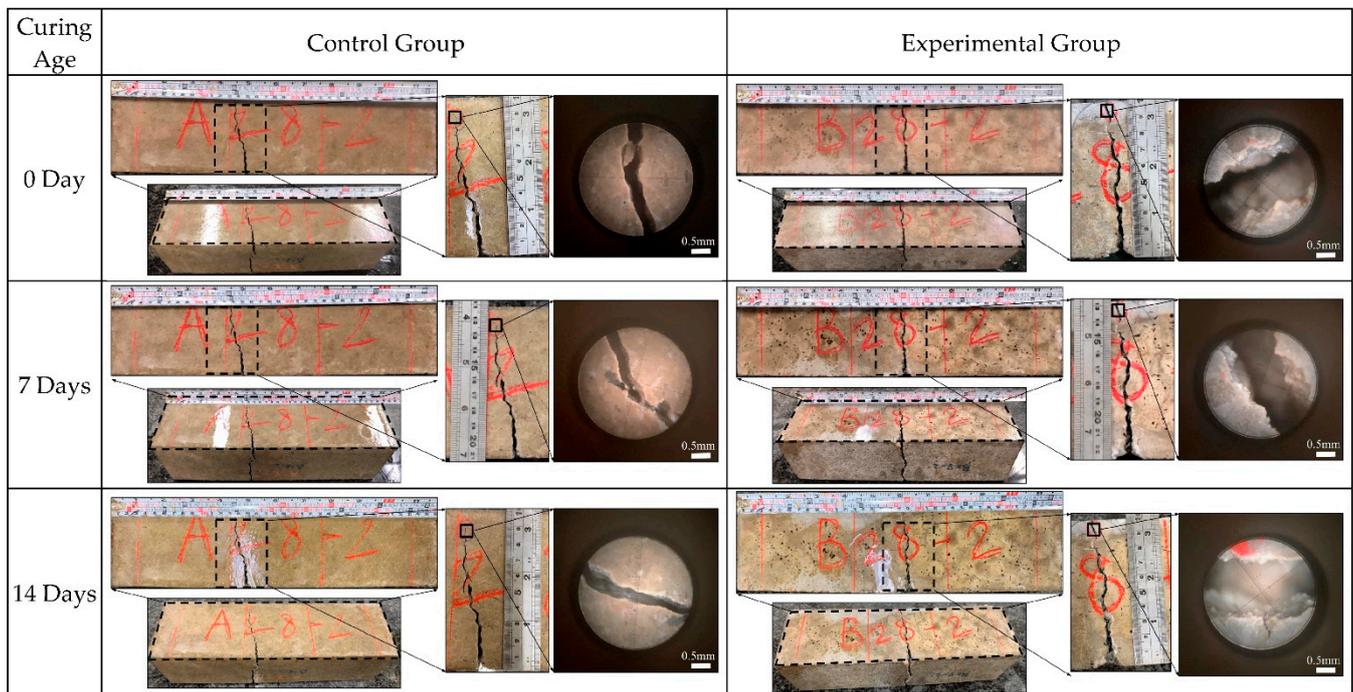
Figure 25. Microscopic images of crack healing of the concrete specimens at different self-healing ages.

Figure 25 shows the microscopic images of the surface cracks of each group of specimens at different healing times. According to the measurement results, the initial surface-crack widths of each group of concrete specimens were much higher than the maximum limit specified by the ACI Building Code (0.10 mm for wet conditions, and 0.44 mm for dry conditions). The crack widths of different concrete specimens decreased gradually with the self-healing age. The healing precipitation at the cracks was observed. After the specimens of the control group and the experimental group were cured in the water tank of the curing room for 14 days, their crack widths gradually healed. This is because secondary water curing promotes the further hydration of unhydrated cement particles and the precipitation of calcium carbonate crystals at smaller-width cracks, the rehydration products of which can fill the cracks and pores [44]. According to this result, the cracks between the cement matrix and aggregates can be repaired by secondary water curing in the water tank [45]. The crack widths of the specimens in the experimental group are not substantially reduced. According to this result, the mineralization of the bacteria with the light aggregates as carriers was not substantial under the curing environment of the water tank without a nutrient source. Another possible reason is that the effect of the high temperature on the survival of the bacteria in the experimental group resulted in slow mineralization.

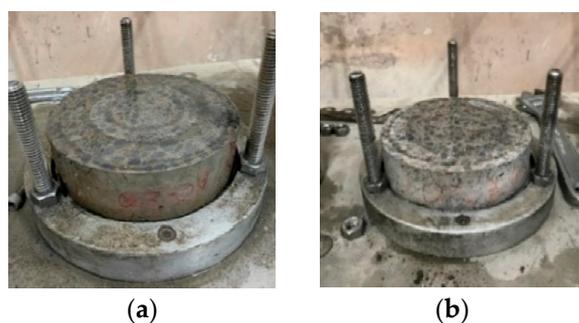
Figure 26. Appearance of the surface of the specimens exposed to high temperature after the water-penetration test: (a) control group; (b) experimental group.

After exposure to high temperature, the water penetration test results of the control group and the experimental group are shown in Table 27. The water-absorption rates of the control group and experimental group were 10.3% and 10.9%, respectively. From this point of view, the water absorption of the control group and experimental group after exposure to high temperature substantially increased, which was caused by the formation of microcracks on the surface of the specimens, internal cracks, and the coarsening of the pore structure caused by the high temperature. The appearance of the water adsorbed on the surface of each group of specimens after the water penetration test is shown in Figure 26. The control group adsorbed less water, whereas the experimental group adsorbed more water.

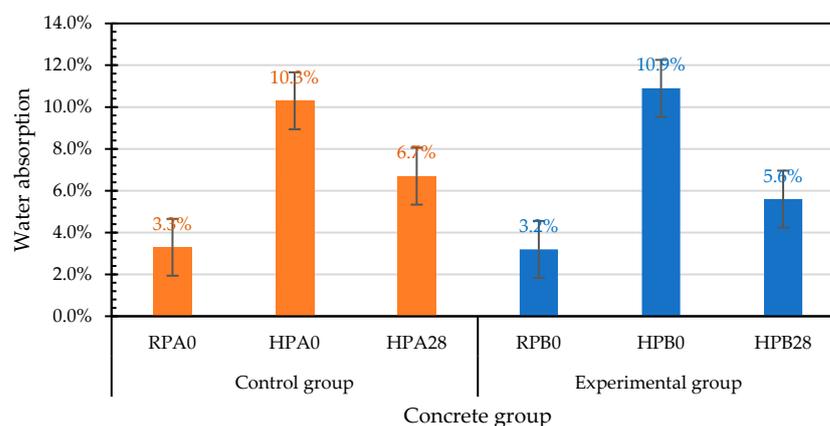
Figure 27. Effects of different test parameters on water absorption of concrete.

According to the above analysis, there were obvious differences in the penetration-test results of each group of concrete under different test parameters, as shown in Figure 27. There was no significant difference in the water-absorption rate of each group of concrete under normal-temperature conditions (control group: 3.3%; experimental group: 3.2%). After the exposure to high temperature, the water-absorption rate of the concrete substantially increased. The water-absorption rates of the control group and experimental group were 10.3% and 10.9%, respectively. After the exposure to high temperature and self-healing for 28 days, the water-absorption rate of each group of concrete was greatly reduced, and the water-absorption rates of the control group and experimental group were 6.7% and 5.6%. The reason for this is that the rehydration-reaction product filled the capillaries and internal cracks, which reduced the water permeability of each group of concrete after curing. For each group of concrete exposed to high temperature, the water permeability after curing was greatly reduced, which meant that the curing had a certain effect.
