# Comparative Performance Evaluation of Multiconfiguration Touch-Trigger Probes for Closed-Loop Machining of Large Jet Engine Cases

**Abstract:** This article presents advances in the methodology of rapid various probe configurations comparison for the five-axis, tilting-head machine tools in conjunction with master artifacts. The research was performed in a direct context of automated machining of large, complex jet engine cases made from 17-4PH and 321 stainless steel materials. The aim of the study was to investigate whether all probe configurations have comparable measurement capability for use in manufacturing environment conditions. Based on the preliminary stage of the study, the T1 main straight probe achieved acceptable results of repeatability and reproducibility, lower than 10%, except for the reference diameter measurement of MT#2, where 15.4% R&R was achieved, conditionally accepted. For the straight probe configuration, error lower than 10  $\mu$ m was achieved for the true position measurement and error  $\pm 10$   $\mu$ m for the reference diameter measurement, in relation to the vertical and horizontal head position, with the exception of the T9 and T5 MT#2 probe

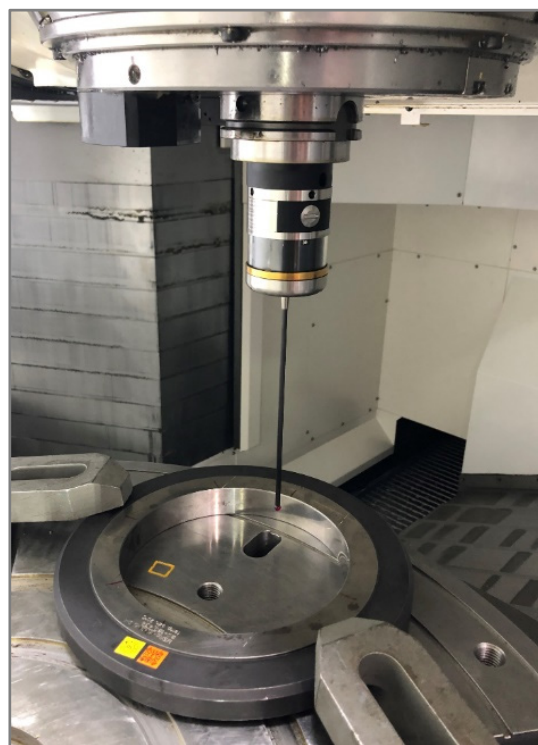
**Figure 6.** Test setup of ring gauge DIA. 180.4410 mm for initial R&R probing system performance analysis, repeatability, and reproducibility, T1 TTP.

The R&R method was used for the definition of the repeatability and reproducibility index value of the measuring system for the T1 probe, the most important probe in the system. The R&R evaluation has been performed for both MTs #2 and #3 according to the methodology as proposed in the article [28]. Initial test setup is presented in Figure 6.

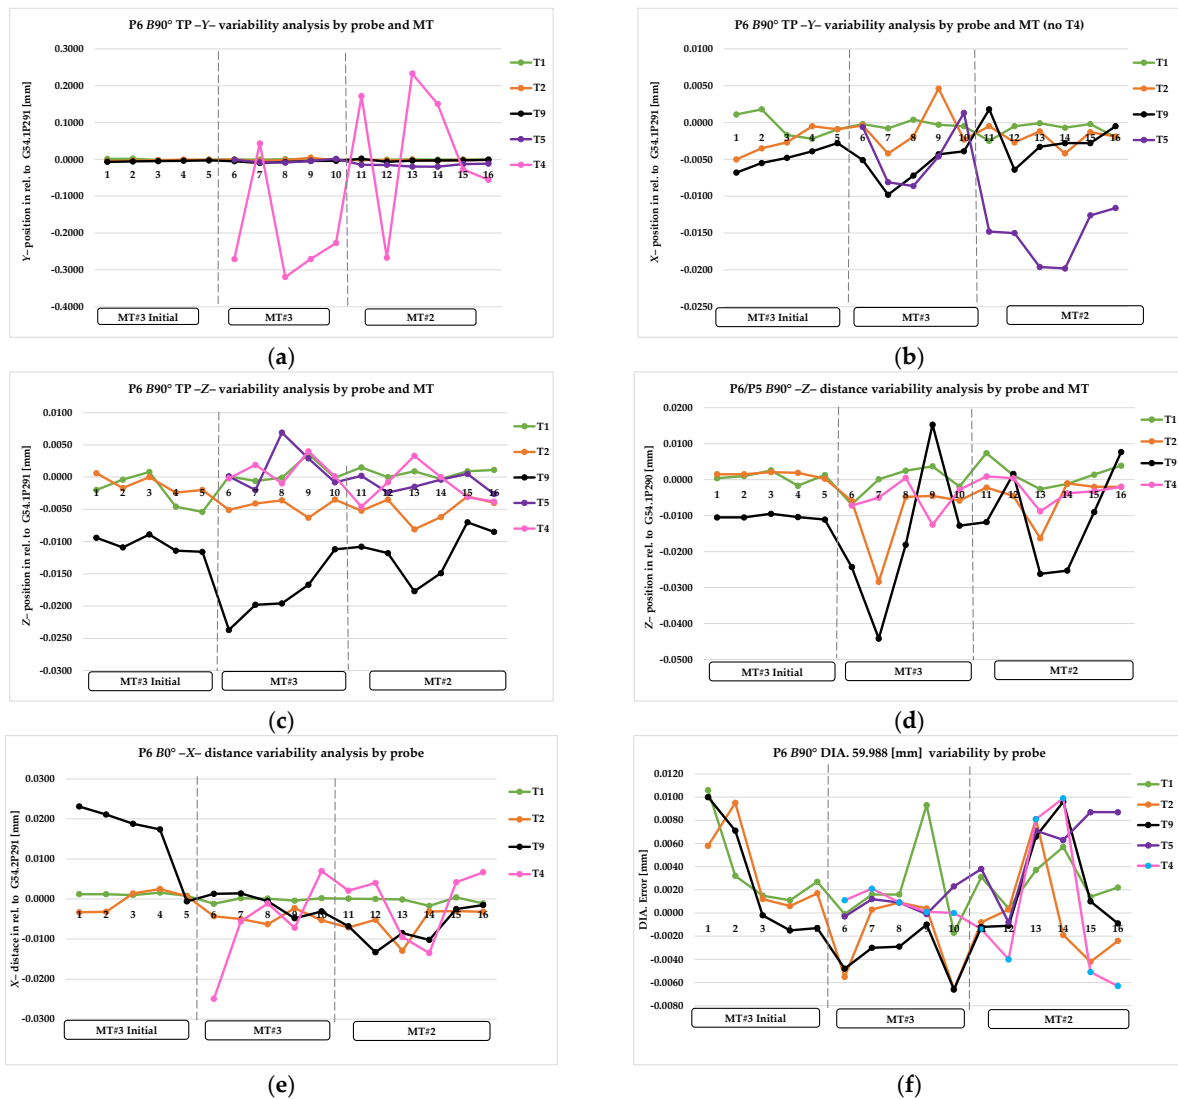
**Figure 12.** Analysis of P6 area measurement for probes T1, T2, T9, T5 ( $B90^\circ$  head), and T4 ( $B0^\circ$  head): (a) variability of hole true position—Y direction, all probes; (b) variability of hole's true position—Y direction, T6 probe error hidden; (c) variability of hole's true position—Z direction; (d) variability of Z—direction distance; (e) variability of X—direction distance; (f) variability of master hole size.

In order to gain a clear interpretation of the results, a numerical analysis was conducted, and assumptions and observations were noted. The most important of these were as follows: Figure 11a–g and Table 7 show the results of probing variability for the P5 artifact area (B0° head position except T6); Figure 12a–f and Table 8 show probing variability for the P6 artifact area (B90° position except T4).

The results of the T1, T2, and T5 probes were consistent with our assumptions for the dimensional conditions and true position condition requirements. Moreover, T5's probe performance in the horizontal head position on MT#2 was much lower than MT#3; the range was  $-0.020$  mm in the Y-axis true position (Figure 12b, Table 8 line 9–10).
