Use of Geopolymer and Carbon Fiber-Reinforced Polymer for Repairing Reinforced Concrete Deck Soffit

Abstract: This study aimed to assess the feasibility of utilizing geopolymer for repairing reinforced concrete beams. Three types of beam specimens were fabricated: benchmark specimens without any grooves, rectangular-grooved beams, and square-grooved beams. The repair materials employed included geopolymer material, and epoxy resin mortar, while carbon fiber sheets were used as reinforcement in select cases. The repair materials were applied to the rectangular and square-grooved specimens, with the carbon fiber sheets attached to the tension side of the specimens. To evaluate the flexural strength of the concrete specimens, a third-point loading test was conducted. The test results indicated that the geopolymer exhibited higher compressive strength and shrinkage rate compared to the epoxy resin mortar. Furthermore, the specimens reinforced with carbon fiber sheets demonstrated even greater strength than the benchmark specimens. In terms of flexural strength under cyclic third-point loading tests, the carbon fiber-reinforced specimens exhibited the ability to withstand over 200 cycl

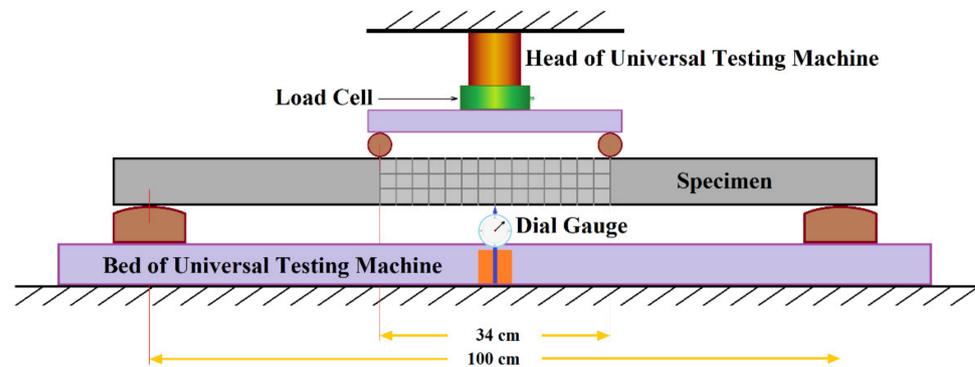
Figure 1. The schematic diagram of the third-point loading test.

Figure 1 illustrates the third-point loading test employed in this study, which was conducted following the specifications outlined in ASTM C78/C78M-22 [46]. However, it is important to note that, as the primary focus of this research centers around concrete slabs rather than the beams referenced in the ASTM standard, test specimens with a total

length of 120 cm and a height of 7 cm were utilized. The lower support span was set at 100 cm, with the middle one-third span measuring 34 cm. Furthermore, the study involved subjecting the specimens to cyclic third-point loading under various loads, as depicted in Figure 1.

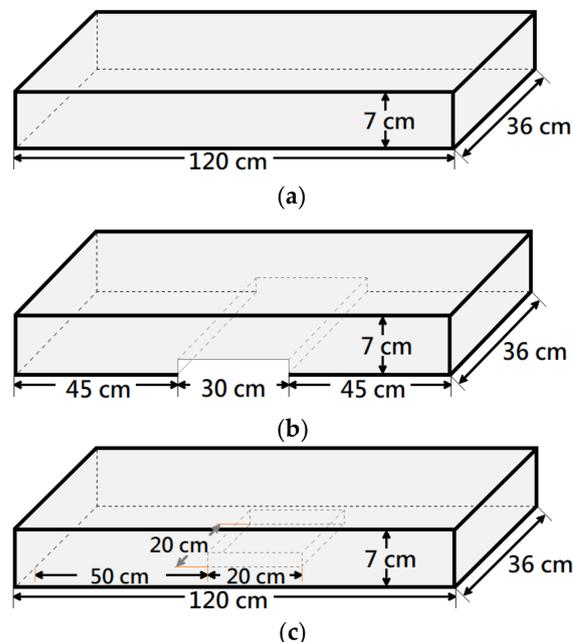
Figure 2. The dimension of specimens: (a) benchmark; (b) rectangular groove; (c) square groove.

This study involved the fabrication of three distinct types of unidirectional reinforced concrete slabs, which were subsequently further categorized. Each unidirectional reinforced concrete slab had dimensions of 120 cm × 36 cm × 7 cm, as shown in Figure 2. The three types of concrete slabs employed in this study were as follows: (1) reinforced concrete (RC) slab without any repair (referred to as B), as seen in Figure 2a; (2) RC slab featuring a 30 cm × 36 cm × 2 cm rectangular groove on the tensile side (referred to as R), as seen in Figure 2b; and (3) RC slab with a 20 cm × 20 cm × 2 cm square groove on the tensile side (referred to as S), as seen in Figure 2c.

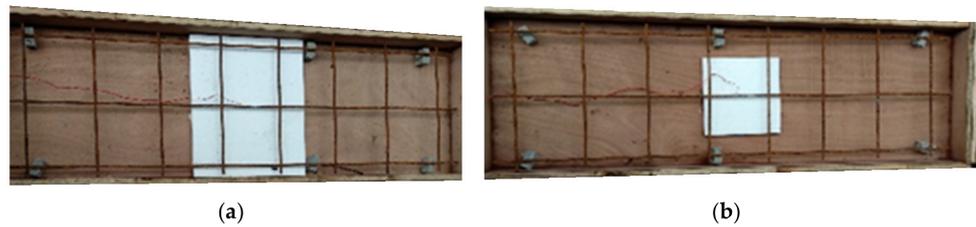
Figure 3. Complete fabrication of wooden molds with polystyrene boards for the rectangular and square-grooved specimens: (a) wooden molds with polystyrene boards for the rectangular-grooved specimens; (b) wooden molds with polystyrene boards for the square-grooved specimens.

The fabrication process of a unidirectional reinforced concrete specimen involved the assembly of a wooden mold on-site, followed by the sequential placement of polystyrene boards to create the desired groove size. Subsequently, #3 steel mesh was positioned within the mold before pouring the concrete, as depicted in Figure 3. To measure the ultimate strain

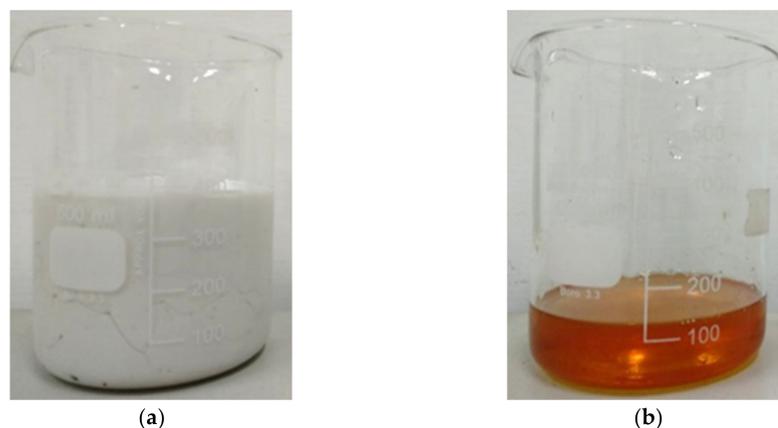
Figure 4. Primer resin: (a) resin A; (b) resin B.

Before applying the repair material, a primer resin (EP 220) provided by Kuosen Enterprise Co., Ltd., Taoyuan, Taiwan, was used as the bonding material. A primer resin adhesive agent was used for each repair specimen before repairing with the repair material. Figure 4 shows the primer resin A and resin B. The composition of the primer resin consists of resin A and resin B, which were blended in a fixed ratio of 4:1. After blending, the mixture was applied to the grooved area of the specimen to be repaired using a brush and allowed to sit for 15 min before repairing with the repair material.

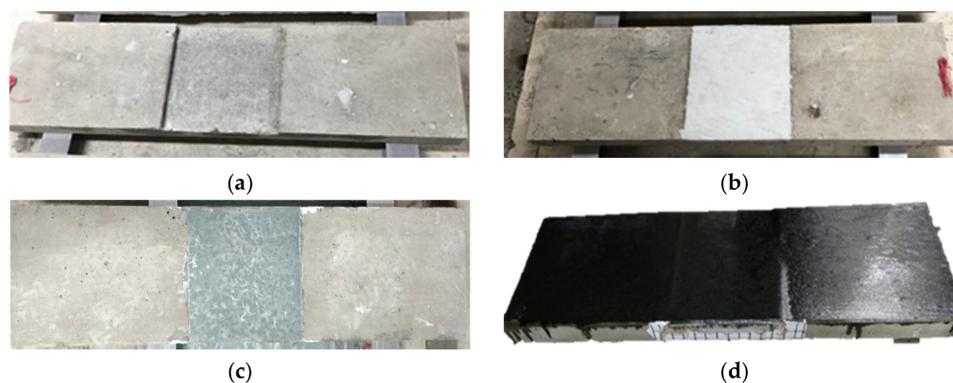
Figure 5. Rectangular-grooved specimens after repair and reinforcement: (a) specimen R; (b) specimen R-E; (c) specimen R-G; (d) specimen R-G-C and specimen R-E-C.

Figures 5 and 6 are the completed images of R-type (rectangular groove) and S-type (square groove) specimens, respectively, after repair and reinforcement.

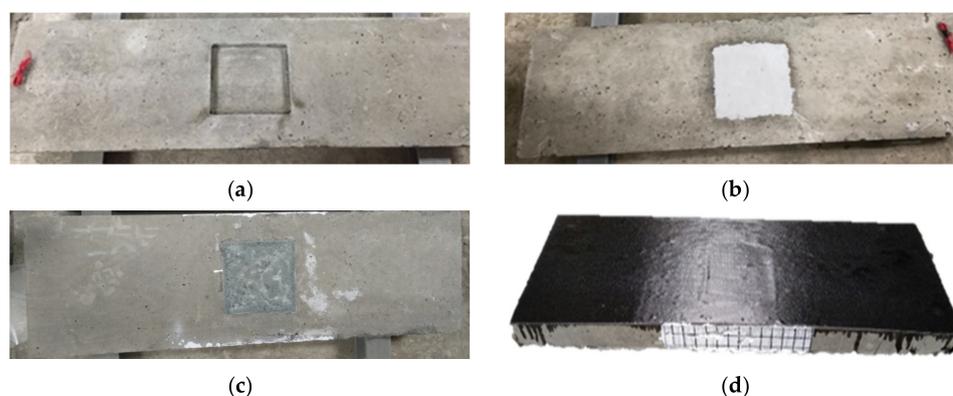
Figure 6. Square-grooved specimens after repair and reinforcement: (a) specimen S; (b) specimen S-E; (c) specimen S-G; (d) specimen S-G-C and specimen S-E-C.

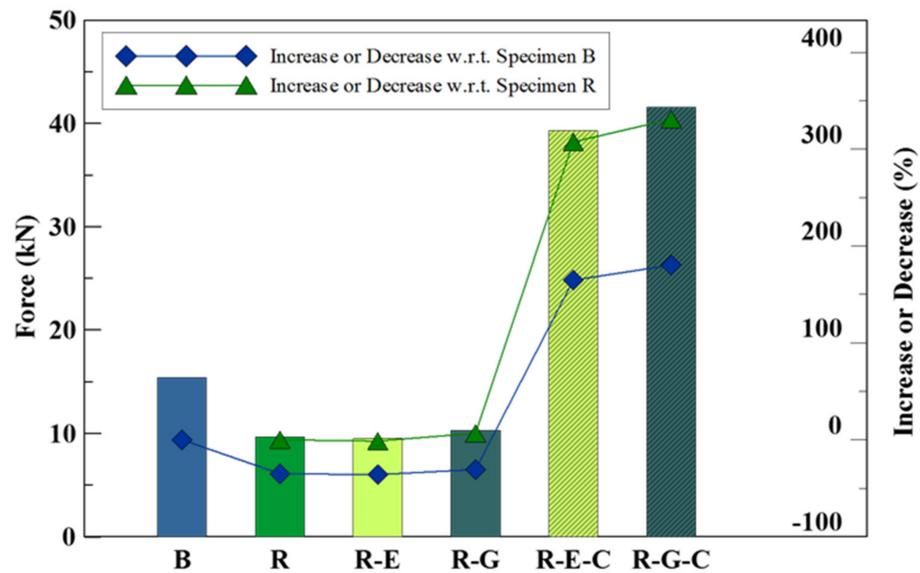
Figure 7. Average ultimate loading of the benchmark and rectangular-grooved specimens.

The average flexural strength of specimens with rectangular grooves was plotted in the bar chart in Figure 7.

From the analysis of Figure 7, it is apparent that undamaged concrete slab specimens (designated as Bs) exhibited higher ultimate loading strength compared to damaged concrete slab specimens (designated as Rs), which simulated the presence of cracks. The impact of repairing the damaged specimens with geopolymer material mixed with dry sand (R-Gs) and epoxy resin mortar (R-Es) on their ultimate loading strength was minimal, with limited observable improvements that could potentially be attributed to experimental errors. However, notable enhancements were observed when the repaired specimens were additionally reinforced with a carbon fiber sheet. The combination of geopolymer material or epoxy resin mortar with carbon fiber reinforcement resulted in a substantial increase in flexural strength for the repaired specimens, ranging from 300% to 330% in comparison to the unrepaired specimen Rs. Moreover, the flexural strength of the reinforced repaired specimens surpassed that of the undamaged concrete slab specimen B by 165% to 180%. Detailed visual documentation of the rectangular-grooved specimens at the point of failure, which occurred at different loading values during the third-point loading test, can be found in Table 7.

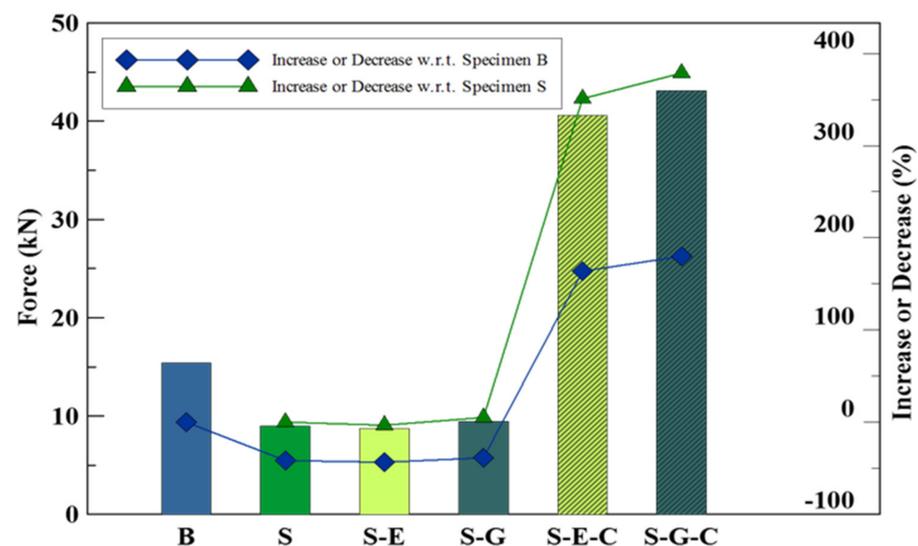
**Figure 8.** Average ultimate bearing capacity of the benchmark and specimens with square grooves.

Figure 8 is the bar chart of the average flexural strength of specimen set S, created from Table 8.

In this subsection involving square-grooved specimens, the results of the third-point loading test exhibited similarities to those observed in the previous subsection. The repair of damaged concrete slab specimens (S) using either epoxy resin mortar or geopolymer material mixed with 150% dry sand had a limited effect on enhancing their flexural strength, resulting in less than a 5% improvement. However, the introduction of carbon fiber sheet reinforcement to the repaired specimens yielded significant enhancements. Irrespective of the repair material utilized, the flexural strength of the carbon fiber sheet-reinforced specimens exhibited a remarkable increase of 350% to 380% compared to the unrepaired specimens. Furthermore, the flexural strength of the carbon fiber sheet-reinforced repaired specimens surpassed that of the undamaged concrete slab (specimen B) by 160% to 180%.

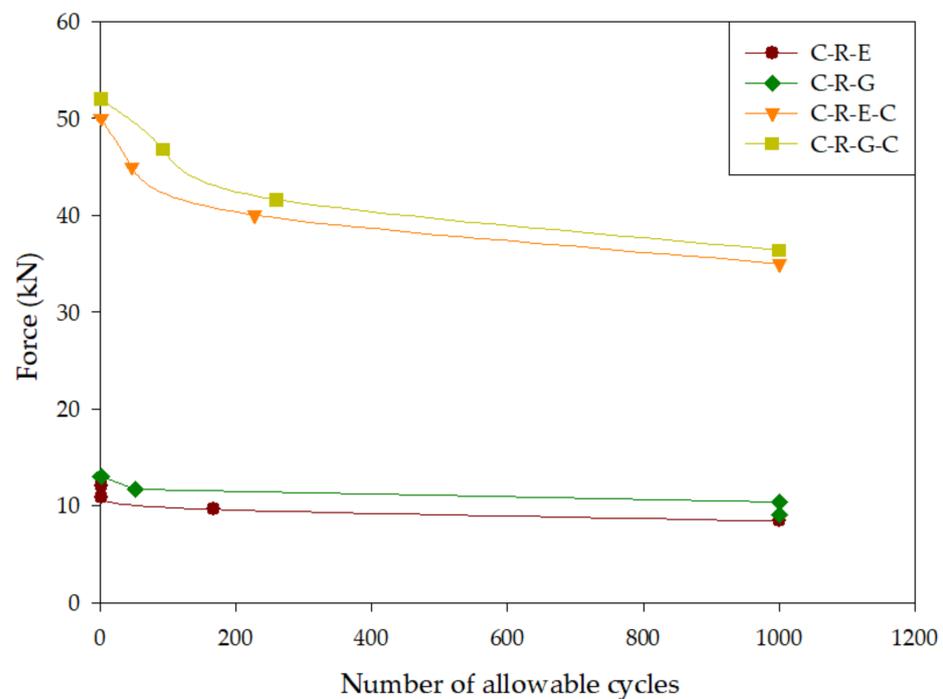
Figure 9. Fatigue curve of rectangular-grooved specimens during cyclic third-point loading test.

Table 9 presents the outcomes of the cyclic third-point loading test conducted on rectangular-grooved specimens. In the table, the notation “N” indicates specimens that experienced no failure, while “Y” signifies specimens that failed. Analysis of Table 9 reveals that, across the four distinct repair methods employed on the specimens, they were able to endure more than 1000 cycles without failure when subjected to cyclic third-point loading tests at an ultimate load ratio of 0.7. Furthermore, under cyclic third-point loading tests at an ultimate load ratio of 0.8, specimen C-R-G, repaired using geopolymer material, demonstrated a capacity to withstand more than 1000 cycles without failure. Notably, under cyclic third-point loading tests at an ultimate load ratio of 0.9, specimen C-R-G-C, which underwent repair with geopolymer material and reinforcement with carbon fiber patches, exhibited the highest cycle count. Detailed information regarding the ultimate load percentages and the corresponding cyclic third-point loading test cycles for each specimen can be found in Table 9, while Figure 9 depicts these data as an S-N curve.

Figure 9 depicts the correlation between the number of load cycles-to-failure and the rectangular-grooved specimens in the cyclic third-point loading test. For instance, let us consider specimen C-R-G-C, which exhibited an ultimate load of 52 kN. At 0.9 times the

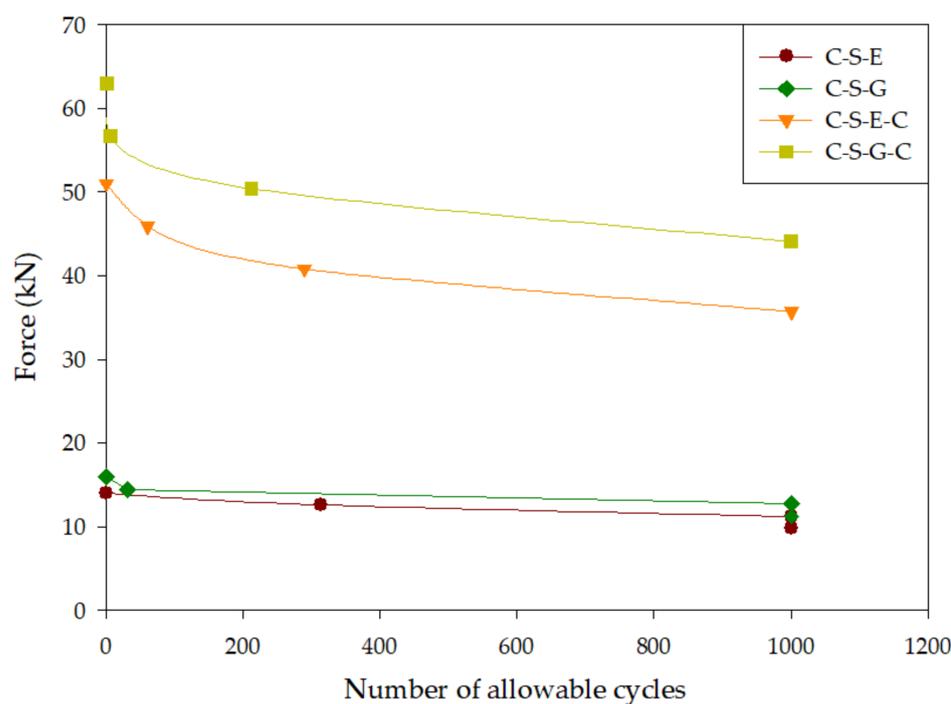
Figure 10. Fatigue curve of square-grooved specimens during cyclic third-point loading test.

Figure 10 provides a visual representation of the data and illustrates that the utilization of carbon fiber reinforcement enhances the fatigue resistance of the specimens. Notably, specimen C-S-G-C demonstrated the highest fatigue resistance under cyclic third-point loading. At 0.8 times its ultimate load, the load strength of this specimen approached the ultimate strength observed in specimen C-S-E-C. It is worth mentioning that the cyclic third-point loading fatigue resistance of specimen C-S-G-C consistently surpassed that of specimen C-S-E-C.
