# Interface Microstructure and Properties of Vacuum-Hot-Rolled 55#/316L Clad Rebars

**Abstract:** The existing process for the preparation of clad rebar is too complicated for large-scale industrial production. Therefore, this paper proposes a 55#/316L rebar preparation method based on vacuum hot rolling. The microstructure and mechanical properties of the composite interface of the rebar, along with the connecting technique, were studied using transmission electron microscopy, X-ray diffraction, and Vickers hardness testing. The obtained results showed that the minimum thickness of the 55#/316L rebar cladding was 0.25 mm, which was twice that of the M 329M/M 329-11 design standard used in the United States of America. Due to the diffusion of carbon, large numbers of second-phase particles were precipitated on the stainless-steel side, which resulted in intergranular chromium depletion. After multi-pass hot rolling, the minimum bonding strength of the composite interface reached 316.58 MPa, which was considerably higher than the specified value of 210 MPa. In addition, we designed three different types of rebar connection joints: sleeve, groove-welded, and bar-welded. According to

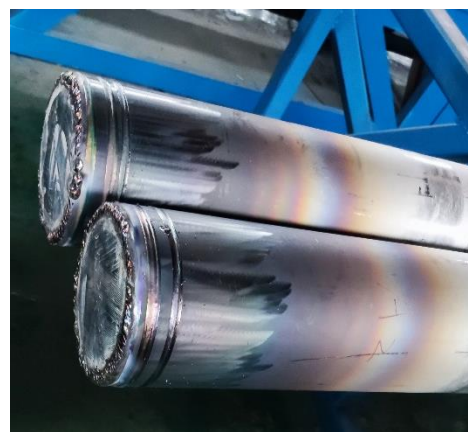
**Figure 1.** Appearance and morphology of the composite billet.

To reduce the formation of inclusions on the composite interface and achieve effective metallurgical bonding of the clad rebars, a 55#/316 rebar formation process based on the clean-interface assembly was used. The 55# steel rod was first machined to the specified size of  $\Phi 147.2 \text{ mm} \times 9000 \text{ mm}$ . The burrs were then removed from the surface of the carbon steel rod using a hand-held grinder. Afterwards, a hydraulic machine was used to push the carbon steel rod into the stainless-steel pipe. Finally, the billet was vacuumed and end-welded [22]. A schematic of the composite billet end-seal is shown in Figure 1. The specifications and size of the composite billet are presented in Table 2.

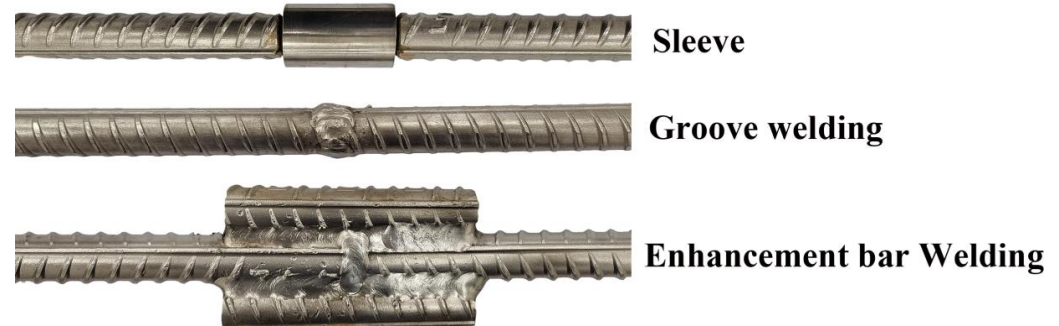
Figure 16. Surface morphology of each joint after rust removal.

A neutral salt spray corrosion test was performed with an exposure time of 30 d. Figures 16 and 17 show the surface morphology and corrosion depth of each joint after rust removal, respectively. Significant corrosion was observed at the connection between the sleeve and the rebar. The corrosion depth was almost 1.04 mm, which was caused by the presence of receding grooves on the surface of the rebar. This prevented effective sealing between the sleeve and the rebar. In addition, the corrosion depth of the composite interface was significantly deeper than that of the carbon steel matrix. The reason for this phenomenon was that a large amount of chromium-rich carbides precipitated from the composite interface of the rebar, which resulted in a chromium-poor composite interface and reduced the corrosion resistance. Therefore, the corrosion cracks preferentially spread

along the composite interface. No small cracks were observed in the groove-welded joint or the bar-welded joint after 30 d of exposure, which indicated that the groove-welded joint and the bar-welded joint had very high corrosion resistance.
