Article

The Impact of Al₂O₃ Particles from Grit-Blasted Ti6Al7Nb (Alloy) Implant Surfaces on Biocompatibility, Aseptic Loosening, and Infection

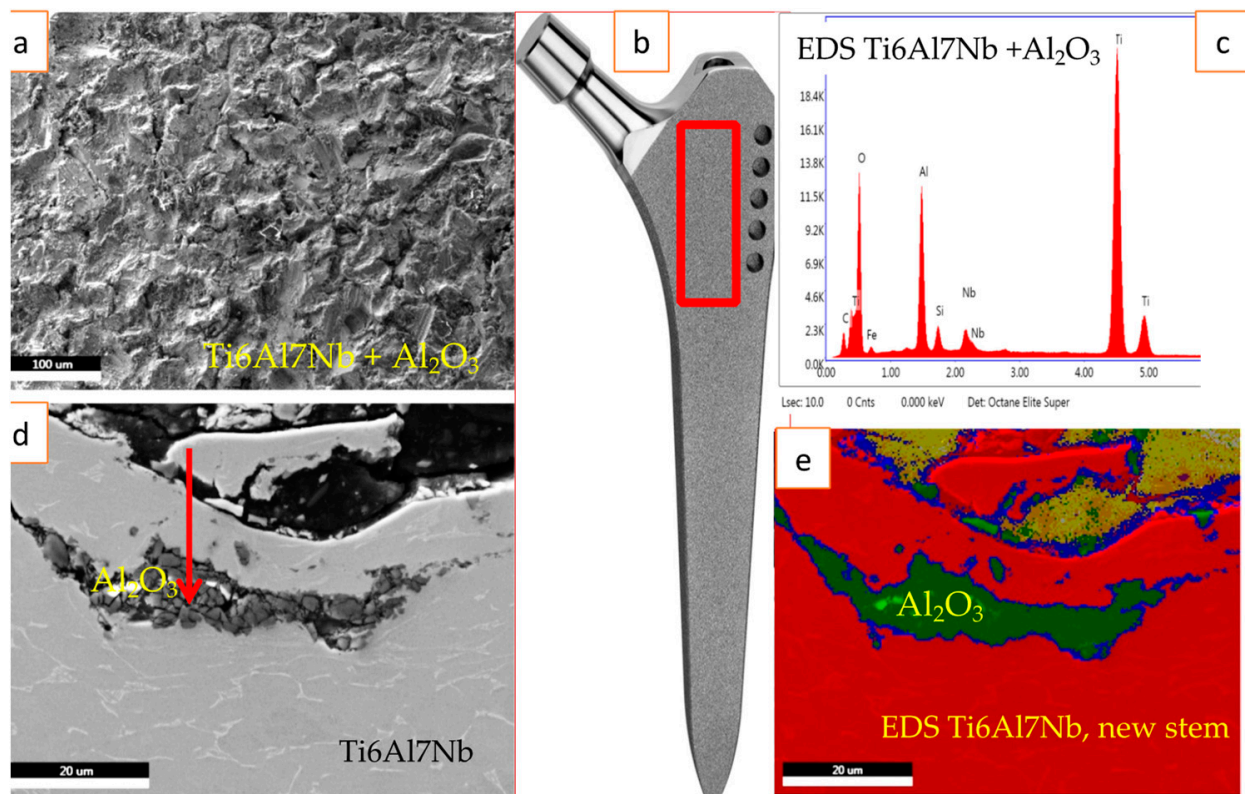
Figure 1. (a) SE image of rough surface (S_a 6 μm); (b) cementless femoral component of a new ZM hip endoprosthesis stem; the retrieved stems after being cleaned and sterilized appear the same; the red box indicates the region investigated; (c) EDS spectrum of a representative sample indicating that the dark grey region in SE image (d) and green in (e) is corundum Al_2O_3 ; (d) SE image of a cross-section of new Ti6Al7Nb stem indicating residual Al_2O_3 surface contamination (dark grey) in the subsurface up to 20 μm from an Al_2O_3 grit blasting; (e) EDS mapping showing the Ti6Al7Nb matrix (red) and Al_2O_3 contamination (green). Different colors correspond to different materials.

From the revision surgeries, we selected three retrieved Ti6Al7Nb stems of the cementless ZM type of hip endoprostheses from each group, and for the comparison, we investigated new stems from different manufacturers (after their expiry date) as described in previous papers [16,19,20]. Representative results on the composition of the stem surfaces from each group are shown in Figure 1.

The rough surface was obtained with an Al_2O_3 grit blasting procedure performed on a new stem made of Ti6Al7Nb alloy; the cross-section of the same surface showed subsurface contamination with the embedded Al_2O_3 debris particles, shown in Figure 1. We found subsurface Al_2O_3 contamination on the samples that prematurely failed due to aseptic loosening and periprosthetic infection.

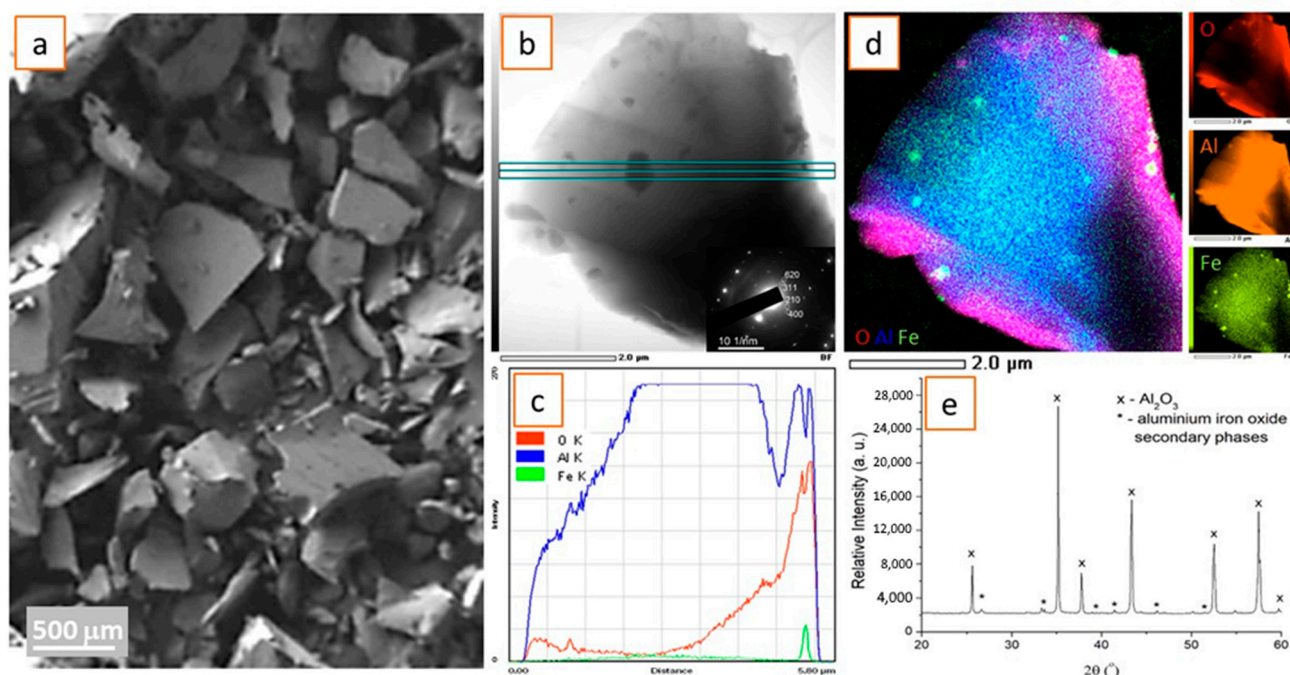
Figure 2. (a) SE image of commercial white fused alumina WFA 40 of irregular granulation 300–400 μm for surface roughening of implants; (b) Bright-field (BF) TEM image of highly purified white corundum particle with marked TEM profile analysis and inset of electron diffraction; (c) TEM profile analysis shows Al, O, and Fe traces in the corundum particle; (d) TEM mapping analysis with Al, O, and Fe elements; and (e) XRD spectrum of highly purified white corundum milled powder.

We analyzed the commercially available WFA40 (White Fused Alumina) used for grit blasting processes in medicine, using SEM, as shown in Figure 2a, TEM (Figure 2b–d), and XRD (Figure 2e). The SEM image shows powder particles or irregular granulation at 300–400 μm . Using TEM and selected area electron diffraction (SAED) on smaller electron-transparent samples, the 210, 311, 400, and 620 planes were determined in the chosen

particle (Figure 2b), which, in addition to profile (Figure 2c) and elemental (Figure 2d) analysis using STEM/EDS, confirmed the presence of aluminum (Al) and oxygen (O) in the sample, with traces of iron (Fe) (likely remnants from bauxite ore [24]). According to the JCPDS-ICDD powder diffraction card (JCPDS-ICDD number 00-010-0173 X'Pert High Score Plus Version 2.2b.2006), the main phase detected with the X-ray detection limit was Al_2O_3 , known as alpha alumina (Figure 2e). A small number of secondary phases based on aluminum iron oxide solid solutions (such as AlFeO_3 (JCPDS-ICDD no. 00-030-0024) and $\text{Al}_3\text{Fe}_5\text{O}_{12}$ (JCPDS-ICDD no. 00-049-1657)) were also observed, which could be attributed to the impurities in the initial aluminum oxide precursor. Some weak unmarked XRD peaks came from W radiation and not from the main and secondary phases, since during XRD analysis W vaporizes on the Cu target and this causes weak peaks at $2\theta = 33.6^\circ$, 41.5° , 50.1° , and 54.8° .

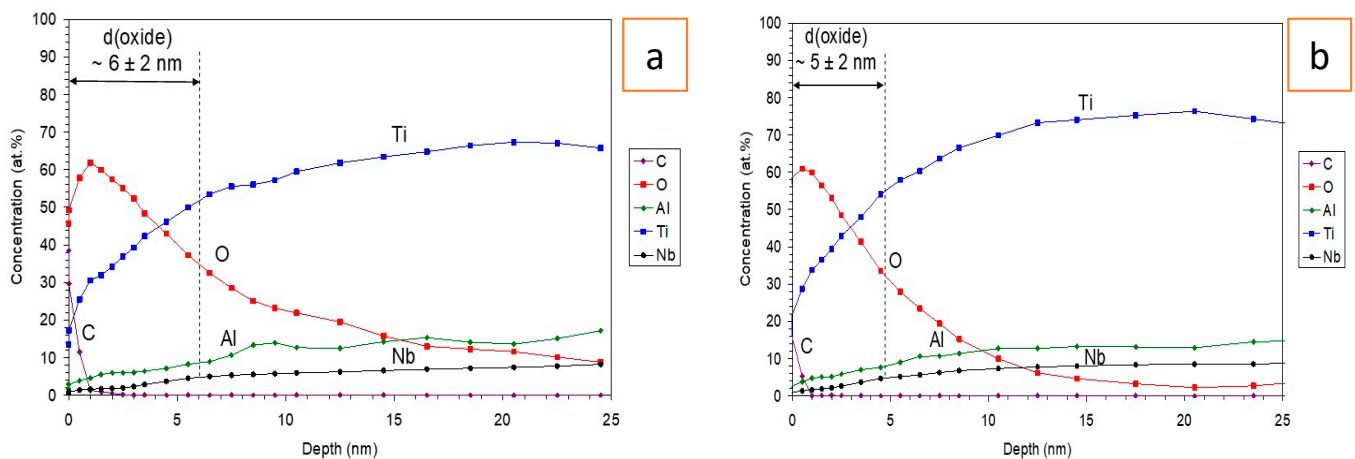
Figure 3. (a) XPS depth profile of a new Ti6Al7Nb alloy covered with native oxide after polishing. The thickness of the oxide was estimated to be 6 ± 2 nm. (b) XPS depth profile of a retrieved Ti6Al7Nb alloy covered with a native oxide after polishing. The thickness of the oxide was estimated to be 5 ± 2 nm.

The surface analysis of the retrieved and new stems was performed with XPS. Figure 3 shows XPS depth profiles of native oxide film which forms on the fresh surface, after grinding and polishing and exposure to the air for 24 h, of new and retrieved stems. The oxide layer on new and retrieved samples consisted of Ti-oxide, Al-oxide, and Nb-oxide. This was evidenced by the Ti $2p_{3/2}$ peak at 458.6 eV, characteristic of Ti (4+) in a TiO_2 -like environment; the Nb $3d_{5/2}$ peak at 207.0 eV, characteristic of the Nb (5+) oxidation state; and the Al 2p peak at 74.0 eV, characteristic for the Al (3+) oxidation state.

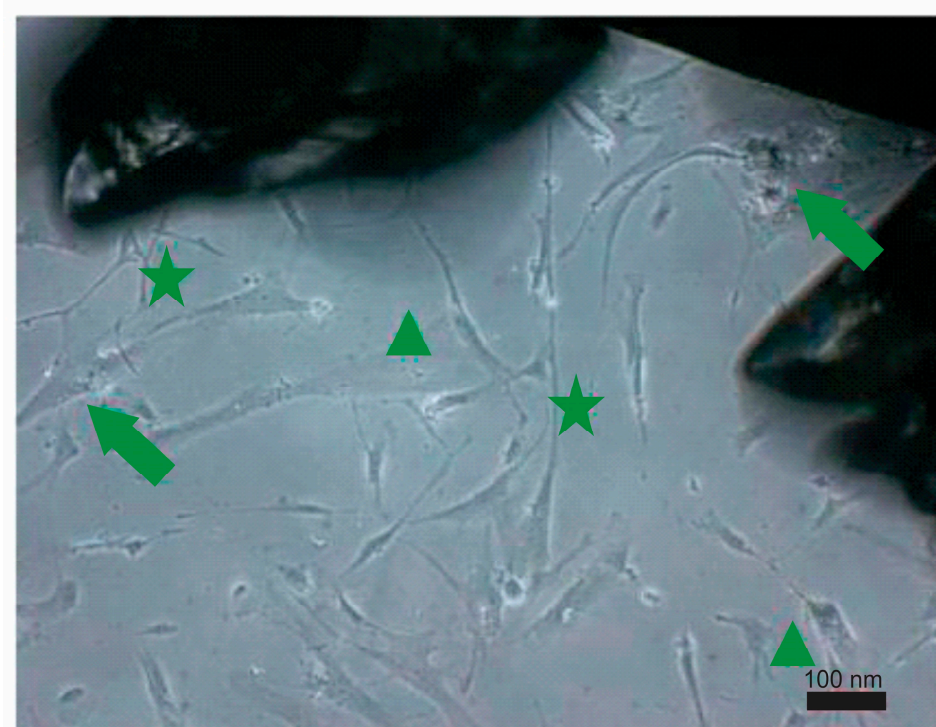
Figure 5. Signs of stress in the vicinity of corundum small particles: inclusion bodies (arrows), overspread cells (stars), and overspread cells (triangles) on a Ti6Al7Nb alloy with a modified surface via grit blasting and with residual debris particles on the surface and subsurface.

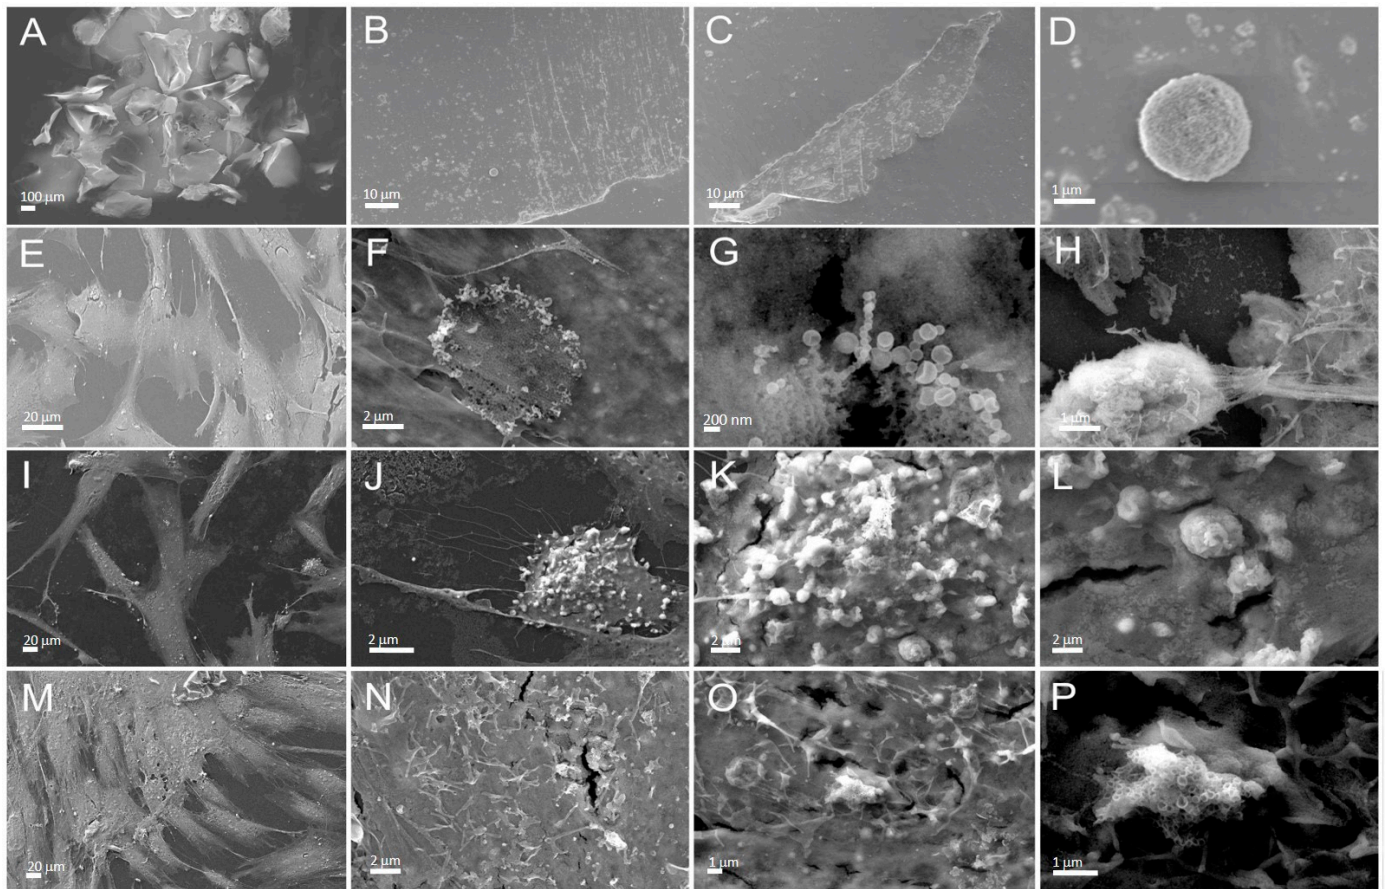
Figure 6. The effect of residual Al_2O_3 particles on the morphology of BMSC cells. (A–D) Corundum particles on the glass surface, (E–H) cells growing one week on corundum ceramic disc, (I–L): cells growing on glass with added toxic compound (positive control), and (M–P) cells growing on glass (negative control).

In Figure 6, the first row (A–D) shows particulate matter distributed over a thin film. The majority of particles are within micrometer size; however, singular larger particles could be found (Panel D). The second row (E–H) shows cells grown on an Al_2O_3 ceramic disk. The cells proliferated (Panel E); however, we found many decaying cells, either in the form of vesicles (Panels F and G) composed in a ring-like form (Panel F) or rounded and deformed (possibly apoptosis or necrosis). The third row shows cells growing on glass but with the addition of toxic compounds. Some of the cells proliferated to about the same extent as the ones growing on the corundum disc (Panels E and I). Many rounded decaying cells were found (Panels J–L) (probably apoptosis). The fourth row (Panels M–P) shows negative controls growing on the glass. Cells proliferated well (Panel M), forming more than one layer. Nanotubular structures characteristic of proliferating cells were abundant (Panels N and O). Interestingly, some colloid-like material was found in the sample (Panel P). We found that titanium after corundum grit blasting and the corundum microparticles exhibited a low cytotoxic effect, while polished titanium and ceramic disks exhibited no cytotoxic effect. None of the tested materials in our setup caused cell death or even a zone of inhibition, which indicates that none of the materials are significantly cytotoxic. In a study on human umbilical vein endothelial cells, no cytotoxicity was observed [26] which is in

line with the presented results. The present cytotoxicity investigation with primary BMSCs shows that retained corundum causes cell stress which might affect osseointegration.

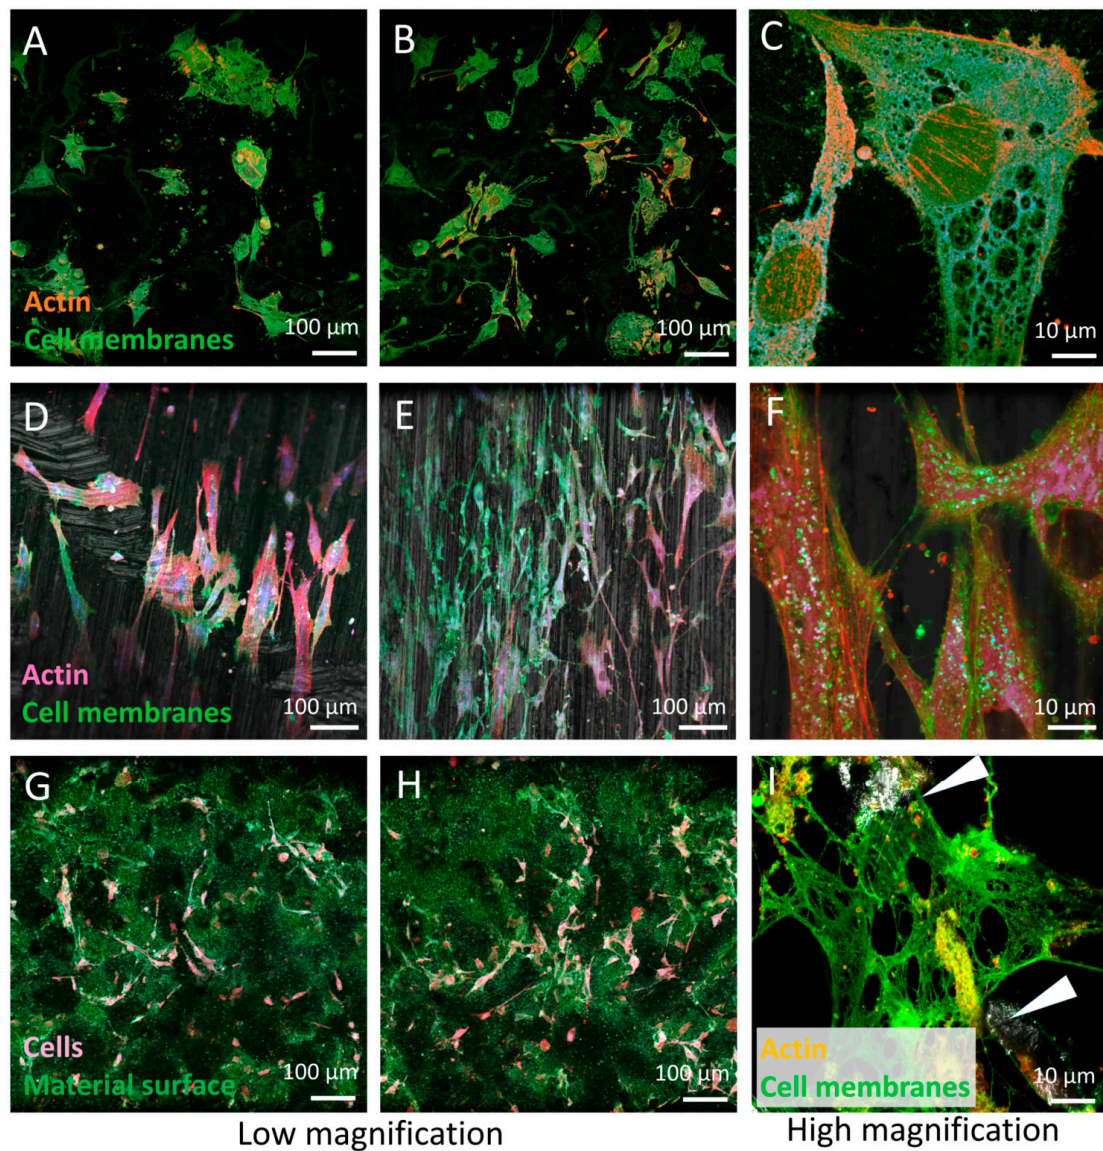
Figure 7. Confocal fluorescence images of live BSMCs grown on Ti6Al7Nb alloys with different surface finishing. (A–C) BSMCs on a polished (mirror-like) surface with non-oriented growth; (D–F) BSMCs on a ground surface with oriented growth; (G–I) BSMCs on a rough, Al_2O_3 contaminated surface with non-oriented poor growth, mostly only partially attached to the surface via anchoring points (see the arrows).

Figures 7 and 8 show that BMSC cell growth is different on materials with different surface finishing. There is no preferred orientation of cells on the polished (mirror-like) surface; while on the ground surface, the cells are oriented in the grinding direction.

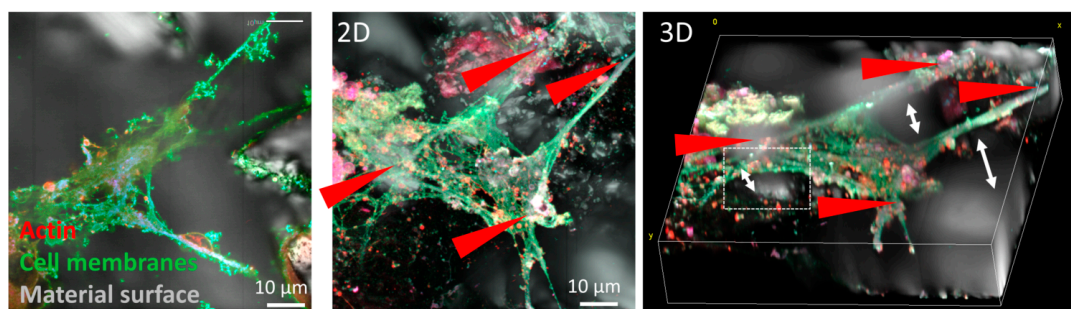
Figure 8. Confocal 2D/3D fluorescence microscopy of locally adhered live BSMCs on the rough Ti6Al7Nb surface with remaining Al_2O_3 particles embedded. The material surface (gray color) is observed

observed through the backscatter detection of the laser source. In this example, cells are adhered to the surface through four anchoring sites (red arrows), where the gaps between the surface and the cell are denoted with a white arrow and dashed rectangle. The gaps could be a possible place for bacteria adherence and consequently premature failure due to periprosthetic infection.

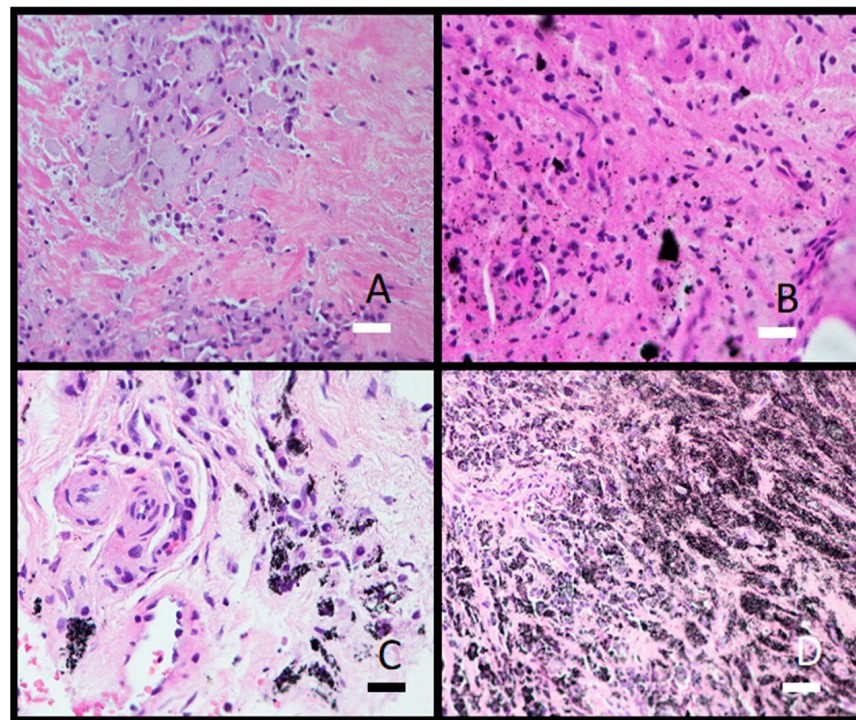
Figure 9. Photomicrographs of granulomatous tissue from a periprosthetic membrane filled with macrophages containing metal wear particles. (A) Gray-blue macrophage cytoplasm (obj. mag. 20×); (B) Black, needle-shaped to polygonal, sharp-edged metal microparticles different in size (obj. mag. 20×); (C) Cytoplasm filled with black particles (obj. mag. 40×); (D) Severe metallosis with metal particles in macrophages and extracellular space (obj. mag. 20×). Black bar = 50 μm and white bars = 100 μm .

Histological analysis showed granulomatous tissue in a periprosthetic membrane (bone marrow) with macrophages and giant cells. Macrophages contained varying amounts of metal particles in the cytoplasm, which appeared as a grey-blue staining of the cytoplasm or visible black particles (Figure 9). In one case, severe metallosis was found. Besides macrophages and giant cells, lymphocyte infiltration was seen as diffuse infiltration or as small perivascular cuffs (Figure 10).

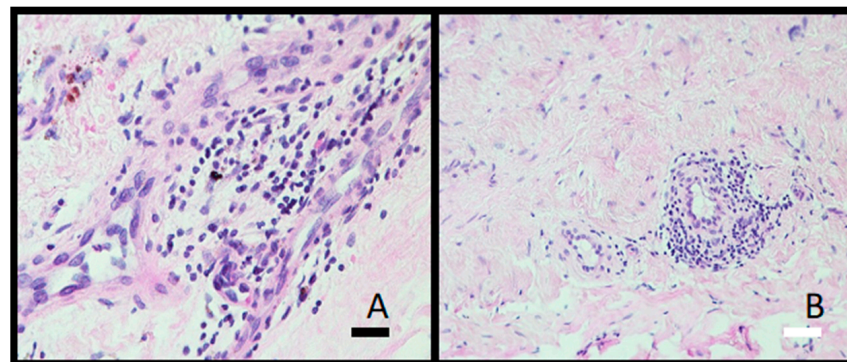
Figure 10. Photomicrograph illustrations of lymphocytic infiltrate in periprosthetic membrane. (A) Diffuse distributed lymphocytes (obj. mag. 40×) and (B) small perivascular lymphocytic cuff (obj. mag. 20×). Black bar = 50 μm and white bar = 100 μm .
