Metallographic Mechanism of Embrittlement of 15 μm Ultrafine Quaternary Silver Alloy Bonding Wire in Chloride Ions Environment

Abstract: Chloride ions contained in the sealing compound currently used in the electronic packaging industry not only interact with intermetallic compounds but also have a serious impact on silver alloy wires. A 15 μm ultrafine quaternary silver-palladium-gold-platinum alloy wire was used in this study. The wire and its bonding were immersed in a 60 °C saturated sodium chloride solution (chlorination experiment), and the strength and elongation before and after chlorination were measured. Finally, the fracture surface and cross-section characteristics were observed using a scanning electron microscope and focused ion microscope. The results revealed that chloride ions invade the wire along the grain boundary, and chlorides have been generated inside the cracks to weaken the strength and elongation of the wire. In addition, chloride ions invade the interface of the wire bonding to erode the aluminum substrate after immersing it for enough long time, causing galvanic corrosion, which in turn causes the bonding joint to separate from the aluminum substrate.

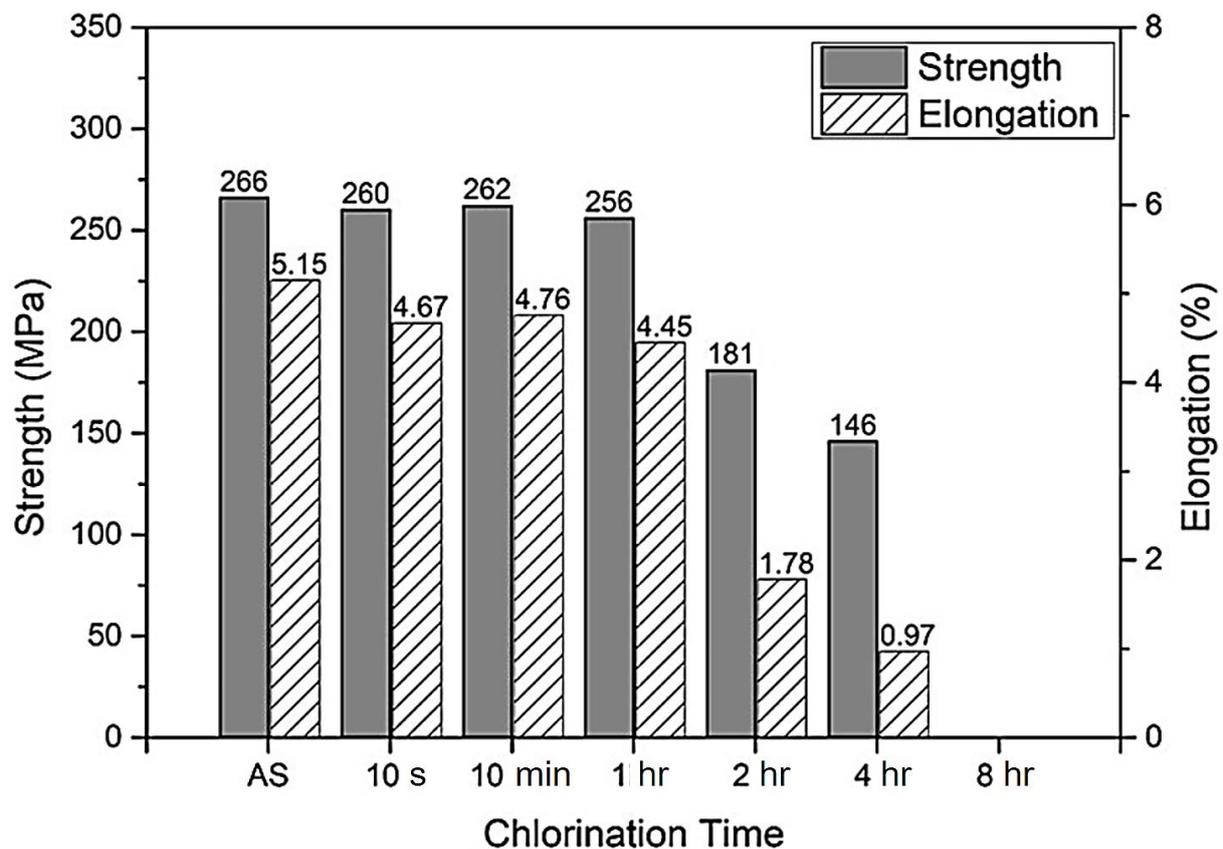
Figure 1. Changes in tensile strength and elongation of the APAP wires after immersion in saturated sodium chloride solution. (The tensile data were the average of five tests).

Figure 1 presents the change in the tensile strength (UTS) and elongation of the APAP wires immersed in the saturated sodium chloride solution for 10 s, 10 min, 1 h, 2 h, 4 h, and 8 h. According to the results, no significant difference in the strength and elongation of the wire within 1 h of immersion was detected, but as the immersion time increased to more than 2 h, a significant decrease in strength and elongation was observed, indicating that the corrosion caused by chloride ions has a considerable influence on the reliability of the wire. After being immersed for 8 h, the wire broke when tensile, indicating that the APAP wire cannot be used in a chlorinated environment for long periods.

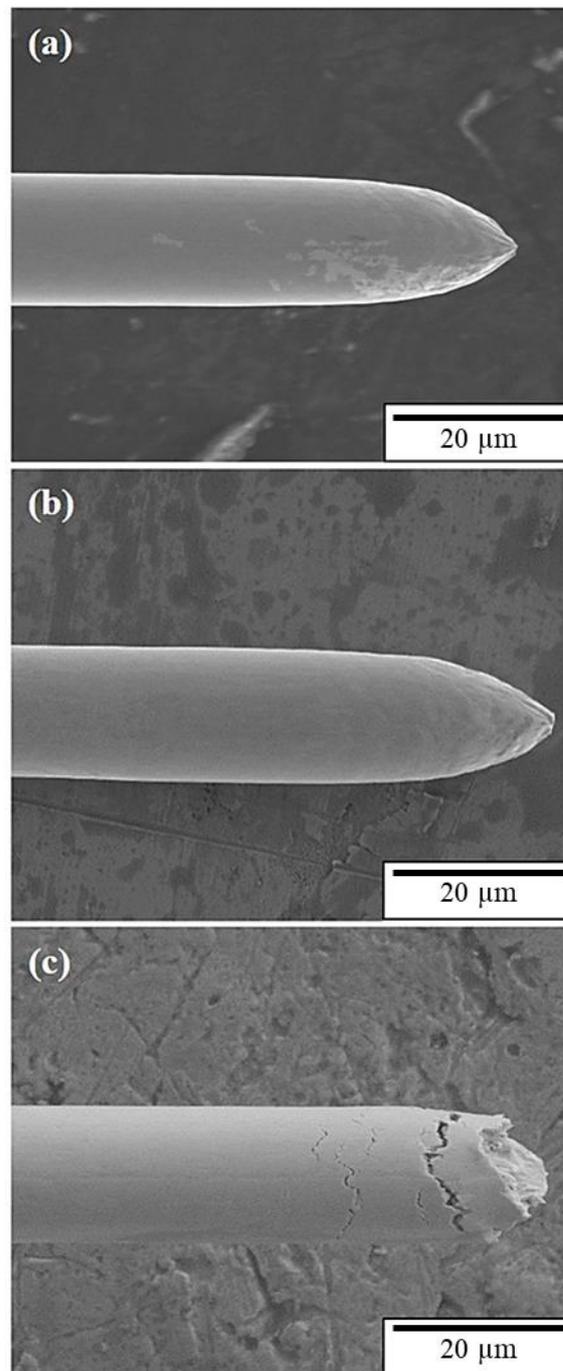
Figure 2. Tensile fracture surface of the APAP wire at different chlorination times: (a) before chlorination, (b) 2 h, and (c) 4 h.

The tensile fracture surface of the APAP wire before and after chlorination was observed using an SEM (Figure 2). According to the literature [1], the fracture morphology of general metal wires is conical (the fracture mode is dominated by ductility). The APAP wire exhibited ductile failure characteristics before chlorination and after chlorination for 2 h. After chlorination for 4 h, the failure characteristics changed from ductile to brittle. After immersion in the saturated sodium chloride solution for 4 h, numerous fine cracks were distributed on the surface of the wire (Figure 3b,c), which was different from the wire before immersion in the saturated sodium chloride solution (Figure 3a,b). When the wire was subjected to tensile stress, these small cracks gradually connected to form large cracks, which eventually led to brittle fractures.

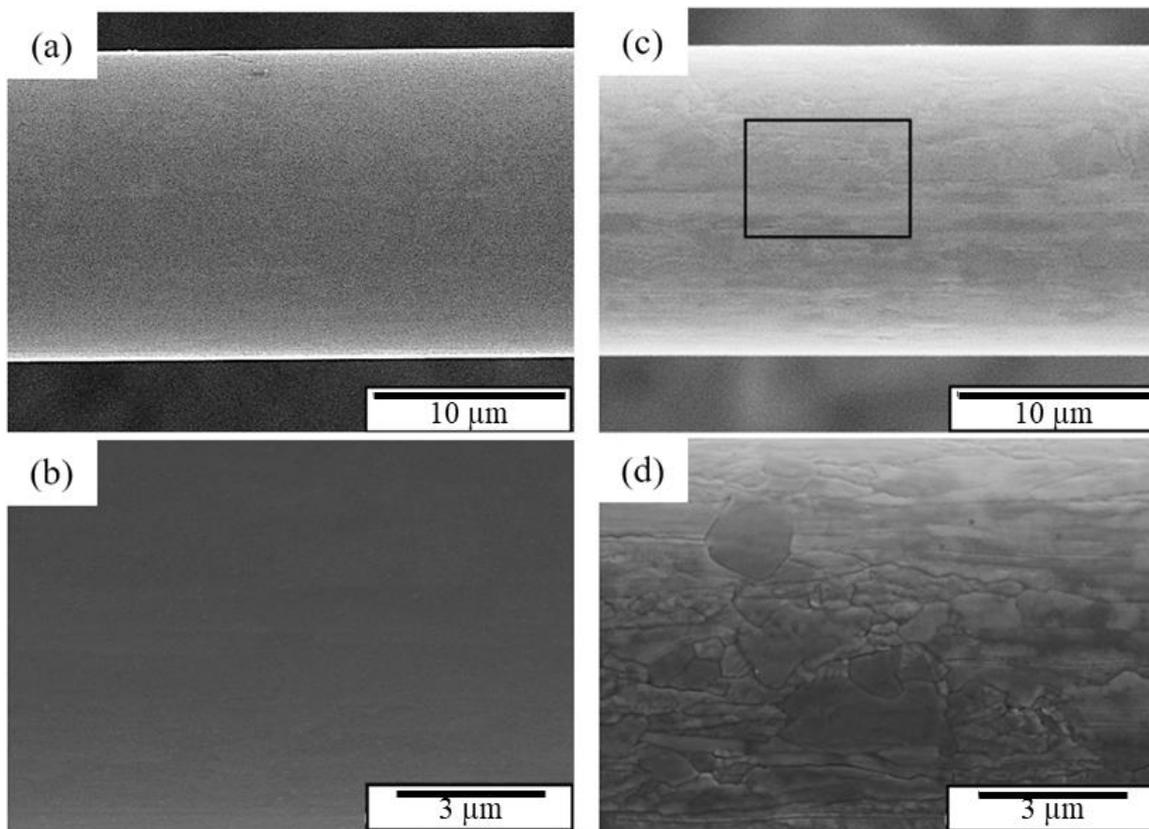
Figure 3. Surface morphology of the APAP wire: (a) macroscopic image before chlorination, (b) local magnified image before chlorination, (c) macroscopic image after chlorination for 4 h, and (d) local magnified image after chlorination for 4 h.

As the wire diameter gradually shrank, subtler phenomena, such as electromigration and chloride ion diffusion, became more evident. Another study [27] revealed that the silver-based wire exhibits a weakened grain boundary and intergranular fracture caused by electromigration during the electrification process. This is because the wires used today are mostly narrower than 20 μm in diameter; thus, even small changes cause major changes to the wire. For example, the longest crack in this study was 5 μm, and the unaffected wire diameter at the center was only 5 μm, too. This highlights the influence of the chlorine embrittlement phenomenon.

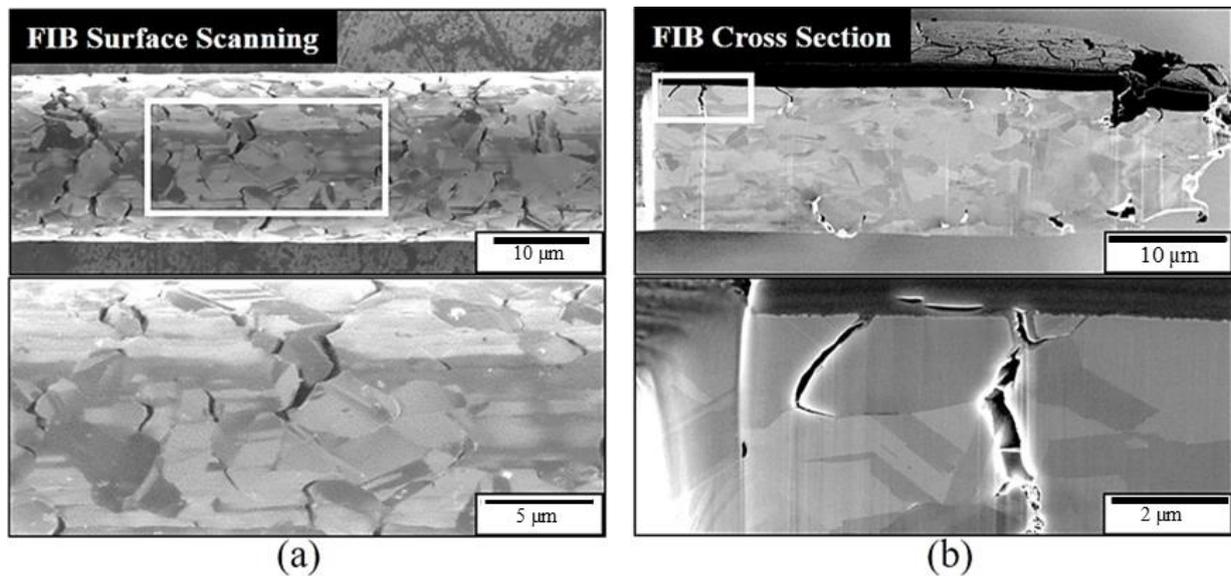
Figure 4. Tensile fracture cross-section of the APAP wire after 4 h of chlorination: (a) focus ion beam (FIB) surface scanning, and (b) cross-section image.

To clarify the chlorination mechanism of the APAP wire, FIB scanning and profile analysis were performed on the fracture surface after chlorination for 4 h (Figure 4). Figure 4a presents the surface features 100 μm from the fractured surface. In addition to a large number of cracks on the surface of the wire, most cracks are located at the boundary of different color blocks. This indicates that the location of the cracks is at the grain boundary. Figure 4b presents the FIB profile analysis, and the microstructure was similar to our previous coated silver wire study [26]. The results demonstrate that the cracks penetrate deep into the wire along the grain boundary, and the longest crack is approximately 5 μm . Figure 5 presents the EDS element analysis results inside the cracks, revealing that chlorides have been generated inside the cracks. This demonstrates that chloride ions penetrate the wire through the grain boundary to form chlorides, causing the grain boundary to weaken.

During the tensile test, the core not affected by chloride ions remained connected after the surface was broken and continued to deform. The cracks gradually widened from the inside to the outside, gradually penetrating the wire because of stress concentration. Finally, a brittle intergranular fracture occurred. The brittle fracture mechanism of the silver alloy wire is illustrated in Figure 6. The chlorine embrittlement phenomenon that occurs in silver alloy wires is caused by foreign chlorine ions that gradually erode the inside of the wire along the grain boundary or defects. Subsequently, a brittle fracture occurs when the wire is subjected to strain. The weakening of the grain boundary causes decreases in the tensile strength and elongation.

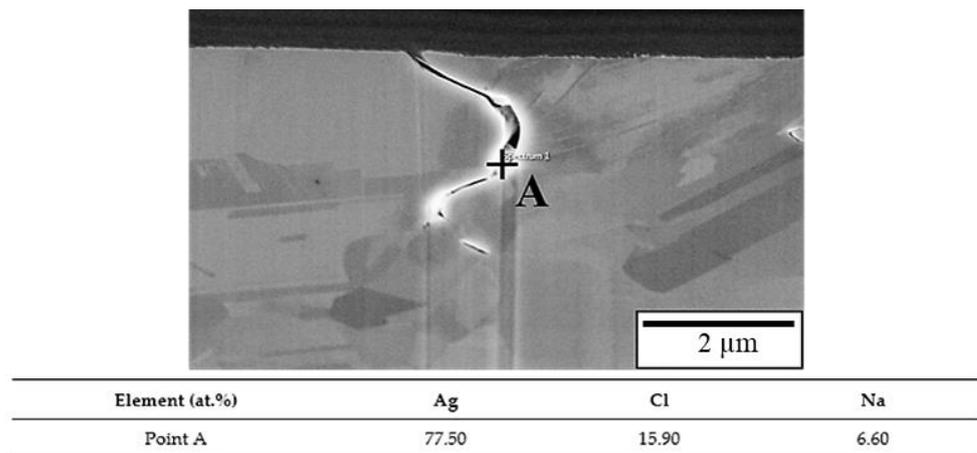
Figure 5. Energy dispersive spectroscopy (EDS) element analysis results of the crack.

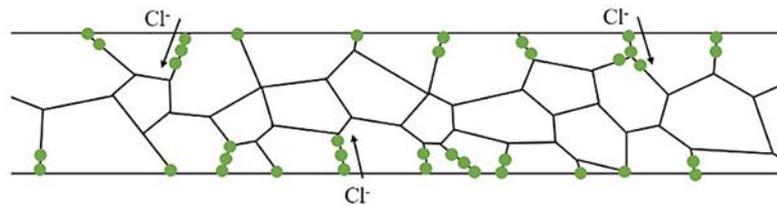
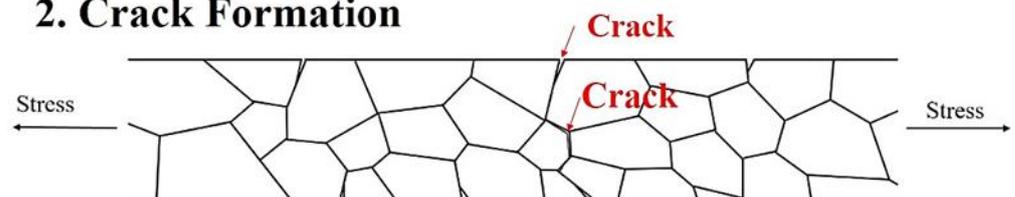
1. Chloride ions attack along grain boundaries

2. Crack Formation

3. Brittle Fracture

Figure 6. Intergranular brittleness fracture mechanism.

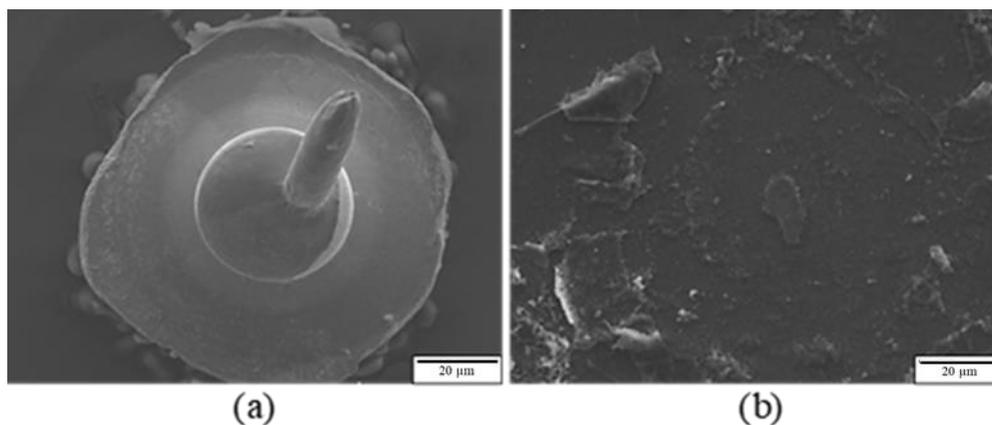
Figure 7. Fracture position of the first bond of the APAP wire after chlorination: (a) 10 min and (b) 30 min.

Figure 7 presents the tensile fracture position of the first bond of the APAP wire immersed in a saturated sodium chloride solution at 60 °C for 10 and 30 min. After 10 min of chlorination, the first bond fracture position occurred in the heat-affected zone (Figure 7a), indicating that it retained some strength under these conditions. However, as the chlorination time increased to 30 min, the first bond joint separated from the aluminum substrate, and some traces remained on the substrate (Figure 7b). This suggests that after a long period of chlorination, chloride ions corrode the joint surface of the first bond, possibly causing the bond joint to separate and reducing reliability. Figure 8 presents the EDS analysis results of the fracture surface after 30 min of chlorination of the first bond joint of the APAP wire. The aluminum film on the substrate has been eroded by chloride ions and has peeled off. Points A and B in the figure denote the residual aluminum film, and point C is the exposed silicon substrate after the aluminum film has peeled off.

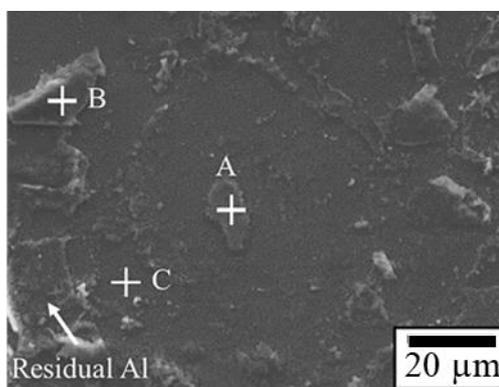
Element(At.%)	A	B	C
Na	4.88	10.01	1.93
Al	39.97	61.72	1.93
Si	54.85	0.61	95.7
Cl	0.30	27.65	0.44

Figure 8. EDS analysis of the fracture surface of the first bond of the APAP wire after 30 min of chlorination. (A, B: residual aluminum film; C: silicon substrate).

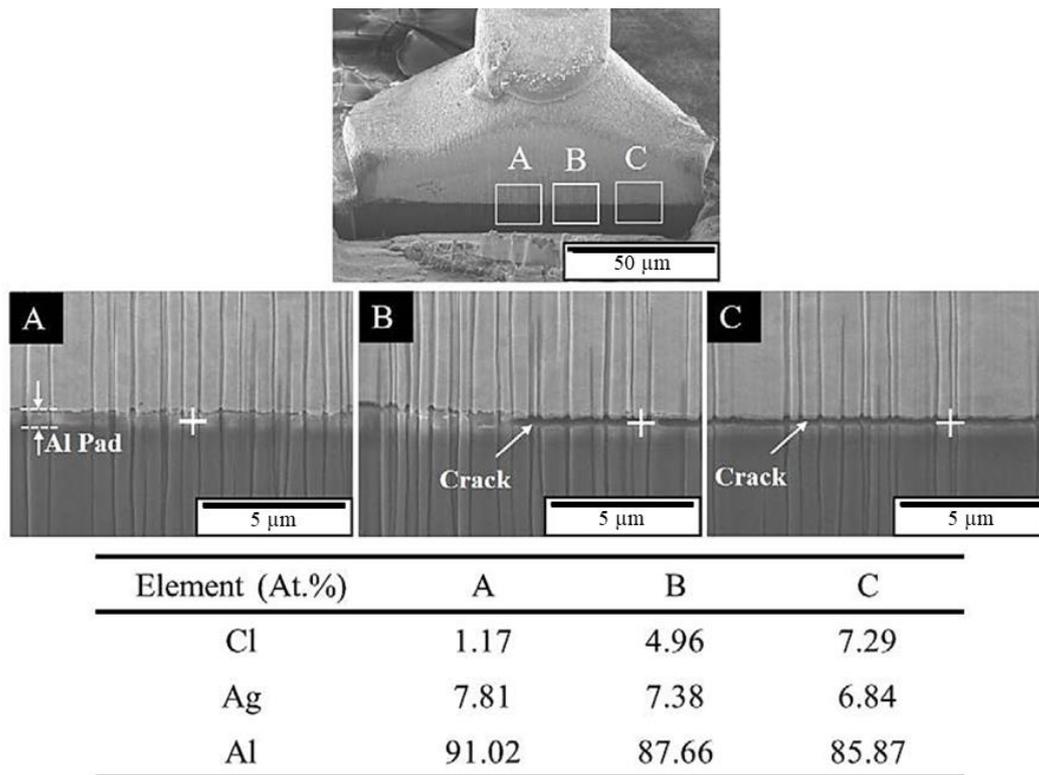
Figure 9. FIB cross-section and EDS element analysis results of the first bond of the APAP wire after 30 min of chlorination.

The FIB cross-section and EDS element analysis results of the first bond of the APAP wire after chlorination for 30 min are presented in Figure 9. A clear bond boundary can be identified at the center of the bond. At the periphery of the bond (point C), the silver ball and aluminum film have peeled off, reducing the bond strength. The EDS element analysis reveals a very small chlorine signal at the center of the bond (point A) and a larger chlorine signal at the periphery of the bond (point B). This finding indicated that chlorine ions corroded the aluminum film from the outside to the inside of the bond. As the chlorination time increased, the aluminum film at the bond junction was gradually eroded and hollowed out. Finally, the first bond joint was peeled off and failed (Figure 10).

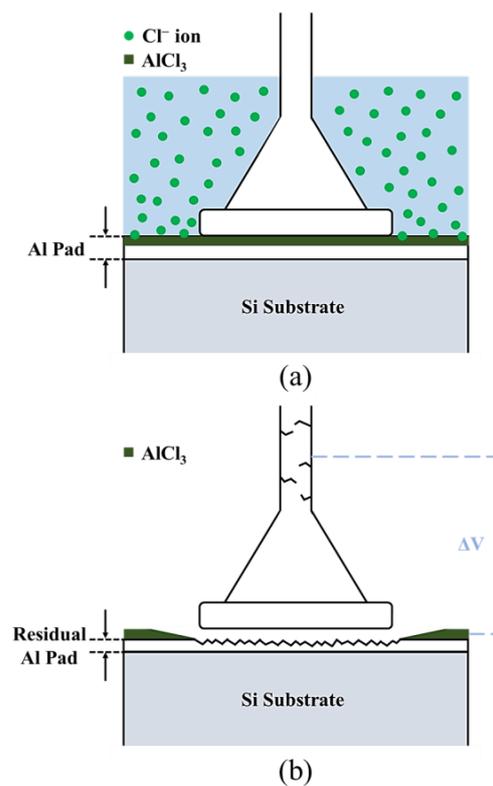
Figure 10. Schematic of the joint of the first bond after chlorination: (a) chloride ions corrode the aluminum film; (b) the joint of the first bond peels off.

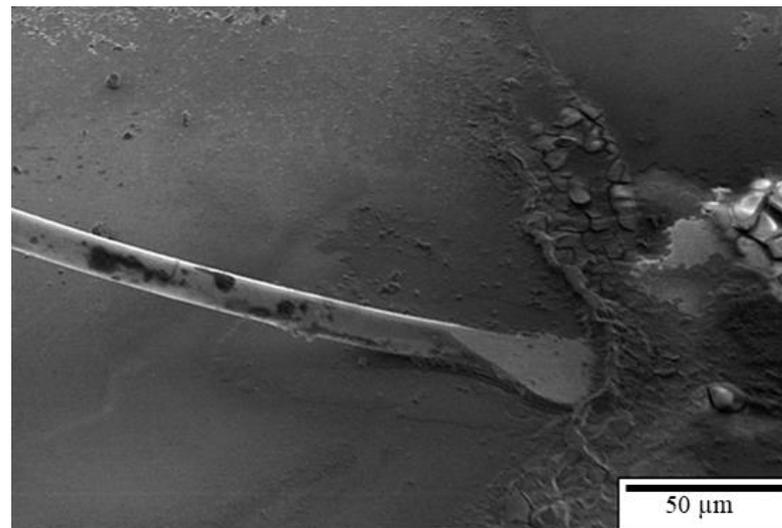
Figure 11. Surface morphology of the second bond of the APAP wire after 30 min of chlorination.

Figure 11 presents the surface morphology of the second bond of the APAP wire after 30 min of chlorination, with no bond joint peeling. Figure 12 presents the FIB cross-section analysis results, which reveal that the second bond is well joined; only the aluminum film at the end of the fishtail joint is eroded and hollowed out at approximately 1.5 μm. The downforce of the second bond is usually greater than that of the first bond, maintaining a tighter second bond. Therefore, the joint surface of the second bond has greater reliability. A schematic of the chlorination process is presented in Figure 13.

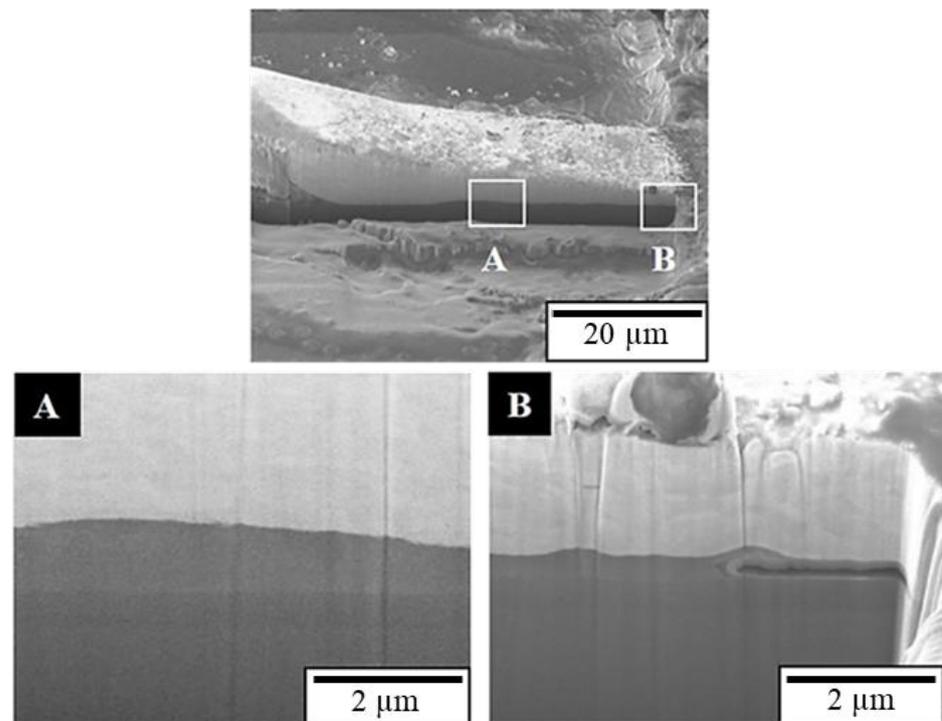
Figure 12. FIB cross-section of the second bond of the APAP wire after 30 min of chlorination. (A) Smooth interface; (B) aluminum film at the edge is eroded and hollowed out.

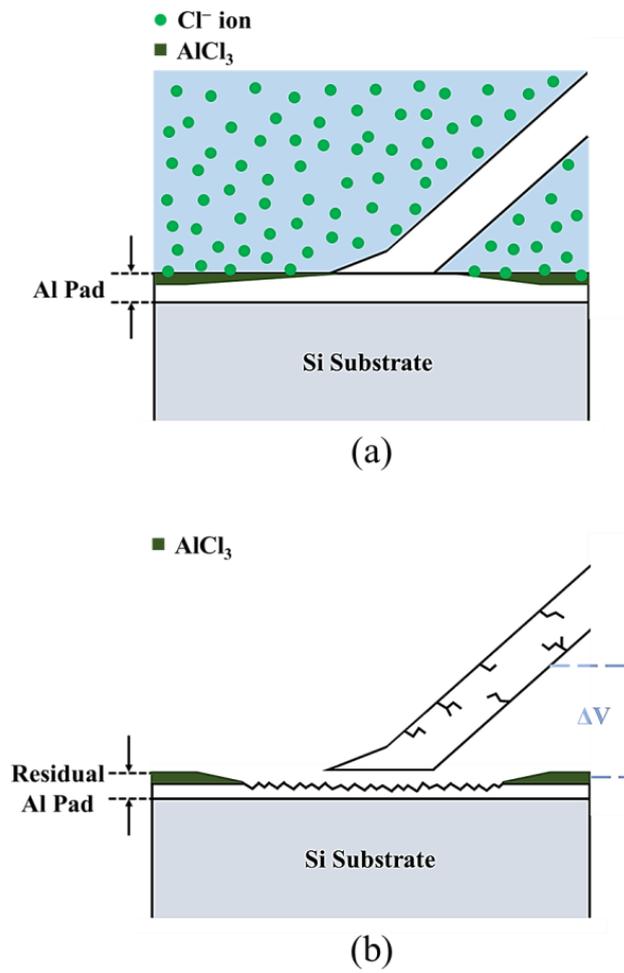
Figure 13. Schematic of the joint of the second bond after chlorination: (a) chloride ions corrode the aluminum film; (b) partial cracks produced at the joint of the second bond.

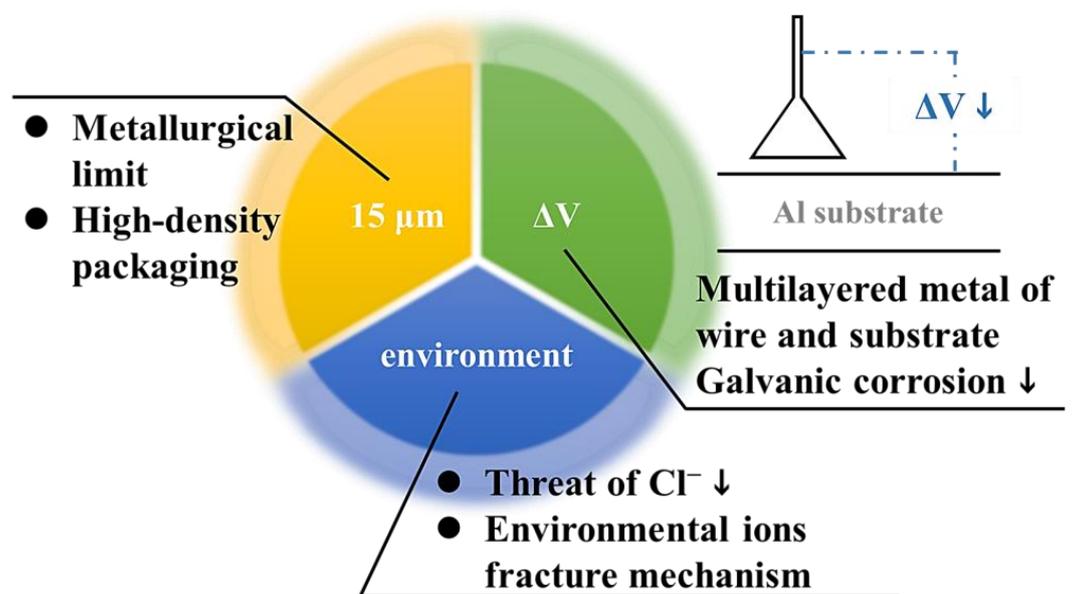
Figure 14. Summary of the study results.

This study has three strengths (Figure 14). First, a quaternary alloy APAP wire was used to replace the common coated wire to reduce the galvanic corrosion caused by the multilayered metal when the wire is bonded to the substrate [28]. Furthermore, the diameter of the quaternary alloy APAP in this study was 15 μm, which is thinner than the silver wire with a diameter of 18–20 μm currently available in the market, reducing the use of precious metals and increasing the packaging density. Finally, we investigated the wire's corrosion fracture in a halogen environment to establish application reference data in depth. The results indicate that the sealant used in the microelectronics packaging industry should contain few chloride ions in the future.
