# Experimental Research on Fatigue Performance of Reinforced Concrete T-Shaped Beams under Corrosion–Fatigue Coupling Action

**Keywords:** corrosion–fatigue coupling device; accelerated corrosion of reinforcement; reinforced concrete T-beam; corrosion-fatigue coupling test; simple fatigue test; fatigue life analysis

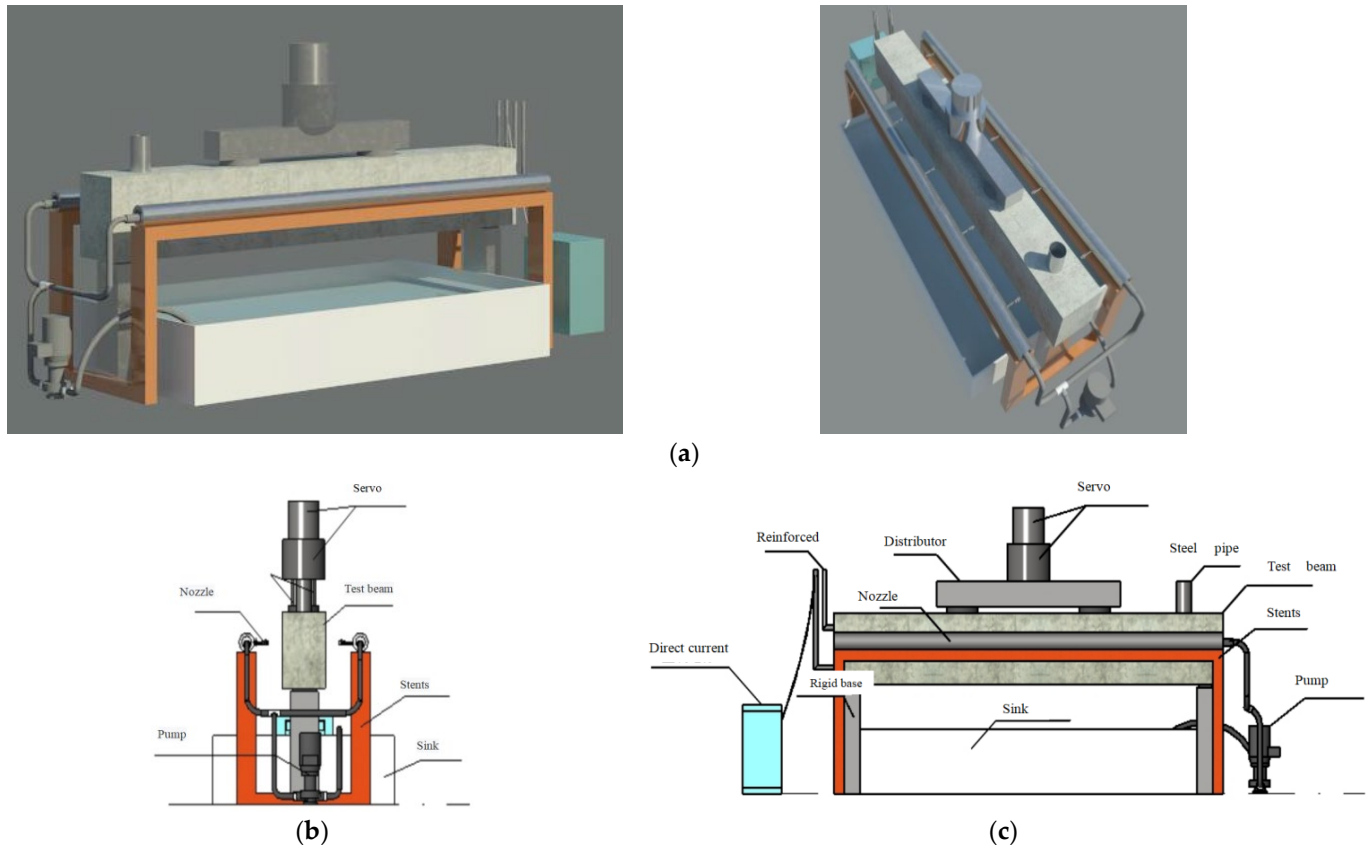
**Figure 1.** Coupling test device considering both corrosion environment and cyclic loads. (a) Design sketch. (b) Side view. (c) Front view.

According to the test method described above, a new spray test and loading device is designed, which can be used to simulate the corrosion environment and the cyclic loading simultaneously. The design diagram of the proposed test device is shown in Figure 1.

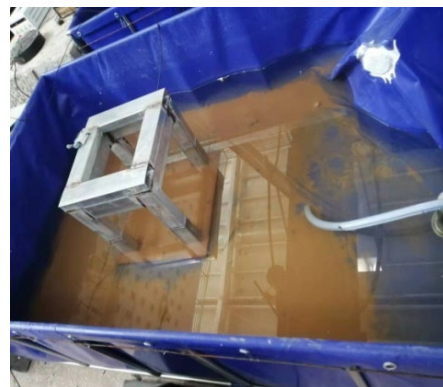
**Figure 2.** Water tank.

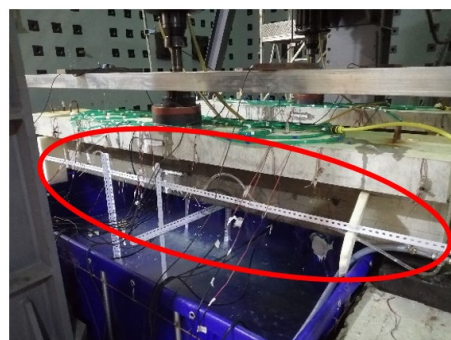
**Figure 3.** Frame supporting spraying facilities.

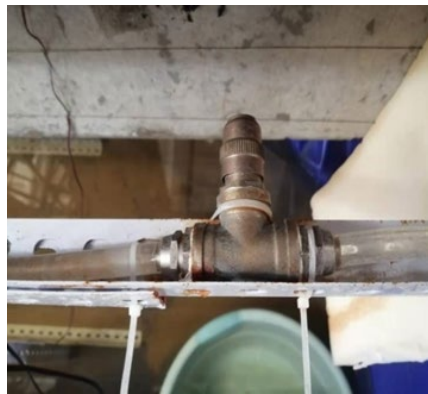
Figure 4. Spray nozzle.

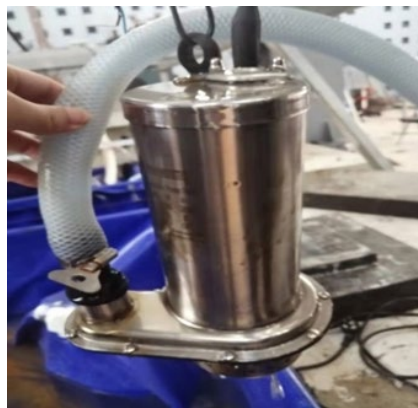
Figure 5. Stainless-steel water pump.

- (3) Considering the corrosion of the water pump itself, the test device uses a stainless-steel submersible pump, as shown in Figure 5. The submersible pump is placed in the water tank, and the water level just exceeds the height of the water pump. By connecting the water pump to the water pipe, the nozzles can stably spray NaCl solution in the water tank on the side of the test beam, and the excess NaCl solution flows back to the water tank for recycling.

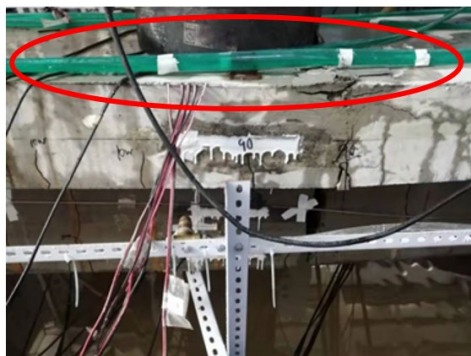
Figure 6. Drip irrigation pipe.

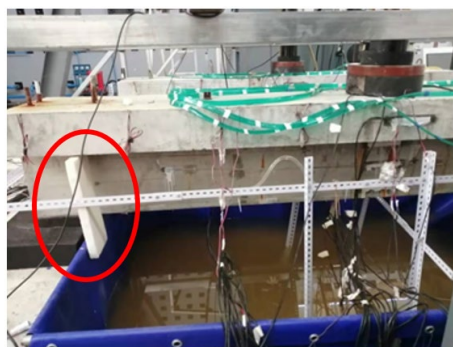
Figure 7. Sponge.

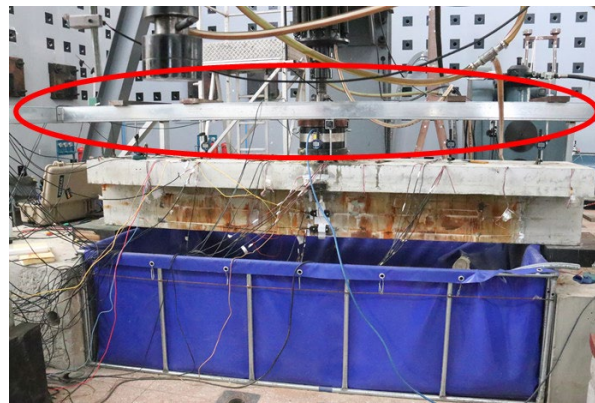
**Figure 8.** Square steel frame.

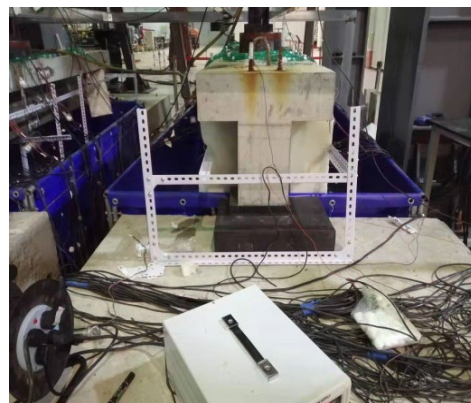
**Figure 9.** Corrosion–fatigue coupling test device.

Through the innovative design of the test device, the following problems are mainly solved: fatigue loading and reinforcement corrosion are carried out simultaneously; effective simulation of spraying time and environmental effect; protection of hydraulic servo loading equipment in salt fog environment; isolation of test beam reaction device and support system from salt fog environment, etc. The physical device of the corrosion–fatigue coupling test is shown in Figure 9.

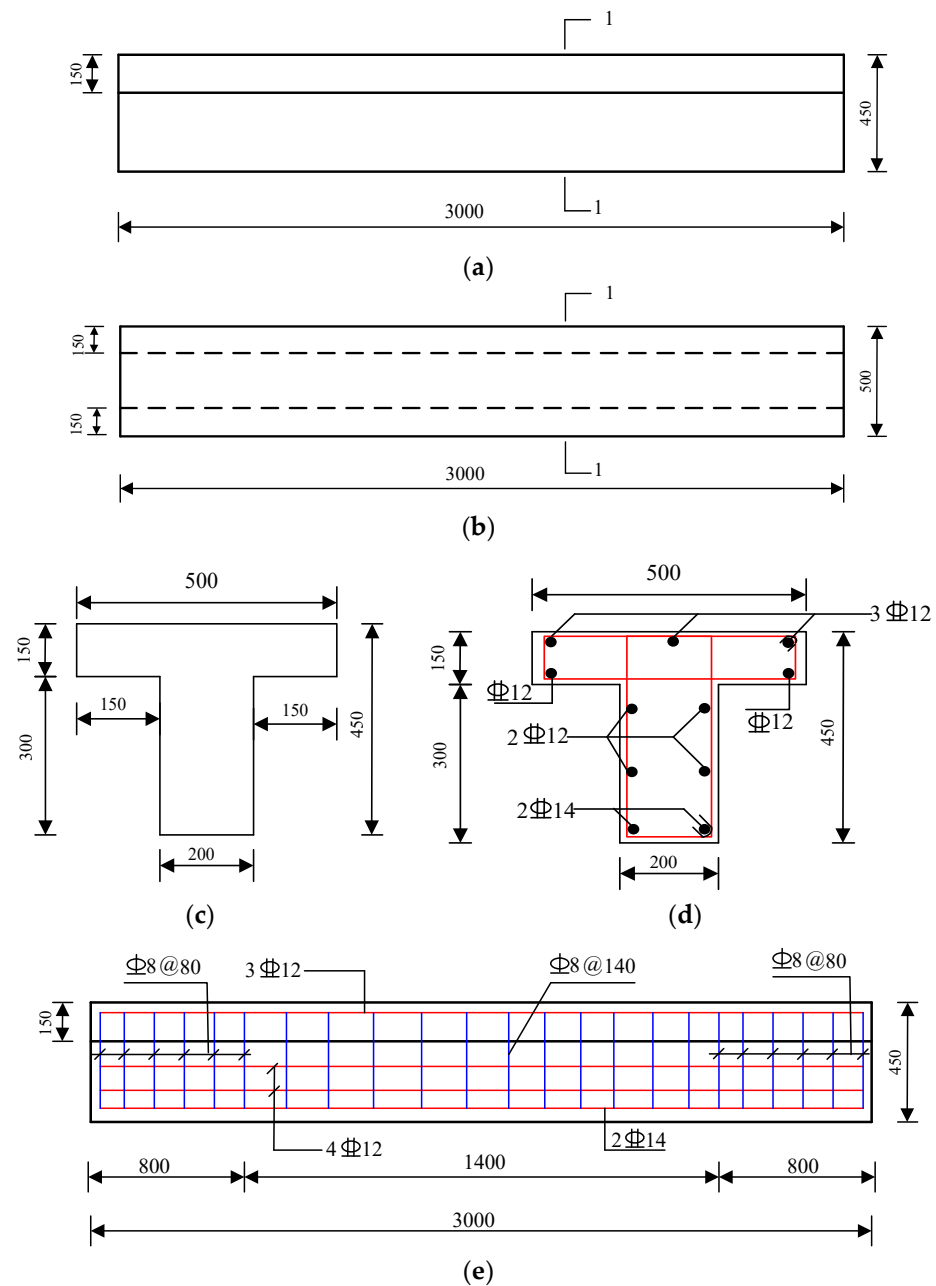
**Figure 10.** Geometry and reinforcement drawings of the test beam (mm). (a) Elevation. (b) Vertical view. (c) Side view. (d) 1-1 cross-section profile. (e) Longitudinal-section profile.

In the design process of these test beams, considering that the test beams in the previous fatigue tests were mostly rectangular, but the proportion of rectangular beams used in practice projects is small, so the actual highway-reinforced concrete T-beam is selected for this test, and the geometric size of the test beams is calculated by a certain proportion of the scale, and on the premise of keeping the reinforcement ratio unchanged, the reinforcement of the test beam is rearranged. The span of the test beam is 3 m, the thickness of the concrete cover is 4 cm, and the beam end constraints are simply supported type. The test beam is a reinforced concrete T-shaped beam, with the bottom width of the rib  $b = 200$  mm, the top plate width  $b_f = 500$  mm, the flange height  $h_f = 150$  mm, and the total beam height  $h = 450$  mm. The beam rib is provided with 6 longitudinal steel bars, and the lower part of the flange is provided with 2 longitudinal steel bars, with a total sectional area  $A_s = 986.5 \text{ mm}^2$ ; the upper part of the top plate is provided with 3 longitudinal steel bars, and the sectional area is  $A_s' = 226.2 \text{ mm}^2$ . The test beam is poured with C50 concrete, and the concrete compressive strength  $f_{ck} = 41.3 \text{ MPa}$  and the elastic modulus  $E_c = 39,940 \text{ MPa}$  are measured by the material test. The longitudinal steel bar at the rib bottom of the test beam is an HRB400 rebar with a diameter of 14 mm, and the other longitudinal steel bars are HRB400 rebar with a diameter of 12 mm. The stirrup is an HRB335 rebar with a diameter of 8 mm. The geometric dimension and reinforcement drawing of the test beam are shown in Figure 10.

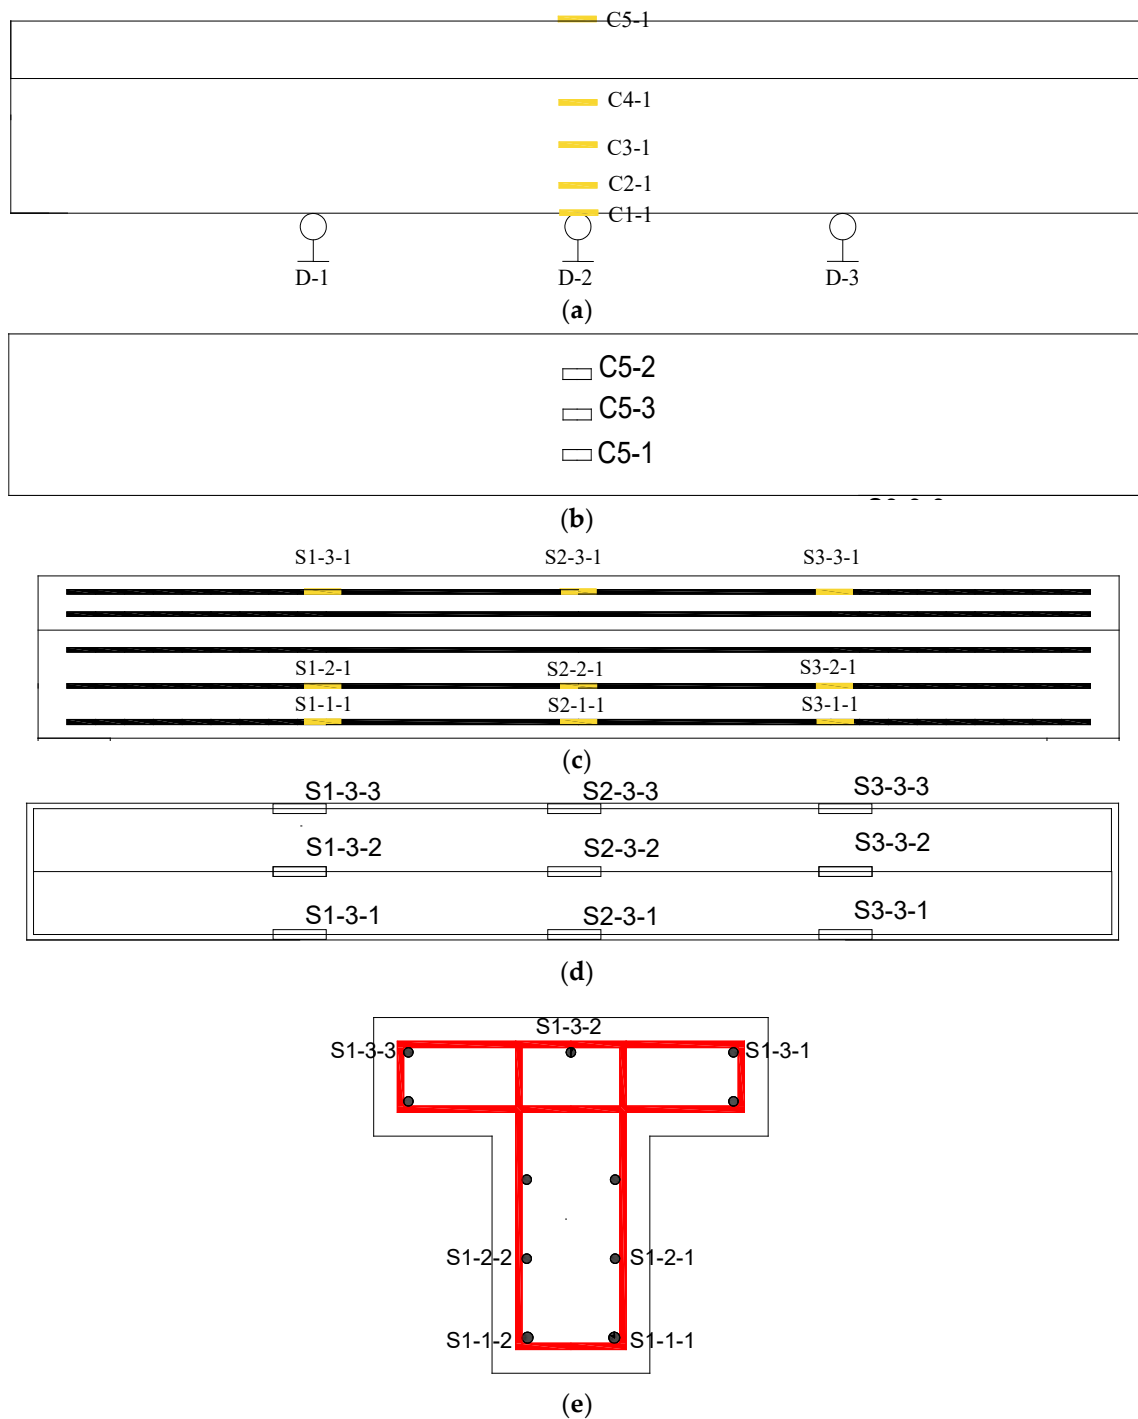
**Figure 11.** Layout of strain and displacement measuring points. (a) Side view of strain measuring points of concrete and displacement measuring points of the test beam. (b) Top view of strain measuring points of concrete. (c) Side view of strain measuring points of steel bars. (d) Top view of strain measuring points of steel bars. (e) Strain measuring points of steel bars in Section 1.

In order to measure the responses of the test beam during the experiment to evaluate the mechanic performance of the beam, strain gauges shall be pasted on both sides of the rib of the test beam, the top surface, and the reinforcement surface, and displacement meters shall be installed at the bottom of the test beam. The arrangement of measuring points is shown in Figure 11. The naming format of the concrete strain gauge number is CX-X, where X is a number, the first number from small to large represents the relative height changing from low to high, and the second number indicates the side direction of the concrete beam. Generally, the number 1 represents the strain gauge on the south side. For example, the concrete strain gauge at the bottom measuring point on the south side is numbered C1-1, and the corresponding strain gauge on the north side is numbered C1-2. The naming format of the steel bar strain gauge number is SX-X-X, where X is also a number, the first number represents the section number, the second number represents the relative height of the steel bar position, and the third number represents the number of

the steel bar on each side. Generally, the number 1 represents the steel bar on the south side; for example, S1-1-1 represents the strain gauge on the steel bar at the south side of the bottom layer in Section 1. The number of the displacement meter is D-1, D-2, and D-3, respectively, to indicate the displacement measuring points of the left 1/4 span, the middle span, and the right 1/4 span of the beam. 'C' represents concrete strain, 'S' represents steel bar strain, and 'D' represents displacement.

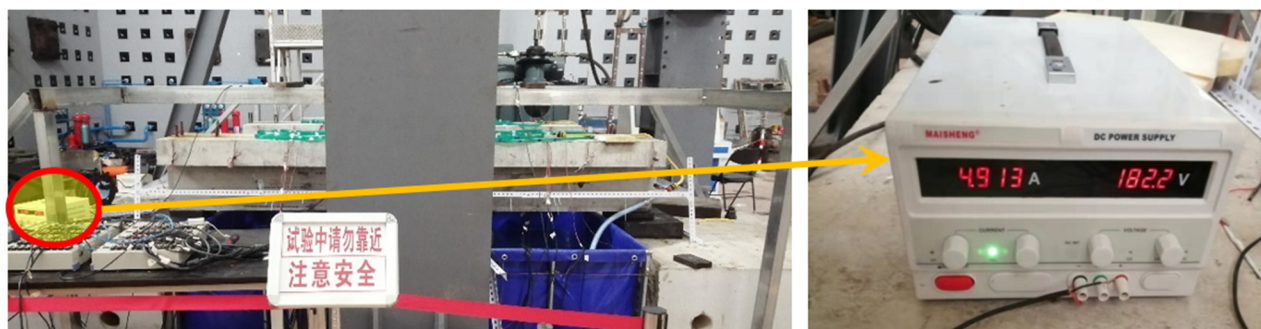
**Figure 12.** Constant current and constant voltage power supply.

the corrosion–fatigue tests, it was estimated that the fatigue life of the corrosion–fatigue reinforced concrete beam corresponding to China Highway-I vehicle load is more than 2 million times, by referring to the previous research result [25]. Then the theoretical corrosion rate of reinforced concrete beams can be calculated by Faraday’s electrolysis law [36], and the constant current density during accelerated corrosion is derived as  $0.45 \text{ mA/cm}^2$  by constant current and constant voltage power supply shown in Figure 12.

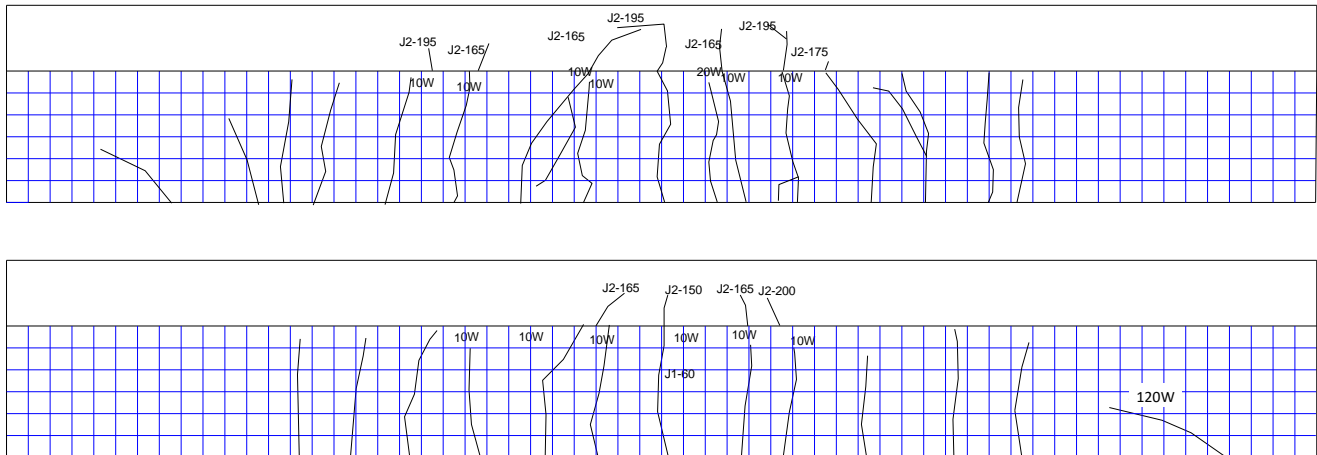
**Figure 13.** Crack distribution of XP-1 test beam during static load failure after 2 million times cyclic loading (both sides of rib).

The upper limit of the fatigue load of the XP-1 test beam is 70 kN, and there is no obvious change at the initial stage of loading. With the progress of the fatigue test, cracks begin to develop. Most of the cracks extend vertically along the beam height, which is all typical bending cracks. After two million cycles of loading, the test beam has no fatigue failure, and then the test beam is statically loaded until failure. When the static load reaches 140 kN, the test beam enters the yield stage, and when the load is greater than 160 kN, the

cracks of the flange begin to appear and expand into a large number of secondary cracks at 190 kN; finally, the test beam is damaged due to crushing of concrete at the top flange when the load is 225 kN. The crack distribution is shown in Figure 13.

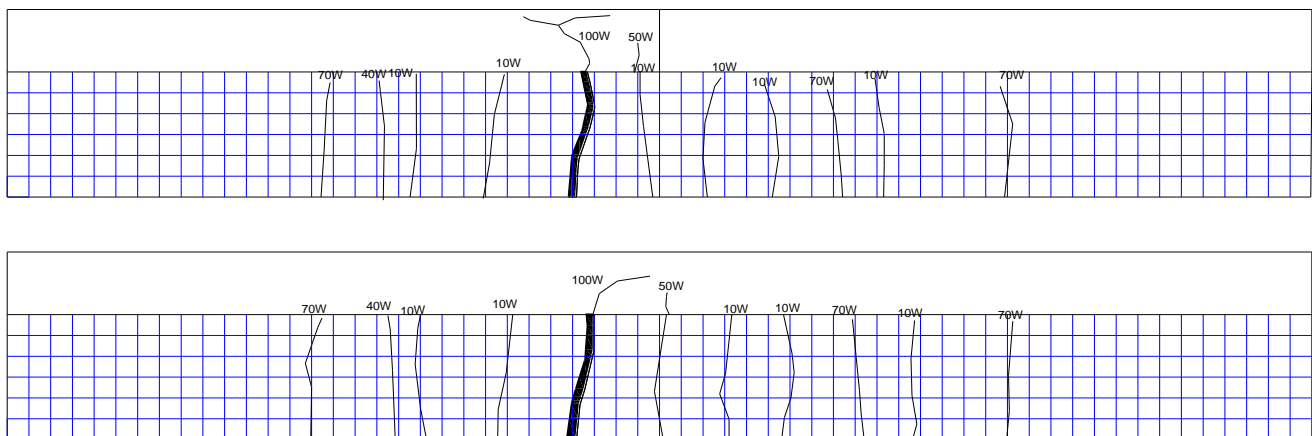
**Figure 14.** Crack distribution of XP-2 test beam at fatigue failure (both sides of rib).

The upper limit of the fatigue load of the XP-2 test beam is 80 kN, and there is no obvious change at the initial stage of loading. When the cyclic load reaches 1.01 million times, the fatigue failure of the XP-2 test beam occurs, and the specific crack distribution is shown in Figure 14.

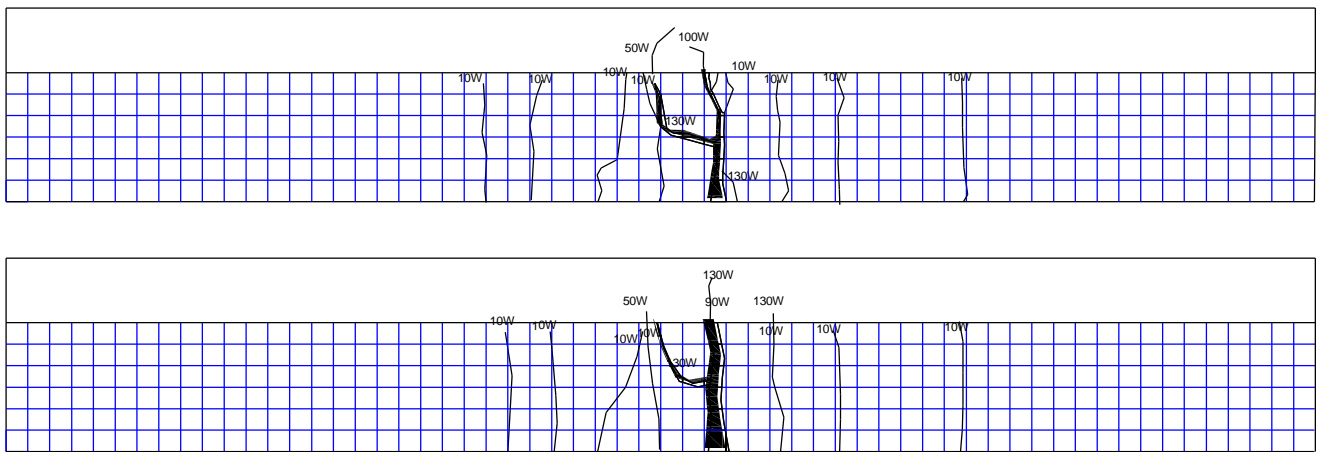
**Figure 17.** Crack distribution of P-2 test beam at fatigue failure (both sides of rib).

The upper limit of the fatigue load of the P-2 test beam is 80 kN, and there is no obvious change at the initial stage of loading. With the progress of the fatigue test, cracks begin to develop, and most of the cracks extend vertically along the beam height, which are typical bending cracks. The crack distribution of the test beam is shown in Figure 17 at fatigue failure of the P-2 test beam.

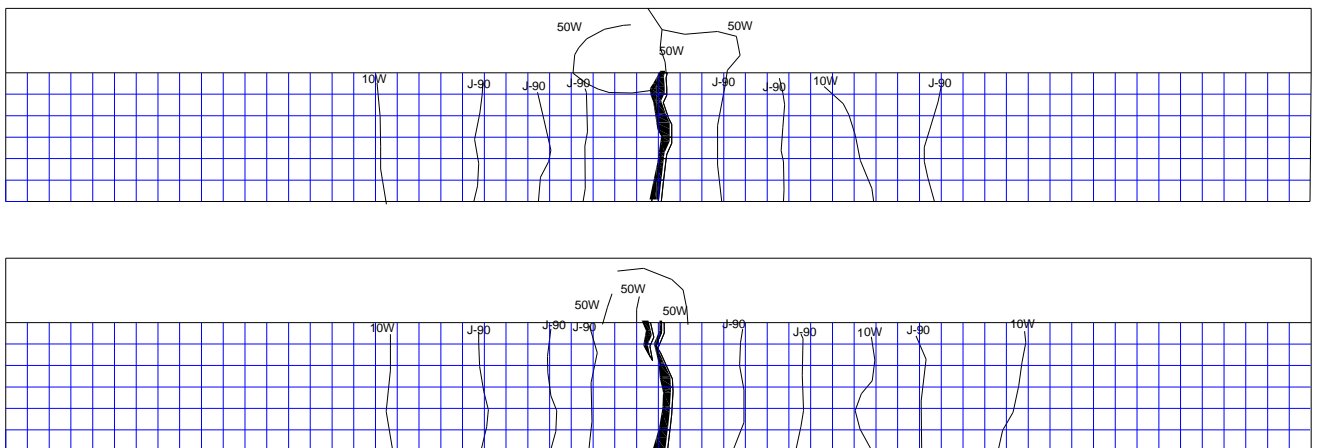
**Figure 18.** Crack distribution of P-3 test beam at fatigue failure (both sides of rib).

The upper limit of the fatigue load of the P-3 test beam is 90 kN, and there is no obvious change at the initial stage of loading. The fatigue failure occurs at 530,000 times cycle loading. The crack distribution is shown in Figure 18.

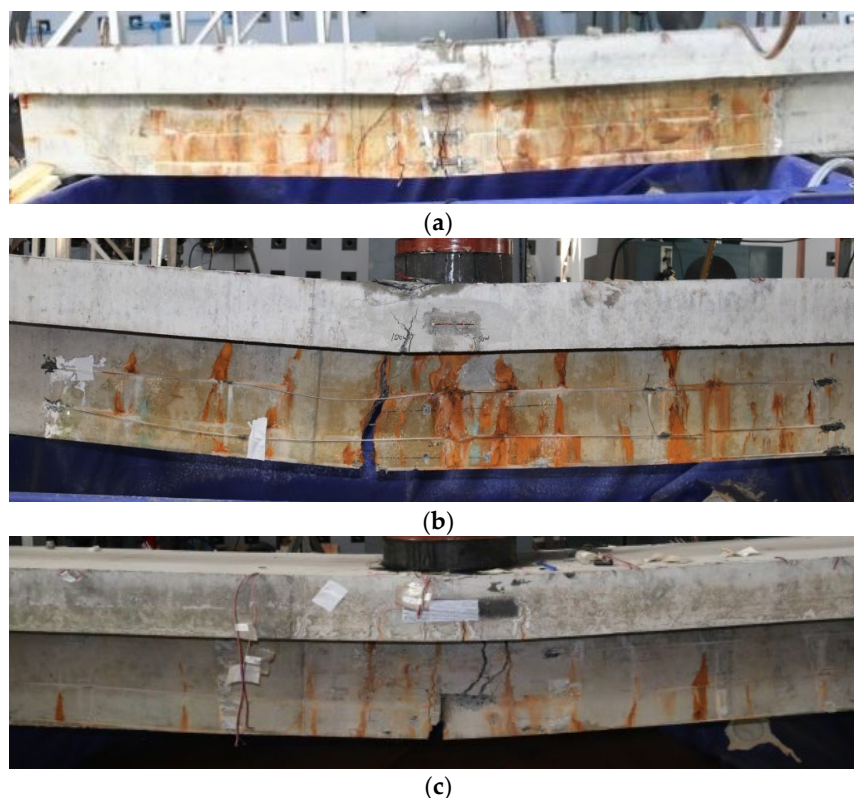
**Figure 19.** Failure mode of corrosion–fatigue coupling test beams. (a) XP-1 test beam. (b) XP-2 test beam. (c) XP-3 test beam.

For the corrosion–fatigue coupling tests and simple fatigue tests, the failure mode of the test beams is summarized in Table 4. The failure status of each beam is shown in Figures 19 and 20.

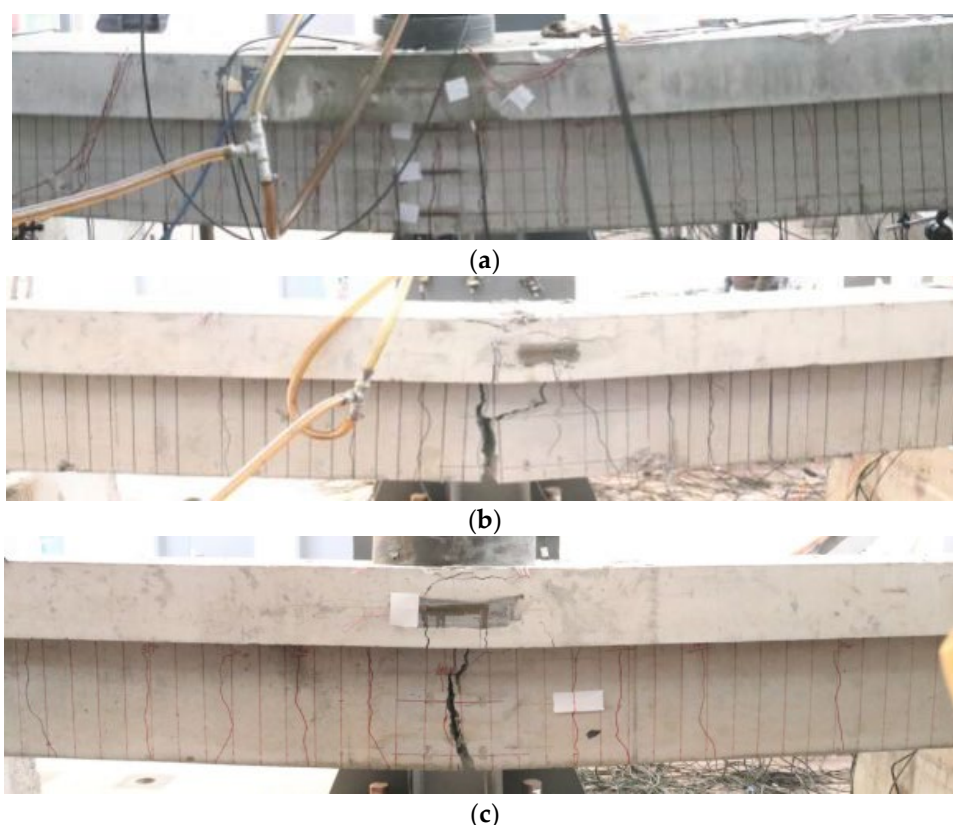
**Figure 20.** Failure mode of simple fatigue test beams. (a) P-1 test beam. (b) P-2 test beam. (c) P-3 test beam.

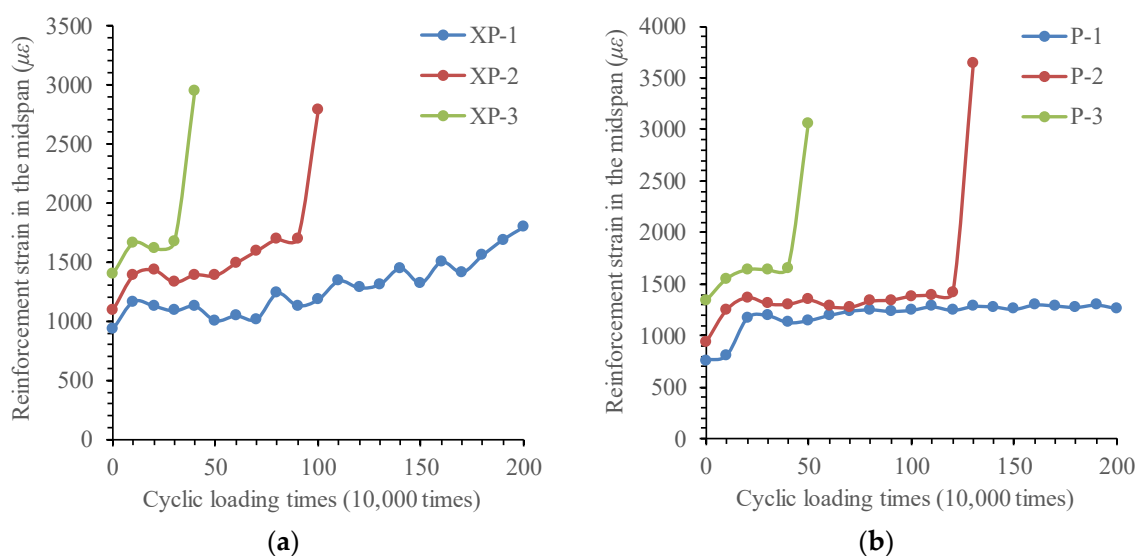
**Figure 21.** Changing curve of reinforcement strain in the midspan with cycle times. (a) Corrosion–fatigue coupling test beams. (b) Simple fatigue test beams.

In the process of cyclic loading for test beams, taking the average value of the reinforcement strain in the same section as the representative value, the changing law of the tensile strain of the bottom longitudinal reinforcement in the midspan of the test beam with the number of cyclic loadings is shown in Figure 21. It can be inferred from the figure that when the corrosion–fatigue coupling effect reaches a certain degree, it accelerates the expansion of fatigue crack, then lead to the transformation of reinforcement strain from steady state to linear growth. Judging from the time of reinforcement strain transformation of XP-1 and XP-2 test beams, corrosion–fatigue interaction plays a mutual role in promoting the expansion of fatigue crack of rebars. With the increase in fatigue stress amplitude, this promotion role becomes more obvious. Until the fatigue fracture of the reinforcement occurs, the maximum strain in the reinforcement does not reach the yield strain.

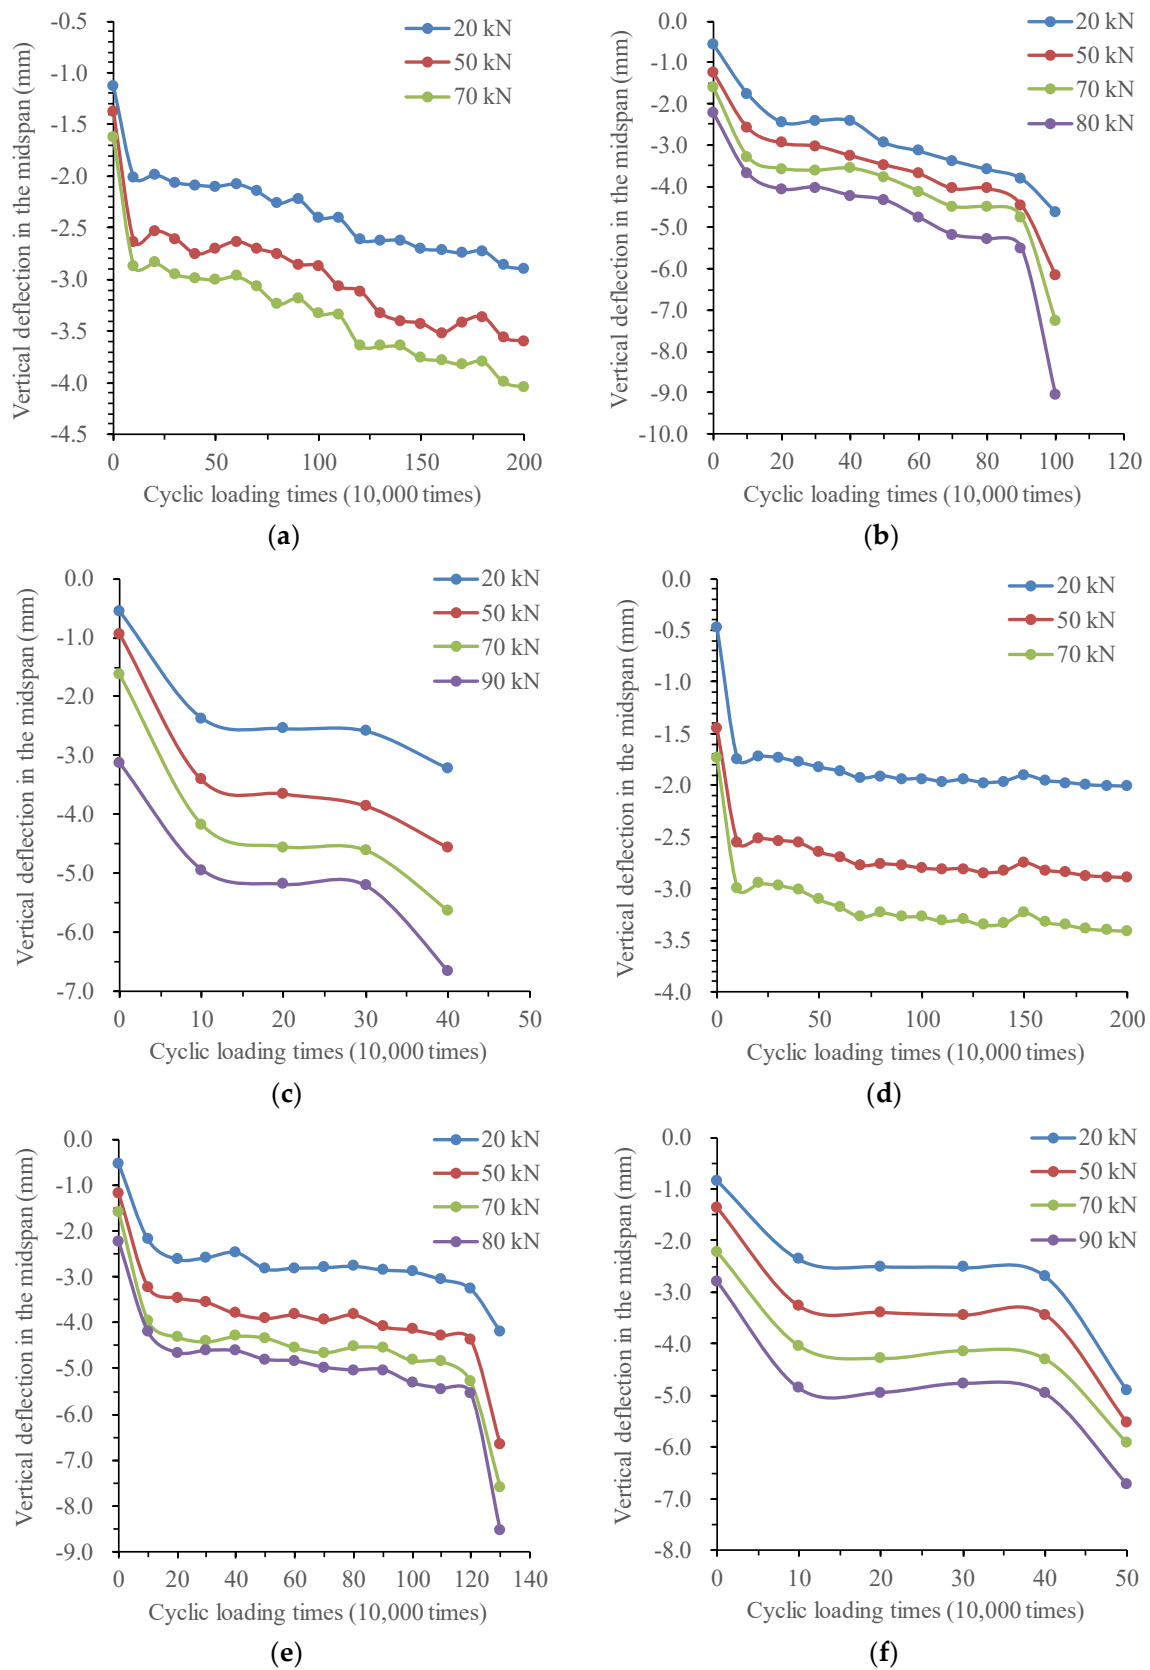
**Figure 22.** Midspan deflection of test beams with cycle times. (a) XP-1 test beam. (b) XP-2 test beam. (c) XP-3 test beam. (d) P-1 test beam. (e) P-2 test beam. (f) P-3 test beam.

When the fatigue loading times reach the multiple of 100,000 times, the static load test is carried out on the beam to discuss the effect of corrosion–fatigue interaction on the stiffness of reinforced concrete beams. The variation curve of mid-span deflection of corrosion–fatigue coupled beams XP-1, XP-2, and XP-3 with fatigue cycle times under different levels of the static load is shown in Figure 22, as well as that of different simple fatigue test beams.

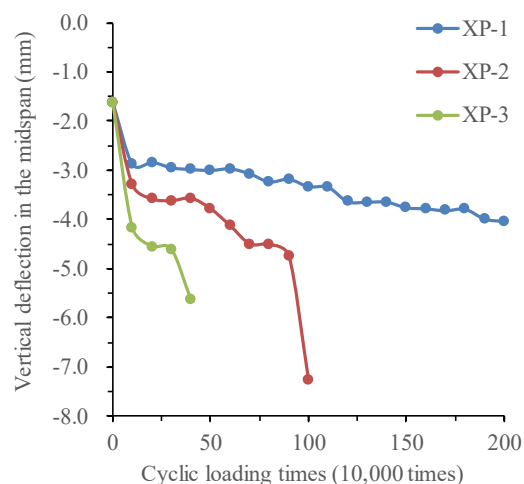
**Figure 23.** Midspan deflection of corrosion–fatigue coupling test beams under 70 kN static load.

In order to compare the stiffness degradation of the corrosion–fatigue coupling beam under different stress amplitudes, the deflection curve of each test beam with the number of cycles under 70 kN static load is plotted in Figure 23. It can be seen from this figure that when the fatigue cycle times reach 300,000, the deflection of XP-3 and XP-2 test beams is increased by 22.8% and 44.8%, respectively, compared with the XP-1 test beam. Under the condition of accelerated corrosion at the same current density and the same fatigue cycle

times, the stiffness degradation amplitude of each test beam increases with the increase in stress amplitude.
