Article

Experimental Investigation of the Effect of Steel Fibers on the Flexural Behavior of Corroded Prestressed Reinforced Concrete Beams

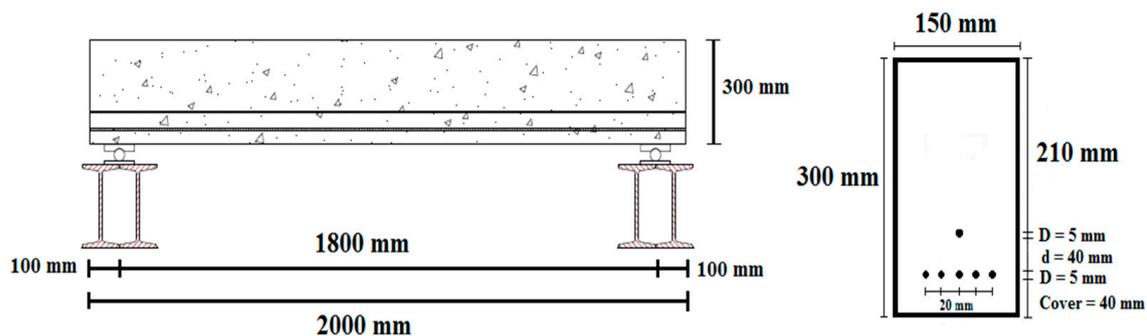
Figure 1. Beam dimensions and cross-section details.

The experimental program consisted of testing 12 pretensioned PRC beams. Each concrete beam was designed and fabricated, with a total length of 2000 mm, a net span of 1800 mm, and a cross-section size of 150 mm × 300 mm. Wire-type prestressing tendons with a 5 mm diameter were utilized to introduce prestress to the specimens. Six prestressing wires were used in the cross-section according to the arrangement shown in Figure 1. Prestressing force was estimated to be approximately 23.7 kN per tendon. However, the loss of tension in prestressed tendons and the loss of jack force were not taken into account. The typical total loss is estimated to be around 20%, resulting in an effective prestressing force of approximately 19 kN. Per Table 20.5.1.3.3 of the ACI 318 [37] standard, the concrete cover over the wire was considered 40 mm. Beam dimensions and cross-section details are shown in Figure 1. Corrugated and hooked-end steel fibers were used in different fractions of 0.5% and 1.0% by volume of concrete. Beams were divided into four groups: A, B, C, and D. Group A served as the reference with beams free of corrosion. Group B contained beams with 5% corrosion, Group C had 10% corrosion, and Group D comprised 15% corrosion. Each group contained one prestressed concrete beam without fibers and two steel fiber-reinforced prestressed concrete (SFRPC) beams with two different fiber volume fractions.

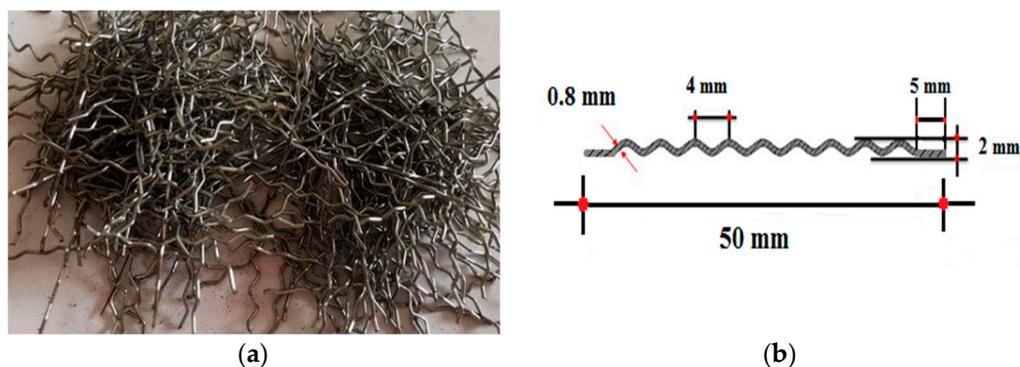
Figure 2. The appearance of corrugated and hooked-end steel fibers: (a) Clump of the steel fibers and (b) Steel fiber size.

Corrugated and hooked-end steel fibers were utilized in concrete at different fractions by volume of concrete. Figure 2 and Table 2 present the geometric shape and mechanical properties of the steel fibers, respectively.

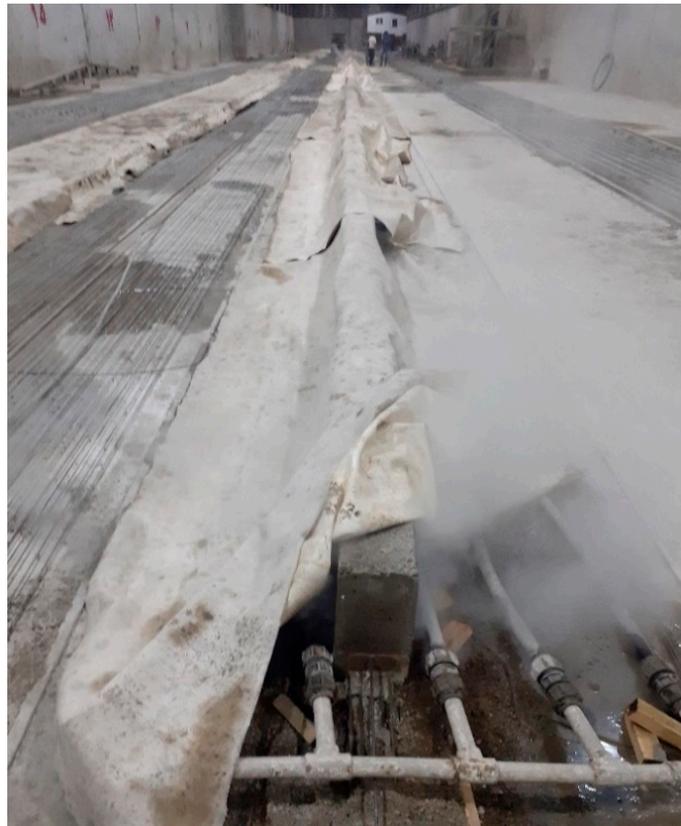
Figure 3. Curing of specimens via the steam method.

The concrete was mixed using a batching plant, which ensured accurate measurements of the weight of cement, sand, and gravel, as well as water, through the use of high-precision digital measuring equipment. The test specimens were molded using metal molds. Before pouring the concrete, the reinforcing wires were restrained at both ends using mechanical anchorage. Each prestressing wire was pretensioned up to 70% of its nominal ultimate tensile strength (F_{pu}), equivalent to about 23.7 kN per wire. After the concrete was poured and allowed to set for 48 h, the side metal molds were removed. Then, the beams were cured using the steam curing method. In this manner, following the production of the beams, a set known as a steam blanket was applied to the beams per the images, see Figure 3. This system was outfitted with a grid of porous steam pipes. The temperature of the produced steam gradually reached 70 °C and the beams remained at this temperature for a certain period while under the steam blanket. The temperature then decreased and gradually approached a cool state. The cured products were identical and uniform along the length of the beam, and they were ready for loading and operation after 24 h.

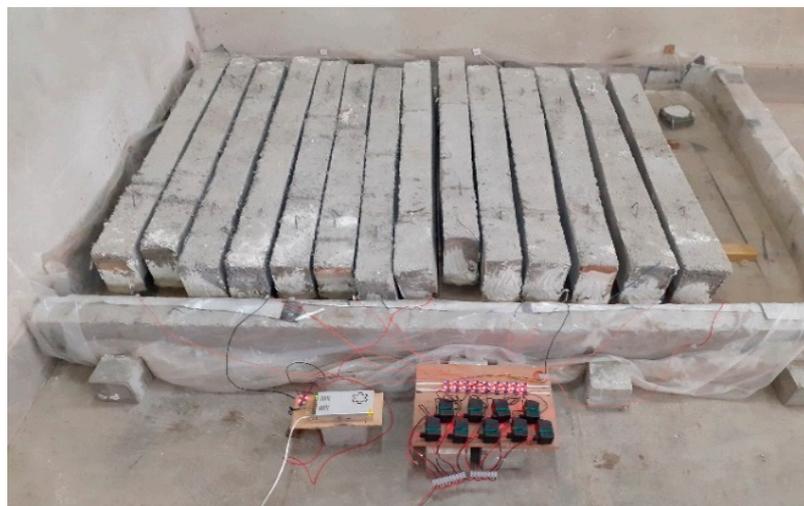
Figure 4. Accelerated corrosion of the prestressed concrete beams.

The corrosion of the specimens was accelerated through the application of an electric current. Electrochemical action and the application of a constant current intensity between the anode (prestressing wires) and the stainless tube (copper tube) as the cathode outside the specimen accelerated corrosion. The corrosion process was initiated by placing the specimens and the cathode in a pool containing a 5% sodium chloride solution, as present in Figure 4, and establishing a constant electric current between the anode and the cathode using a power supply with a constant electric current. The solution level was enough to submerge the prestressing wires. The applied current density was maintained at 150 $\mu\text{A}/\text{cm}^2$, and the power supply voltage was kept below 12 volts. As a comparison, the current

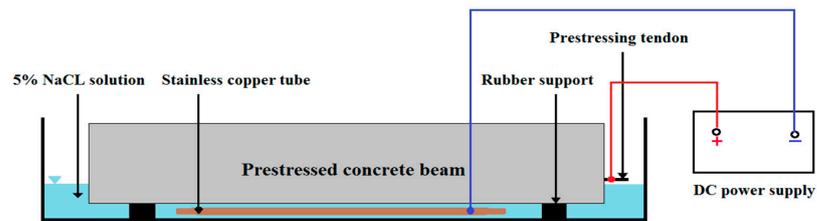
Figure 5. Schematic view of the corrosion test setup.

density in most recent studies is commonly chosen in the range of 100 to 500 $\mu\text{A}/\text{cm}^2$ [42]. Figure 5 illustrates a schematic representation of the laboratory's electrical circuit used to accelerate corrosion. The accelerated corrosion method is based on the method presented in Zhang et al. [33] research. Different durations of the impressed current were utilized per Faraday's law to achieve varying degrees of corrosion of the wires in the beams. The duration of applying electric current to the specimens in order to cause accelerated corrosion at different levels and the actual corrosion rate are presented in Table 5.

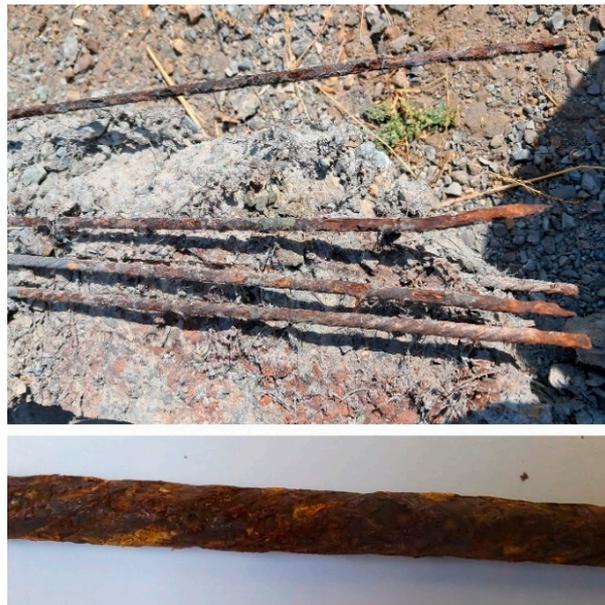
Figure 6. Corroded prestressing wires.

Figure 6 shows an example of corroded prestressing wires after destroying the concrete and removing them, as shown in Figure 7.

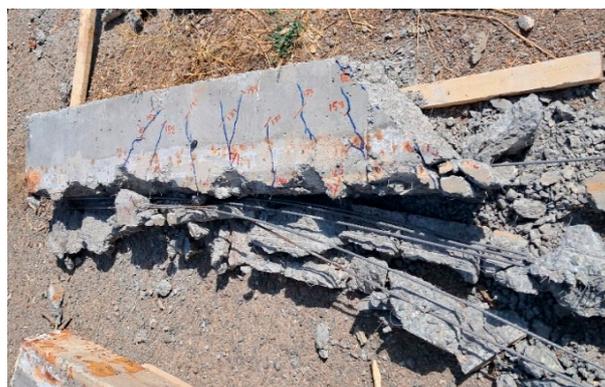
Figure 7. Destruction of specimens and removal of prestressing wires.

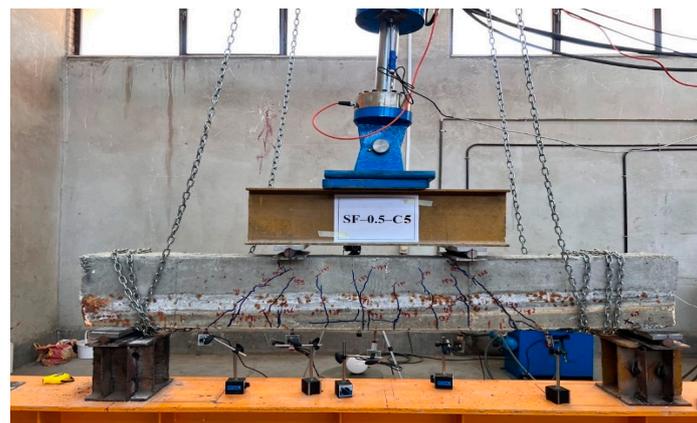
Figure 8. Four-point bending test setup.

All the beams were tested in a four-point bending configuration. Loading was applied monotonically in displacement control mode at a rate of 0.01 mm/s. Load from the actuator was transferred to the specimen through the spreader beam and then to the double I-beams. A photograph of the four-point bending test setup is shown in Figure 8. Loading continued until the specimens completely failed. The ultimate failure of the specimens resulted from the degradation of the bond between the concrete and reinforcement caused by corrosion, which gave rise to the formation of cracking patterns. Specifically, bending-shear and bending cracks were observed to develop beneath the beam and propagate toward the beam's top edge. These cracks ultimately led to the complete failure of the specimens. Linear variable displacement transducers (LVDT) were used to measure the vertical displacement at various beam points; a load cell measured the amount of load, and a hydraulic jack and pump were used to apply the load. The capacity of the jack used in this experiment was 500 kN. The LVDTs were positioned at specific locations (at distances of one-sixth of the net span) along the length of the beam to capture the entire curvature profile during testing. The cracks that formed and their growth paths in the beams were documented by marking them on the surface of the specimens. In addition, the force responsible for each crack was also recorded. The beam schematic and loading configuration are presented in Figure 9.

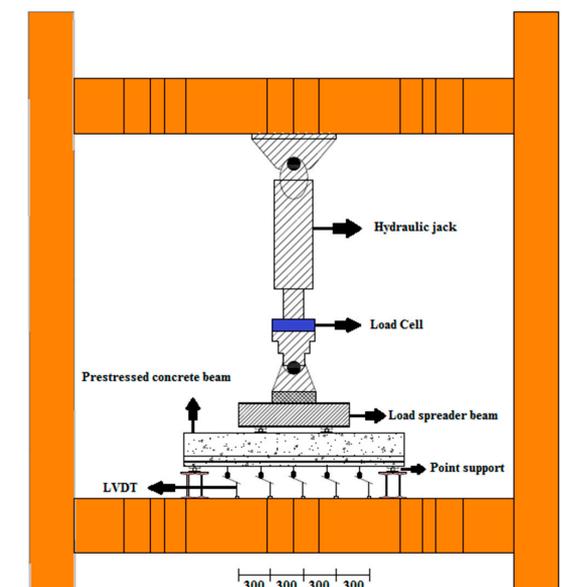
Figure 9. Schematic of the four-point flexural test setup.

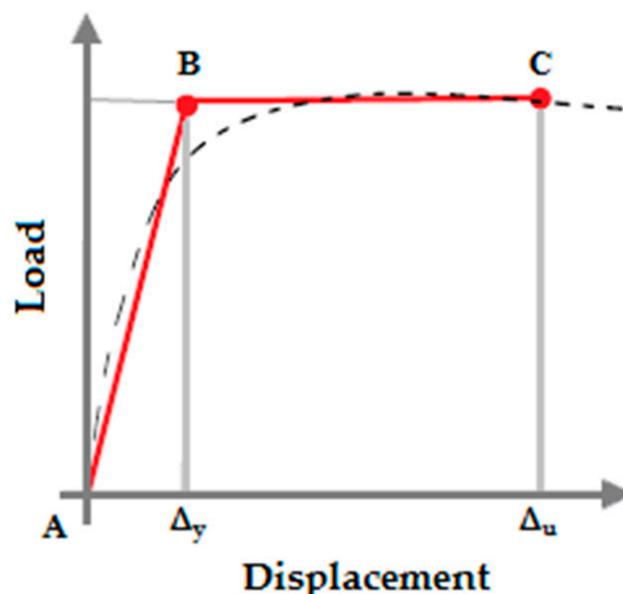
Figure 10. Idealization of the load–displacement curve with an equivalent bilinear diagram.

The experimental load–midspan displacement diagrams, which were used to demonstrate the structural behavior of beams based on the method proposed by Paulay and Priestley [43], were idealized and converted into an equivalent bilinear diagram. The seismic characteristics of the beams, including effective hardness and ductility, can be calculated using this equalized diagram. The equivalent bilinear diagram was generated by equalizing the enclosed area between the load–displacement curve and the diagram. This was completed by ensuring that the area under both curves was the same. In addition, the structure’s stiffness after yielding (secondary slope of the bilinear curve) is zero. Therefore, effective hardness equals the hardness of the specimen’s yield point in the load–midspan displacement diagram. In other words, the effective hardness, which according to the definition is the amount of an object’s resistance to deformation, is equal to the slope of the load–midspan displacement diagram line that connects the origin to the point at which 75% of the maximum load is applied on the load–midspan displacement diagram [43].

The ductility μ , which is defined as the ability to withstand hyperelastic deformations in a part or the entire length of a structural element without appreciable resistance loss, is derived from the equivalent bilinear diagram by calculating the ratio of the final displacement Δ_u to the yield displacement Δ_y (Equation (1)). The final and yield displacements were calculated using the equivalent bilinear diagram. The yield displacement corresponds to the endpoint of the first linear segment and the beginning of the second linear segment, as depicted in Figure 10. The endpoint of the second linear segment in the equivalent bilinear diagram represents the final displacement.

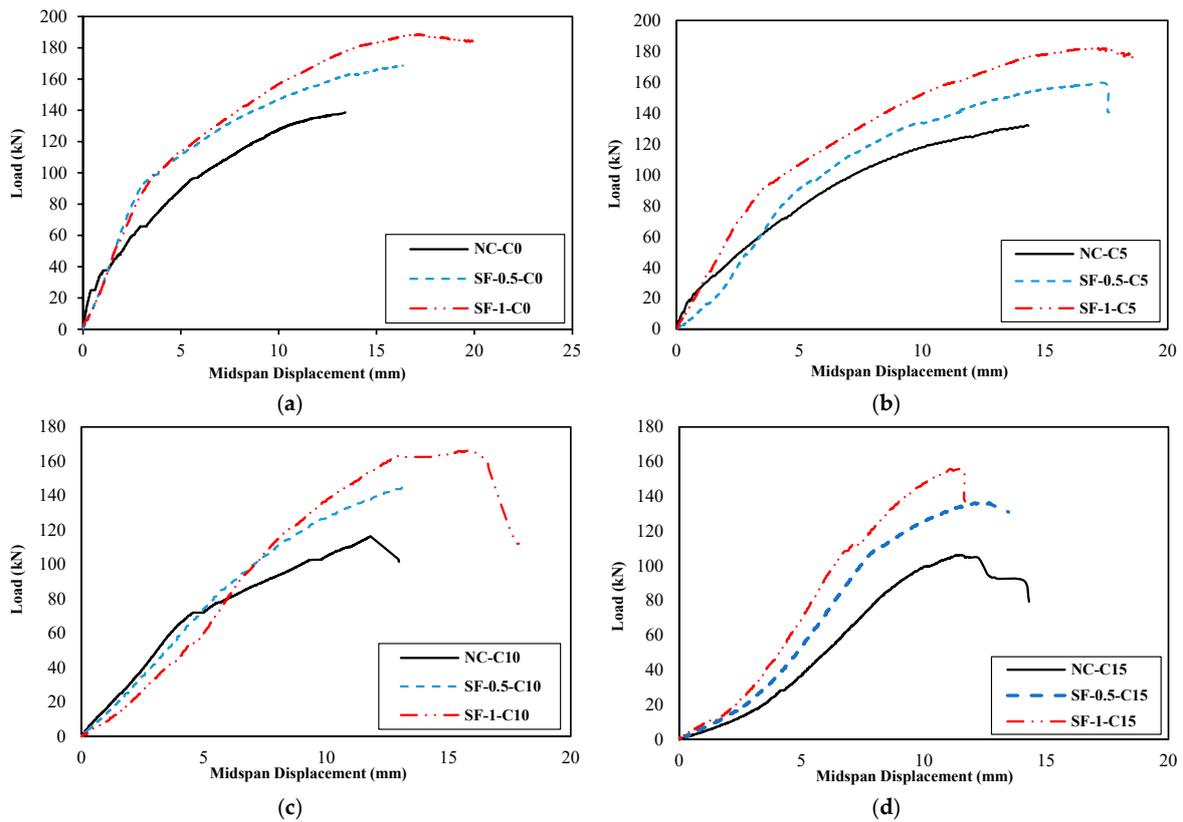
Figure 11. Load–midspan displacement diagrams: (a) Group A specimens, (b) Group B specimens, (c) Group C specimens, and (d) Group D specimens.

Figure 11 presents the load–midspan displacement diagrams of groups A, B, C, and D, and Figure 12 illustrates their equivalent bilinear diagrams for comparison purposes.

As shown in the diagrams of Figures 11 and 12 and the results presented in Table 6, it can be concluded that the steel fiber positively affected the bearing capacity, energy absorption, and final displacement of the beams.

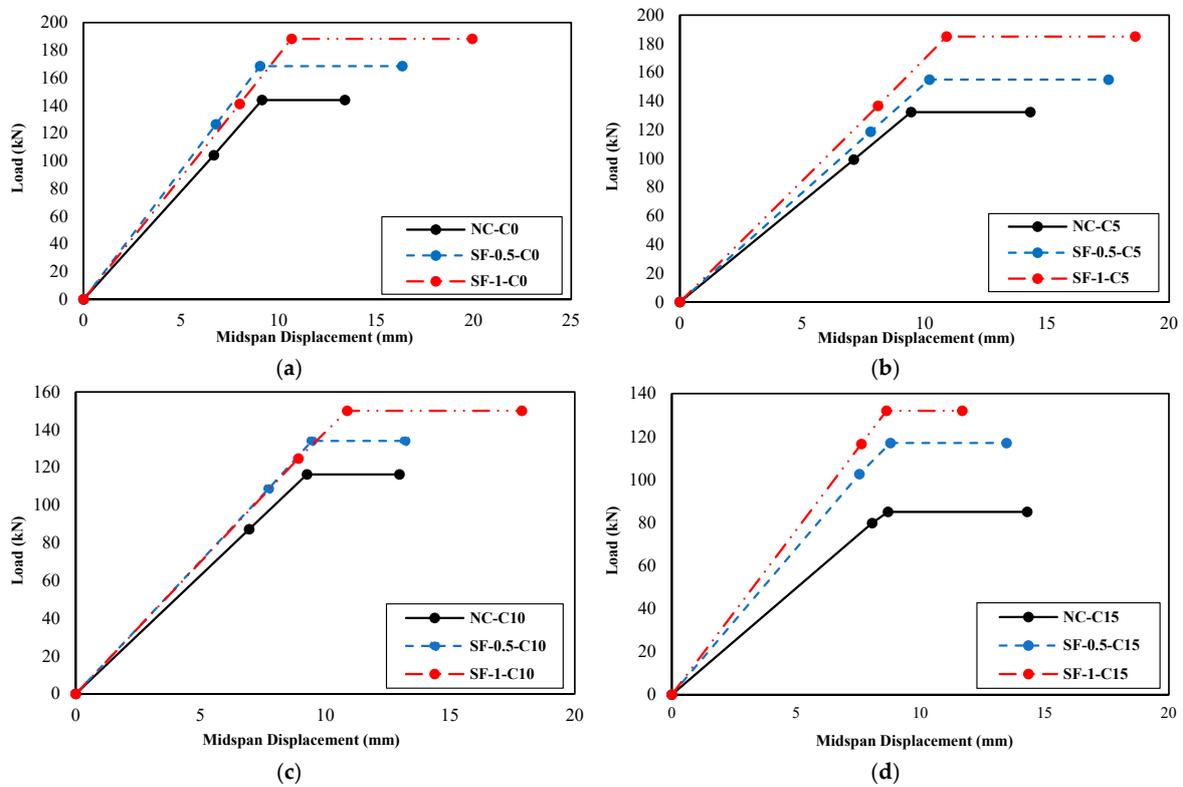
Figure 12. Equivalent bilinear diagrams: (a) Group A specimens, (b) Group B specimens, (c) Group C specimens, and (d) Group D specimens.

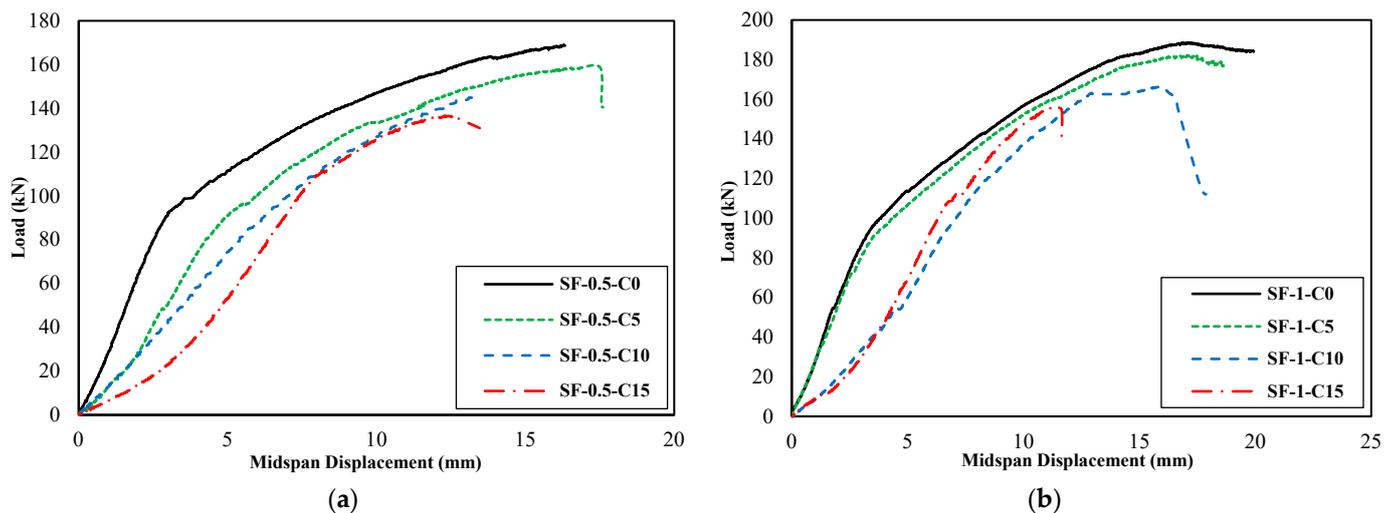
Figure 13. Load–midspan displacement diagrams: (a) specimens with a 0.5% volume fraction, (b) specimens with a 1.0% volume fraction.

Figure 13 displays the comparative diagram of specimens with the same volume fraction of steel fibers subjected to different levels of corrosion.

As seen in the diagram in Figure 13, with the increase in corrosion levels, the structural performance parameters, including bearing capacity, energy absorption rate, and final displacement, decrease both in specimens with a 0.5% volume fraction and those with a 1.0% volume fraction.

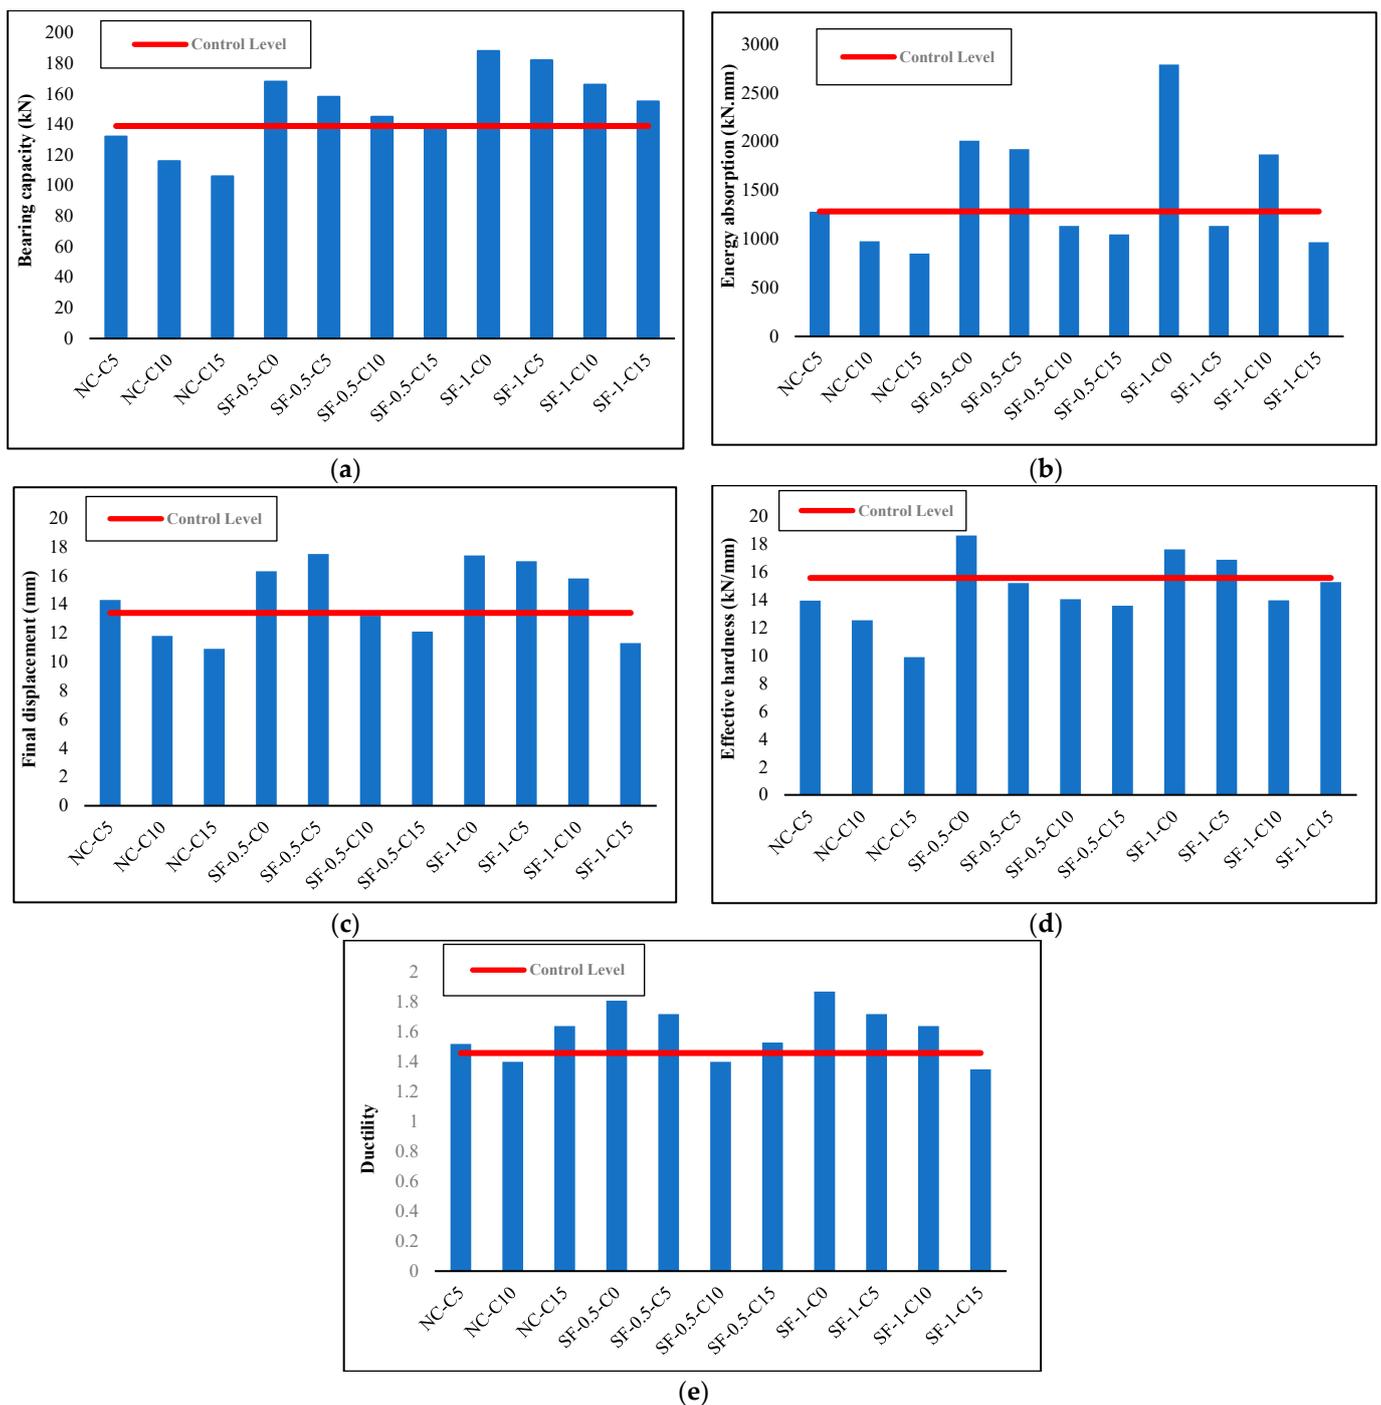
Figure 14. Comparative diagram of the change in (a) bearing capacity, (b) energy absorption, (c) final displacement, (d) effective hardness, and (e) ductility of the beams compared to the control specimen.

Comparative diagrams of the investigated parameters for the structural performance are presented in Figure 14.

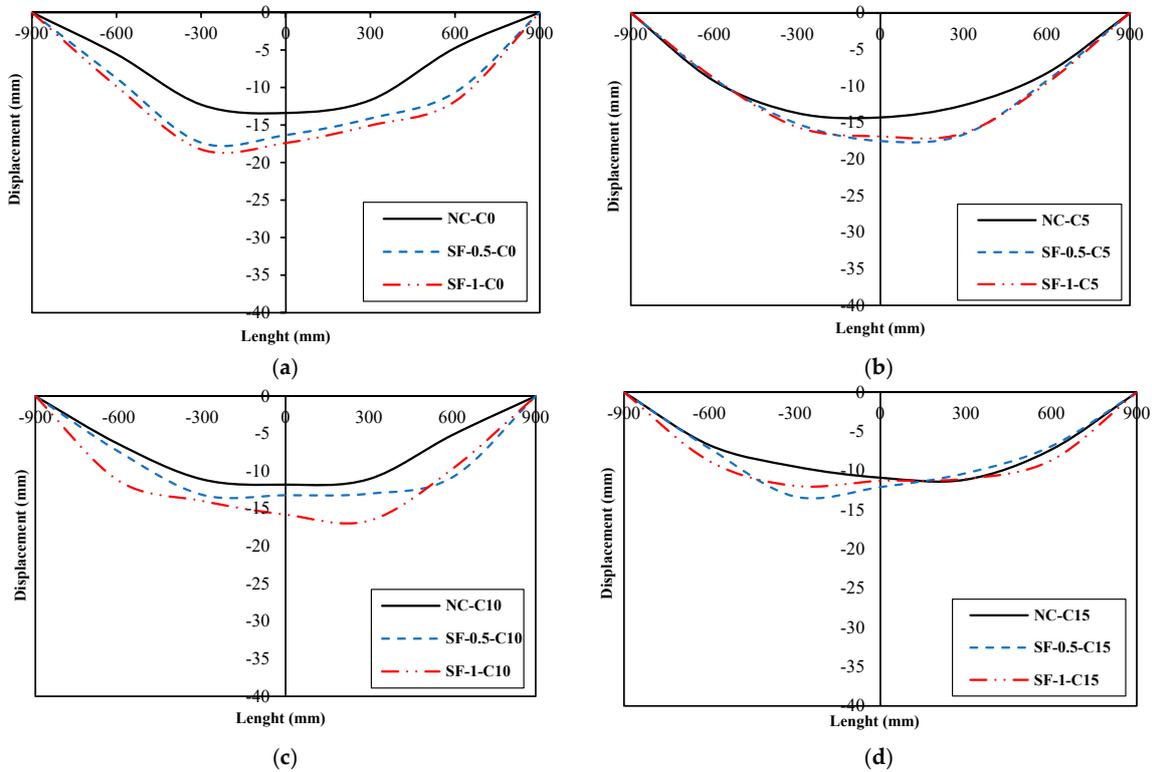
Figure 15. Displacement longitudinal profile diagrams: (a) Group A specimens (b) Group B specimens (c) Group C specimens (d) Group D specimens.

Figure 15 presents the displacement longitudinal profile diagrams of group A, B, C, and D specimens. The longitudinal displacement profile of the beams is drawn at a load equivalent to 90% of the bearing capacity.

Displacement longitudinal profile diagrams of all beams are asymmetric, and the value of displacement in the half of the failing beam is greater than in the other half.

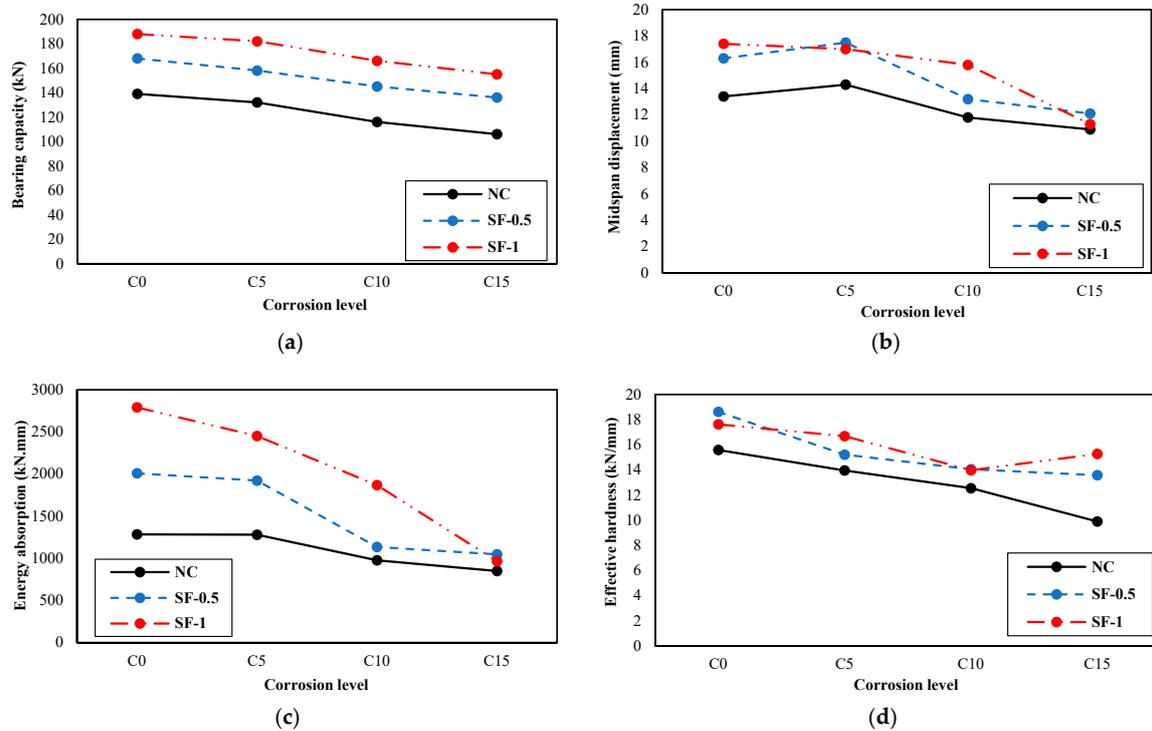
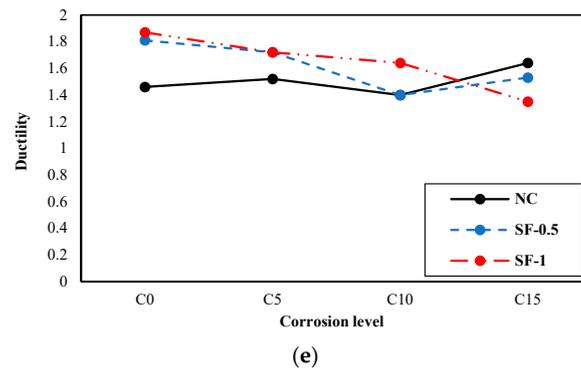
Figure 16. Changes in the studied characteristics with increasing corrosion levels: (a) bearing capacity, (b) midspan displacement, (c) energy absorption, (d) effective hardness, and (e) ductility.

Figure 16 depicts the trend diagrams of the changes in the studied characteristics in the flexural behavior of the beam under the influence of corrosion at different levels.

The diagrams show that the values of the investigated parameters for the bending behavior of the beam decreased with increasing corrosion levels for most of the specimens. The largest reductions in most beams occurred from 5% to 10% corrosion. However, the investigated structural behavior parameters increased in the specimens with steel fibers.

There is a direct correlation between the increase in these values and the volume fraction of fibers used.

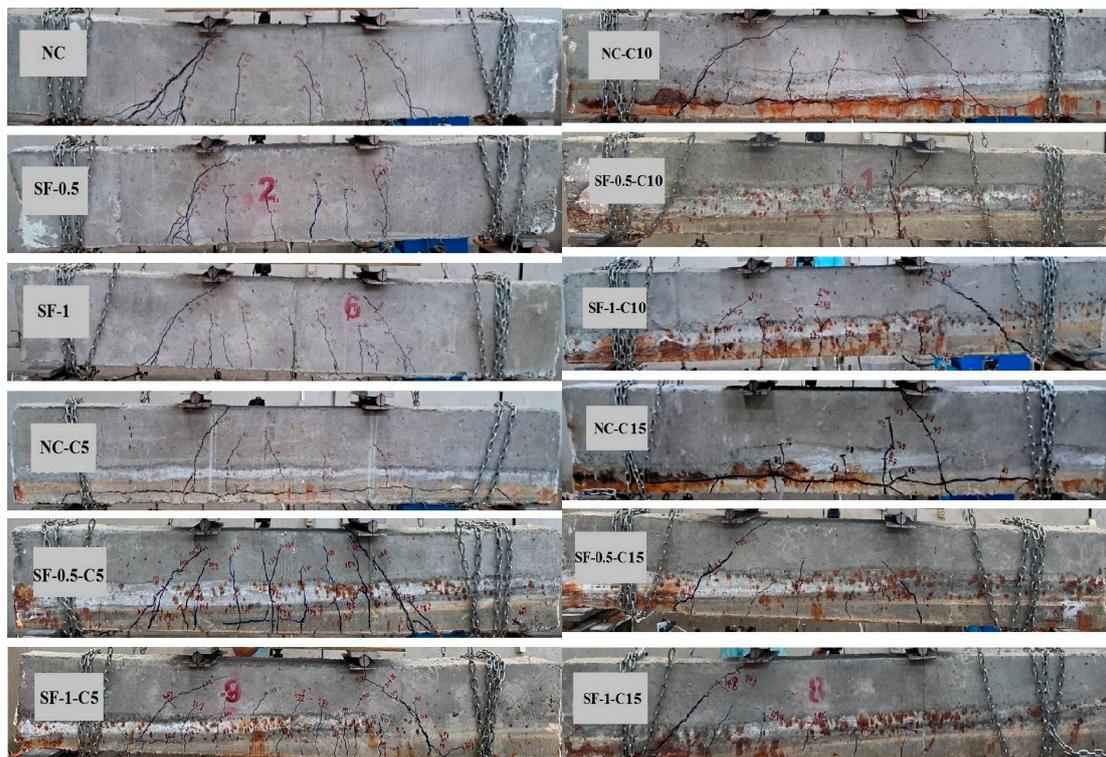
Figure 17. Failure mode and crack pattern of beams.

The failure mode and crack propagation of the beams are shown in Figure 17. The addition of steel fibers altered the failure mode of the two beams (SF-0.5-C0 and SF-1-C0) from shear failure to flexure-shear for the beams without corrosion. At the corrosion level of 5% for beams with steel fibers, it was observed that some shear cracks appeared in the region between the supports and loads, in addition to some short flexural cracks appearing in the bending region, as shown in Figure 17. It was observed that the corrosion level of 15% significantly impacted the failure mode of the beams (NC-C15, SF-0.5-C15, and SF-1-C15), causing them to fail in a brittle manner. This is because severe localized corrosion was found in the extracted prestressing wires after the failure test. It was observed that different levels of corrosion reduce bond strength and cause continuity crack at the region of the wires and sudden shear and splitting for beams without steel fibers (NC-C5, NC-C10, and NC-C15), as shown in Figure 17. The research results presented in [16,20] also indicate a decrease in bond strength due to corrosion. It can also be concluded that the presence of steel fibers decreases the width of cracks.
