Experimental Investigation of the Effect of Steel Fibers on the Flexural Behavior of Corroded Prestressed Reinforced Concrete Beams

Keywords: prestressed concrete beam; flexural behavior; fiber reinforced concrete; corrosion; bearing capacity

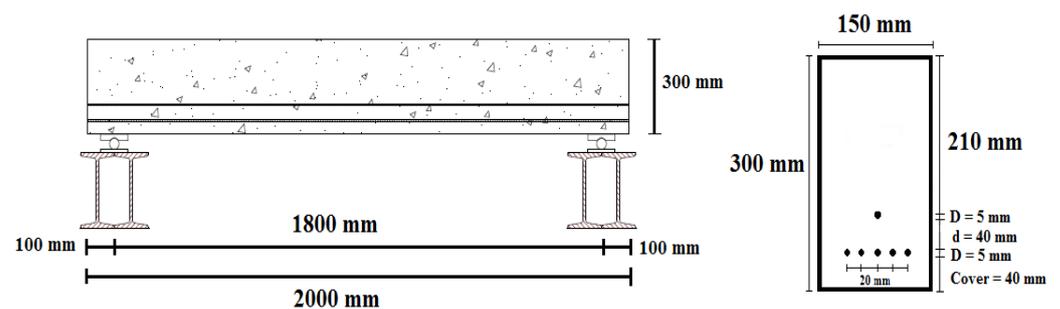
Figure 1. Beam dimensions and cross-section details.

The experimental program consisted of testing 12 pretensioned PRC beams. Each concrete beam was designed and fabricated, with a total length of 2000 mm, a net span of 1800 mm, and a cross-section size of 150 mm × 300 mm. Wire-type prestressing tendons with a 5 mm diameter were utilized to introduce prestress to the specimens. Six prestressing wires were used in the cross-section according to the arrangement shown in Figure 1. Prestressing force was estimated to be approximately 23.7 kN per tendon. However, the loss of tension in prestressed tendons and the loss of jack force were not taken into account. The typical total loss is estimated to be around 20%, resulting in an effective prestressing force of approximately 19 kN. Per Table 20.5.1.3.3 of the ACI 318 [37] standard, the concrete cover over the wire was considered 40 mm. Beam dimensions and cross-section details are shown in Figure 1. Corrugated and hooked-end steel fibers were used in different fractions of 0.5% and 1.0% by volume of concrete. Beams were divided into four groups: A, B, C, and D. Group A served as the reference with beams free of corrosion. Group B contained beams with 5% corrosion, Group C had 10% corrosion, and Group D comprised 15% corrosion. Each group contained one prestressed concrete beam without fibers and two steel fiber-reinforced prestressed concrete (SFRPC) beams with two different fiber volume fractions.

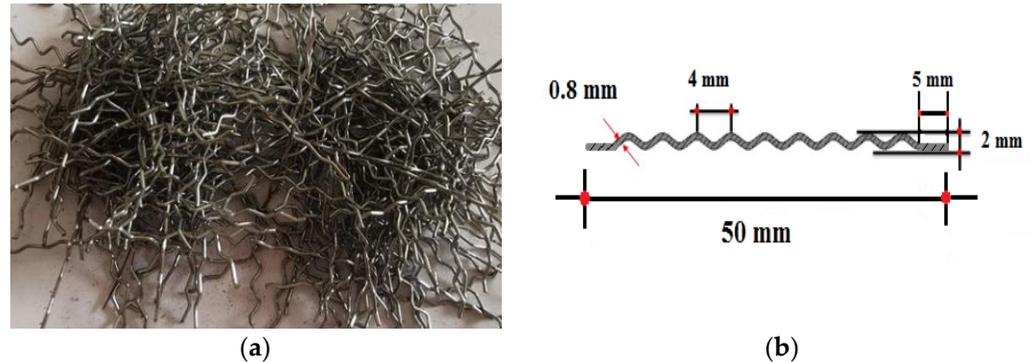
**Figure 2.** The appearance of corrugated and hooked-end steel fibers: (a) Clump of the steel fibers and (b) Steel fiber size.

Corrugated and hooked-end steel fibers were utilized in concrete at different fractions by volume of concrete. Figure 2 and Table 2 present the geometric shape and mechanical properties of the steel fibers, respectively.

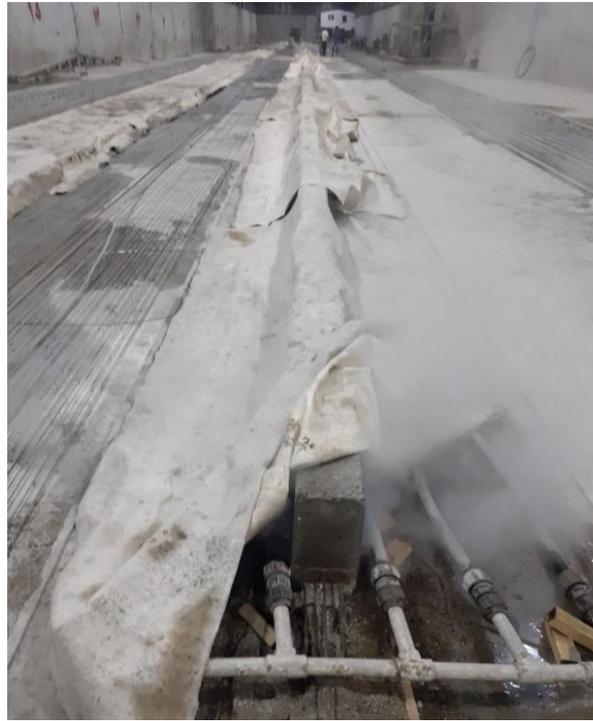
Figure 3. Curing of specimens via the steam method.

The concrete was mixed using a batching plant, which ensured accurate measurements of the weight of cement, sand, and gravel, as well as water, through the use of high-precision digital measuring equipment. The test specimens were molded using metal molds. Before pouring the concrete, the reinforcing wires were restrained at both ends using mechanical anchorage. Each prestressing wire was pretensioned up to 70% of its nominal ultimate tensile strength (F_{pu}), equivalent to about 23.7 kN per wire. After the concrete was poured and allowed to set for 48 h, the side metal molds were removed. Then, the beams were cured using the steam curing method. In this manner, following the production of the beams, a set known as a steam blanket was applied to the beams per the images, see Figure 3. This system was outfitted with a grid of porous steam pipes. The temperature of the produced steam gradually reached 70 °C and the beams remained at this temperature for a certain period while under the steam blanket. The temperature then decreased and gradually approached a cool state. The cured products were identical and

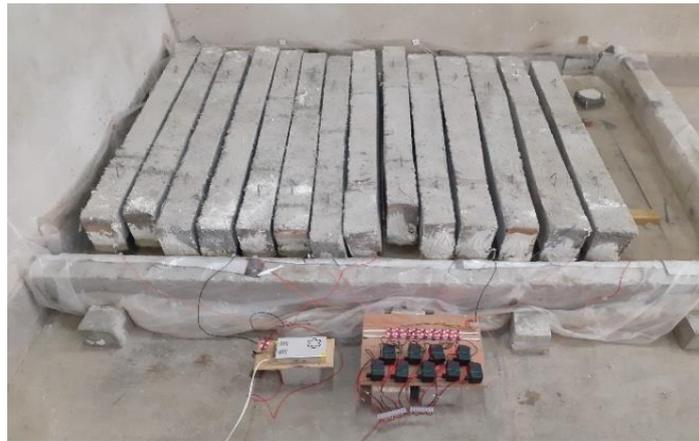
Figure 4. Accelerated corrosion of the prestressed concrete beams.

The corrosion of the specimens was accelerated through the application of an electric current. Electrochemical action and the application of a constant current intensity between the anode (prestressing wires) and the stainless tube (copper tube) as the cathode outside the specimen accelerated corrosion. The corrosion process was initiated by placing the specimens and the cathode in a pool containing a 5% sodium chloride solution, as present in Figure 4, and establishing a constant electric current between the anode and the cathode using a power supply with a constant electric current. The solution level was enough to submerge the prestressing wires. The applied current density was maintained at $150 \mu\text{A}/\text{cm}^2$, and the power supply voltage was kept below 12 volts. As a comparison, the current density in most recent studies is commonly chosen in the range of 100 to $500 \mu\text{A}/\text{cm}^2$ [42]. Figure 5 illustrates a schematic representation of the laboratory's electrical circuit used to accelerate corrosion. The accelerated corrosion method is based on the method presented in Zhang et al. [33] research. Different durations of the impressed current were utilized per Faraday's law to achieve varying degrees of corrosion of the wires in the beams. The duration of applying electric current to the specimens in order to cause accelerated corrosion at different levels and the actual corrosion rate are presented in Table 5.

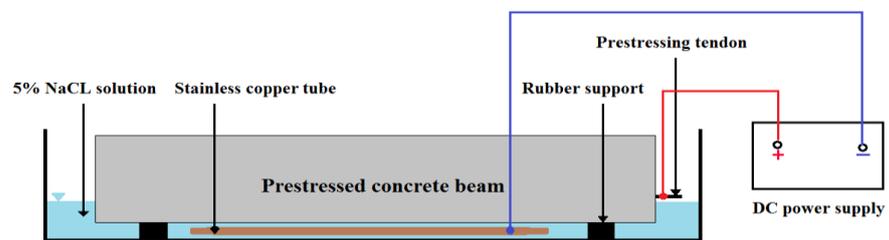
Figure 5. Schematic view of the corrosion test setup.

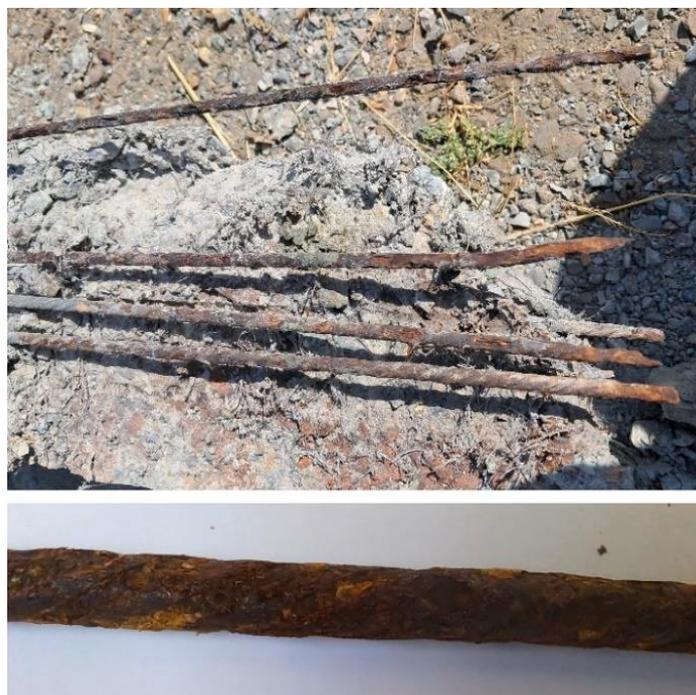
Figure 6. Corroded prestressing wires.

Figure 6 shows an example of corroded prestressing wires after destroying the concrete and removing them, as shown in Figure 7.

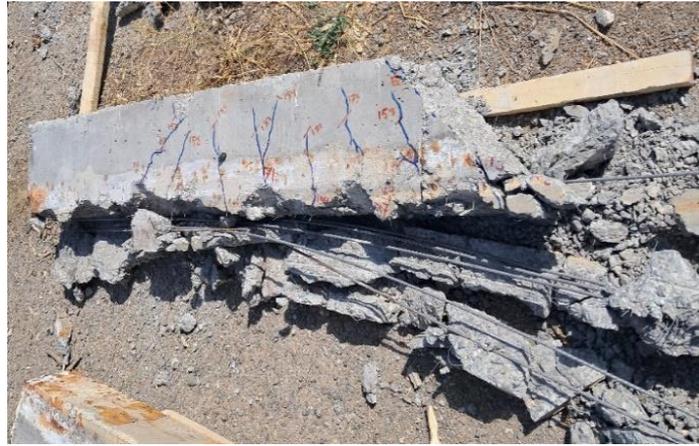
Figure 7. Destruction of specimens and removal of prestressing wires.

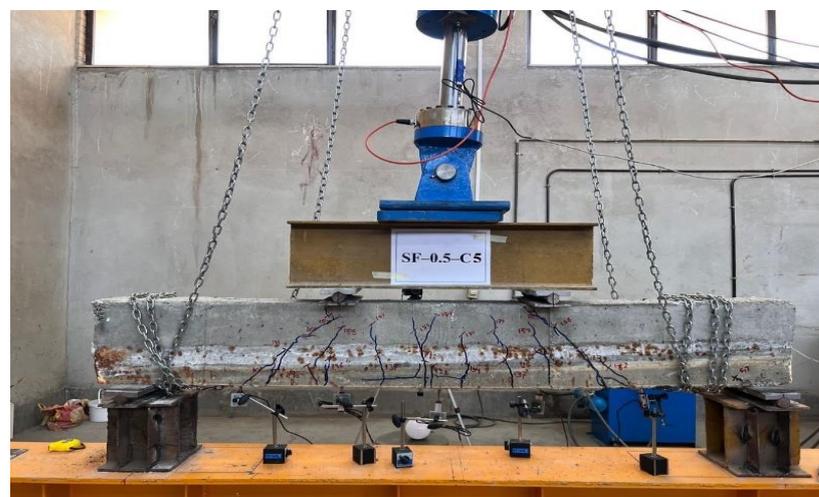
Figure 8. Four-point bending test setup.

All the beams were tested in a four-point bending configuration. Loading was applied monotonically in displacement control mode at a rate of 0.01 mm/sec. Load from the actuator was transferred to the specimen through the spreader beam and then to the double I-beams. A photograph of the four-point bending test setup is shown in Figure 8. Loading continued until the specimens completely failed. The ultimate failure of the specimens resulted from the degradation of the bond between the concrete and reinforcement caused by corrosion, which gave rise to the formation of cracking patterns. Specifically, bending-shear and bending cracks were observed to develop beneath the beam and propagate toward the beam's top edge. These cracks ultimately led to the complete failure of the specimens. Linear variable displacement transducers (LVDT) were used to measure the vertical displacement at various beam points; a load cell measured the amount of load, and a hydraulic jack and pump were used to apply the load. The capacity of the jack used in this experiment was 500 kN. The LVDTs were positioned at specific locations (at distances of one-sixth of the net span) along the length of the beam to capture the entire curvature profile during testing. The cracks that formed and their growth paths in the beams were documented by marking them on the surface of the specimens. In addition, the force responsible for each crack was also recorded. The beam schematic and loading configuration are presented in Figure 9.

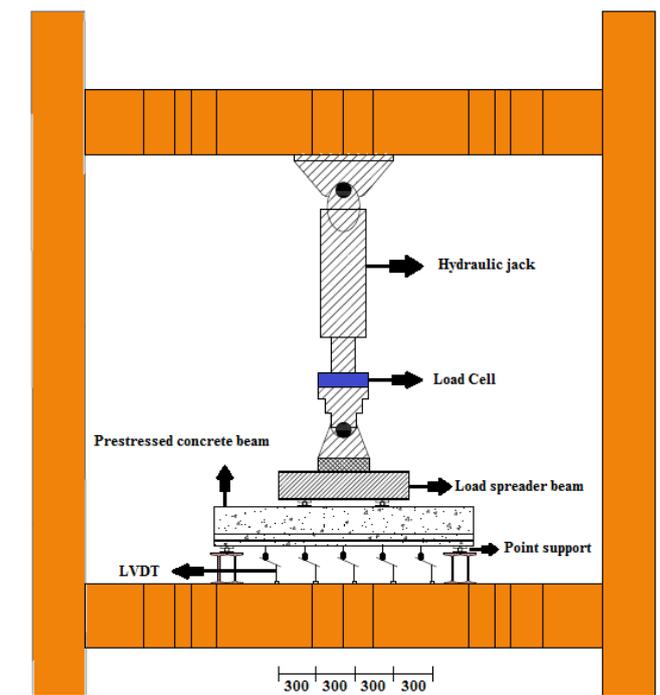
Figure 9. Schematic of the four-point flexural test setup.

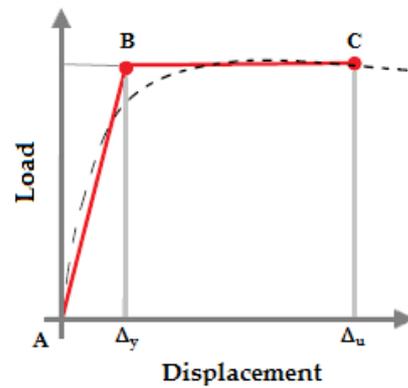
Figure 10. Idealization of the load–displacement curve with an equivalent bilinear diagram.

The ductility μ , which is defined as the ability to withstand hyperelastic deformations in a part or the entire length of a structural element without appreciable resistance loss, is derived from the equivalent bilinear diagram by calculating the ratio of the final displacement Δ_u to the yield displacement Δ_y (Equation (1)). The final and yield displacements were calculated using the equivalent bilinear diagram. The yield displacement corresponds to the endpoint of the first linear segment and the beginning of the second linear segment, as depicted in Figure 10. The endpoint of the second linear segment in the equivalent bilinear diagram represents the final displacement.

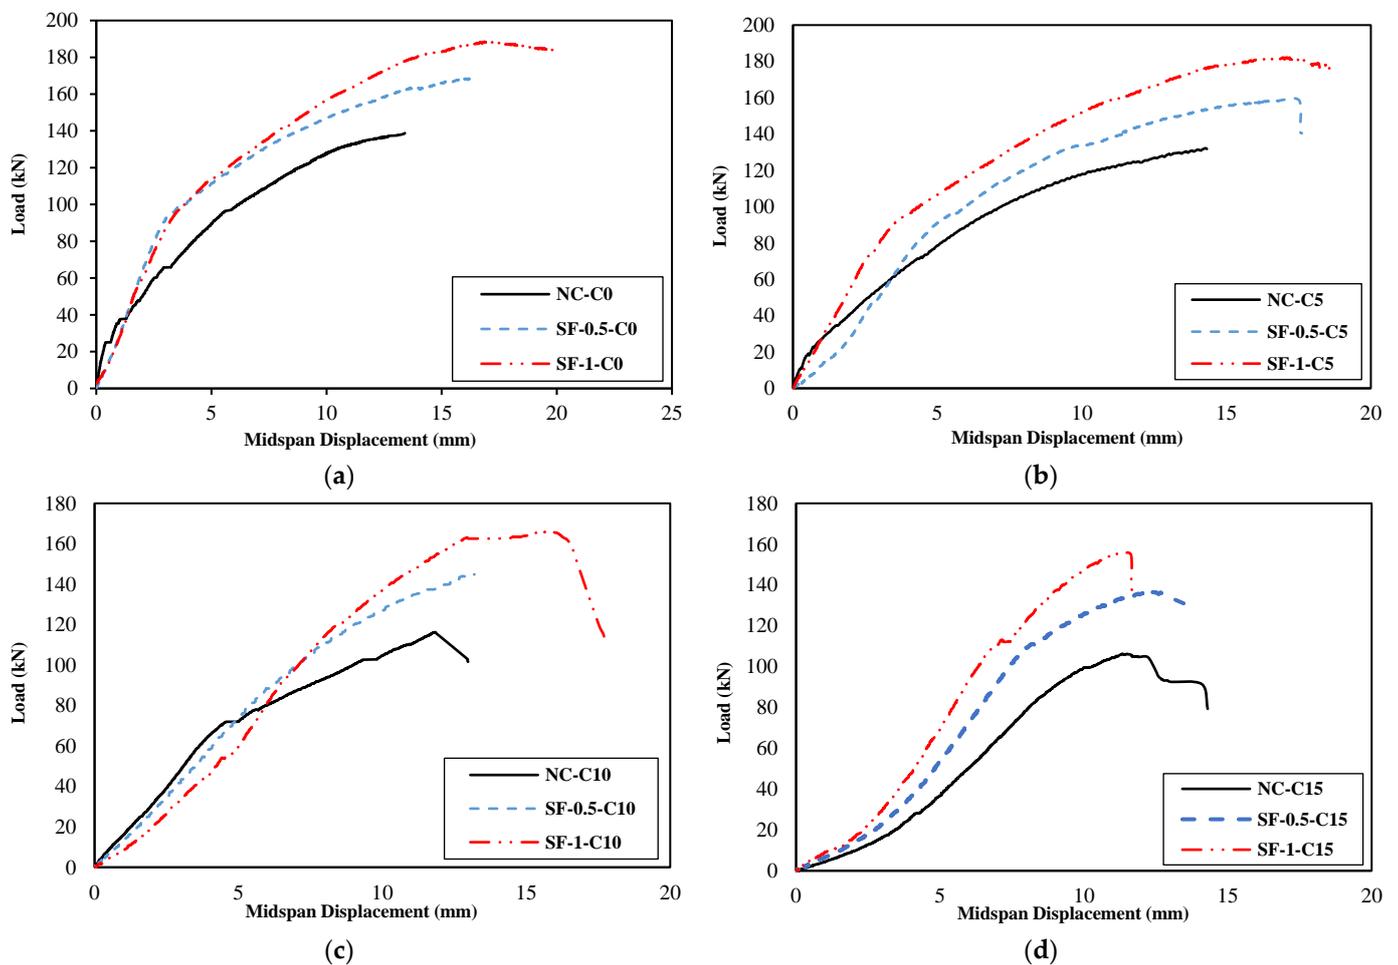
Figure 11. Load–midspan displacement diagrams: (a) Group A specimens, (b) Group B specimens, (c) Group C specimens, and (d) Group D specimens.

Figure 11 presents the load–midspan displacement diagrams of groups A, B, C, and D, and Figure 12 illustrates their equivalent bilinear diagrams for comparison purposes.

As shown in the diagrams of Figures 11 and 12 and the results presented in Table 6, it can be concluded that the steel fiber positively affected the bearing capacity, energy absorption, and final displacement of the beams.

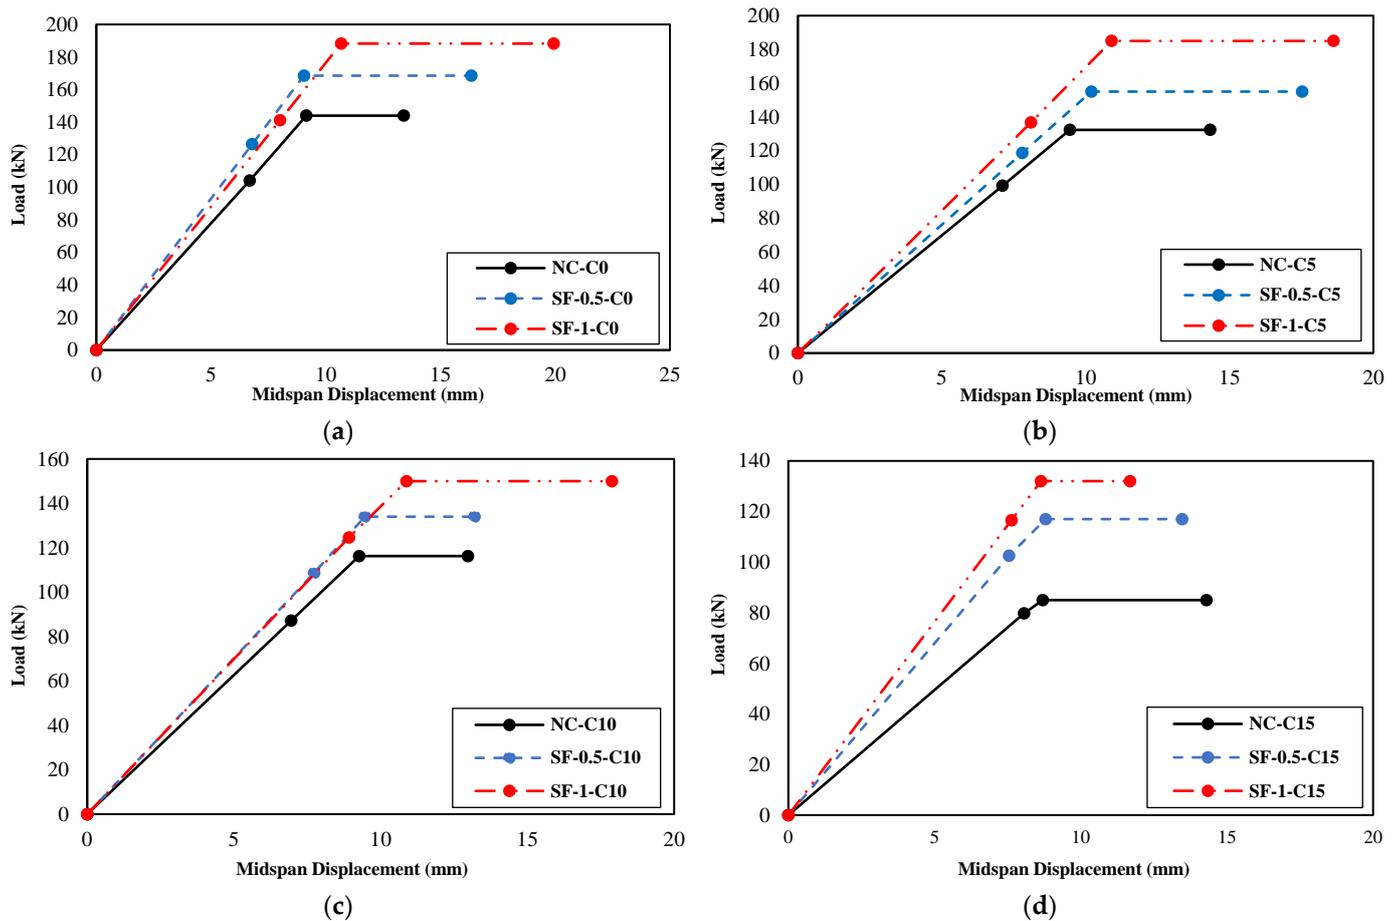
Figure 12. Equivalent bilinear diagrams: (a) Group A specimens, (b) Group B specimens, (c) Group C specimens, and (d) Group D specimens.

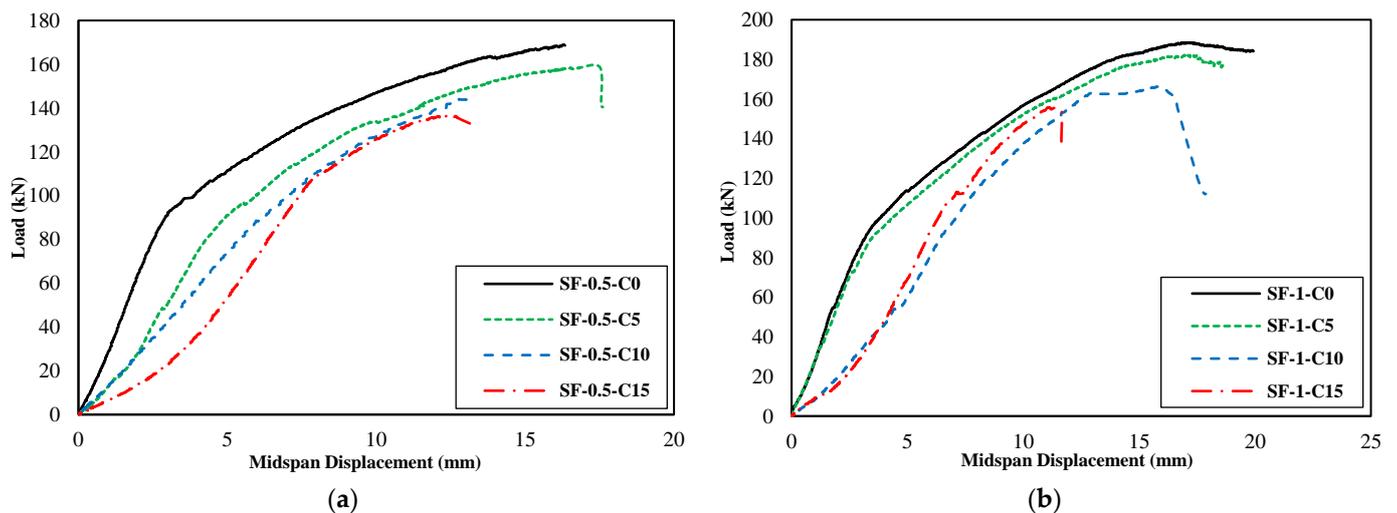
Figure 13. Load–midspan displacement diagrams: (a) specimens with a 0.5% volume fraction, (b) specimens with a 1.0% volume fraction.

Figure 13 displays the comparative diagram of specimens with the same volume fraction of steel fibers subjected to different levels of corrosion.

As seen in the diagram in Figure 13, with the increase in corrosion levels, the structural performance parameters, including bearing capacity, energy absorption rate, and final displacement, decrease both in specimens with a 0.5% volume fraction and those with a 1.0% volume fraction.

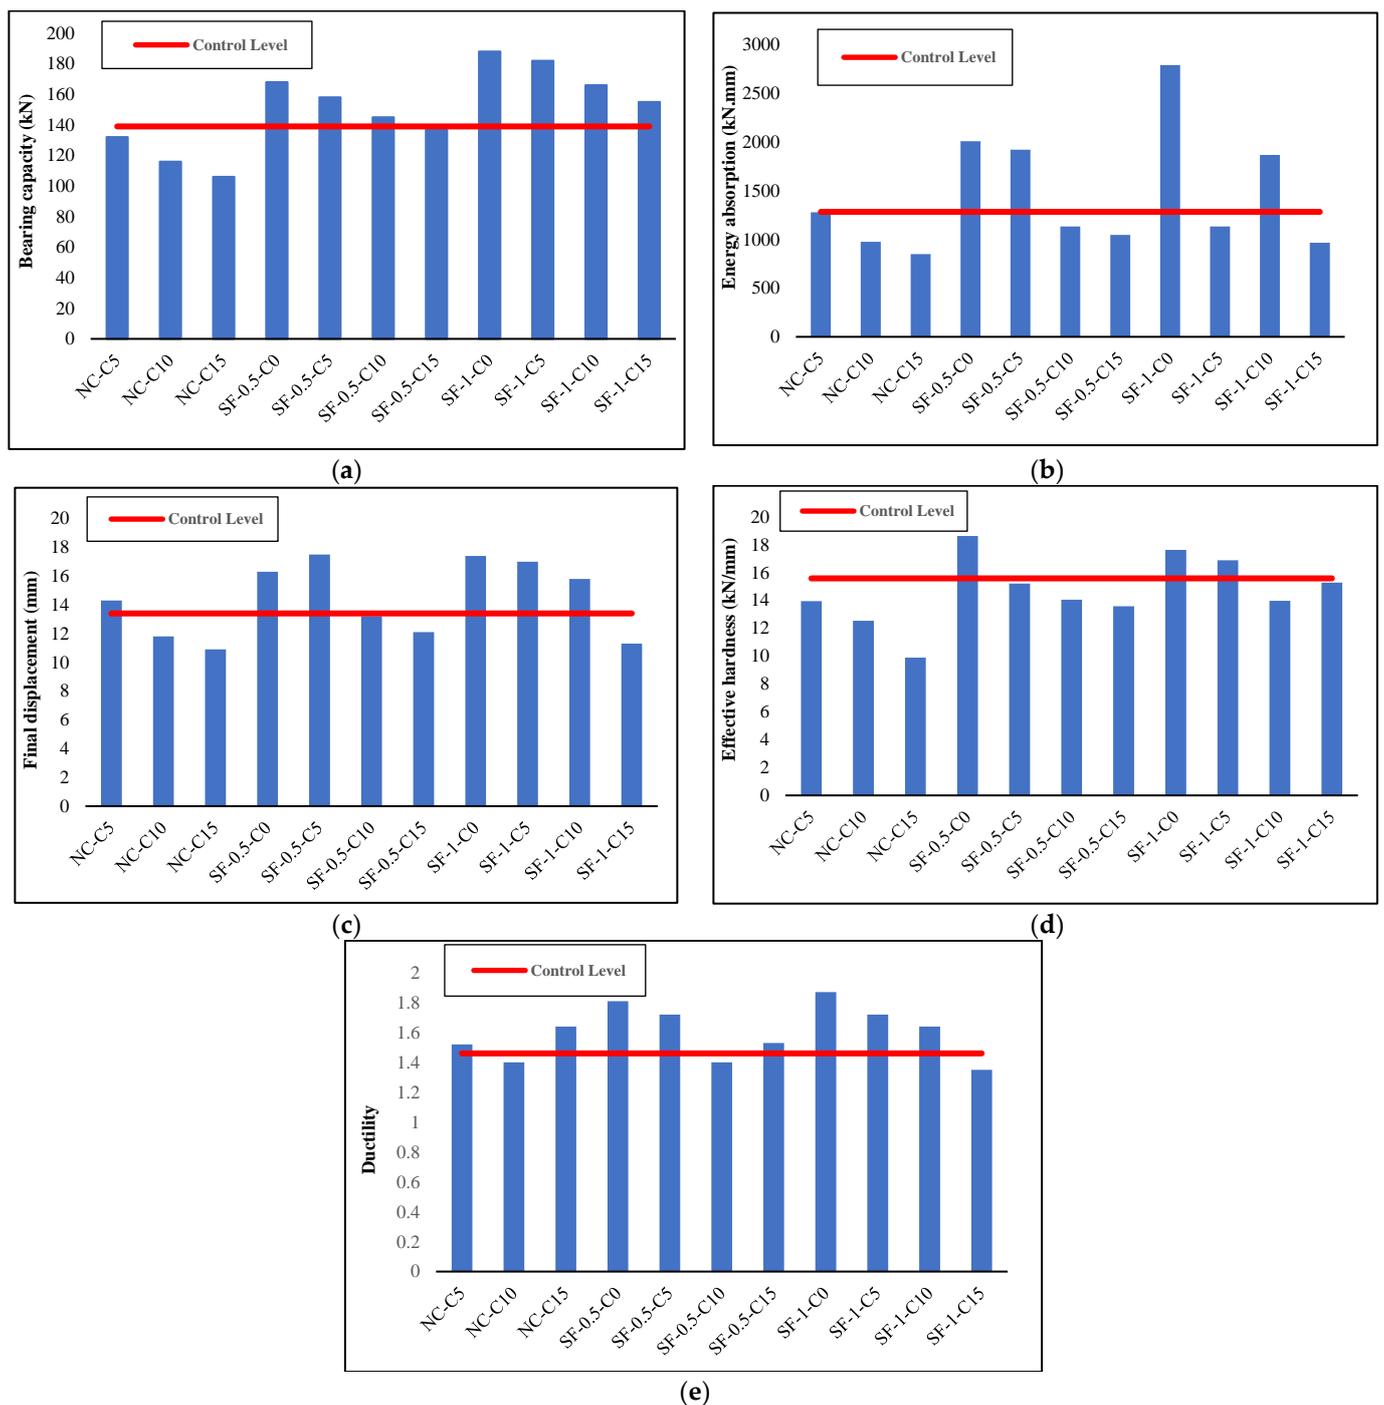
Figure 14. Comparative diagram of the change in (a) bearing capacity, (b) energy absorption, (c) final displacement, (d) effective hardness, and (e) ductility of the beams compared to the control specimen.

Comparative diagrams of the investigated parameters for the structural performance are presented in Figure 14.

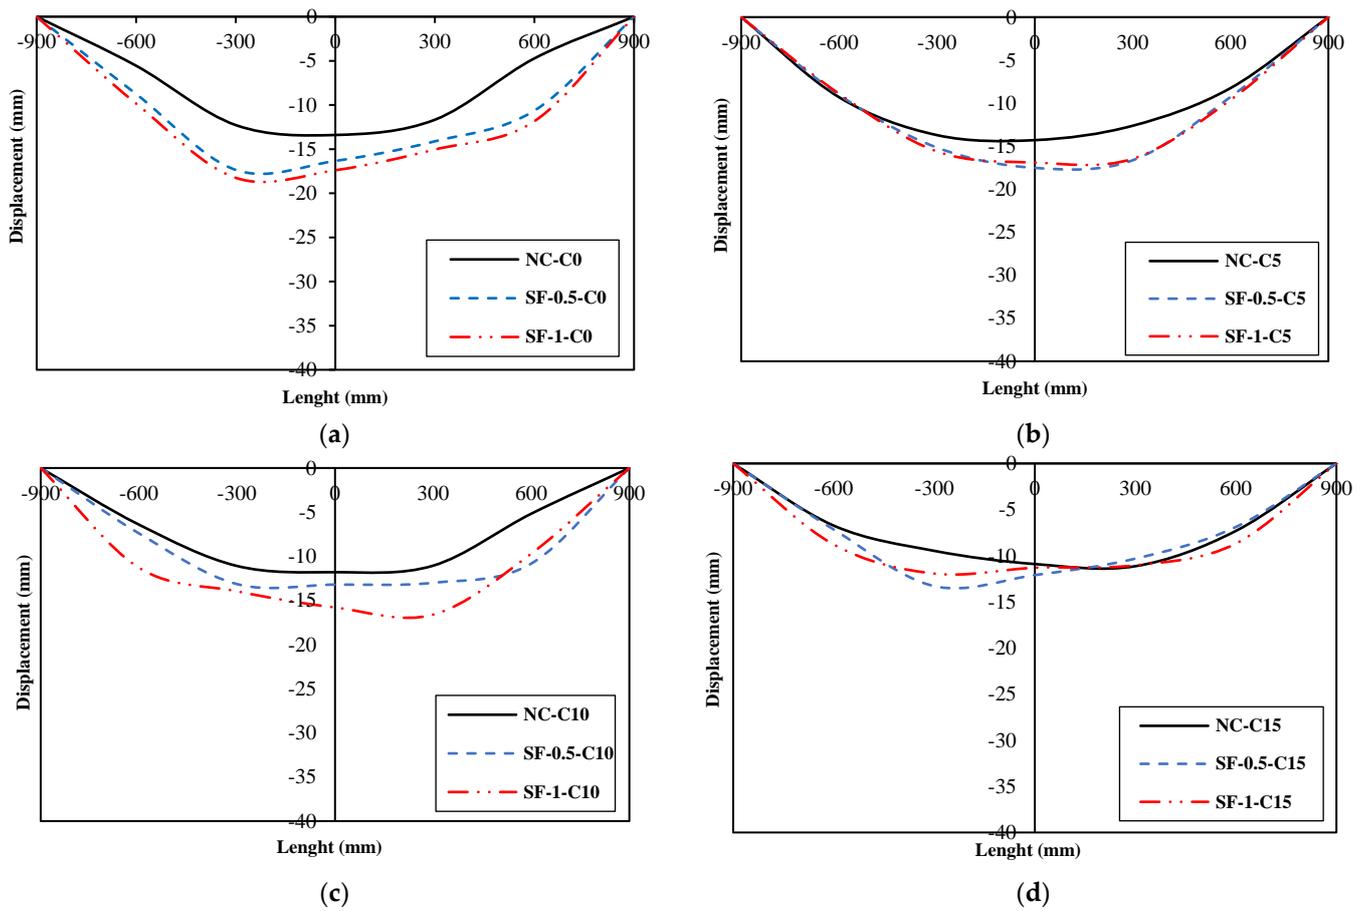
Figure 15. Displacement longitudinal profile diagrams: (a) Group A specimens (b) Group B specimens (c) Group C specimens (d) Group D specimens.

Figure 15 presents the displacement longitudinal profile diagrams of group A, B, C, and D specimens. The longitudinal displacement profile of the beams is drawn at a load equivalent to 90% of the bearing capacity.

Displacement longitudinal profile diagrams of all beams are asymmetric, and the value of displacement in the half of the failing beam is greater than in the other half.

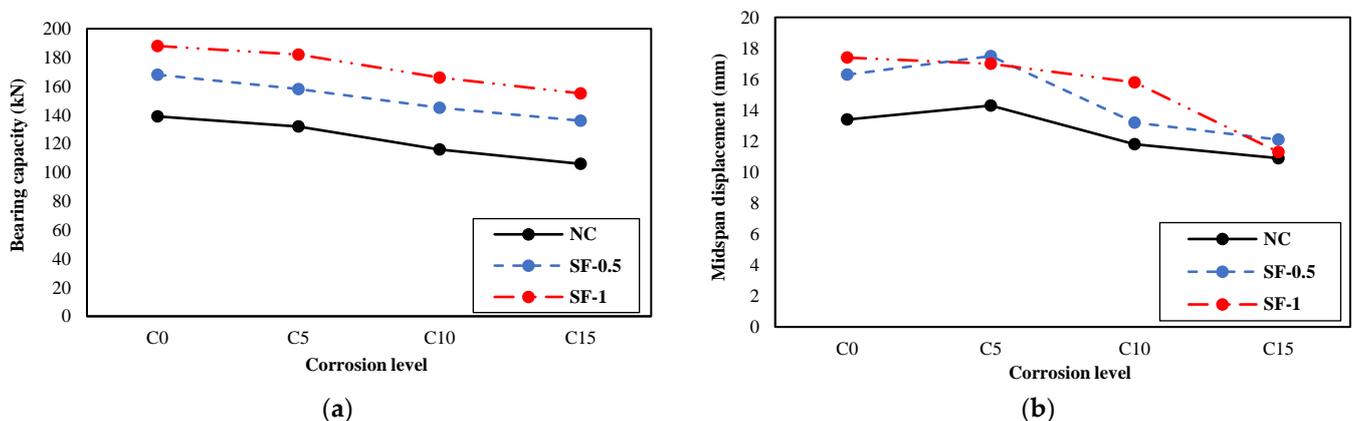
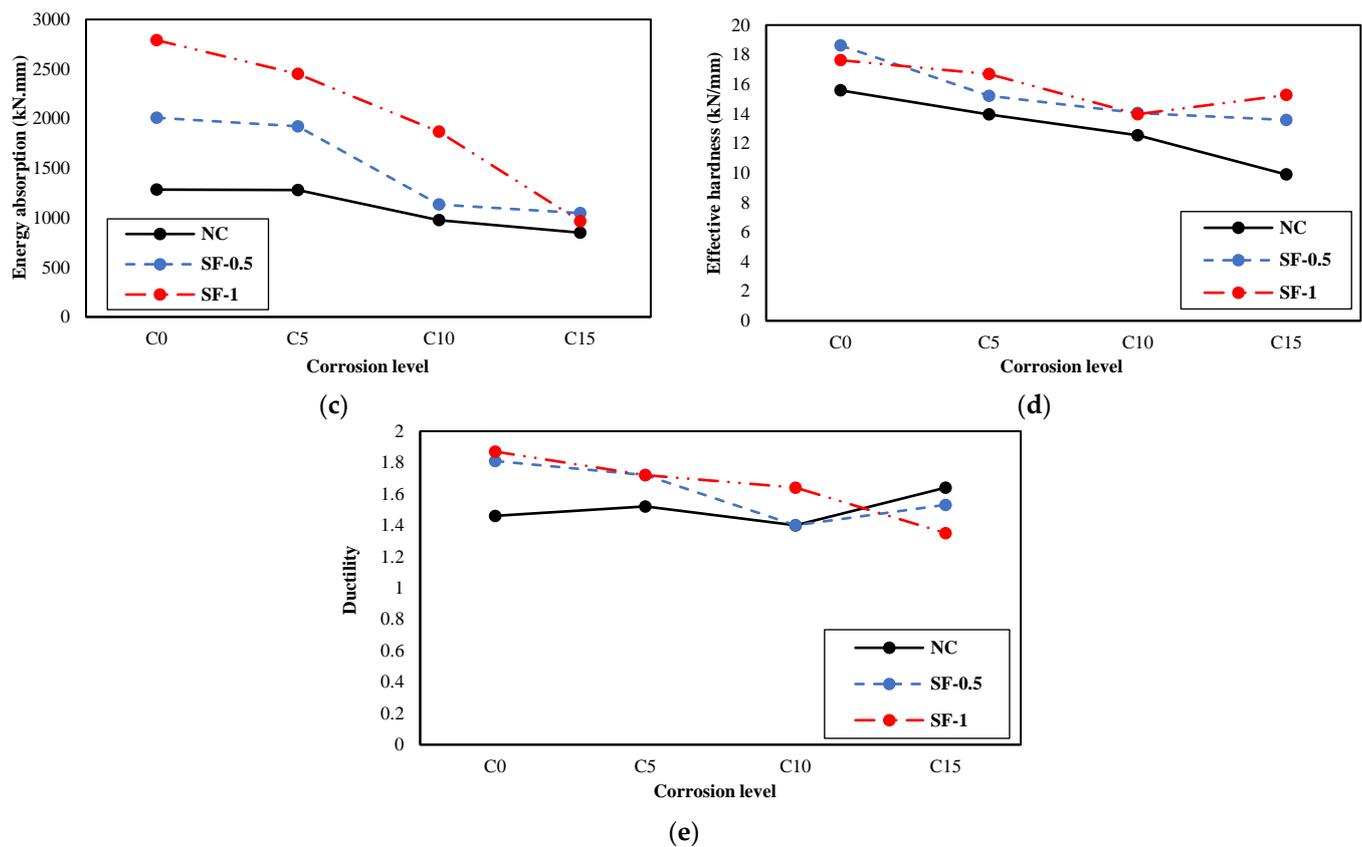
Figure 16. Changes in the studied characteristics with increasing corrosion levels: (a) bearing capacity, (b) midspan displacement, (c) energy absorption, (d) effective hardness, and (e) ductility.

Figure 16 depicts the trend diagrams of the changes in the studied characteristics in the flexural behavior of the beam under the influence of corrosion at different levels.

The diagrams show that the values of the investigated parameters for the bending behavior of the beam decreased with increasing corrosion levels for most of the specimens. The largest reductions in most beams occurred from 5% to 10% corrosion. However, the investigated structural behavior parameters increased in the specimens with steel fibers. There is a direct correlation between the increase in these values and the volume fraction of fibers used.

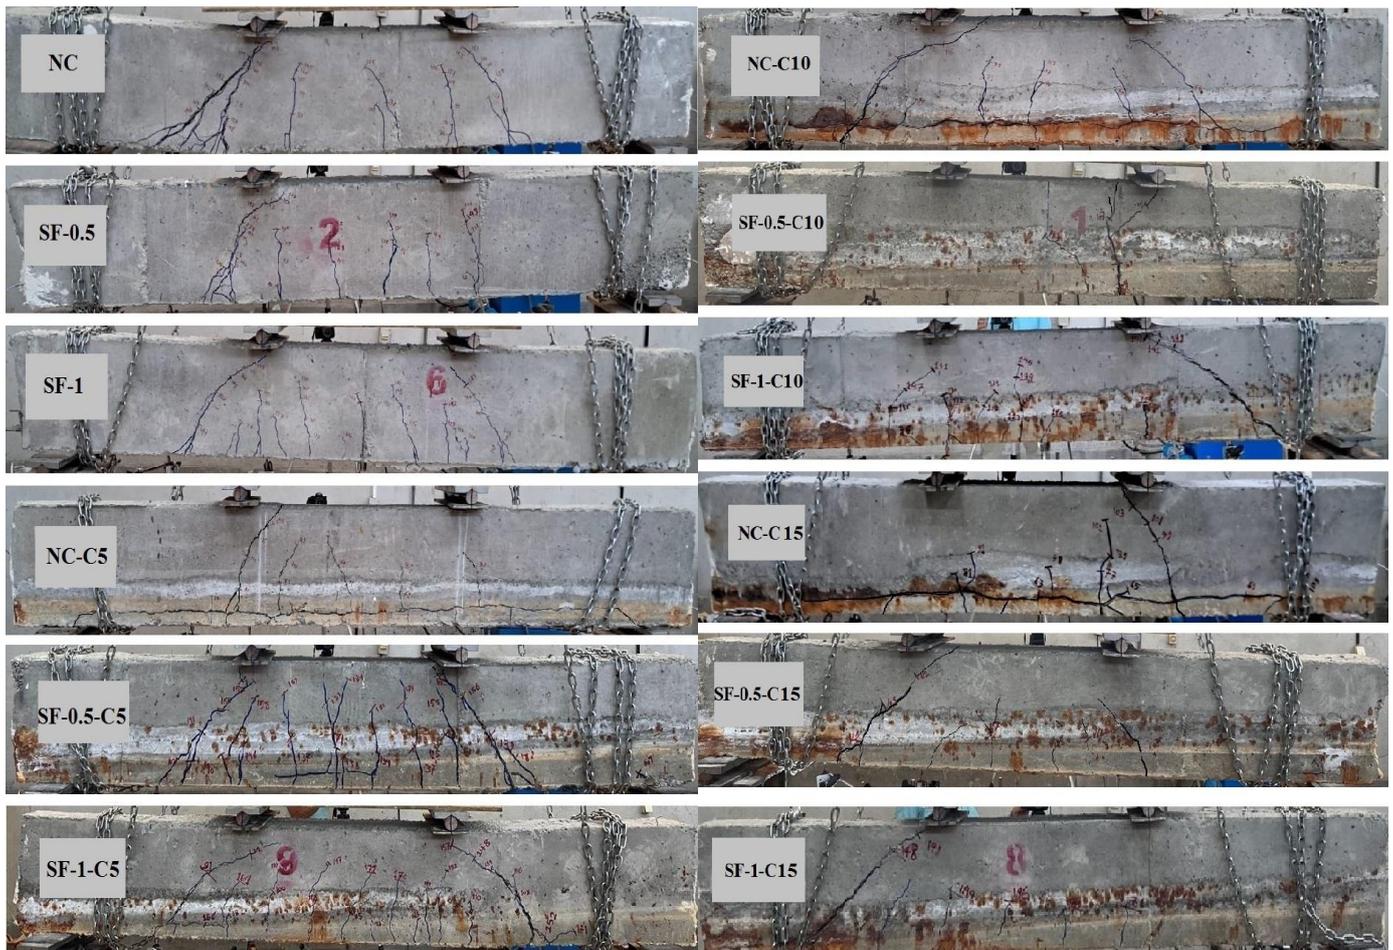
Figure 17. Failure mode and crack pattern of beams.

The failure mode and crack propagation of the beams are shown in Figure 17. The addition of steel fibers altered the failure mode of the two beams (SF-0.5-C0 and SF-1-C0) from shear failure to flexure-shear for the beams without corrosion. At the corrosion level of 5% for beams with steel fibers, it was observed that some shear cracks appeared in the region between the supports and loads, in addition to some short flexural cracks appearing in the bending region, as shown in Figure 17. It was observed that the corrosion level of 15% significantly impacted the failure mode of the beams (NC-C15, SF-0.5-C15, and SF-1-C15), causing them to fail in a brittle manner. This is because severe localized corrosion was found in the extracted prestressing wires after the failure test. It was observed that different levels of corrosion reduce bond strength and cause continuity crack at the region of the wires and sudden shear and splitting for beams without steel fibers (NC-C5, NC-C10, and NC-C15), as shown in Figure 17. The research results presented in [16,20] also indicate a decrease in bond strength due to corrosion. It can also be concluded that the presence of steel fibers decreases the width of cracks.
