# The Cracking of Al-Mg Alloys Welded by MIG and FSW under Slow Strain Rating

Faculty of Marine Engineering, Gdynia Maritime University, 81-256 Gdynia, Poland

**Abstract:** Al-Mg alloys used in the shipbuilding industry were tested. The most commonly used alloy AW 5083 and alloy AW 5059 with higher strength properties were selected. Both native materials and their joints welded by the traditional MIG arc welding method and the friction stir welding (FSW) method were tested. Both methods are approved by classification societies which allow them to be used in construction by the shipbuilding industry. The research was carried out in two stages. The first study was an “in-situ tensile test in SEM”. The surfaces of the deformed specimens’ changes were observed in the vacuum chamber of a Philips XL30 scanning electron microscope. During the tests, the force and elongation of the specimen were recorded. In addition, a chemical analysis of selected precipitates was performed by energy dispersive spectrometry (EDS) using the EDAX adapter. Slip lines were observed on the surface of the tested specimens, which are arranged in bands in the native material and in a disordered manner in the j

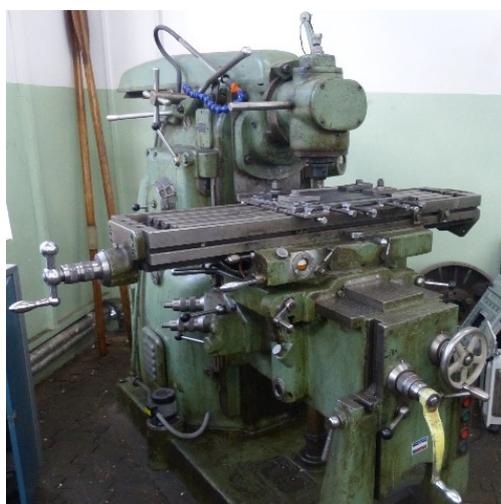
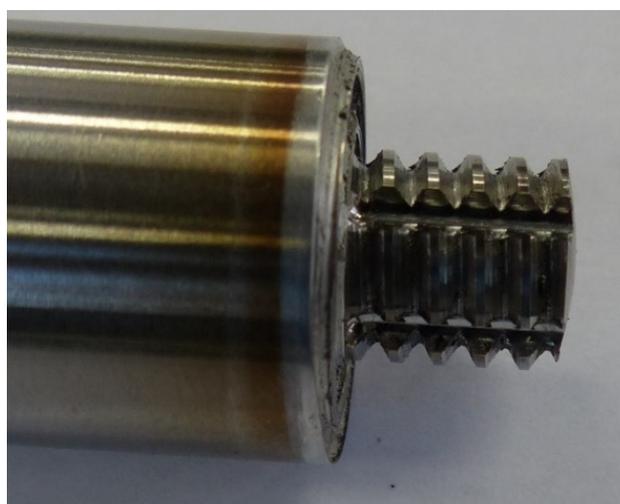
**Figure 1.** View of (a) the FSW welding station and (b) the FSW tool.

The thickness of the welded sheets was 12 mm and they were milled on one side to a thickness of 10 mm in the contact parts. Appropriate rigid fastening of the sheets was ensured by the instrumentation of the welding machine, built on the basis of the FWA-31 universal milling machine. The view of the FSW welding station and the tool used is shown in Figure 1.

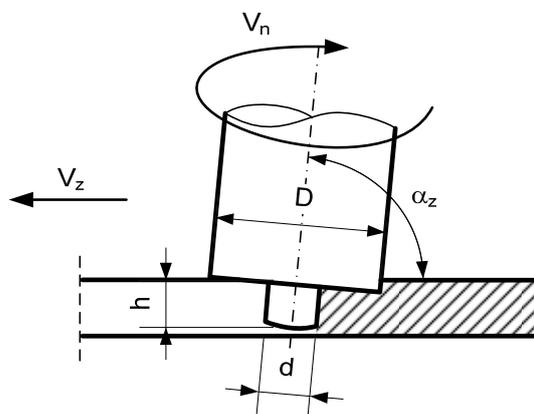
**Figure 2.** The diagram of FSW.

The contact surfaces of the joined elements were degreased. The sheets were welded on both sides with the same parameters as shown in Table 2. Figure 2 shows an overview diagram of the friction stir welding method. The welding parameters were selected on the basis of previous studies where the criterion of the smallest grains in the stirring zone was used. An additional criterion was the absence of defects and voids in the weld.

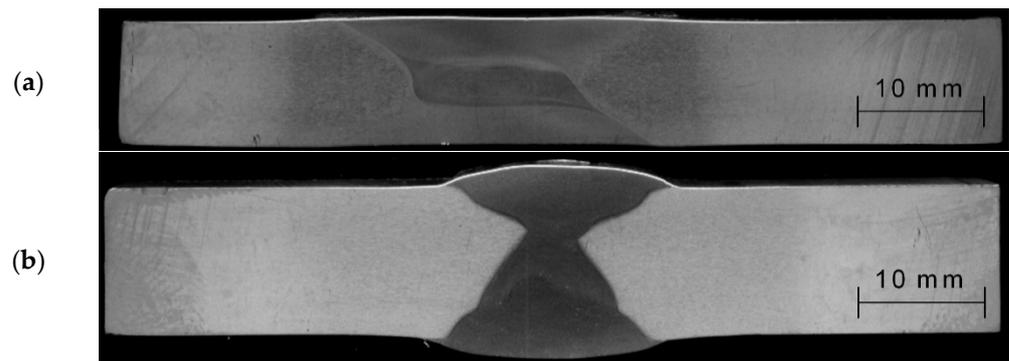
**Figure 3.** Macrostructure of the joint welded by (a) FSW and (b) MIG.

Joints welded by both methods have been verified by X-ray flaw detection and showed no welding defects. Cross-sectional views of the joints are shown in Figure 3.

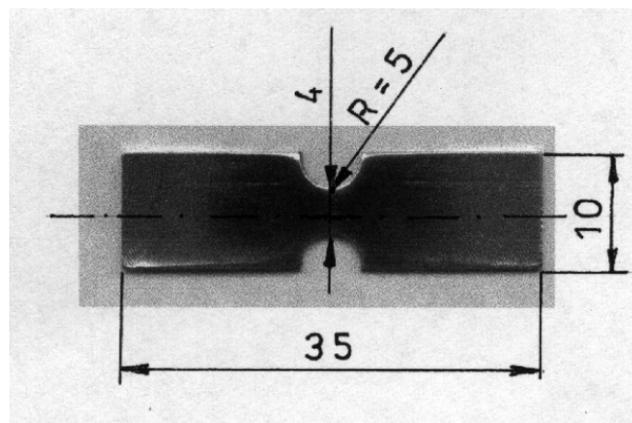
**Figure 4.** The shape and dimensions of a flat sample for an in situ tensile test in SEM.

The first stage of the research consisted of the observation of changes on the surface of the deformed sample in the vacuum chamber of a Philips XL30 scanning electron microscope (Amsterdam, Netherlands). The Microtest strain gauge from DEBEN (“in-situ tensile test in SEM”) was used for the tests. It is a tool for testing controlled deformation of samples, current recording of stress characteristics appearing in samples, and simultaneous observation of changes in the microstructure of the tested material. Samples with a thickness of 1 mm and a cross-section of  $F = 4 \text{ mm}^2$  were used for the tests. The observed surfaces of the sample were polished. The dimensions and shape of the sample are shown in Figure 4.

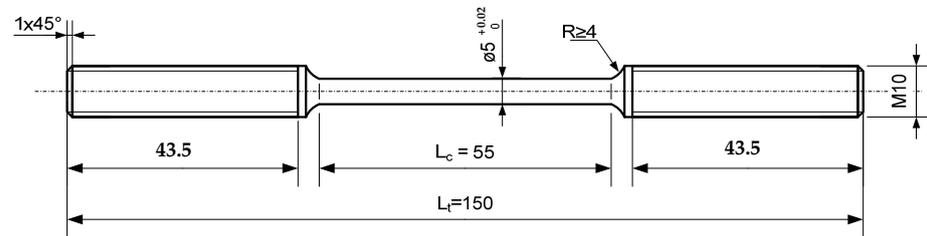
**Figure 5.** Shape and dimensions of stress corrosion test specimens.

The test consisted of increasingly deforming the specimens with the recommended strain rate for aluminum alloys  $\dot{\epsilon} = 1.6 \times 10^{-6} \text{ s}^{-1}$  until the complete destruction of the specimens. Smooth, cylindrical specimens with a diameter of 5 mm and an initial measuring length of  $L_0 = 50 \text{ mm}$  were used. The specimens were cut in a direction perpendicular to the rolling direction. The shape and dimensions of the specimens are shown in Figure 5.

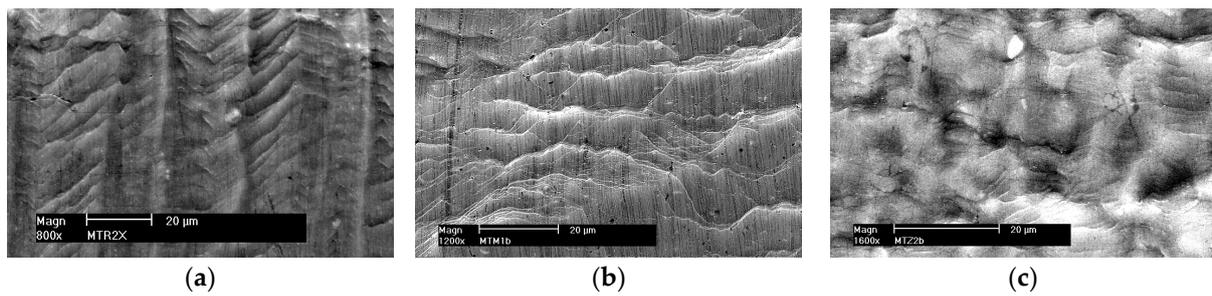
**Figure 6.** Set of plastic deformations on the surface of a sample made of alloy 5059. (a) Native material, (b) MIG weld, and (c) FSW weld.

Figure 6a shows the arrangement of slip bands on the surface of a polished sample made of alloy 5059. Regular interlocking slip bands are visible and arranged at an angle to each other in a system of parallel planes, suggesting that slip occurs simultaneously in different systems. The slip lines, which are up to 20  $\mu\text{m}$  long, run at an angle of about 45° to the load axis in the direction of the greatest tangential stresses. Figure 6b shows a fragment of the surface of the MIG welded sample with continuous, wavy slip lines, while Figure 6c shows irregularly distributed slip lines in alloy 5059 welded by the FSW method. The exact same character of surface changes of samples during plastic deformation was observed for alloy 5083 and its joints welded by both methods: MIG and FSW (not shown in the paper).

The presented examples show a great diversity in the structure and course of the slip lines. The images of the slip lines formed in wrought aluminum alloys (Figure 6a,c) differ from those obtained in the cast weld material (Figure 6b), which proves the existence of different ways of dislocation slippage depending on the structure of the material.

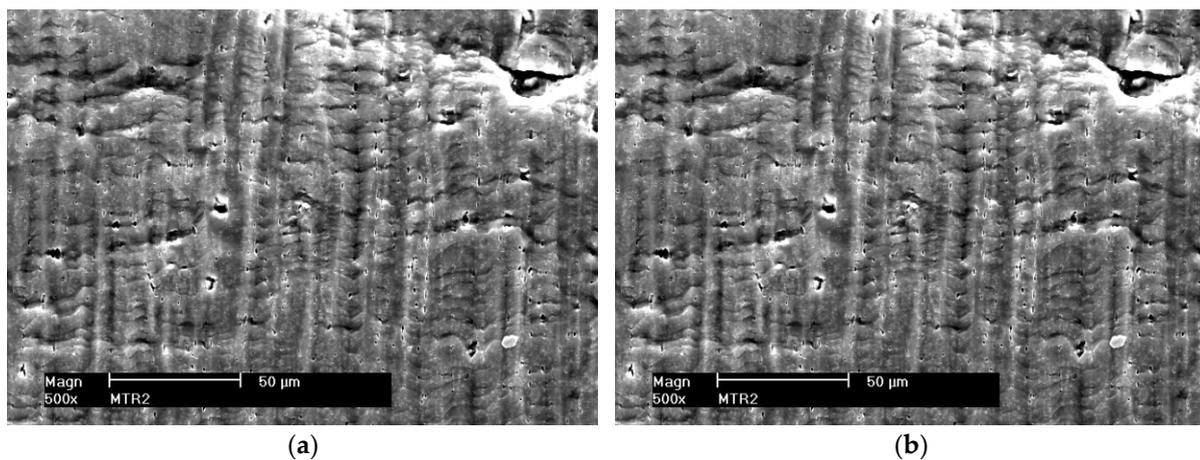
**Figure 7.** Surface fragments of deformed samples of base materials. (a) Alloy 5059 and (b) alloy 5083.

As a result of increasing plastic deformation, micro-voids are formed in tested materials, from which micro-cracks nucleate. The resulting micro-voids were observed both in deformed alloys 5059 and 5083, as well as in their welded joints. Examples of the obtained images of the non-etched sample surface with visible micro-voids are shown in Figures 7–9.

The analysis of the obtained results shows that the size of the micro-voids for native materials of the considered alloys and their welded joints are small and occur in the range of 2–10  $\mu\text{m}$ . For samples welded by the FSW method, the occurrence of a smaller number of micro-voids was observed compared to the native material. Probably, the tool plasticized the material during welding leading to their fragmentation or even removal (Figure 9a). During the FSW process, the joined material is subjected to dynamic recrystallization, which fundamentally has been influenced by heat input, strain, strain rate, etc. This additionally results in grain size reduction, which plays a vital role in determining physical and mechanical properties [23].

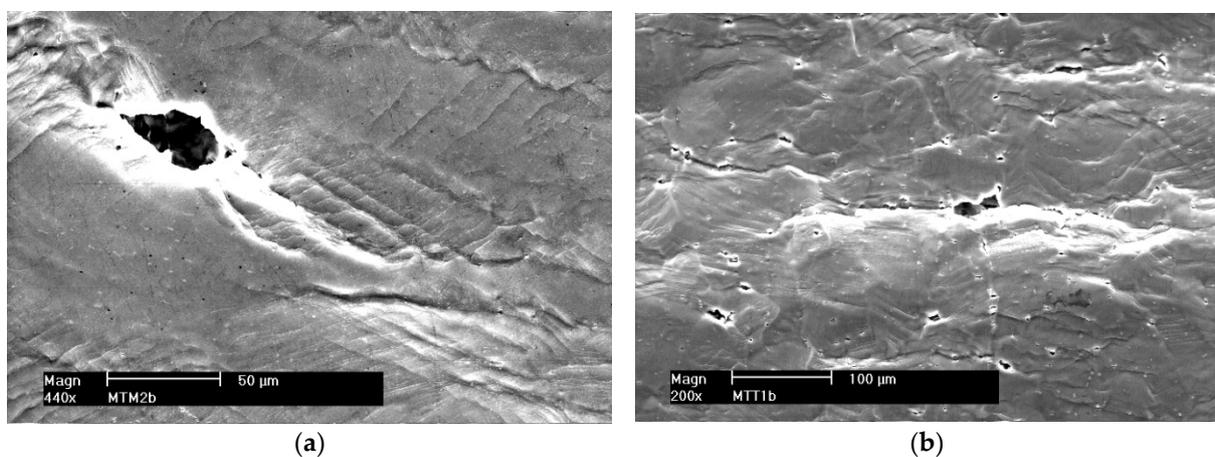
**Figure 8.** Surface fragments of deformed MIG welded samples. (a) Alloy 5059 and (b) alloy 5083.

In the case of MIG welded joints, the size of micro-voids reaches 50  $\mu\text{m}$  for both alloy 5059 and 5083.

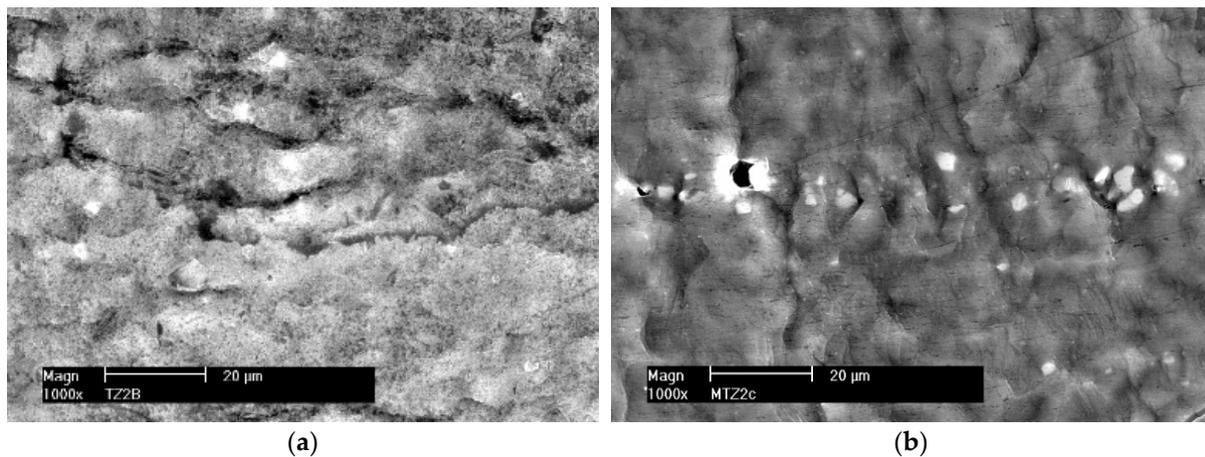
**Figure 9.** Surface fragments of deformed FSW welded samples. (a) Alloy 5059 and (b) alloy 5083.

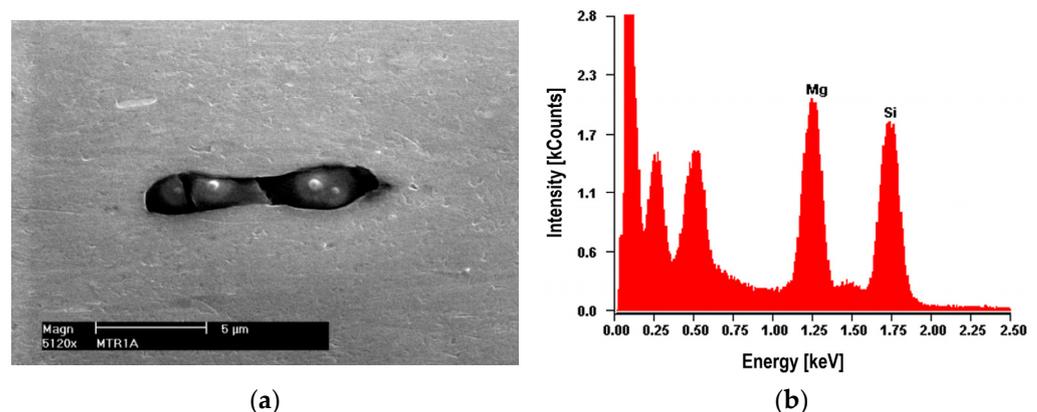
**Figure 10.** Alloy 5083. (a) The dark cracked precipitate of  $\text{Mg}_2\text{Si}$  about 10  $\mu\text{m}$  long with visible decohesion of interfacial boundaries along with (b) a microanalysis of the chemical composition of EDS.

The nucleation of micro-voids usually occurs with the participation of precipitates. The view of sample precipitates together with their point microanalysis of chemical composition (EDS) is shown in Figures 10–13. The places where micro-voids are formed are phase precipitates or their boundaries with the matrix. They are formed as a result of the cracking of the precipitates (Figures 10 and 13) or the formation of free spaces at the interfaces between the precipitates and the matrix (Figures 11 and 12). Such a mechanism occurs both in the tested Al-Mg alloys and in the welded joints.

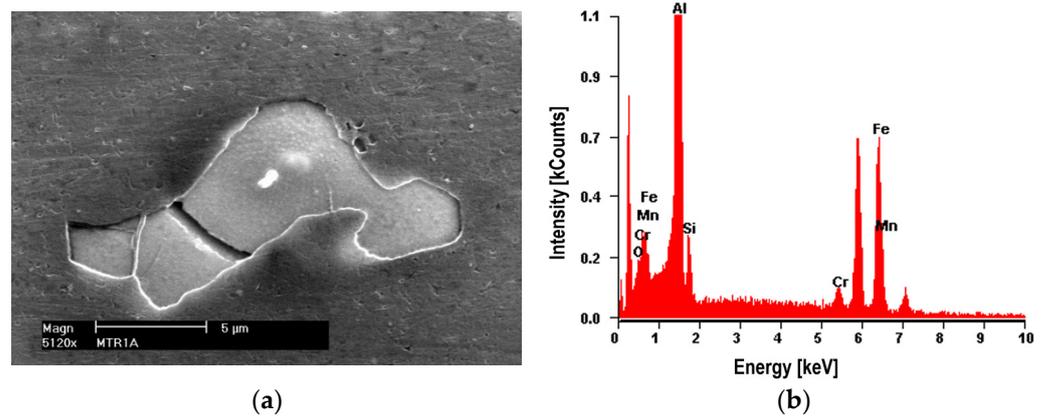
**Figure 11.** Alloy 5083. (a) Cracked bright precipitate with (b) EDS analysis. Precipitate  $(\text{Mn, Fe})\text{SiAl}_{12}$  with a length of about  $20 \mu\text{m}$ .

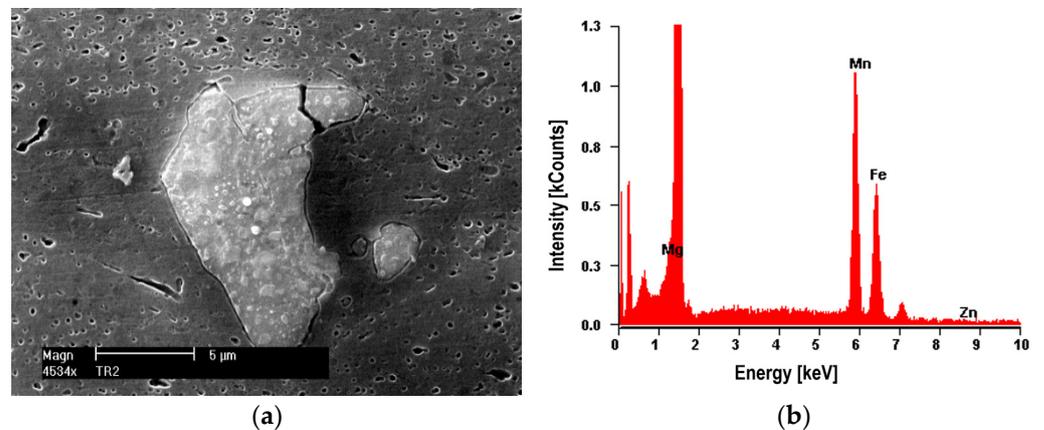
**Figure 12.** Alloy 5059. (a) Bright cracked precipitate of  $(\text{Mn, Fe})\text{Al}_7$  with dimensions of  $10 \times 5 \mu\text{m}$  with (b) EDS analysis. Small precipitates of the  $\text{Al}_3\text{Mg}_2$  phase with a diameter of up to  $1 \mu\text{m}$  are visible.

On small precipitates with a diameter of up to  $1 \mu\text{m}$ , nucleation of micro-voids was not found (Figure 12). The phase equilibrium diagram of Al-Mg alloys shows that it is the  $\beta$  phase ( $\text{Al}_3\text{Mg}_2$ ), strengthening the alloy.

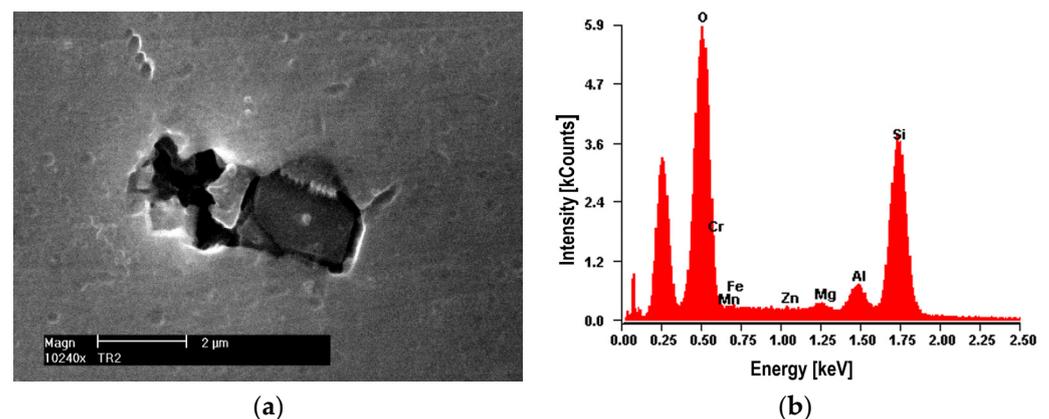
**Figure 13.** Alloy 5059. (a) Dark precipitate with dimensions of  $2.5 \times 1.25 \mu\text{m}$  (pure Si) with (b) EDS analysis. Visible decohesion of the matrix-molecule interface.

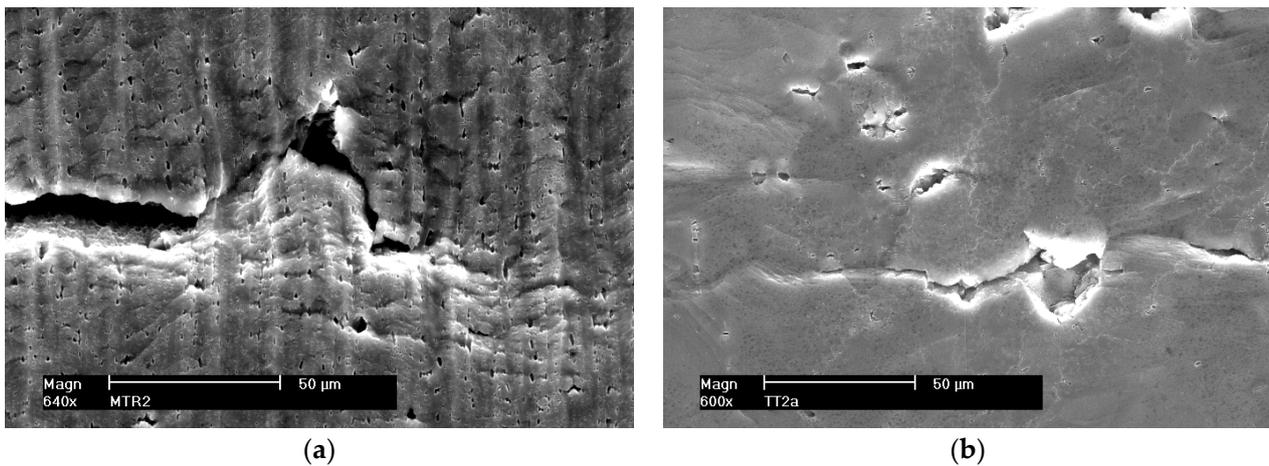
**Figure 14.** Growth of a micro-crack by connecting micro-voids; alloy 5059. (a) Native material and (b) MIG weld.

As a result of plastic deformation, micro-cracks and micro-voids merge. Figures 14 and 15 (non-etched samples) show examples of connecting micro-cracks and micro-voids in Al-Mg alloys and their welded joints. Figure 15b shows a secondary crack branching off from the main crack.

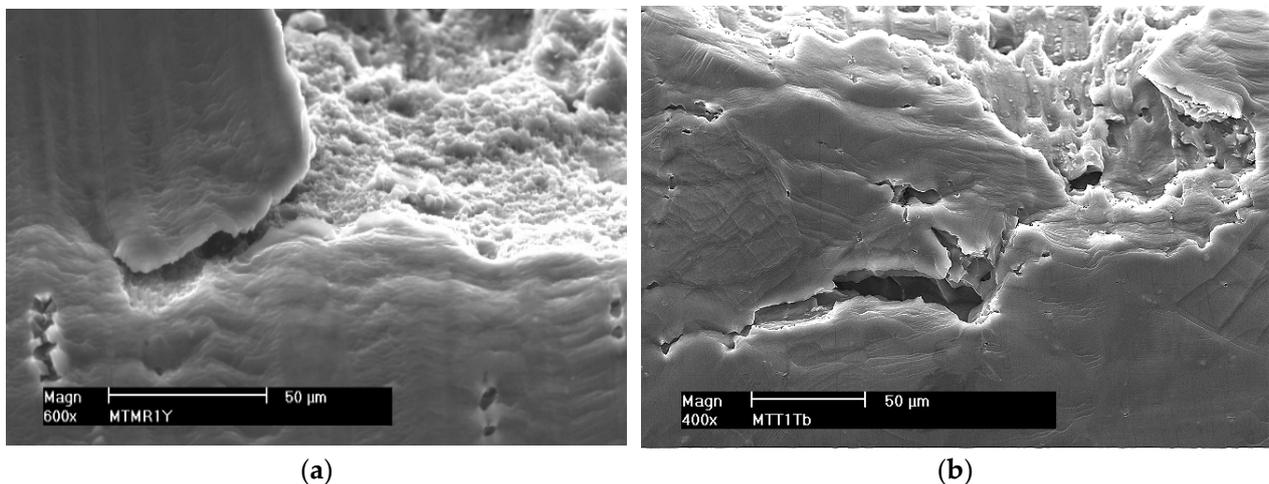
**Figure 15.** Growth of a micro-crack by connecting micro-voids; alloy 5083. (a) Native material and (b) secondary crack, MIG weld.

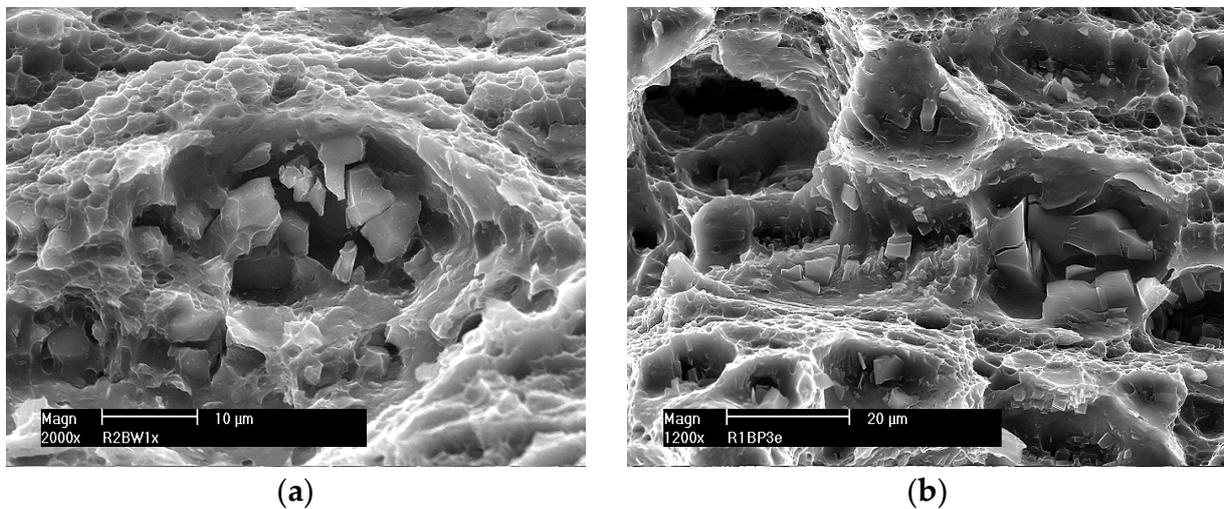
**Figure 16.** Microstructure of the crack surface with pits formed around the precipitates. MIG welded joints (a) 5059 and (b) 5083.

Figure 16 shows fragments of the surface of a ductile crack with visible dimples formed around the precipitates, which are separated by the edges of the tear. The pits visible at the fractures of the tested samples are formed on the precipitates by the nucleation of

micro-voids and their growth. At the bottom of the wells, there are often precipitates of various sizes, most often destroyed.

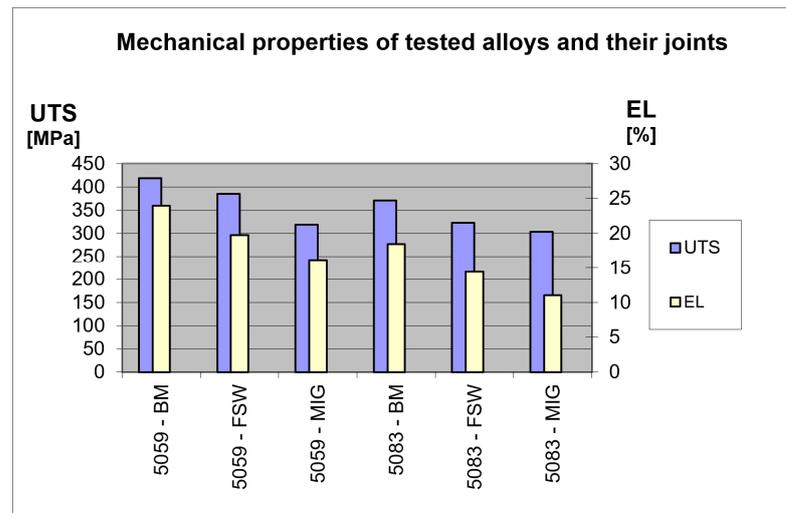
Figure 17. Research results of a SSRT.

For the analysis of the test results using the slow strain rate test, the two most important parameters were selected in terms of determining the mechanical properties: the maximum stress value at the moment of sample breakage,  $S_{max}$ , and its elongation, EL. The graphical interpretation of the test results is shown in Figure 17.

As expected, alloy 5059 showed higher strength compared to alloy 5083. Similarly, the base material (BM) samples of both considered alloys had higher mechanical properties than their bonded joints. In the case of joints welded by the FSW method, a smaller decrease in strength and plastic properties was observed compared to the joints welded by the traditional MIG method.

Considering the effect of welding on the strength properties, it can be seen that the maximum stress value was definitely lower for welded samples compared to samples from the base material. The  $S_{max}$  parameter registered for MIG welded samples was lower by approx. 23% for alloy 5059 and 18% for alloy 5083 compared to the base material. Similar results were obtained for samples joined by the FSW method. In this case, the strength properties were also reduced compared to the base material; however, to a lesser extent. Comparing the test results, a decrease in the maximum stress of 13% for 5083 and 8% for 5059 can be seen.

Joining with both considered methods resulted in a decrease in plastic properties in relation to the native material. For MIG welded samples, the relative elongation, EL, was lower by 32% for 5059 and 40% for 5083, while for FSW welded samples, it was 17% and 22%, respectively.

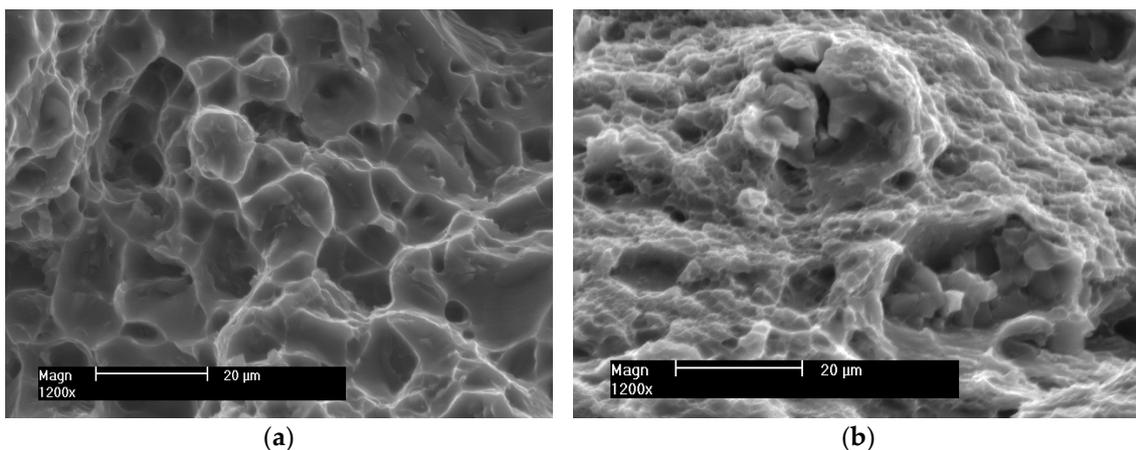
Figure 18. Example fractures of native material samples (a) 5059 and (b) 5083.

The fractures of the samples from the native material of alloys 5083 and 5059 (Figure 18) are trans-crystalline ductile. Their surfaces are strongly developed with pits of various sizes. They are open to the effect of the increasing strain during SSRT. Micro-voids are visible, in the depth of which there are few cracked intermetallic phases.

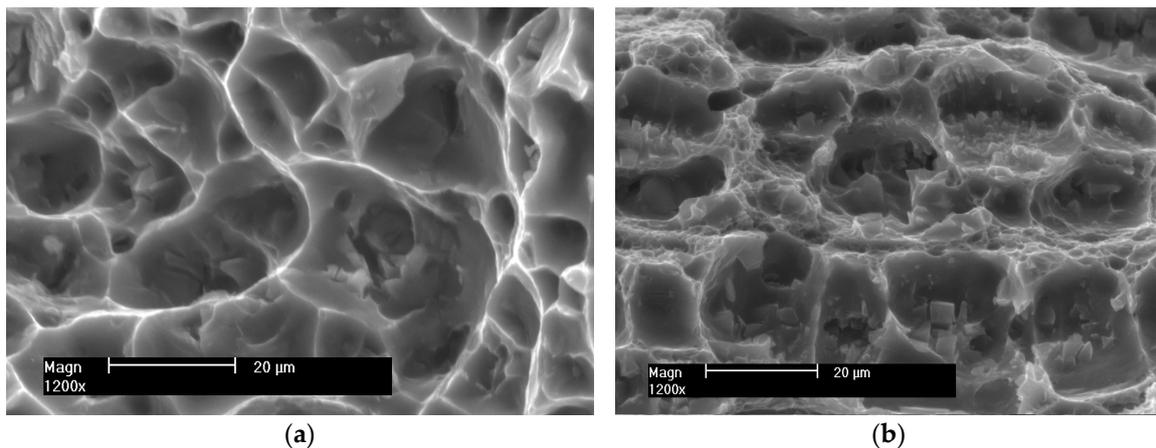
**Figure 19.** Example fractures of MIG welded samples (a) 5059 and (b) 5083.

In the case of MIG welded joints (Figure 19), the fracture is also trans-crystalline ductile. At the bottom of the wells, a significant number of cracked intermetallic phases are visible, which initiated the cracking process. This is especially evident in the case of weld 5083.

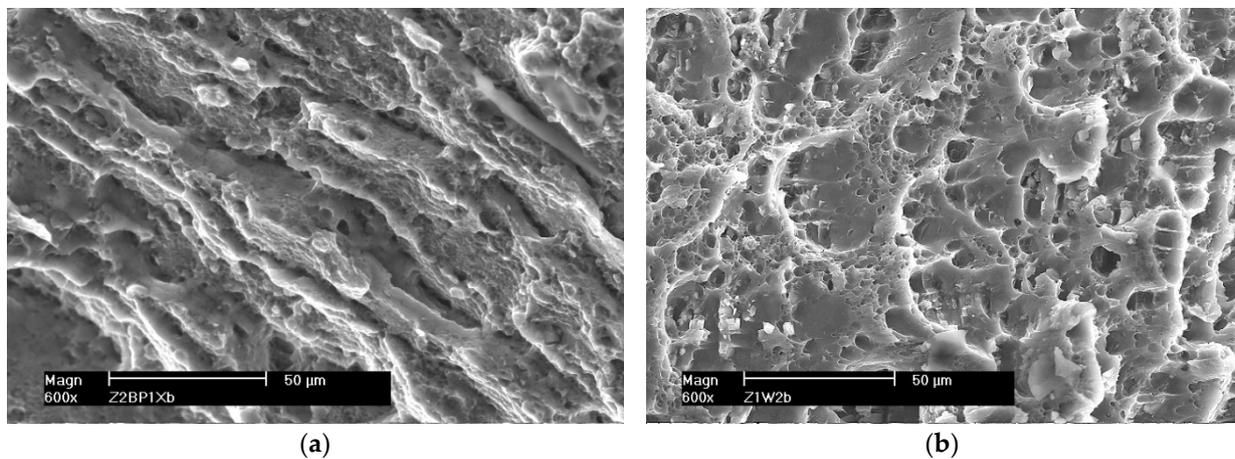
**Figure 20.** Example fractures of FSW welded samples (a) 5059 and (b) 5083.

The fractures of the samples welded by the FSW method are shown in Figure 20. Micro-voids are visible on the fracture surface, but no cracked intermetallic phases exist. The cracking was ductile and mainly intercrystalline, as evidenced by the presence of a few craters open in the direction of the force loading the sample. The tearing edges are inclined in one direction. This proves that the sample cracked as a result of shearing. The crack boundaries merge into bands resulting from the impact of the plasticizing tool during the welding process.
