Article

Comparison of Ultrasonic Phased Array and Film Radiography in Detection of Artificially Embedded Defects in Welded Plates

Arijan Herceg, Leon Maglić *, Branko Grizelj and Vlatko Marušić

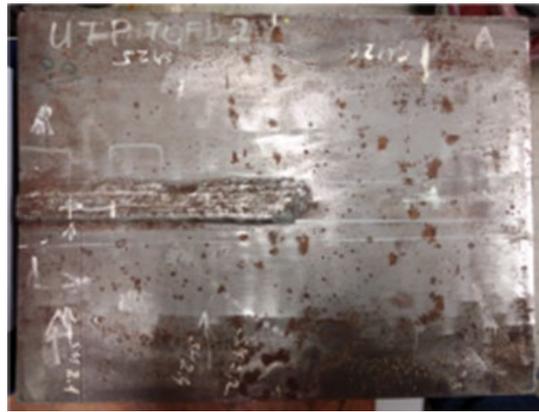
Figure 1. Welded plate—1.

Figures 1–6 show images of all three specimens (welded plates 1, 2, and 3) and their respective approximate defect locations within the weld material. The specimens were designed to simulate different possibilities for the location of defects relative to each other. For welded plate 1, shown in Figures 1 and 2, the embedded defects were intentionally placed very close to each other. In this way, it was possible to experimentally investigate how such fault positioning affects the test results of UT and RT.

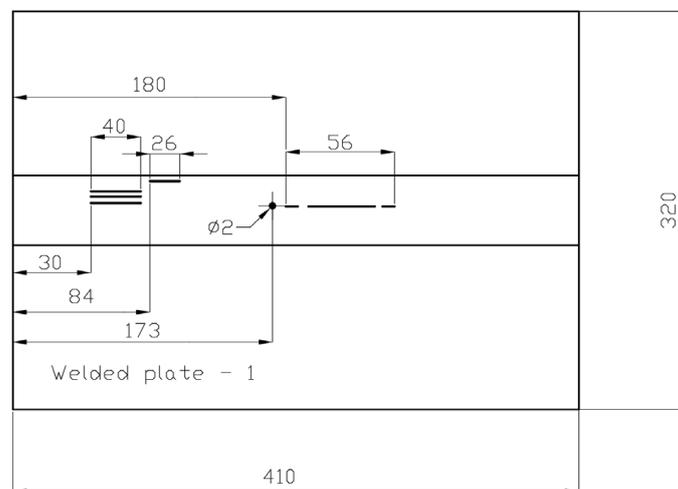
Figure 2. Welded plate—1—approximate defect positions.

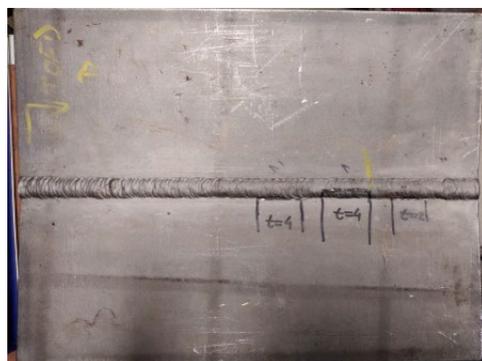
Figure 3. Welded plate—2.

Welded plate 2 and its approximate defect locations are shown in Figures 3 and 4. The positioning of the defects is deliberately different from that of welded plate 1. The defects are relatively far apart, although some are still very close. Such defect placement in the weld should allow realistic testing of the ability of the UT and RT methods to detect and distinguish between different defects. The units in Figures 2, 4 and 6 are in millimetres.

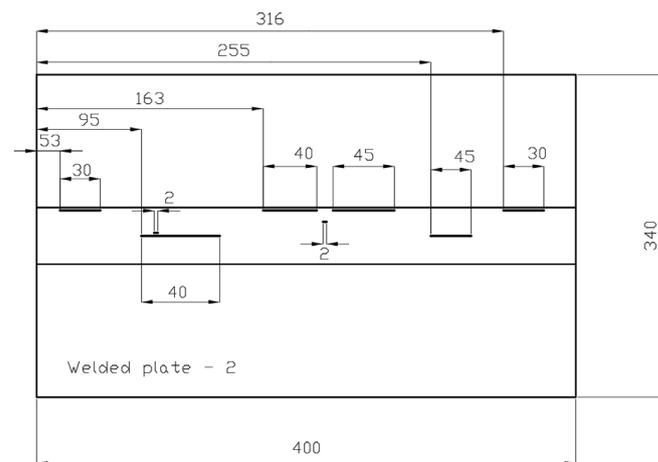
Figure 4. Welded plate—2—approximate defect positions.

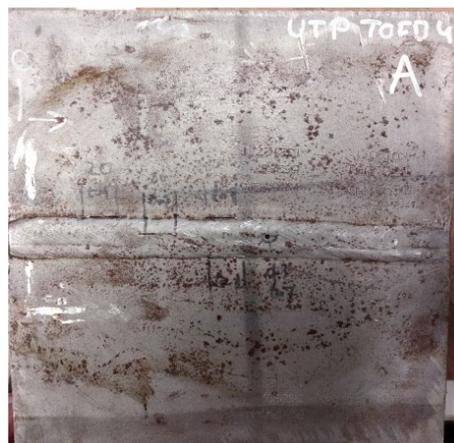
Figure 5. Welded plate—3.

The defects in welded plate 3, shown in Figures 5 and 6, were intentionally spaced far apart. With such an arrangement, there should theoretically be no problems with defect detection and the detection of individual defects with either method.

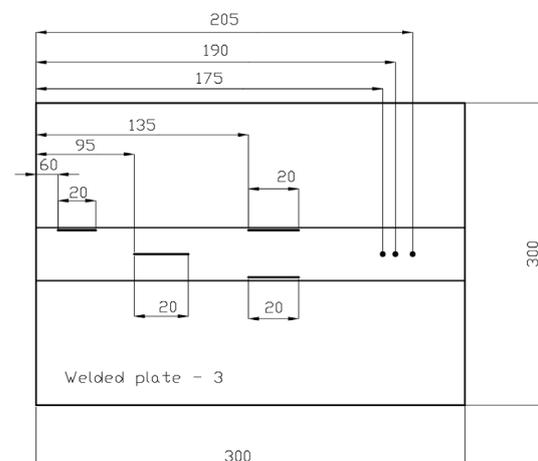
Figure 6. Welded plate—3—approximate defect positions.

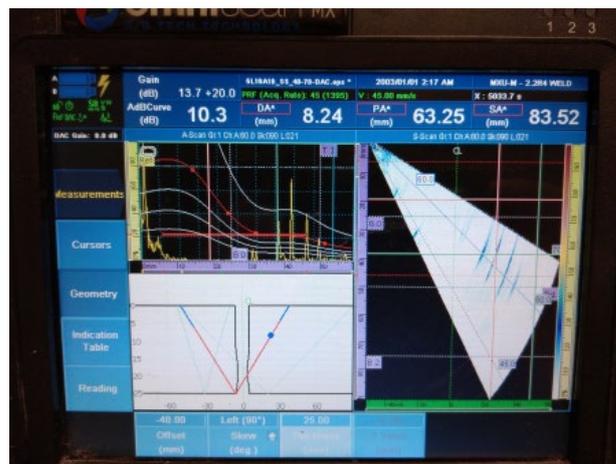
1. Continuous signal 1: fusion flaw (40 mm of length) + fusion flaw (26 mm of length)

Figure 7. Welded plate—1: continuous signal 1.

The results of the examination by UT can be seen in Figures 7 and 8 in both the A- and S-scans. The A-scan is the amplitude–time-based part (upper left part of Figures 7 and 8), and the S-scan represents the sectorial part (right part). The UT beam directed into both the weld and the heat-affected zone is reflected from the discontinuities, returns to the probe, and produces a clear and recognizable signal on the screen of the UT instrument. Some variation in accurate defect positioning occurs during UT testing, mainly due to weld geometry and imperfect sound reflection. These factors also contribute to the fact that it was impossible to achieve individual defect resolution. Detected defects generated two continuous signals with small amplitude variations.

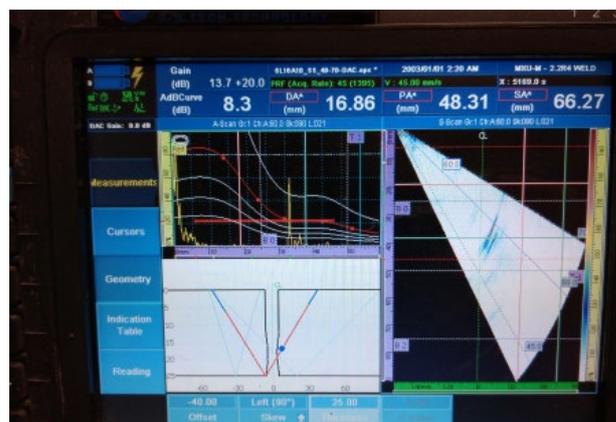
2. Continuous signal 2: drilled hole ($\phi 2$ mm) + fusion flaw (56 mm of length)

Figure 8. Welded plate—1: continuous signal 2.

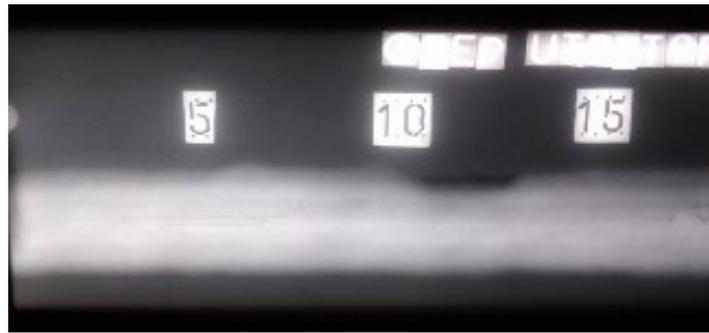
Figure 9. Radiogram of welded plate 1: 0–15 distribution.

Radiograms (Figures 9 and 10) show the results of the examination by RT. The absence of material is shown as a darker area on the film. Due to the nature of the RT examination, the positioning of the defects in two-dimensional space (length and width) is reliable. The X-ray images produced show all four defects individually. Figure 10 shows the characteristic absence of a “white” zone from distribution 20. This is due to the fact that the weld cap was removed by grinding. In this zone, there is less material to absorb the ionizing radiation as it propagates, resulting in a darker radiogram. The difference in optical density can be confirmed both visually and by using a densitometer.

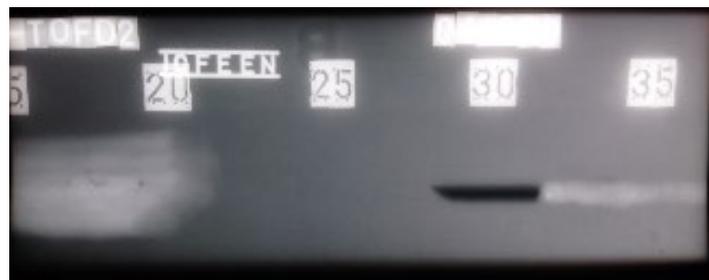
Figure 10. Radiogram of welded plate 1: 15–35 distribution.

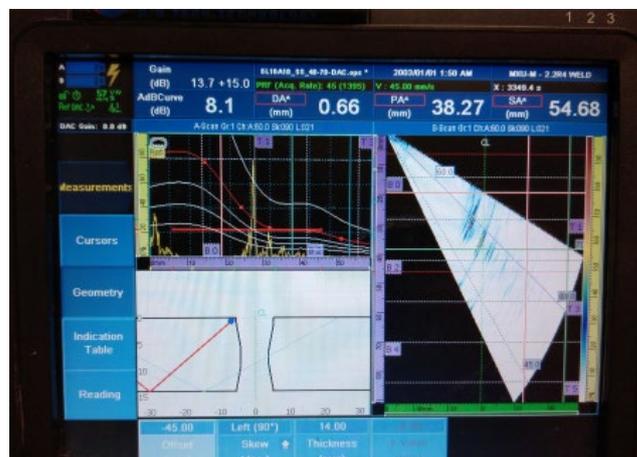
1. Individual signal 1: fusion flaw (30 mm of length)

Figure 11. Welded plate—2: individual signal 1.

The UT examination results of welded plate 2 (Figures 11–15) show the detected defects and their approximate positions within the test zone. Similar to the results of welded plate 1, both the amplitude in the A-scan and the differently coloured area in the sectorial scan indicate the presence of defects. If necessary, by changing the position of the probe UT during the test and by increasing the gain, an even stronger sound reflection and thus easier detection can be achieved. However, even with these parameters selected, results are easily obtained.

Spherical defects (drill holes), as seen in Figure 12, generally produce lower acoustic energy reflection and are therefore more difficult to detect than areal defects (lack of fusion). This can be easily verified by following the amplitude peak in the A-scan (upper left part of the UT instrument screen). The amplitude drop in the detection of spherical defects was 40% of the screen height, as confirmed by a comparison of Figures 11 and 12.

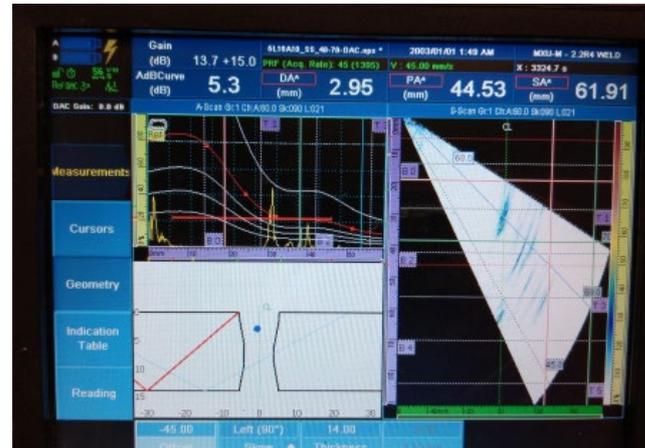
2. Continuous signal 1: drilled hole ($\phi 2$ mm) + fusion flaw (40 mm of length)

Figure 12. Welded plate—2: continuous signal 1.

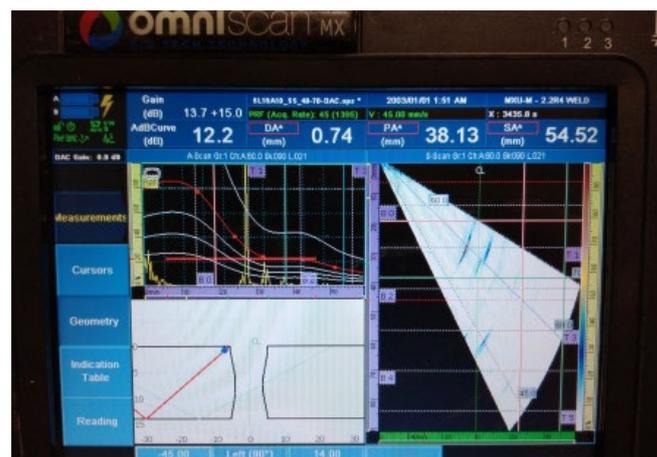
3. Continuous signal 2: drilled hole ($\phi 2$ mm) + fusion flaw (40 mm of length) + fusion flaw (45 mm of length)

Figure 13. Welded plate—2: continuous signal 2.

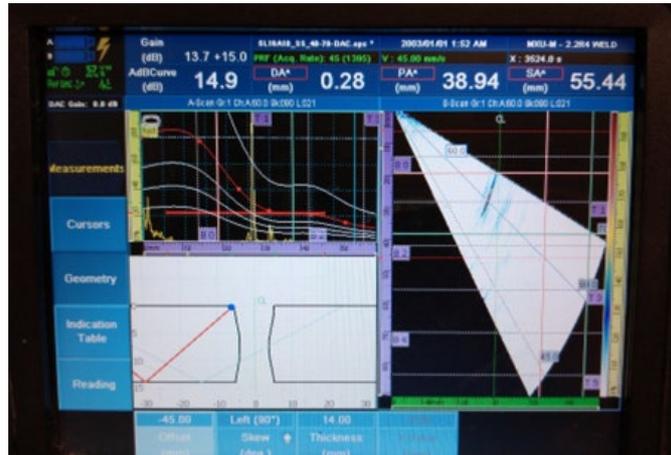
- Individual signal 2: lack of fusion (45 mm of length)

Figure 14. Welded plate—2: individual signal 2.

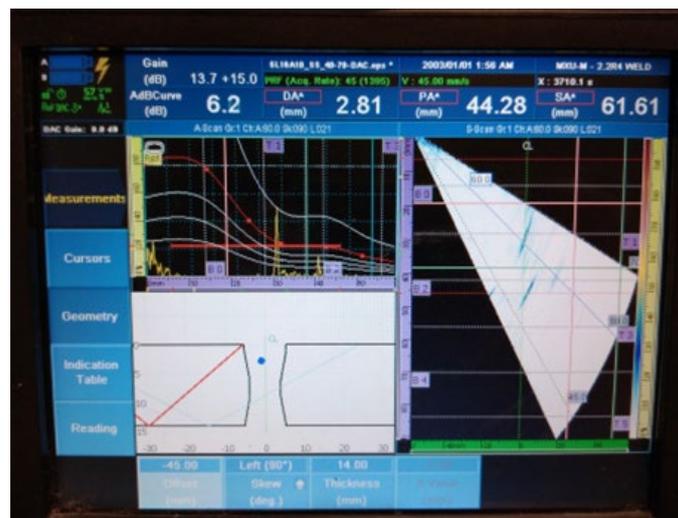
- Individual signal 3: lack of fusion (30 mm of length)

Figure 15. Welded plate—2: individual signal 3.

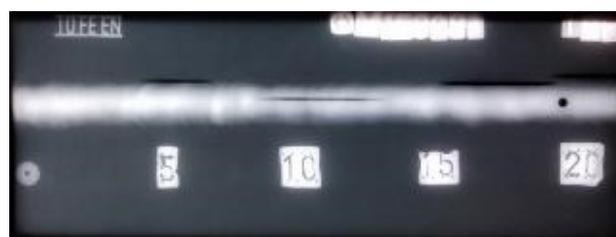
Figure 16. Radiogram of welded plate 2: 0–20 distribution.

Figures 16 and 17 show the results of RT testing for welded plate 2. Two radiograms were required to cover the entire area examined. Defects are visible as darker areas in the white of the weld and base metal. Both radiograms also show how some relatively close defects can produce a continuous signal when examined at UT and appear as a single defect (continuous signal 2).

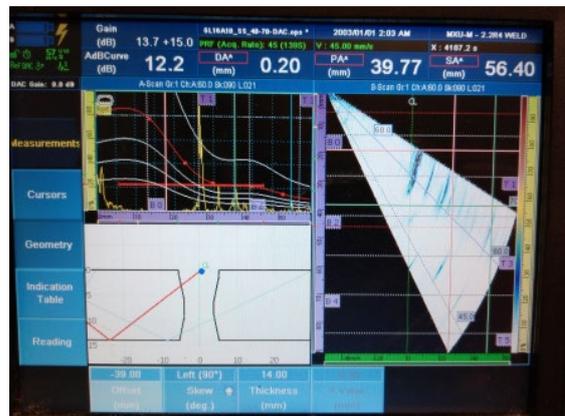
1. Individual signal 1: fusion flaw (20 mm of length)

Figure 18. Welded plate—3: individual signal 1.

Figures 18–24 show the results of the test UT. For welded plate 3, all embedded defects were relatively far apart or were located in different weld sections, so it was possible to identify individual defect signals. The defects were oriented and large enough to allow significant ultrasonic reflection. The sound returning to the phased-array probe resulted in a significant amplitude that was visible on the amplitude–time-based portion of the UT instrument screen. The sectorial scan also confirmed the survey results, as it was based on the A-scan.

The approximate location of the flaw in the weld area, shown in the lower left portion of Figures 18–24 also achieved acceptable accuracy. This is especially important because there are significant differences between the ideal weld configuration available in the instrument UT and the actual weld configuration in the welded plate. Sound reflection must also be taken into account when determining the UT defect location. Since it was possible to obtain individual signals if needed, the approximate defect size could also be determined by the amplitude decay technique. A fusion flaw in the centre of the weld (individual signal 2) could also be effectively used to simulate a longitudinal crack.

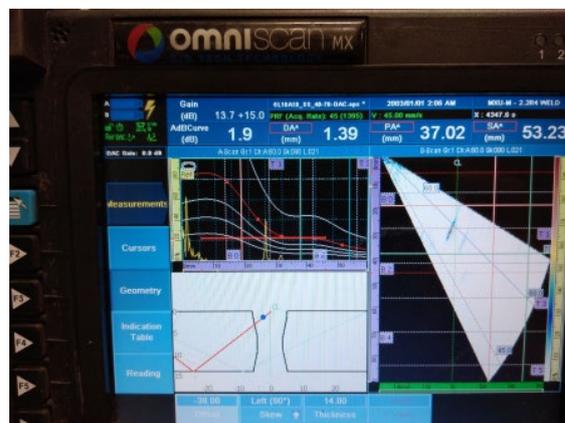
2. Individual signal 2: fusion flaw (20 mm of length)

Figure 19. Welded plate—3: individual signal 2.

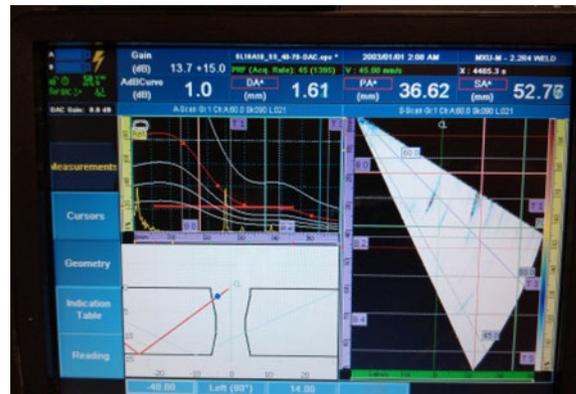
3. Individual signal 3: fusion flow (20 mm of length)

Figure 20. Welded plate—3: individual signal 3.

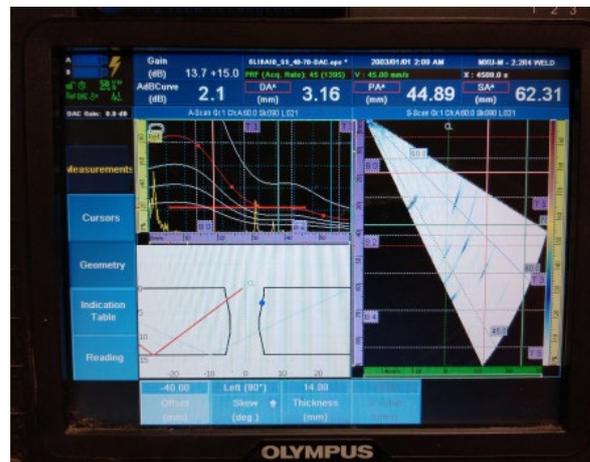
4. Individual signal 4: fusion flow (20 mm of length)

Figure 21. Welded plate—3: individual signal 4.

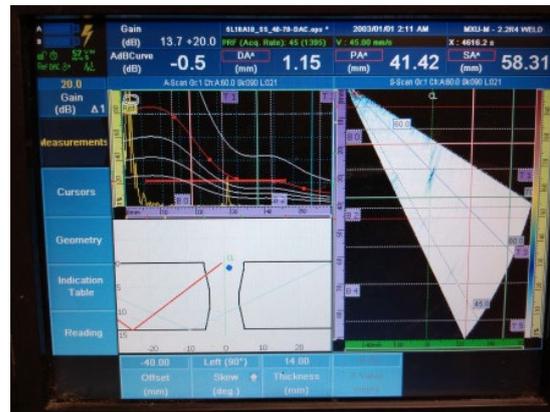
5. Individual signal 5: drilled hole ($\phi 2$ mm)

Figure 22. Welded plate—3: individual signal 5.

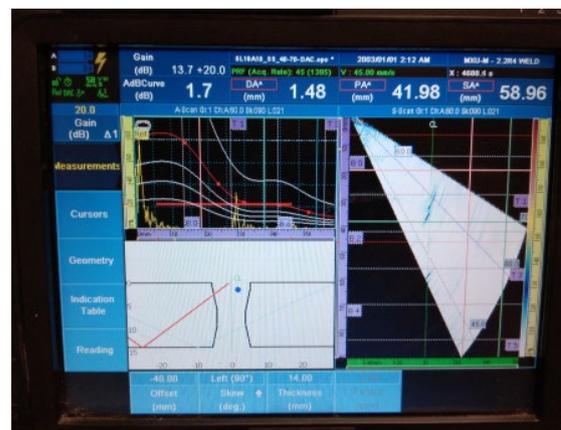
6. Individual signal 6: drilled hole ($\phi 2$ mm)

Figure 23. Welded plate—3: individual signal 6.

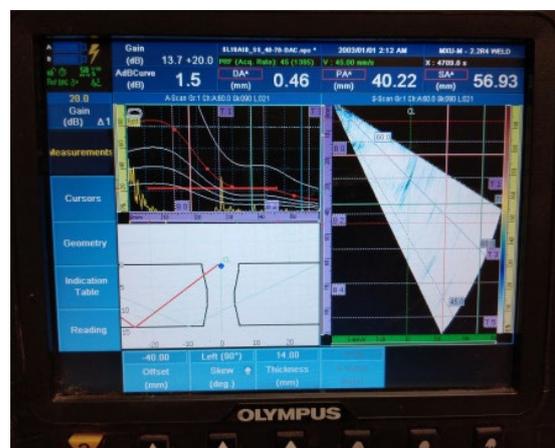
7. Individual signal 7: drilled hole ($\phi 2$ mm)

Figure 24. Welded plate—3: individual signal 7.

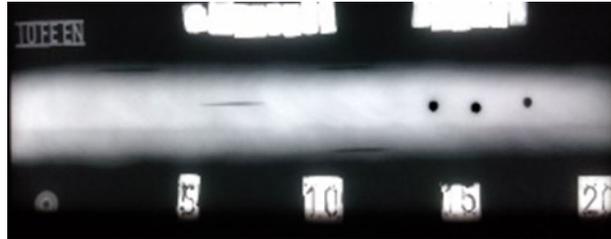
Figure 25. Radiogram of welded plate 3: 0–20 distribution.

The radiogram for welded plate 3 (Figure 25) also clearly shows all defects. According to the principle of different optical density, the defects are shown as dark areas in the

white of the weld. The spatial distribution of the defects within the weld explains why it was possible to detect individual defect signals with UT. As with earlier plates, classical RT testing can reliably determine defect size in two dimensions (length and width). The third dimension, which can be understood as both defect depth and depth in the weld metal, cannot be reliably determined. This is due to the technical limitations of the RT method itself.

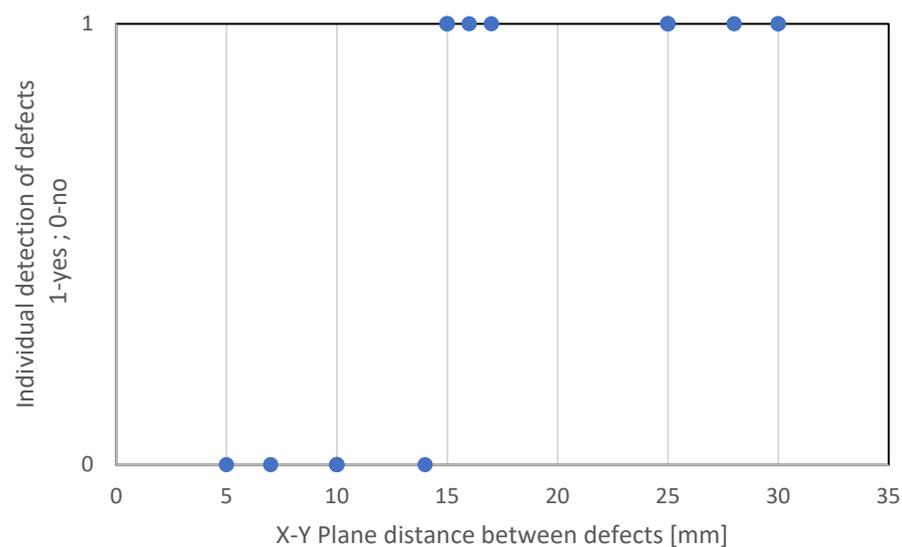
Figure 26. Dependence of individual detection of defects during UT examination on the distance between defects.

The examination results of welded plates 1, 2, and 3 confirm the assumption that it is possible to identify all embedded defects with both UT and RT. Tables 3–5 show that the main difference between the results obtained with RT and UT is the detection of individual defects. Experimental investigation confirmed that an approximate minimal distance between indications of 15 mm is necessary for UT to produce individual signal detection.
