# Test Research on Residual Mechanical Properties of Fiber-Reinforced Concrete Segments after High Temperature

**Abstract:** In order to research the residual mechanical properties of concrete shield tunnel segments after exposure to high temperatures, two types of concrete segments were designed: a self-compacting concrete segment and a mixed fiber (steel fiber and polypropylene fiber) self-compacting concrete segment. The mechanical properties of seven blocks of concrete segments (five segments after high-temperature exposure and two segments at room temperature) were tested to analyze the influence of different loading sizes and fibers on the development of cracks after high temperature, failure mode, crack width, deformation, and so on in the concrete segments. The results showed that the damage model of the segment after exposure to high temperature and the segment at room temperature were crushed in the pressurized zone, but the high temperature had little effect on the concrete in the pressurized area. The size of the preload at high temperatures had little effect on the remaining load capacity, and the effect on the number of cracks was mainly concentrated on the internal

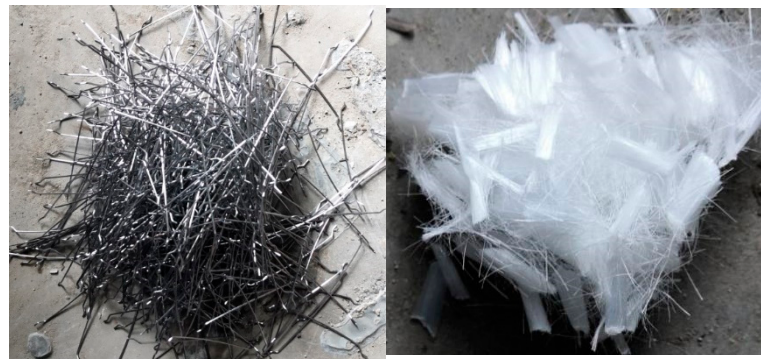
**Figure 1.** Steel fiber and polypropylene fiber.

The cubic concrete strength grade of the segment concrete was C50; the concrete mix proportion refers to the design results of self-compacting concrete given in references [17,18], and its matching ratio is shown in Table 1. Steel fiber can improve the strength of concrete, whereas polypropylene fiber forms pores after being exposed to high temperatures, facilitates the flow of water, and can reduce the vapor pressure of concrete. As shown in Figure 1, 30 kg/m<sup>3</sup> of steel fiber and 2 kg/m<sup>3</sup> of polypropylene fiber were added to the mixed fiber concrete. The length of the steel fiber was 35 mm and its diameter was 0.7 mm; the length of the polypropylene fiber was 12 mm and its diameter was 0.03 mm; and the melting point was about 170 °C.

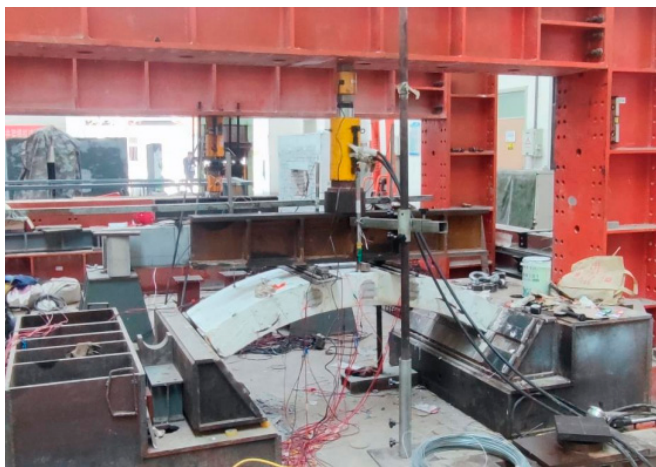
**Figure 3.** Restraint device and loading device. (a) Real view of the test device. (b) Three-dimensional diagram of the test device.

The test device was formed with a set of reaction frames, a vertical jack, a horizontal jack, a distribution beam, and a set of supports (the left and right ends of the test sample correspond to fixed hinge supports and movable hinge supports, respectively), and the specific dimensions were the same as those described in reference [22], the test device was shown in Figure 3 (China University of Mining and Technology, Xuzhou, China).

At the movable support end, the horizontal displacement of the segments was limited to form a restraining axial force.

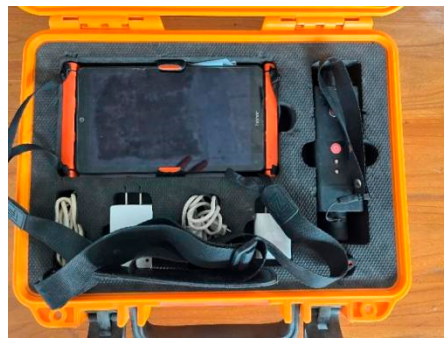
**Figure 6.** Crack width observation instrument.

As shown in Figure 6, the crack width was measured using a ZBL-F120 crack width observation instrument (Zhengzhou Zhuotai Testing Equipment Co., Ltd, Zhengzhou, China).
