# Behavior and Early-Age Performance of Continuously Reinforced Concrete Bus Pad

Sang Cheol Park, Kang In Lee, Soon Ho Baek, Sang Jin Kim and Seong-Min Kim \*

## Abstract

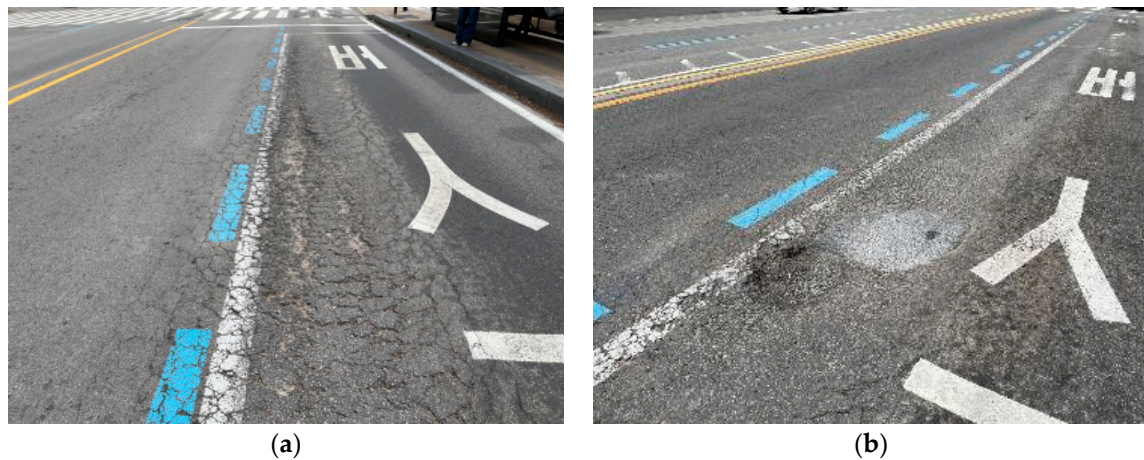
**Figure 1.** Damages of bus stop asphalt concrete pavement: (a) cracks and rutting; (b) pothole.

in pavement damages such as cracks, rutting, and potholes, as shown in Figure 1. The damages to asphalt concrete pavement cause inconvenience to users and require frequent maintenance, resulting in significant costs.

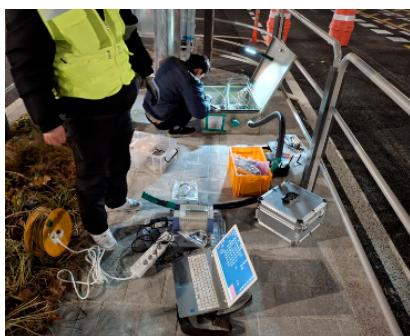
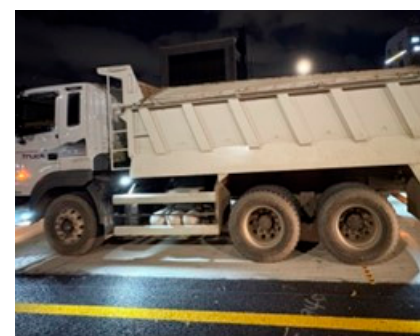
**Figure 19.** Dynamic load test using moving vehicle: (a) data logging system; (b) vehicle moving on bus pad; (c) vehicle stopping on bus pad.
