# Stress Corrosion Cracking (SCC) Resistance of the AW-5083 Alloy with a Plasma Electrolytic Oxidation (PEO) Coating in the Presence of Chloride ( $\text{Cl}^-$ )

This article presents a comparative study of mechanical properties and stress corrosion cracking (SCC) resistance of bare AW-5083 aluminum alloy and the same alloy coated by plasma electrolytic oxidation (PEO). Although Al–Mg alloys of the 5XXX series have been extensively studied with respect to SCC behavior, data concerning their performance after PEO treatment under mechanical loading in chloride-containing environments remain scarce. Prior to SCC testing, potentiodynamic polarization measurements were performed to assess the barrier properties of the PEO coating against general corrosion. The results demonstrate that the PEO coating significantly modifies the electrochemical response of the alloy and improves its resistance to corrosion processes in the presence of chloride ions. SCC tests revealed that the application of the PEO coating leads to enhanced resistance to stress-assisted degradation of the AW-5083 alloy, while distinct features of coating cracking under tensile loading were observed and discussed. The s

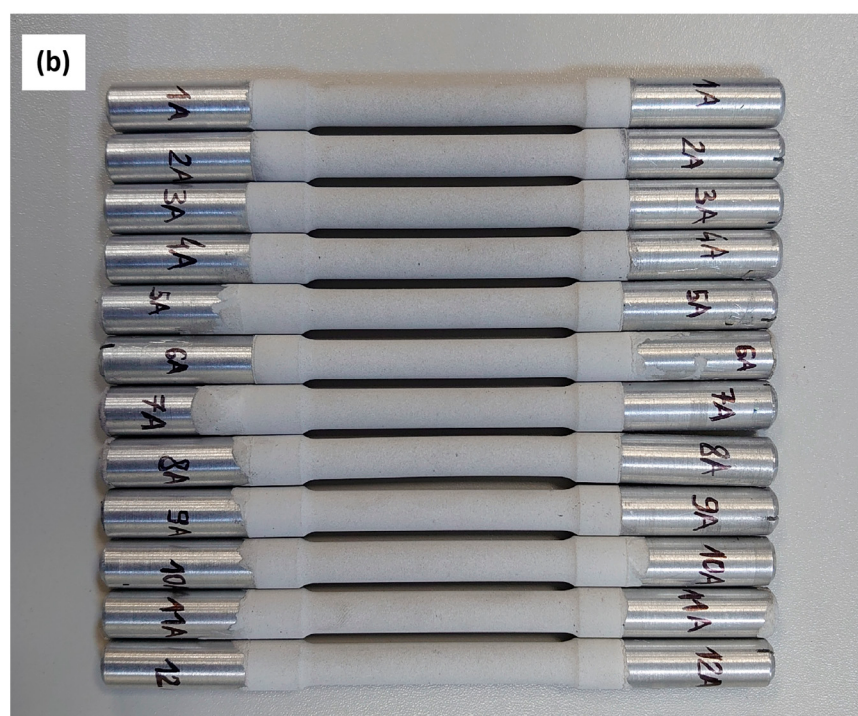
**Figure 1.** (a) Geometry and dimensions of the samples for tensile testing in accordance with PN-EN ISO 6892-1 standard  $L_0 = 50$  mm,  $L_c = 70$  mm,  $L_t = 165$  mm,  $d_0 = 8$  mm,  $S_0 = 50.27$  mm<sup>2</sup> ( $d_0 = 5$  mm for the samples used in SCC testing with threaded grip sections—Figure 2); (b) A photo of the samples after PEO coating.

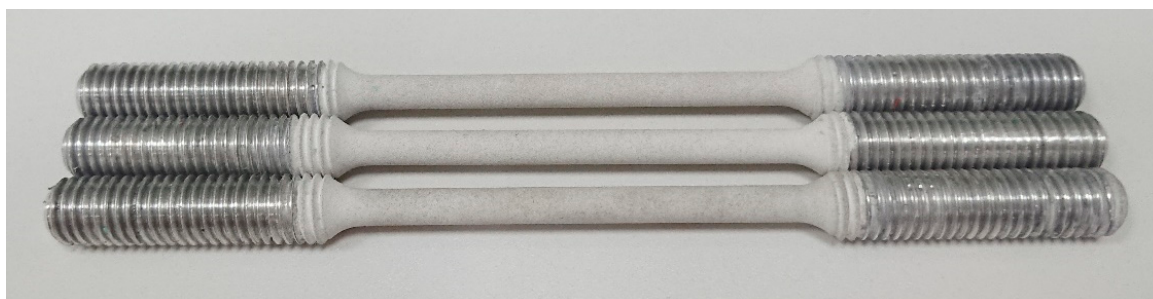
**Figure 2.** AW-5083 alloy samples with  $Al_2O_3$  PEO coating and with threaded grip sections for SCC testing.

Figure 2 shows the AW-5083 alloy samples with  $Al_2O_3$  PEO coating and with threaded grip sections for SCC testing. The surfaces of the samples coated with the PEO layer were not polished and were left in the as-obtained state after removal from the electrolyzer. The measured surface roughness values were  $R_a = 4.171$   $\mu$ m and  $R_z = 20.756$   $\mu$ m. Surface roughness was determined using an Olympus OLS40-SU confocal microscope (Olympus, Tokyo, Japan) equipped with LEXT OLS4100 software, version 3.1.7.14.

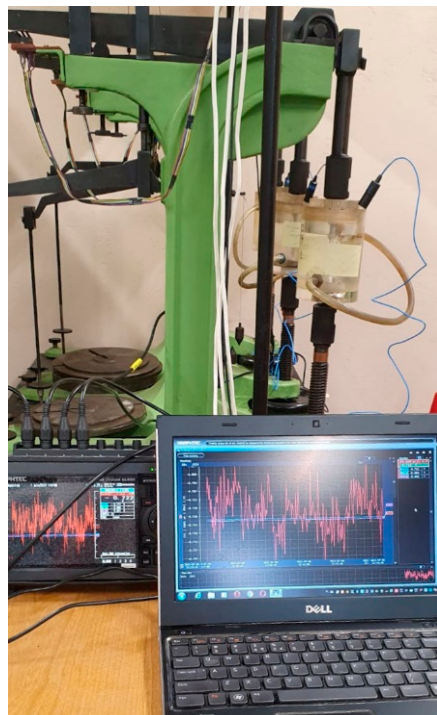
**Figure 6.** The measuring station for SCC at the constant tensile stress that can assess corrosion potential.

Figure 6 shows the measuring station for SCC at the constant tensile stress that can assess corrosion potential. The tensioning device exerts tensile stress on a given part of the sample which is placed in a container with 20 °C 3.5 wt.% NaCl solution and equipped with a saturated calomel electrode as a reference electrode. A tested sample was a counter electrode and together with the reference electrode EK-101 they were connected to a multi-channel potential measuring device working on-line. The samples were placed in the containers with NaCl solution in such a way that only the parts with PEO coating were submerged. Threaded parts (without coating) were isolated with silicone.

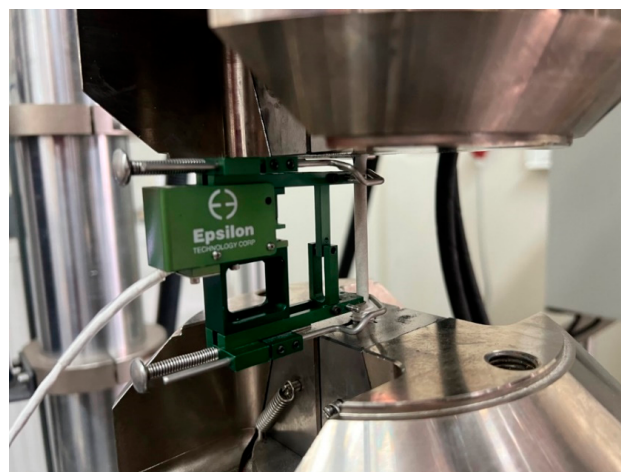
**Figure 7.**  $Al_2O_3$  coated AW-5083 alloy sample after SCC testing in a universal testing machine with the extensometer Epsilon model 3542.

After SCC testing and corrosive exposure in NaCl solution were finished, coated AW-5083 alloy samples were cleansed, dried, and weighed. Afterwards, static tensile testing was performed, as prescribed by the PN-EN ISO 6892-1 standard [26] with a universal testing machine produced by Zwick&Roell type MPMD P10B [29] with an extensometer, Epsilon model 3542 [30] (Figure 7). The results were registered with testXpert II software version 3.61 released by Zwick&Roell.
