# Unveiling the Degradation Mechanism of Impermeability and Pore Structure in Concrete Under Long-Term Water Exposure

To investigate the evolution of impermeability and pore structure in concrete under long-term service, systematic tests were conducted on submerged concrete from dam sections with over 75 years of service. Results show that the surface water permeation resistance index of concrete in the downstream section of the main dam is only  $9.19 \times 10^{-9}$ , significantly lower than that of concrete from the upstream of the main dam (UMD), downstream of the main dam (DMD), upstream of the auxiliary dam (UAD), and upstream of the weir (UW). Moreover, its impermeability improves noticeably within the 0–100 mm depth range. Mercury intrusion porosimetry revealed that the median pore diameter, average pore diameter, pore content, and porosity in this region reach 306.7 nm, 55.4 nm, 35.64%, and 3.961 mm, respectively—all markedly higher than in other dam sections. Combined XRD and SEM/EDS analyses indicate that crystallization pressure from saline solutions in the coastal environment, together with long-term carbonation, leads to structural loosening and increased porosity i

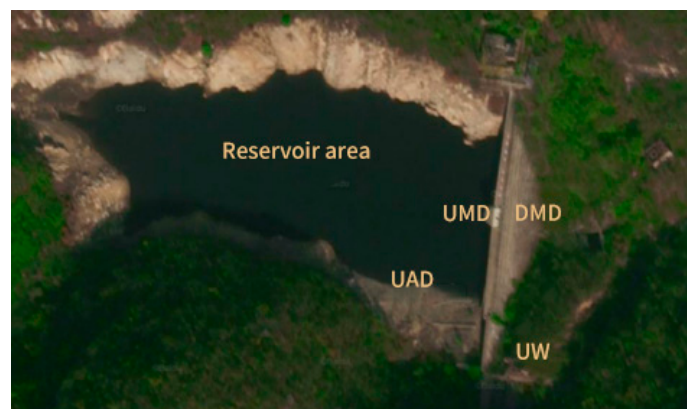
**Figure 1.** The schematic location of UMD; DMD; UAD; UW.

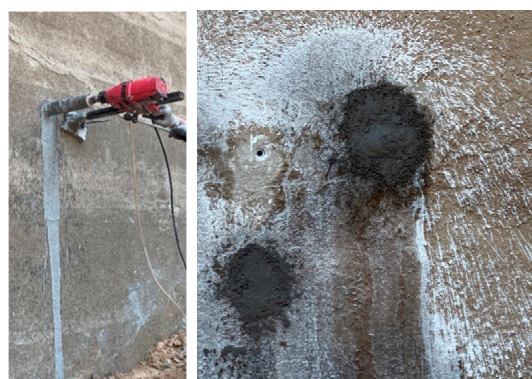
**Figure 2.** Dam sampling and sealing process.
