Communication

# First Exploratory Study on the Ageing of Rammed Earth Material

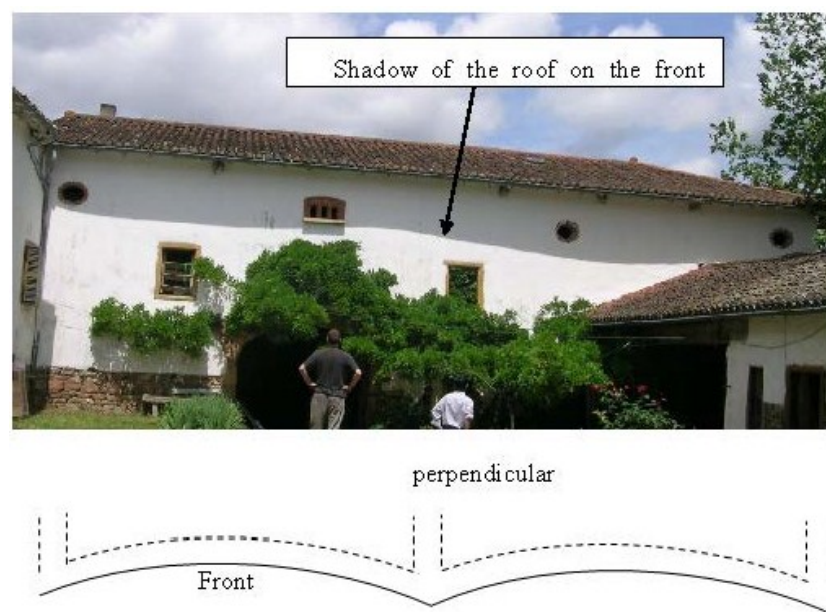
**Figure 1.** A rammed earth wall more than 200 years old. Upper: front view; bottom: plan.

Figure 1 presents an example of a rammed earth wall which is more than 200 years old. Note that the shadow of the roof on the front wall is not a horizontal straight line. This is due to the horizontal buckling of this wall that can be seen on the plan (Figure 1, bottom). The buckling

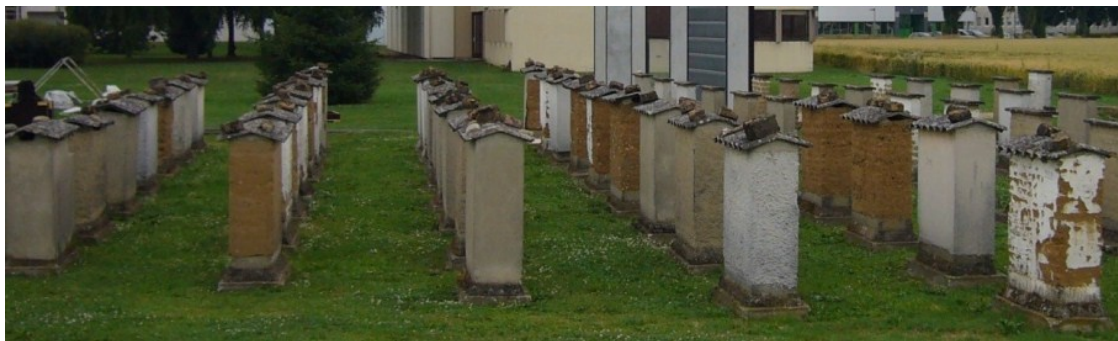
The wall specimens were built in 1985 (Figure 2) thanks to the Rexcoop program, controlled by the French Scientific and Technical Building Center (CSTB), near Grenoble, in a French Alpine valley, at an altitude of 212 m. The temperature of the site can vary from  $-20^\circ\text{C}$  to  $38^\circ\text{C}$  for some particular years and its average varies from  $2^\circ\text{C}$  to  $20^\circ\text{C}$ . The annual rainfall is about 1000 mm, the direction of prevailing winds is NE-SW and the maximum wind speed is 21 m/s.

**Figure 2.** Rammed earth walls constructed and exposed for 22 years to natural weathering.

The rammed earth walls (1 m width  $\times$  1.1 m height  $\times$  0.4 m thickness) were manufactured on a concrete foundation with a 25 cm base exposed above ground level. A bituminous layer was painted on top of the base to prevent water from capillary rise penetrating into the RE walls. Local soil from a nearby site mixed with a cultivator was used for the RE walls. Three soils were used but in this study, only walls from one soil were investigated. Its grain size distribution is presented in Figure 3.

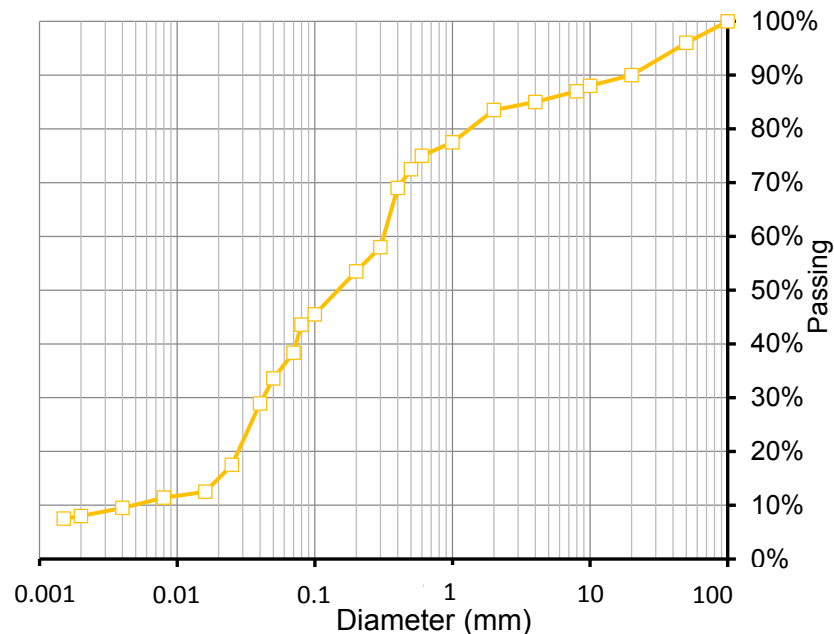
**Figure 3.** Grain size distribution of the used soil.

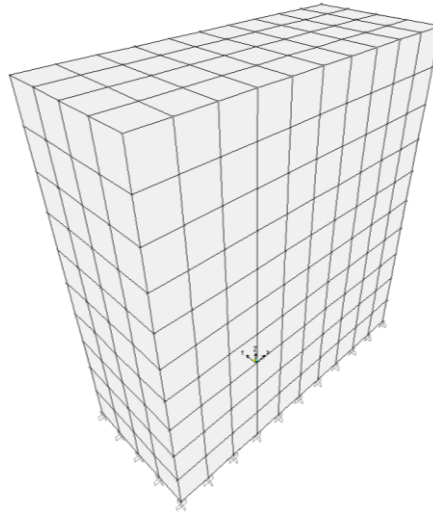
The walls are modelled with solid elements (Figure 6). Following the dynamic of structures theory, for given dimensions, the natural frequencies depend only on the density and the elastic characteristics of the material. For the modelling, the material was assumed isotropic (which is acceptable for dynamic measurements which were performed in very small strain [1]). The Poisson's ratio was taken of 0.22 following a previous study [7]. The nodes between the RE wall and the concrete foundation were restrained in translations. This boundary condition can be justified following the results presented

**Figure 6.** Wall A modelled with FEM.

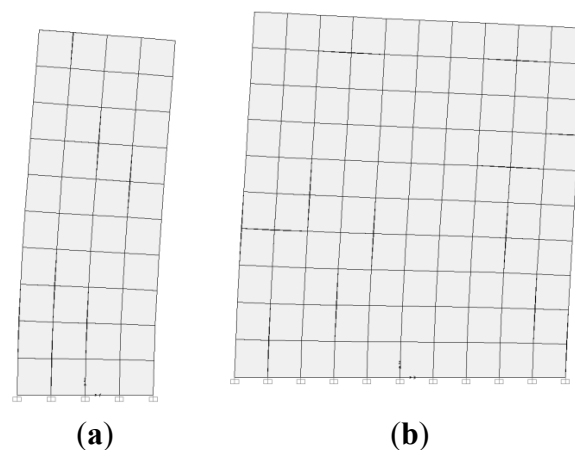
The dry density was measured in laboratory and will be presented in Section 3.2. The results of the identified modulus are given in Table 1. The first main modes of vibration are shown in Figure 7.

**Figure 7.** First vibration modes of the wall A. (a) First vibration mode, in the transversal direction; (b) second vibration mode, in the longitudinal direction.

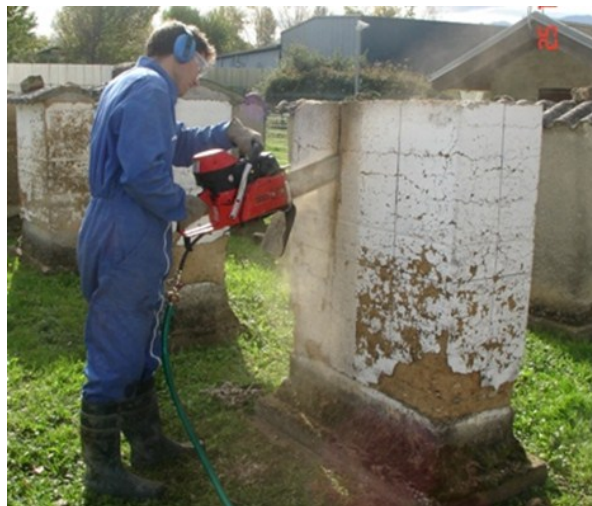
The specimens were taken from the walls using a chainsaw generally used to cut concrete and stones (Figure 8). Its blade was 30 cm long, meaning that the total thickness of the wall (roughly 41 cm) had to be cut in two steps. The disadvantages of using this method to take specimens are the generation of vibrations and the use of water, which can decrease the mechanical strength of the specimens, notably due to the splitting apart of the layers of earth.

**Figure 8.** Cutting a wall with chainsaw.

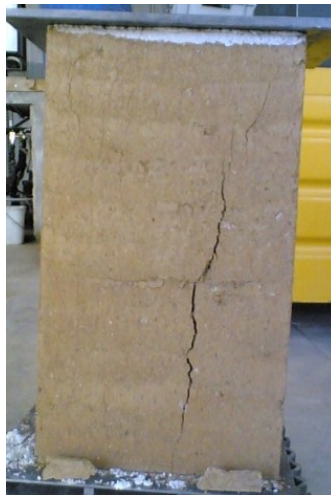
Discussions about the representativeness of specimens manufactured in laboratory were presented in the literature [1,9]. Indeed, to ensure a faithful representation of the *in-situ* wall material, the manufacturing mode and material used for laboratory specimens should be as identical as possible to those used *in situ*. The manufacturing water content and the compaction energy in the laboratory were chosen similar to that on site. The manufacturing water content was 10%. The specimens were rammed by an artisan of rammed earth with his pneumatic rammer. The dimensions of specimens tested in the direction perpendicular to the layers were  $40 \text{ cm} \times 40 \text{ cm} \times 70 \text{ cm}$ , with nine layers (Figure 9).

**Figure 9.** A specimen  $(40 \times 40 \times 70) \text{ cm}^3$  after the compression test.

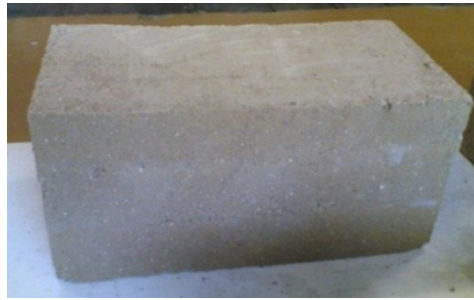
The specimens to be tested in the parallel direction were composed of three layers; their dimensions were  $40 \text{ cm} \times 40 \text{ cm}$  and  $20 \text{ cm}$  high. Special attention was given during compaction of the last layer to obtain a surface that was as flat as possible. To achieve a slenderness ratio of 2, the specimens were then cut with a table saw. Two specimens  $(40 \times 40 \times 20) \text{ cm}^3$  provided four specimens  $(20 \times 20 \times 40) \text{ cm}^3$  for testing in the parallel direction (Figure 10). For specimens tested in the direction parallel to the layers, a surfacing was not necessary, because the two surfaces that were in contact with the formwork were sufficiently flat.

**Figure 10.** A specimen ( $20 \times 20 \times 40$ ) cm<sup>3</sup> cut from a specimen ( $40 \times 40 \times 20$ ) cm<sup>3</sup>.
