# Application of Nondestructive Testing Technologies in Preserving Historic Trees and Ancient Timber Structures in China

**Citation:** Xu, P.; Guan, C.; Zhang, H.; Li, G.; Zhao, D.; Ross, R.J.; Shen, Y. Application of Nondestructive Testing Technologies in Preserving Historic Trees and Ancient Timber Structures in China. *Forests* **2021**, *12*, 318. <https://doi.org/10.3390/f12030318>

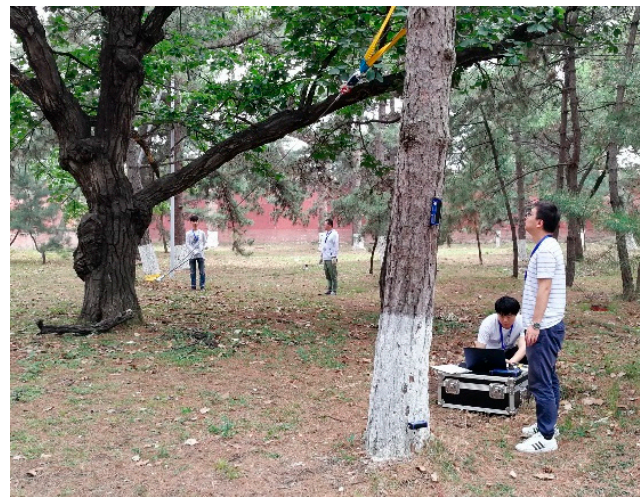
**Figure 2.** Field inspection of anchorage using the pulling test [45].

A total of 29 trees were selected and fully inspected with a combined method of visual inspection, sounding, stress wave transmission velocity method, Resistograph, stress wave tomography, and the pulling test as well. First, scholars used a visual inspection to evaluate overall conditions of the trees including tree height, DBH, tree shape, crown area and centroid height, trunk surface defects, and a branch growth trend. The heights were measured using a Brul es altimeter. The crown area, crown shape, and contour center height were measured using AutoCAD software to outline and scale photos of trees taken by a smartphone. Then, researchers conducted an NDT study of a tree trunk's internal defects (Figure 1) with a combination of a stress wave transmission velocity method, Resistograph, and stress wave tomography. After a rapid screening of the trunk's internal defects using the stress wave transmission velocity method, further defect detection was performed using Resistograph and stress wave tomography. By this detection of trunk defects, researchers verified the effectiveness of these three NDT methods mentioned above and, thus, developed an accurate and efficient NDT procedure for detecting defects inside the trunk. In addition, tree anchorages of eight trees were determined by the pulling test (Figure 2).

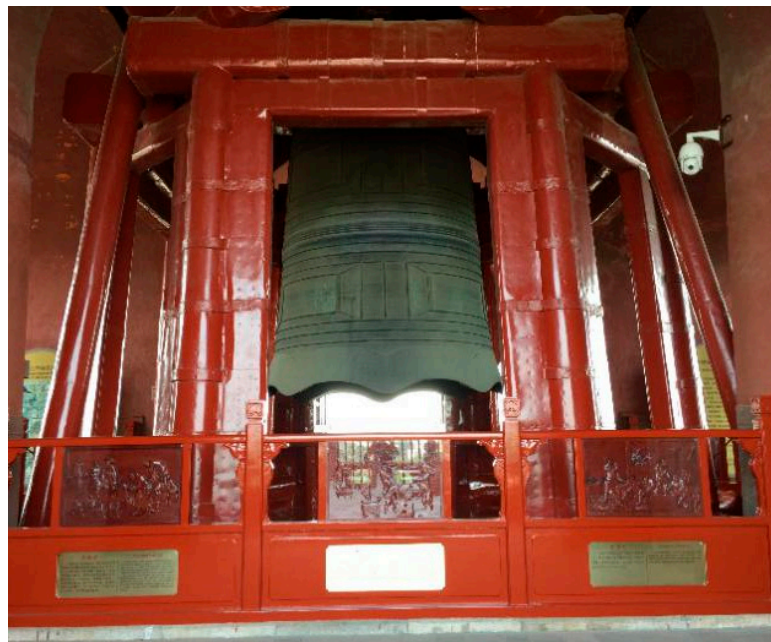
The Bell Tower (Figure 4), located on Di'anmen Outer Street in Dongcheng District, Beijing, China, was built in the 18th year of the Yongle period of the Ming Dynasty (1420) and rebuilt in the 10th year of the Qianlong period of the Qing Dynasty (1745). The bell, which weighs 63 tons, is supported and suspended by an octagonal wooden frame, as shown in Figure 5. Based on the need for protection and maintenance of the Bell Tower, a research team from the Beijing Forestry University conducted an on-site research inspection for wooden elements of the Supporting Wood-Frame, such as columns, beams, and tie-beams [52].

Figure 4. Bronze bell on the second floor of the Bell Tower [52].

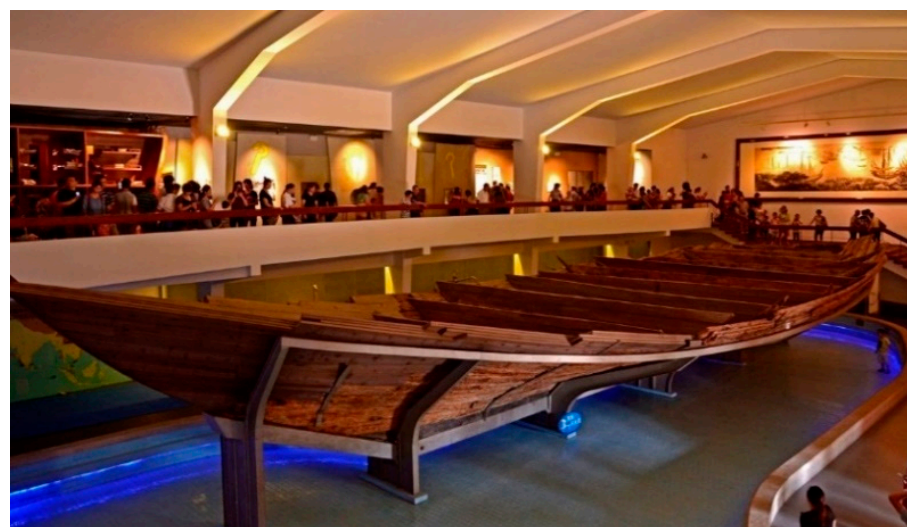
Figure 7. The Song Dynasty shipwreck in Quanzhou Bay [53].

The Song Dynasty shipwreck (Figure 7), built over 900 years ago, is the oldest, largest, and relatively well-preserved ancient shipwreck that has been excavated in China so far. Based on the unique preservation status of Song dynasty ships in Quanzhou Bay, urgent research is required for the preservation of the materials and structure of ancient ships. Recently, the research team at the Beijing Forestry University conducted NDT research on this shipwreck and some progress has been obtained [53]. In this project, researchers adopted an NDT method of AE technology combined with digital image technology to build a monitoring system for the Song Dynasty Shipwreck.

Researchers conducted a visual inspection and an AE detection on the second bulk-head at the stern as well as a digital image monitoring on the bottom of the stern, and closely monitored the temperature and humidity in the room. After a year of continuous monitoring, researchers found that both AE monitoring and digital image monitoring were of a practical value for monitoring the preservation status of wooden ships. By monitoring the relative humidity of the environment and AE counts, researchers found that the AE parameter—ring counting were positively and significantly correlated with the daily variation of relative humidity in the indoor environment. In addition, researchers have observed the deformation of wooden structures over time through digital images.
