## Article

# Impacts of Hurricane Michael on Watershed Hydrology: A Case Study in the Southeastern United States

**Citation:** Worley, E.; Liu, N.; Sun, G.; Norman, S.P.; Christie, W.M.; Gavazzi, M.; Boggs, J.; McNulty, S.G. Impacts of Hurricane Michael on Watershed Hydrology: A Case Study in the Southeastern United States. *Forests* **2022**, *13*, 904. <https://doi.org/10.3390/f13060904>

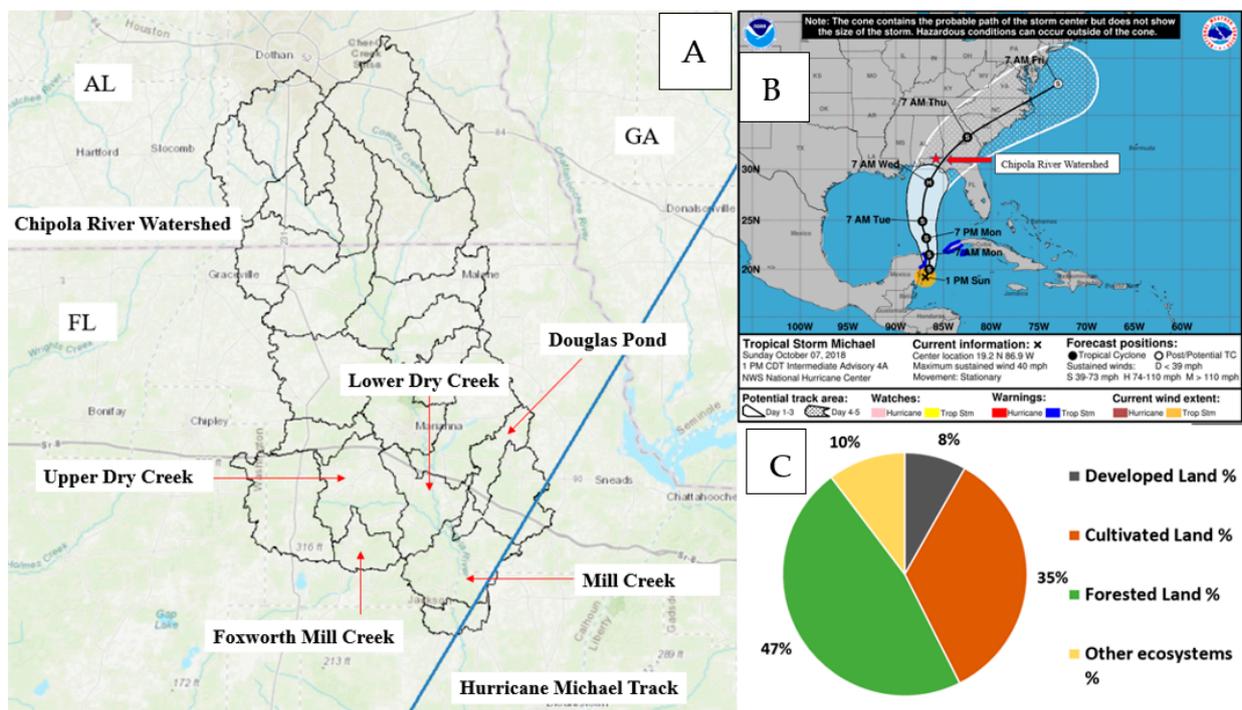
**Figure 1.** Location of Chipola River watershed (A) in association with hurricane track (blue line), hurricane track and categories over time (B) (<https://www.weather.gov/tae/HurricaneMichael2018>) (accessed on 15 February 2022), and breakdown of land use and land cover of the study watershed (C).

The Chipola River watershed (2023 km<sup>2</sup>) was chosen as the area of interest for this study due to its location within the track of Hurricane Michael, the availability of pre-disturbance and post-disturbance streamflow data, and the large fractional forest cover (47%) of the watershed (Figure 1). The Chipola River watershed includes a portion of the northern panhandle of Florida and southeastern Alabama and includes the city of Marianna, Florida, and southern portions of Dothan, Alabama. Most forested areas within this watershed are in low gradient areas with water table levels close to the surface. Small streams' drainage is characterized, and coastal wetlands aid in surface water retention [13]. The average annual precipitation for this area is approximately 1360 mm/yr. The annual temperature across this watershed ranges between 10 and 28 °C. Based on the 2016 National Land Cover Database (NLCD) data product, the Chipola River watershed includes 47% forested land, 35% cultivated land, 8% developed land, and 10% classified as other ecosystems (Figure 1). The majority of forested areas within the watershed are classified by the NLCD as evergreen forest (24%) or woody wetlands (21%). Aerial and ground photographs shown in Figure 2 depict severe forest damage from Hurricane Michael across the Chipola River watershed.

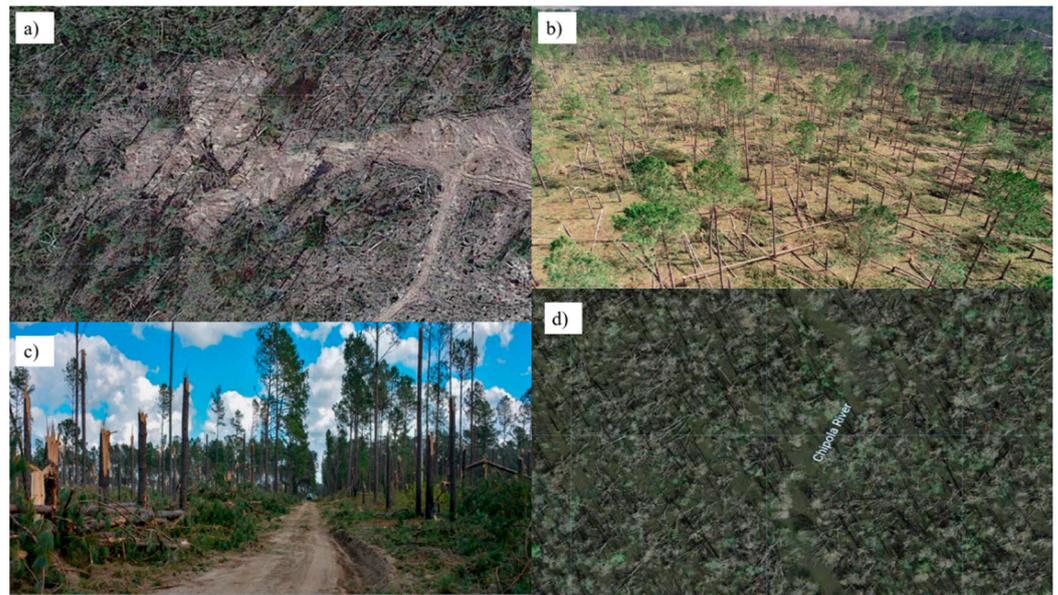
**Figure 2.** Aerial and ground imagery of Hurricane Michael damage to both plantation and natural forests. Salvage harvesting efforts within the Chipola River watershed (a), aerial (b) and ground (c) imagery of Hurricane Michael damage from the Alabama Forestry Commission Initial Damage Report [27] (reprinted/adapted with permission from the Alabama Forestry Commission. 2018, Elishia Ballentine), and (d) downed stems and canopy damage to riparian forests surrounding the Chipola River.

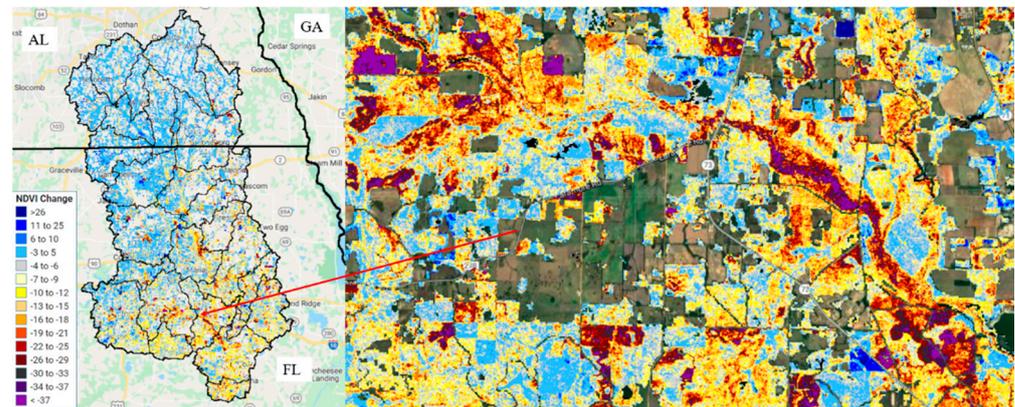
**Figure 3.** Change in growing season NDVI of forested lands between pre-storm (2018) and post-storm (2019–2020) periods within the Chipola River watershed using Google Earth Engine Sentinel 2 Level-2A data. NDVI change output is calculated as absolute change (NDVI value multiplied by 100). Satellite RGB images illustrate post-storm conditions, salvage harvesting, and riparian zone destruction. Within the highlighted areas NDVI levels of 0.77 before the storm dropped to 0.22 within the severely impacted (purple) areas following Hurricane Michael.

Utilizing the capabilities of Earth Engine and Sentinel 2 imagery data, we found severe and large-scale forest disturbance within the southern portion of the Chipola River watershed (Figure 3). High-resolution satellite images depict broken stems, damaged crowns, and other impacts on managed forest stands and bottomland riparian systems buffering the Chipola River. These impacts correspond with the timber damage estimates listed in the reports issued by the Alabama, Florida, and Georgia Forestry Commissions. An overall shift in the frequencies of NDVI values between the 2018 and 2019 growing seasons is shown in Figure 4. The average NDVI value dropped from 0.64 to 0.59, illustrating a significant shift to lower values ( $p < 0.0001$ ). From the 2019 to 2020 growing season, a positive NDVI change was observed ( $p < 0.0001$ ). This recovery could be explained by the regrowth of early successional species, natural regeneration of previous overstory species, and artificial regeneration efforts by land managers within the area.

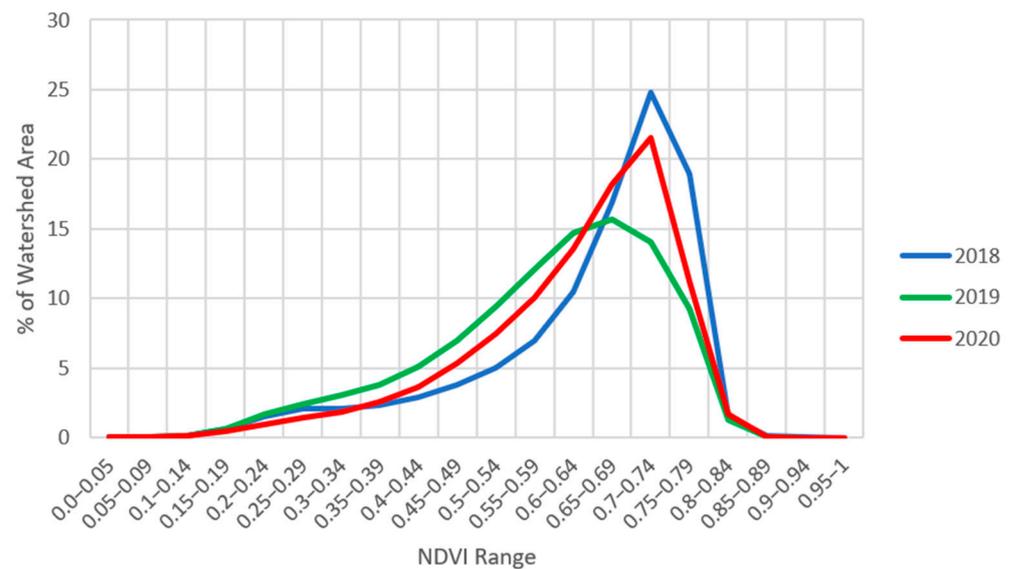
**Figure 4.** Growing season Sentinel-2 NDVI distribution between 2018, 2019, and 2020 within the Chipola River watershed. Average NDVI values were approximately 0.64, 0.59, and 0.62 for 2018, 2019, and 2020.

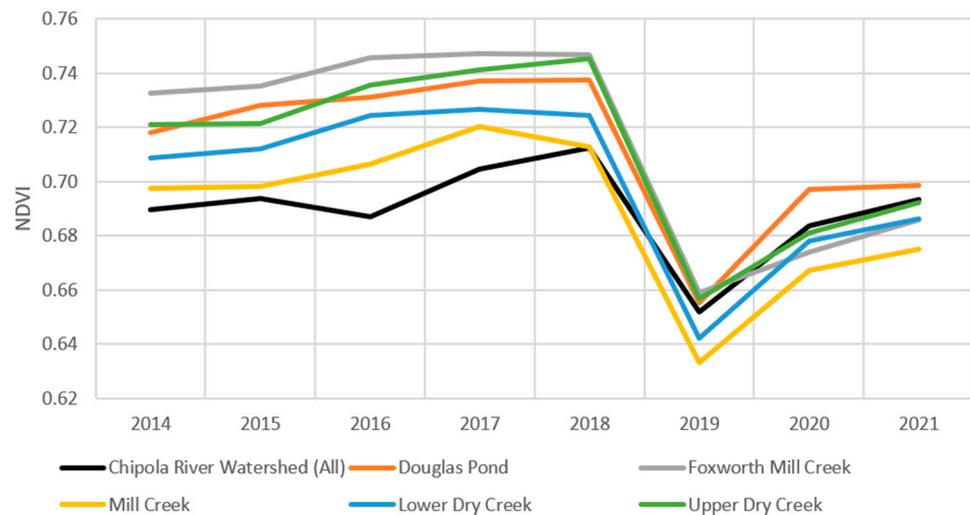
**Figure 5.** Changes in average growing season MODIS NDVI of severely impacted HUC12 subwatersheds by Hurricane Michael located in the southern portion of the Chipola River Watershed. Growing season for this analysis was defined as May through October.

Pronounced changes in the growing season MODIS NDVI occurred in five of the HUC12 sub-watersheds close to Hurricane Michael's path (Figure 5). A significant decline ( $p$ -value = 0.04) in NDVI (>10%) was observed for those sub-watersheds in 2019 compared to 2018, and a slight vegetation recovery was seen in 2020. A sharp decrease in growing season NDVI between 2018 and 2019 is illustrated in Figure 5 using the MODIS remote sensing product.

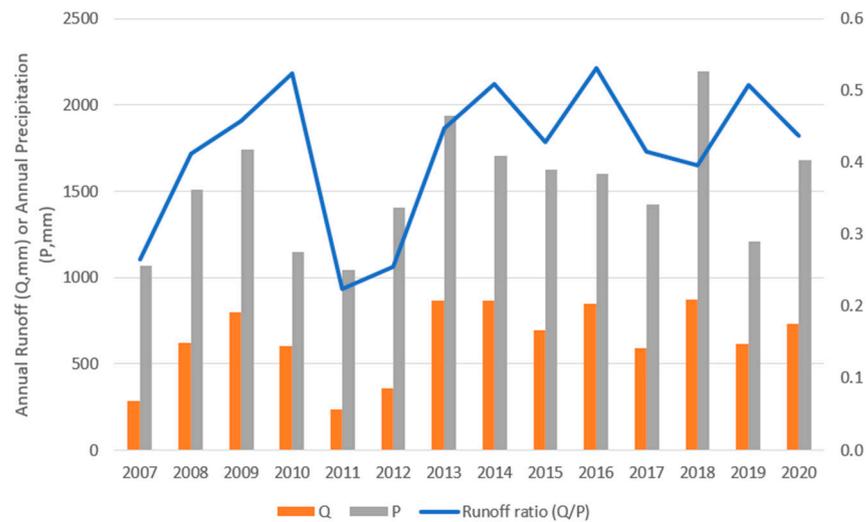
**Figure 6.** Total annual runoff and precipitation and runoff-rainfall ratio for the Chipola River watershed 2007–2020.

During the ten years before Hurricane Michael (2007–2017), the Chipola River’s mean daily watershed discharge was approximately 1392 cubic feet per second or 1.7 mm/day. During this period, the average gauge height was approximately 11 ft (3.4 m). During 2018, the daily average discharge increased to 1971 cubic feet per second or 2.4 mm per day; however, this increase was not significant ( $p > 0.05$ ). In the month of the hurricane event (October 2018), streamflow rates were 230% higher than the 10-year pre-hurricane flow values. These discharge rates were sustained into November 2018. Streamflow rates decreased by an average of 18% in 2019 compared to the 10-year average rates. Near-normal discharge rates were recorded over the majority of the 2020 year until observed streamflow were recorded at above-average rates from September through December. At the annual scale, the 2018 streamflow (870 mm) was much higher, but not significant, compared to 10-year “normal” values (642 mm) ( $p > 0.05$ ). During the following two years, streamflow values were lower (614 mm in 2019) and higher (733 mm in 2020) than the long-term mean but were not significantly different from this mean ( $p > 0.05$ ). However, the runoff–rainfall ratio (Q/P) (0.40) in 2018 was similar to the long-term mean (0.42). The Q/P for 2019 was 0.51, close to the record high (0.53) that occurred in 2016 after a tropical storm and a category 1 hurricane, both tracked near the Chipola River watershed, but Q/P was recorded at 0.44 in 2020. Measured discharge, precipitation, and corresponding runoff–rainfall ratio for 2007–2020 are shown in Figure 6.

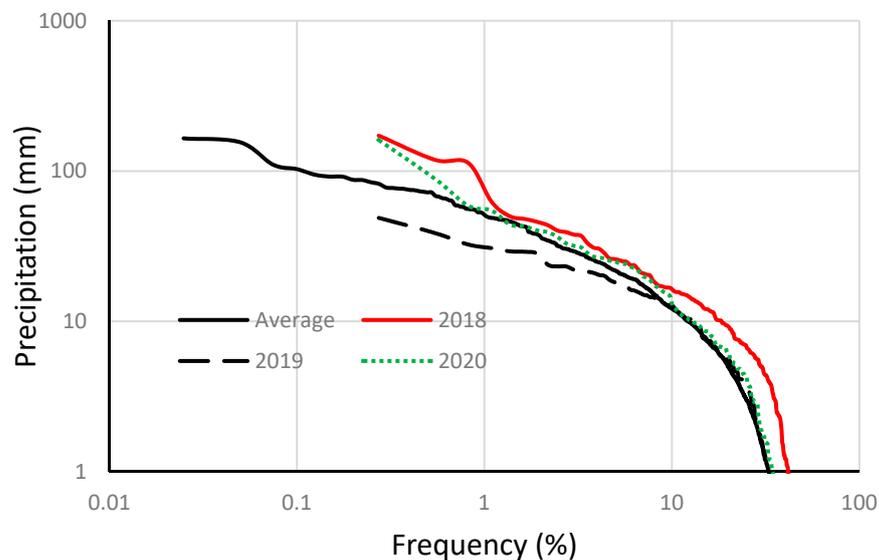
**Figure 7.** Precipitation flow curves for the 11-year (2007–2017) pre-Hurricane Michael and the individual years following the disturbance event in 2018 in Chipola River Watershed.

Daily rainfall in 2018 was much above the historical daily average. Additionally, the 2018 storm frequency (all degrees of intensity) was much above the historic storm frequency, Figure 7). Daily rainfall distributions in 2019 and 2020 were close to the historical means for over 95% of rainfall events. However, fewer storms produced less than 20 mm of precipitation during 2019 and 2020 compared to the historic period.

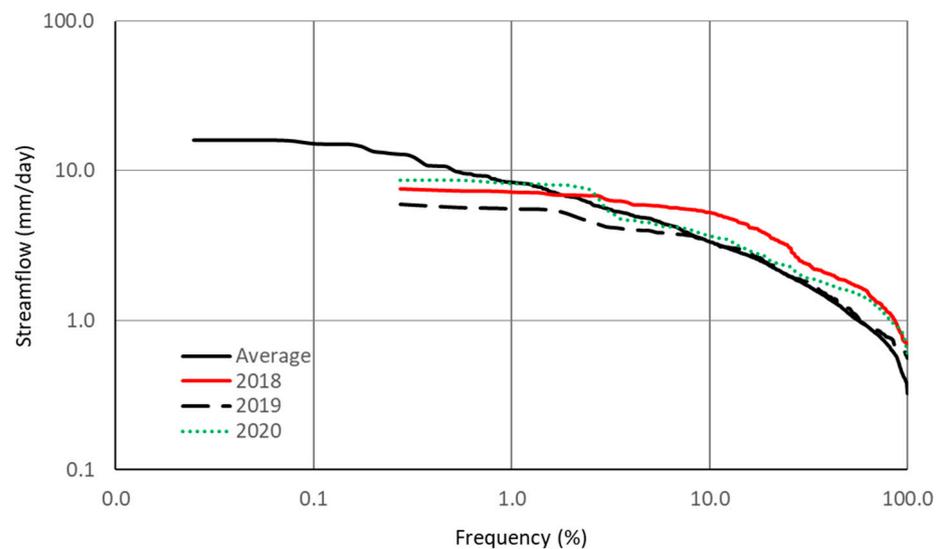
**Figure 8.** A comparison of streamflow flow duration curves for pre-Hurricane Michael (2007–2017) and the individual years following the disturbance event in 2018 in Chipola River Watershed.

Daily streamflow rates in 2018, similar to precipitation patterns, were higher than the 10-year average for all categories (Figure 8). However, most 2020 streamflow rates (exceedance > 10%) were higher than historical data. For 2019, streamflow distribution was similar to historical patterns but was lower in high flow categories (exceedance < 10%).

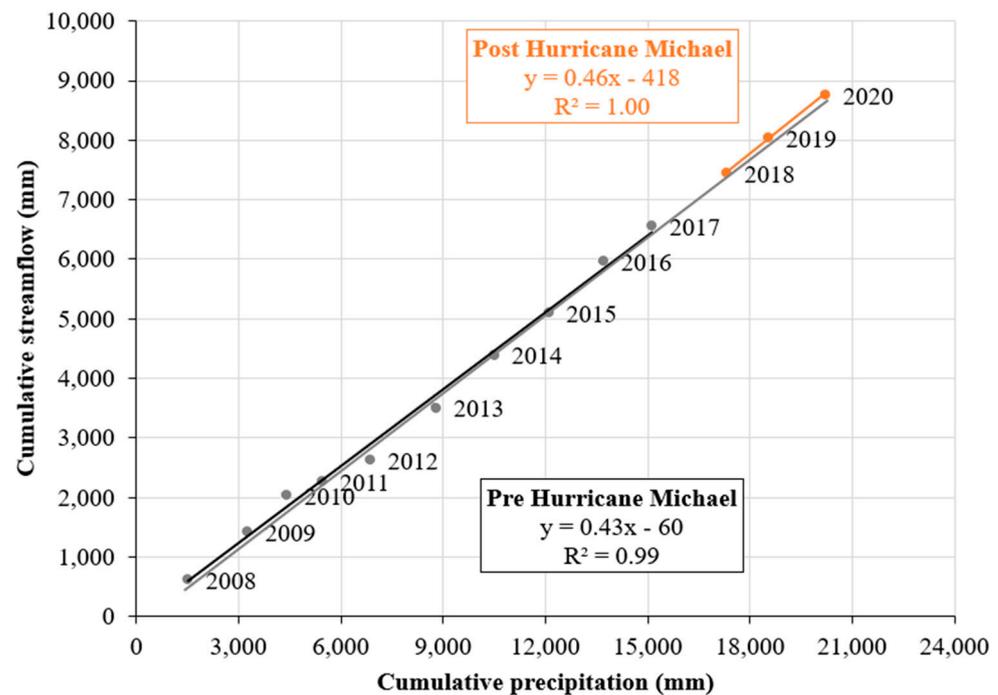
**Figure 9.** Double Mass Curve (Accumulative annual precipitation vs. streamflow for the period from 2007 to 2020) for Chipola River Watershed for detecting streamflow change during 2018–2020 due to Hurricane Michael in October 2018.

The DMC curve (Figure 9) shows that 2018 had the expected flow, but 2019 had no significant departure from the regression line developed using 2007–2017 ( $p > 0.05$ ). Based on the DMC for pre-Hurricane Michael, the expected accumulative flow was 8371 mm in 2019 compared to the measured flow of 8249 mm, suggesting a negative accumulative flow deviation of 121 mm. Because the accumulative deviation in 2018 was  $-215$  mm, the actual flow change in 2019 was determined as 94 mm. Similarly, the change in streamflow of 11 mm was detected for 2020. DMC theory attributed these changes to factors beyond precipitation, such as vegetation change that affected ET. Therefore, the detected magnitudes of increased flow (11–91 mm) were considered within the modeling errors and not significant statistically. From 2007 to 2017, flow change due to factors beyond precipitation by the DMC model varied from +163 mm to  $-246$  mm. Therefore, the slopes of the regression models (0.43 vs. 0.46) for the two periods were not significant ( $p > 0.1$ ).

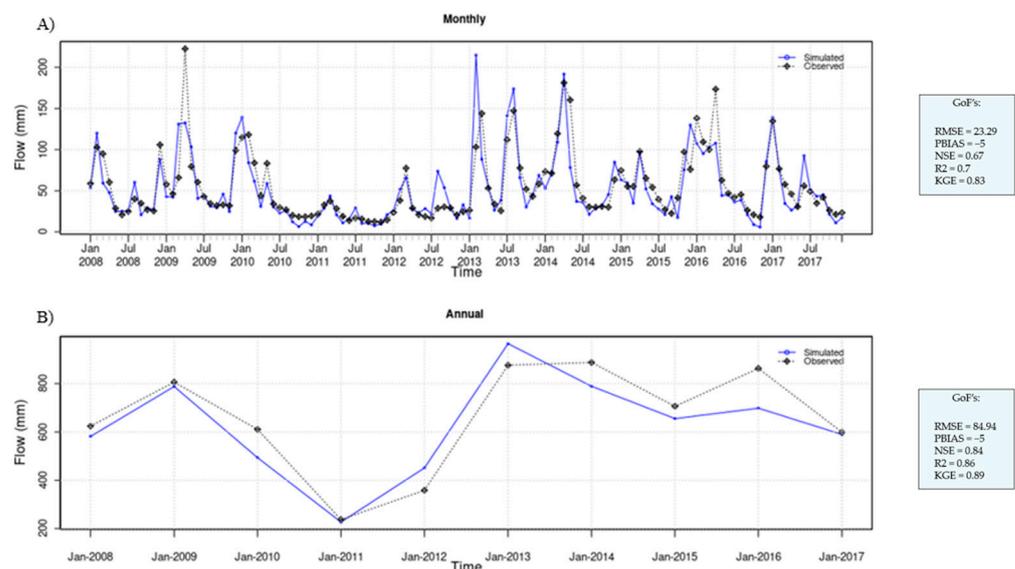
**Figure 10.** The WaSSI model validation with (A) monthly and (B) annual measured streamflow at the USGS gauging station Chipola River near Altha, FL, USA, ID No. 02359000.

The WaSSI model was validated against observed streamflow data for the period before the 2018 Hurricane Michael. The WaSSI model performed satisfactorily at monthly and annual scales from 2008 to 2017. The model was evaluated with  $R^2$ , percent bias, and KGE [45], which were 0.7,  $-5\%$ , 0.83, and 0.86,  $-5\%$ , and 0.89 on the monthly and annual scales, respectively (Figure 10).

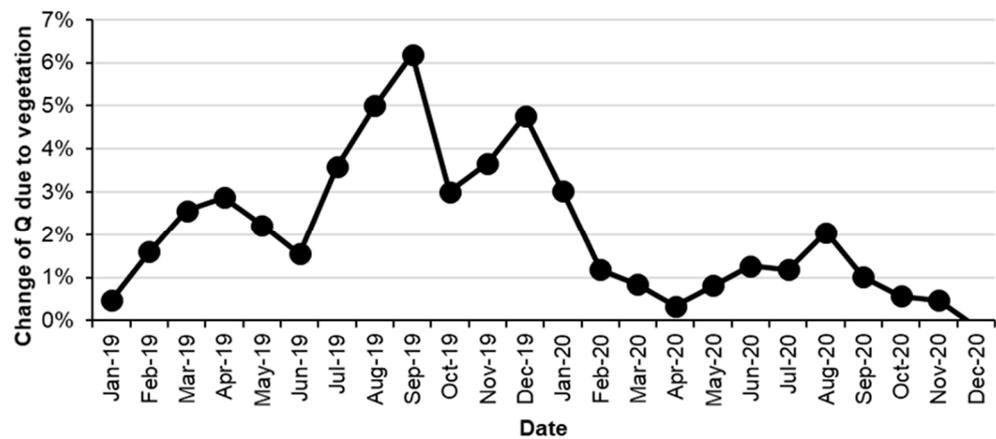
**Figure 11.** The monthly impact of vegetation damage on streamflow after Hurricane Michael from 2019 to 2020.

Consistent with the DMC method, the WaSSI scenario run did not detect significant increases in streamflow during 2019 and 2020 ( $p > 0.05$ ). At the annual scale, LAI change from vegetation damage on streamflow was small, resulting in 12 mm (2.6%) and 7.3 mm (1.0%) increases in inflow in 2019 and 2020. However, the effects of LAI decline were much stronger on the monthly scale in 2019, which led to a more than 5% increase in flow during August and September of 2019 (Figure 11).

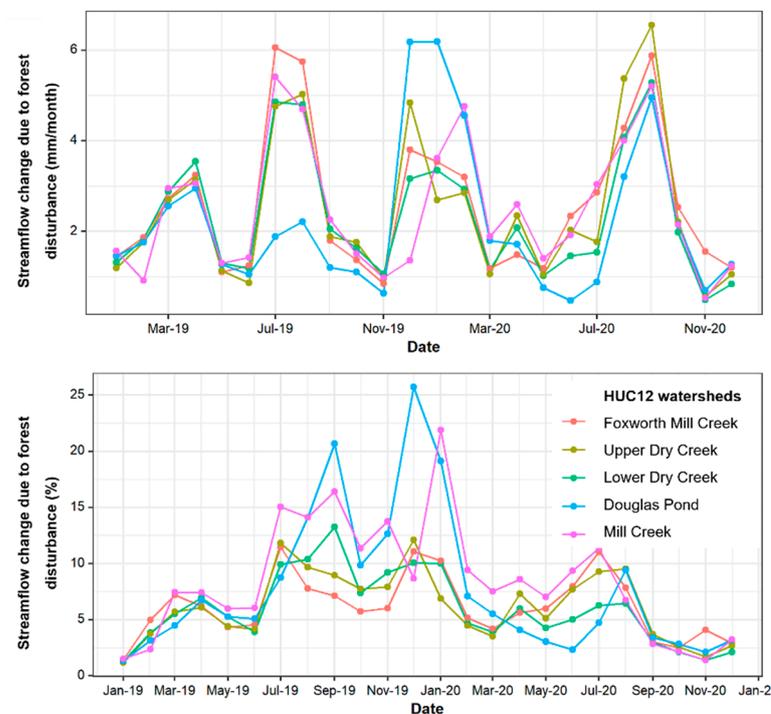
**Figure 12.** WaSSI modeled effects of Hurricane Michael on monthly flow for five HUC12 due to a decline in NDVI and vegetation damage in the Chipola River Watershed.

The impacts of forest disturbance from Hurricane Michael on streamflow were much higher in the southern part of the Chipola River Watershed, as represented in the five HUC12 sub-watersheds where a considerable decline in NDVI after the disturbance was detected (Figures 3–5). The vegetation damage resulted in an average increased flow of 29 mm (6%) (24 mm to 32 mm) during 2019 and 2020. The impact was highest from July 2019 to August 2020 but almost diminished after August 2020 (Figure 11). For example, the NDVI on the Mill Creek subwatershed reduced by an average of 14 % after Hurricane Michael (Figure 12), which resulted in a 27 mm (8%) and 32 mm (6%) increase in streamflow in 2019 and 2020, respectively. Moreover, the forest disturbance increased streamflow by an average of 12% (7–22 %) in July 2019 and July 2020.
