Article

# Rapid Excavation and Stability Control of Deep Roadways for an Underground Coal Mine with High Production in Inner Mongolia

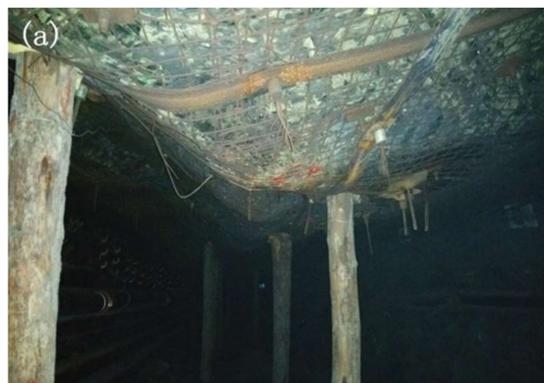
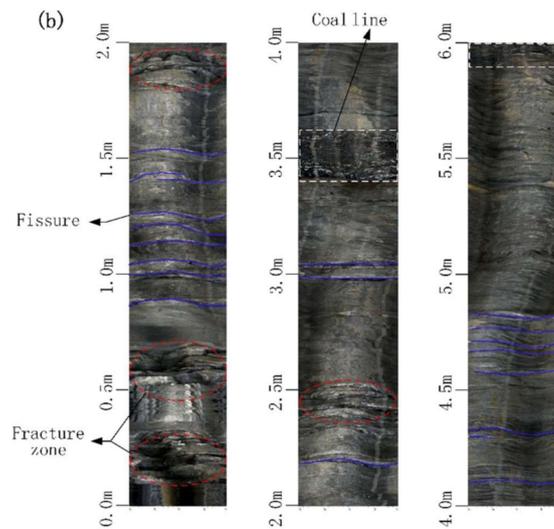
Figure 1. Cont.

**Figure 1.** Deformation of roadway after mining: (a) deformation of the roof of the roadway; (b) roof failure. Notes: Roof deformed by up to 900 mm, and fissures extended to a depth of about 4.8 m from the roof surface.

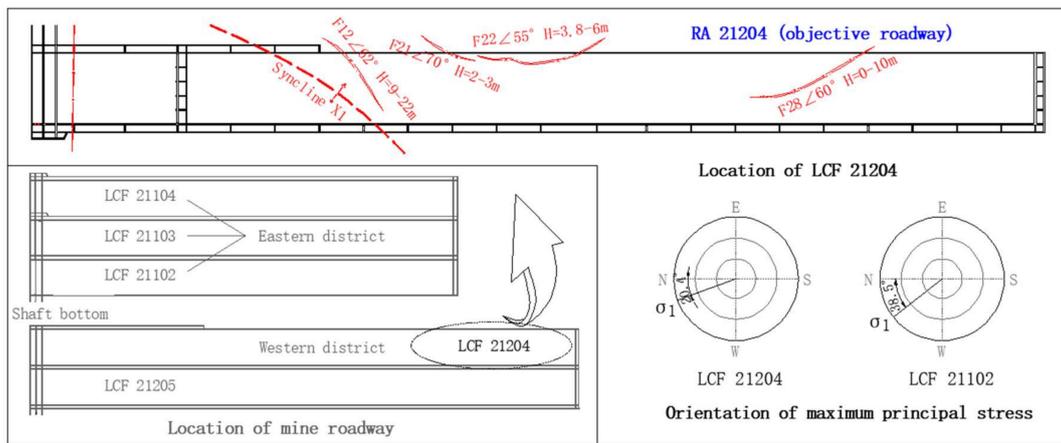
**Figure 3.** Location and geological condition of the roadway selected for this study. LCF = longwall coal face; RA = return airway.

There are four faults in the mine: F12, F21, F22, and F28 (Figure 3). F12, which has an average vertical throw of 18 m, is the only fault that has a large influence on roadway excavation.

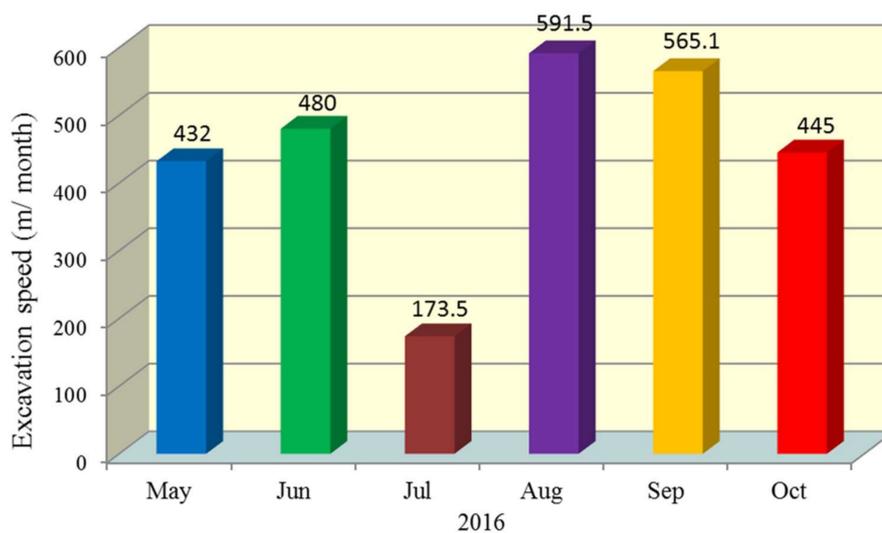
**Figure 4.** Excavation speed of RA 21204.

Return airway (RA) 21204 has been selected as the object of this study. It is 5851.7 m long and runs parallel to auxiliary return airway (ARA) 21204. The excavation of ARA 21204 was stopped after 1228 m. The average excavation speed of RA 21204 is 448 m/month (Figure 4), which is insufficient to meet production needs.

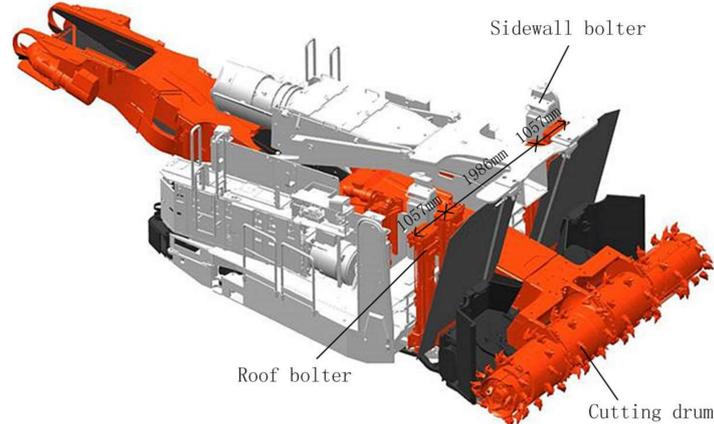
Figure 6. MB670 bolter miner.

- (1) Simultaneous excavation and bolt installation. In RA 21204, excavation and bolt installation are carried out using the MB670 bolter miner, which is manufactured by Sandvik Mining and Construction G.m.b.H (Figure 6). When the bolter miner cuts coal, bolts can be installed simultaneously by the roof bolter and the sidewall bolter, preventing initial deformation of the roadway and failure of rock mass. This can maintain the integrity of the rock mass in the roof and improve excavation speed.

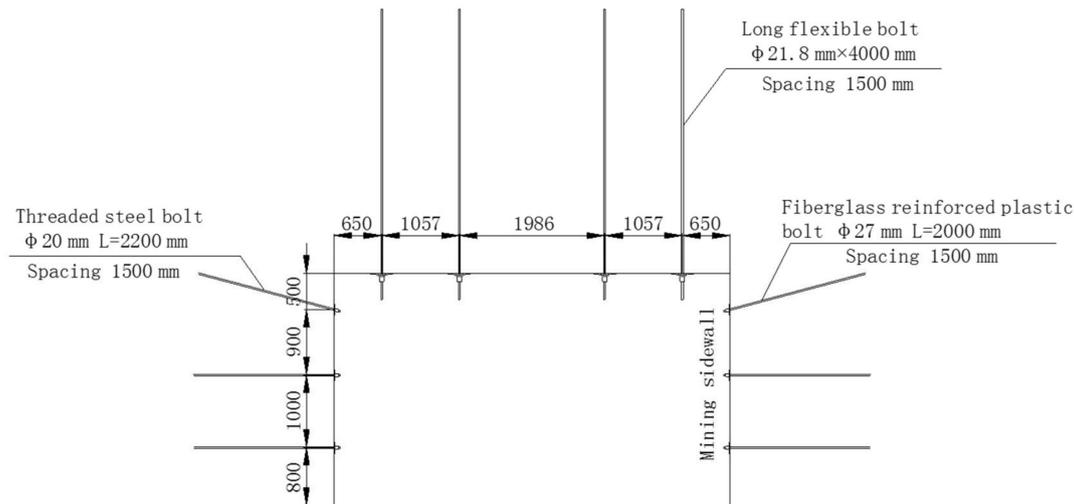
Figure 7. Parameters of the new support system.

A new support system, incorporating the considerations above, was proposed and built in RA 21204 in Hulusu Coal Mine. The roadway was 5400 mm wide and 3200 mm high. Bolts were installed at 1500-mm intervals along the roadway axis (Figure 7).

- (1) The roof was supported by four long flexible bolts, each 21.8 mm in diameter and 4000 mm in length, combined with a reinforced steel mesh that was 5400 mm long and 1600 mm wide. The mesh was made of welded steel bars of 6.5 mm in diameter. Flexible bolts were made of high-strength steel rope strands with a yield strength of 1600 MPa. Each bolt comprised 19 strands and was installed in the roof with a resin capsule of 23 mm in diameter and 700 mm in length. Two types of resin—an SF-type (super-fast anchoring agent) and an MF-type (medium-fast anchoring agent)—were used. To provide effective reinforcement, bolts were pretensioned to

- 200 kN and installed perpendicularly to the roof surface. The four bolts were installed 1057, 1986, and 1057 mm apart because the roof bolter was not designed to make sideways motion (Figure 6).
- (2) The sidewall that was mined was supported with fiberglass-reinforced plastic bolts, each 27 mm in diameter and 2000 mm in length, combined with a plastic mesh that was 5400 mm long and 3200 mm wide. The pretensioned torque was 100 N·m or above. The other sidewall was reinforced by threaded steel bolts, each 20 mm in diameter and 2200 mm in length, combined with a diamond-shaped metal mesh that was 5400 mm long and 3200 mm wide. The corresponding torque was greater than 150 N·m.

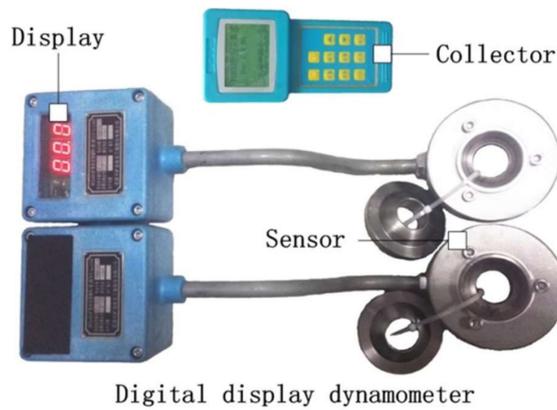
Digital display dynamometer

Figure 8. Digital dynamometer.

The axial load on flexible bolts was monitored in real-time using the MCS-400 digital dynamometer, which can measure up to 400 kN (Figure 8). This is a vital part of routine monitoring of the roadway reinforcement system and provides information on the working conditions of the bolts. The working principle of the digital dynamometer is shown in Figure 9. The dynamometer consists mainly of sensors, transmitters, and displays. The axial load on bolts causes the sensors to deform. The sensors transform the deformation into a voltage signal, which is converted to a pressure value and displayed on the screen. The internal sensor can save the data every two hours. The collector can download the data when its infrared acquisition port is aligned with the dynamometer window under the light of the miner's lamp.

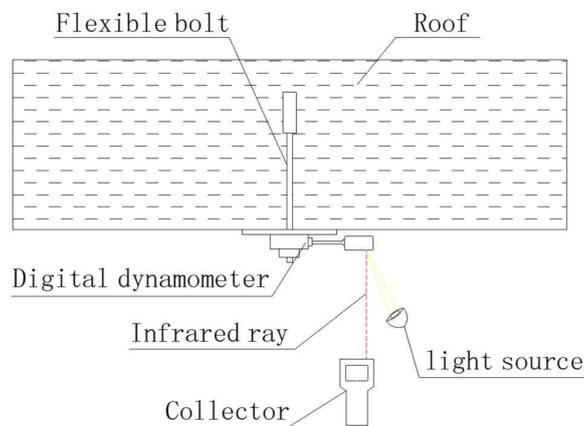
Figure 9. Working principles of the digital dynamometer.

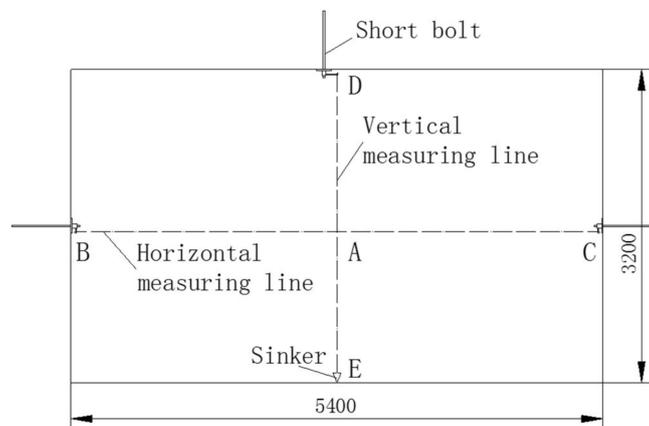
Figure 10. Monitoring sites for surface displacement of the roadway.

Surface displacement of the roadway was measured using the intersection point method shown in Figure 10. Horizontal markers were fixed on to short bolts at B and C inside the two sidewalls. Vertical markers were fixed on to a short bolt inside the roof (D) and on to a sinker inside the floor (E). Lines BC and DE intersect at A. Variations in the lengths of lines BC, DE, AB or AC, and AD or AE with time were monitored. Each line measures the displacement of a different part of the roadway (Table 2).

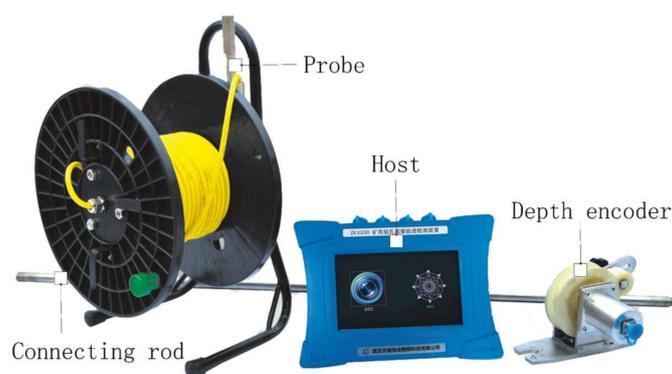
**Figure 11.** Borehole scanner.

Fracture development in the surrounding rock was monitored using a ZKXG30 borehole scanner. The scanner is mainly composed of a computer host, a probe, and a depth encoder (Figure 11). A borehole 10 m in length was drilled into the roof. The probe was inserted into the hole using the connecting rod. The probe has a camera and a three-dimensional high-performance electronic compass that records the azimuthal and dip angle of the borehole. The probe transmits its signals to the host computer via the cable. The host calculates the depth of the probe using signals from the probe and the depth encoder. Video signals are processed. Images are recorded, matched, and spliced, producing panoramic images of the borehole wall.

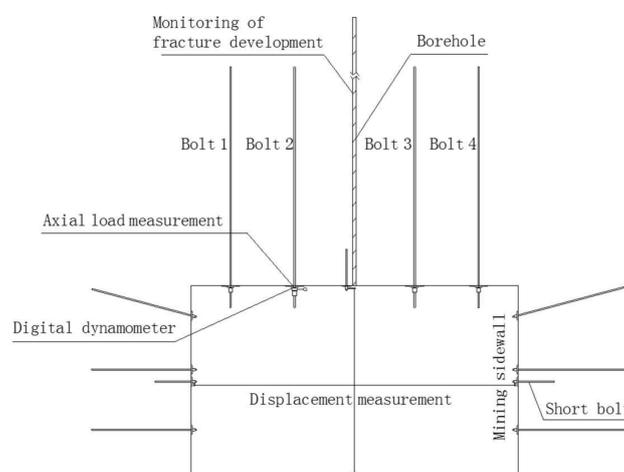
**Figure 12.** Locations of the monitoring instruments on a cross-section of the roadway.

The locations of the monitoring instruments on a cross-section of the roadway are shown in Figure 12. Instruments were installed at different stations along the roadway and their locations are shown in Figure 13. Table 3 indicates the parameters measured at each of the stations shown in Figure 13. Continuous monitoring was carried out during excavation and mining.

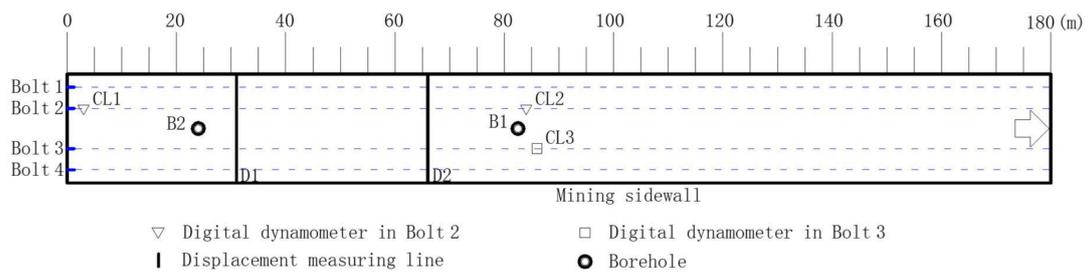
**Figure 13.** Locations of monitoring stations along RA 21204. Note: The point 0 m is referred to as S in the text. Monitoring locations are indicated by their horizontal distance from S.

Axial loads on flexible bolts were monitored at S + 3 m, S + 84 m, and S + 85.5 m (Figure 13). Figure 14 presents the evolution of axial loads during excavation and mining. From its installation during excavation to its damage by mining operations, the dynamometer recorded more than 1000 sets of data over 3 months, tracking the performance of the support system during the entire excavation and mining process.

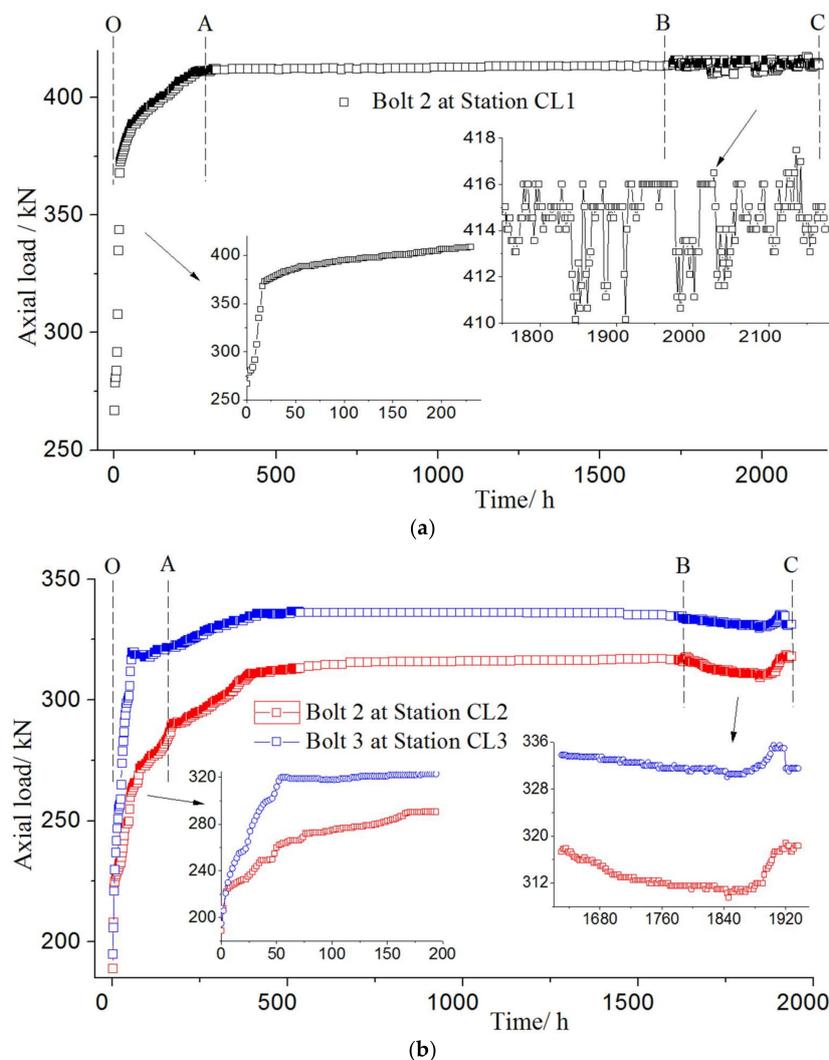
**Figure 14.** Axial loads on bolts in the roof at: (a) Station CL1; (b) Stations CL2 and CL3. Note: OA represents the excavation period. AB represents the period during which the working face was being prepared. BC marks the mining period.

Loads on Bolt 2 at Station CL1 evolved over the surge, stable, and fluctuation stages (Figure 14a). The surge stage (OA in Figure 14a) took place during excavation. The enlargement of section OA (inset in Figure 14a) shows that loads increased by 40% from 267 to 374 kN over 20 h after bolt installation. Over the next 98 h, loads increased by merely 5.6% to 395 kN. Figure 15a and Table 4 show that increased loads due to excavation operations were measured up to 125 m behind the excavation face and that the area within the first 30 m was severely disturbed by excavation. Over the next two months, during the stable stage (AB), loads changed slightly from 411 to 414 kN. During the fluctuation stage (BC), loads fluctuated by 2% and remained between 410 and 418 kN.

The roof inevitably deformed under gravity when the roadway was excavated. The flexible bolts have been pretensioned to up to 200 kN. Axial load on the bolts increased rapidly after the bolts were installed during excavation. Loads continued to increase during mining operation because the roof was disturbed by the cutting action of the bolter miner.

The overall features of the evolution of axial loads on Bolt 2 at Station CL2 and Bolt 3 at Station CL3 are consistent with those at CL1 (Figure 14a,b). Figure 14b shows that loads on Bolts 2 and 3 increased sharply over the first 50 h. Loads on Bolt 3 remained stable at 322 kN from the 50th to the 160th hour, while loads on Bolt 2 increased gently over the same period. Table 5 shows that increased loads due to excavation operations were measured up to 157.5 m behind the excavation

face, and that the area within the first 56.5 m was severely disturbed by excavation. During stage AB, the evolution of axial loads at CL2 and CL3 was different from that at CL1. Loads on Bolts 2 and 3 increased gradually between the 220th and the 340th hours because of disturbances from the preparation of the working face. Loads stabilized after this period. During stage AB, loads dropped slowly, followed by a rapid rise. Disturbances from excavation were measured over a larger area at Stations CL2 and CL3 than at CL1 because of differences in geological conditions at the stations.

The shallow roof around Stations CL2 and CL3 was gradually damaged as a result of the disturbance from mining of the working face. Loads at Stations CL2 and CL3 decreased slowly since they were located 100 m from LCF 21204, and the corresponding descending slopes were 0.021 and 0.009, respectively. Delamination of the roof strata developed as the working face approached the stations. Loads at Stations CL2 and CL3 quickly increased when the working face was at a distance of about 44.5 m, and the corresponding rising slopes were 0.177 and 0.106, respectively. Loads continued to decrease slightly as the roof broke further due to mining influence.

Axial loads fluctuated within 2%, which indicated excellent performance of the support system during excavation and mining. In addition, differences in geological conditions could have contributed to the differences in roadway stability at S + 3 m and S + 85.5 m.

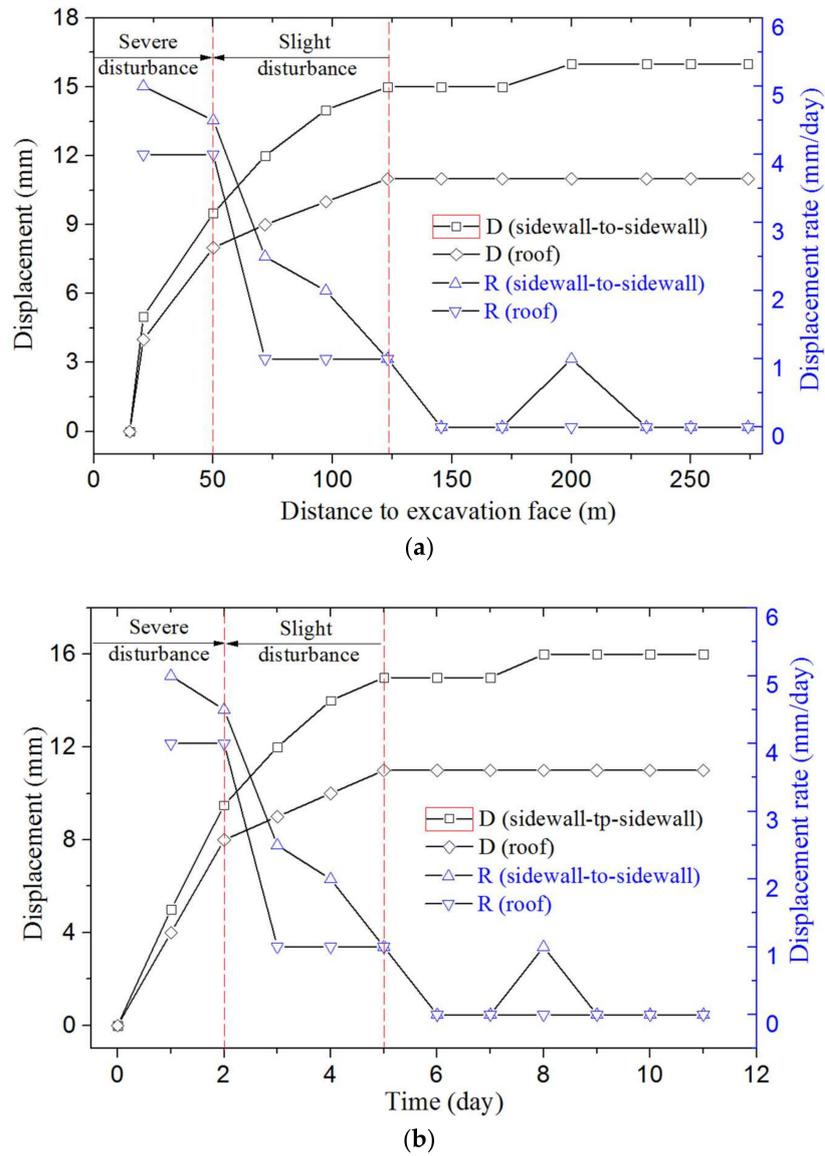
**Figure 15.** Surface displacement of RA 21204 during excavation: (a) Displacement versus distance; (b) Displacement versus time.

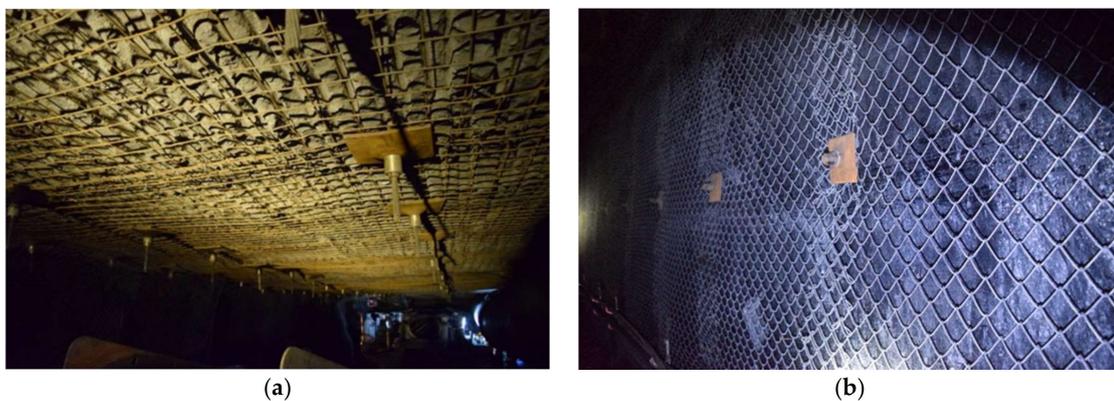
**Figure 16.** Photos of the roadway during excavation: (a) roof; (b) sidewall. Note: Photos were taken at S + 68 m where the distance from the excavation face was 100 m.

Figure 16 shows the displacement profiles of the roof and sidewalls during excavation. Displacements increased rapidly initially, then continued to increase slowly, and finally stabilized. Maximum roof and sidewall-to-side wall displacements were 10 and 16 mm, respectively. When the distance from the excavation face was about 50 m (Figure 15a) on the 2nd day (Figure 15b) after the start of excavation, roof and sidewall-to-side wall displacements were 8 and 10 mm, respectively. This represented 80 and 62.5 percent of the maximum roof and sidewall-to-side wall displacements, respectively. Roof and sidewall-to-side wall displacement rates were 4 and 4.5 mm/day, respectively. The area within 50 m from the excavation face was the most severely disturbed, which is consistent with the data obtained from the monitoring of axial loads. The displacement rate was very small in the area between 50 and 125 m from the excavation face, equivalent to the period between the 2nd and 5th days after the start of excavation. Substantial improvement in the stability of RA 21204 could be visually observed (Figure 16).

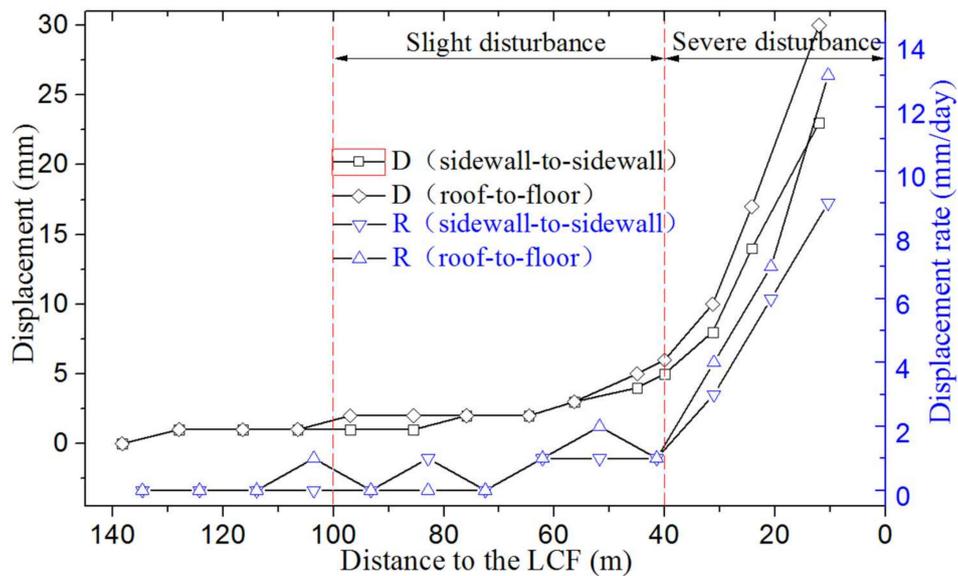
Figure 17. Surface displacement of RA 21204 during mining.

Displacement and the displacement rate experienced an overall upward trend as the working face approached the monitoring stations (Figure 17). Mining of LCF 21204 had a greater impact on the roof and floor than on the sidewalls. For instance, at a distance of 40 m from LCF 21204, roof-to-floor displacement increased from 6 to 30 mm while sidewall-to-side wall displacement only increased from 5 to 23 mm. Roof-to-floor and sidewall-to-side wall displacement rates suddenly increased to 9 and 13 mm/day, respectively. The area within 40 m from the excavation face was the most severely disturbed, with slight disturbances extending across an area of up to 100 m from the excavation face. Deformation characteristics during mining were considerably different from those observed during excavation.

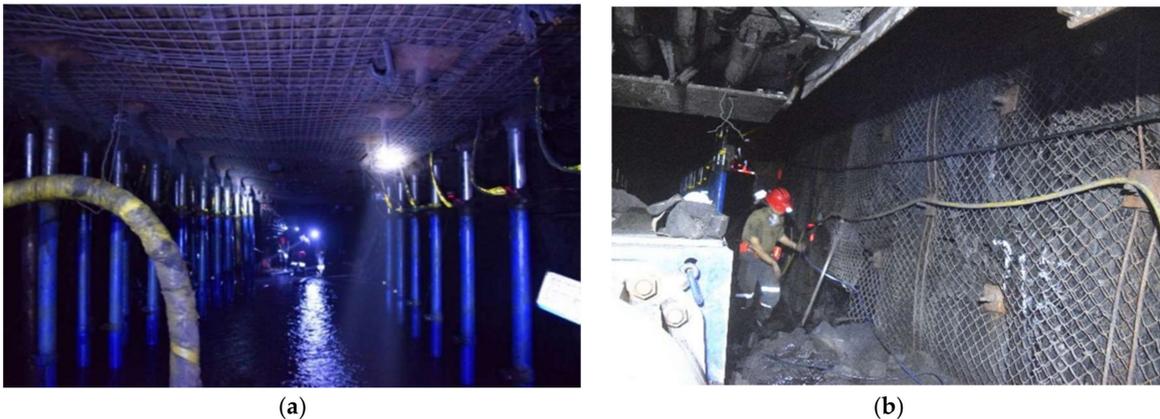
Figure 18. Photos of the roadway during mining: (a) roof; (b) sidewall. Note: Photos were taken at locations close to LCF 21204.

After excavation, a thick anchorage layer was formed in the roof thanks to the rapid active support of the long flexible bolts. It also helped to reduce deformation of the sidewalls. Generally, deformations were small and have been effectively controlled. The performance of the support system was excellent (Figure 18).

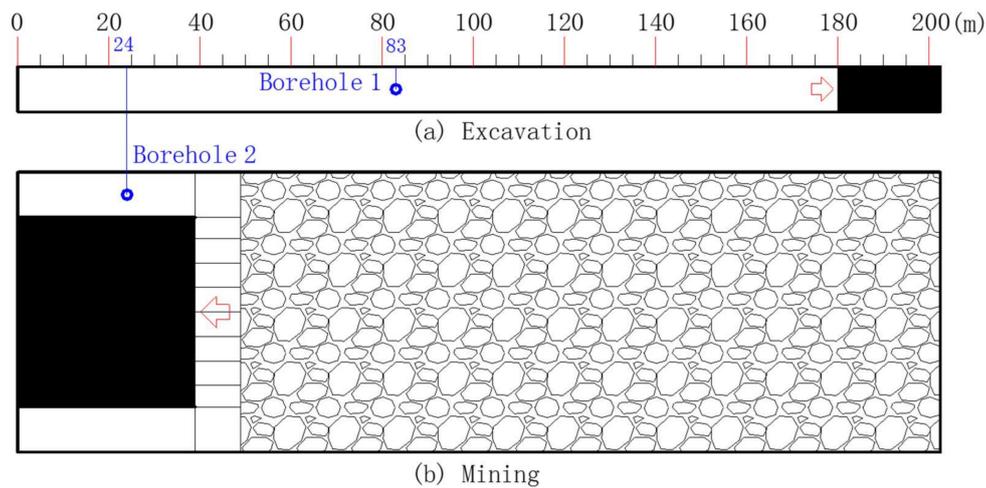
**Figure 19.** Locations of the boreholes used for monitoring fracture development in the roof: (a) Images from borehole 1 were taken at 97 m behind the excavation face; (b) Images from borehole 2 were taken at 25 m ahead of the LCF in the area of strong disturbance.

Figure 19 shows the locations of the 10-m boreholes used for monitoring fracture development in the roof during excavation and mining. Borehole images indicate that the rock mass in the roof remained intact up to 5–6 m into the borehole. Figure 20 shows images from the roof surface up to 6 m into the borehole. The numbers in the figure indicate distance from the roof surface. For example, the image at 2.0 m corresponds to the rock mass located at 2 m from the roof surface within the surrounding rock.

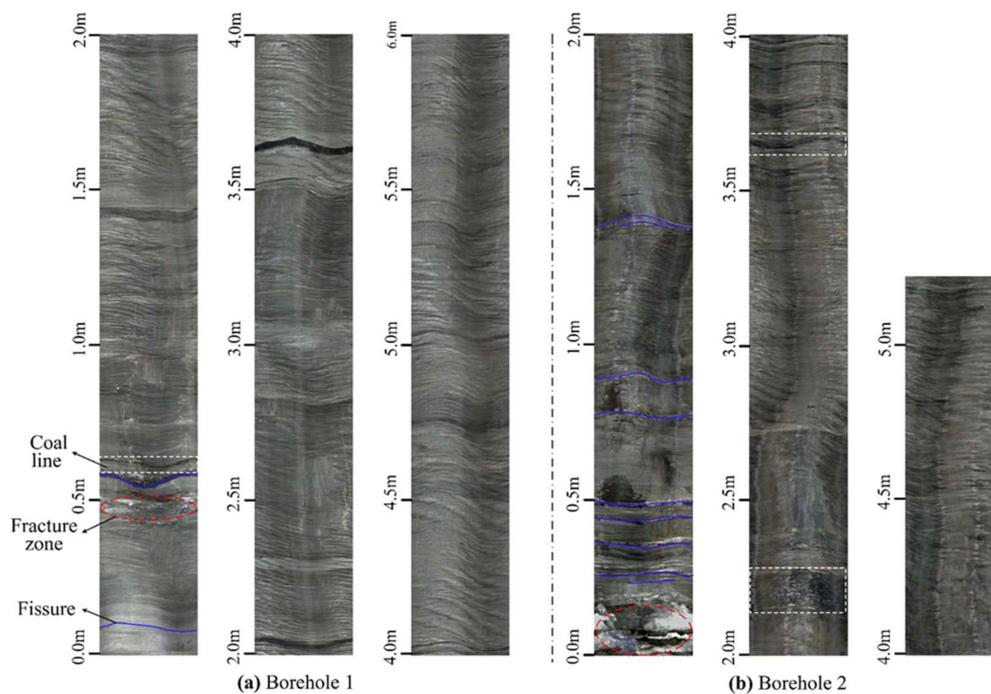
**Figure 20.** Borehole images of the roof during: (a) excavation, (b) mining. Note: Blue lines indicate the locations of fissures, red ellipses indicate fracture zones, and white rectangles mark coal lines.

Borehole 1 was used to monitor fracture development during excavation (Figure 20a). Two fissures were observed at 0.15 and 0.6 m from the roof surface, and one fracture zone was recorded at 0.4 to 0.5 m from the roof surface (Figure 20a). In addition, two ultra-thin coal seams were found at 2.0 and 3.6 m from the roof surface. Fractures mainly occurred in the area close to the roof surface, and did not extend into the deep rock strata.

Borehole 2 was used to monitor fracture development during mining (Figure 20b). In contrast to borehole 1, fissures were observed at a distance of up to 1.4 m from the roof surface (Figure 20b). This illustrated that the support system effectively formed a thick reinforced anchorage zone in the roof,

thereby greatly improving the bearing capacity of the roof. The rock mass within 0.2 m of the roof surface was extremely broken. There were nine fissures in borehole 2 compared with only two in borehole 1. Eight of the fissures in borehole 2 were located within 1.0 m of the roof surface. There were two ultra-thin coal seams without fissures at 2.15 m (100 mm thick) and 3.6 m (100 mm thick) from the roof surface. Thus, compared with the previous bolt and cable support system, the new active support system of long flexible bolts pretensioned to high levels effectively formed a thick reinforced anchorage zone in the roof, which controlled deformation and fracture development of the surrounding rock during excavation and mining.
