Article

Cultural Heritage Conservation and Sustainability Based on Surveying and Modeling: The Case of the 14th Century Building Corral del Carbón (Granada, Spain)

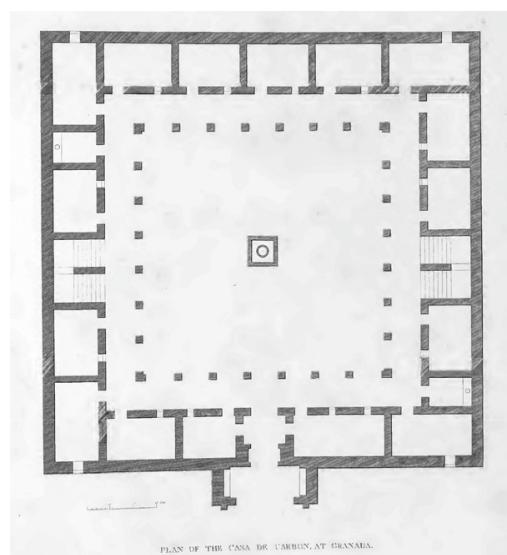
The shape of these buildings corresponds to a type imported from Persia and Syria to Spain. That is, the building, with a central courtyard, square or rectangular, had galleries supported by arches or lintels supported by pillars. To these galleries four bays circling the patio opened up the doors of the rooms in which they were divided. The ground floor was dedicated to warehouses and stables, while the upper floors were offered for lodging, [26] With the Spanish reconquest, the *alhóndigas* lost their function as inns and became warehouses and selling areas (Figure 1).

Figure 1. Plan of the Casa de Carbón [27].

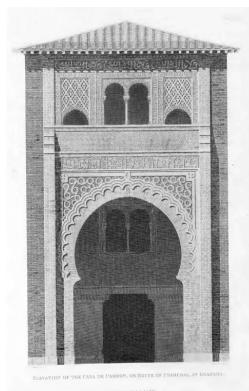
The Corral del Carbón, was one of the three known *alhóndigas* in Granada during the Nasrid period (13th–15th centuries) and is the only example of this building type still preserved in Spain [25]. Most Spanish *alhóndigas* were buildings of small size and poor construction, and therefore, despite being numerous in Islamic times, almost all of them have disappeared. However, the Corral de Carbón complex belonged to the wives of the Sultans of Granada, and after 1492 it was acquired by the Catholic Monarchs. Its royal origin presumably accounts for its exceptional size and the monumentality and decorative richness of its entrance gate, these features being unusual in this type of building (Figure 2).

Figure 2. Elevation of the Casa del Carbón [27].

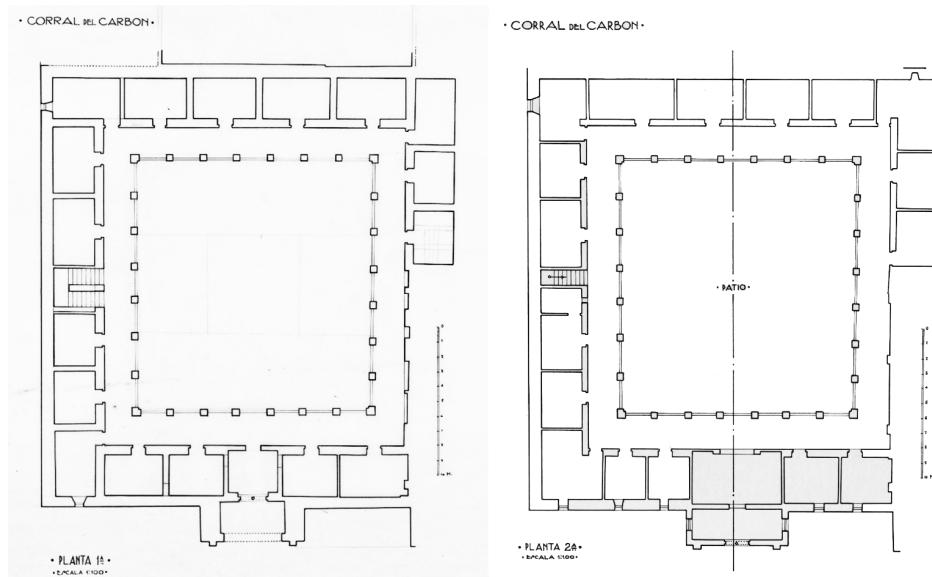
Torres Balbás drafted two restoration projects in 1929 and 1930 (Figures 4 and 5). The first project included the demolition of the added parts as well as the removal and repair of the roof as well as almost all the floors, plus the repair of the courtyard pillars and certain interior walls. The second project continued the work begun in 1929, demolishing the modern staircase and reconstructing it in its original location, as well as some walls. The original floor was discovered in the courtyard and in the galleries, and the flooring of the rooms and the trim of the exterior walls were made.

Figure 4. Plans of the restored building by L. Torres Balbás (1929–1930). Patronato de la Alhambra y el Generalife.

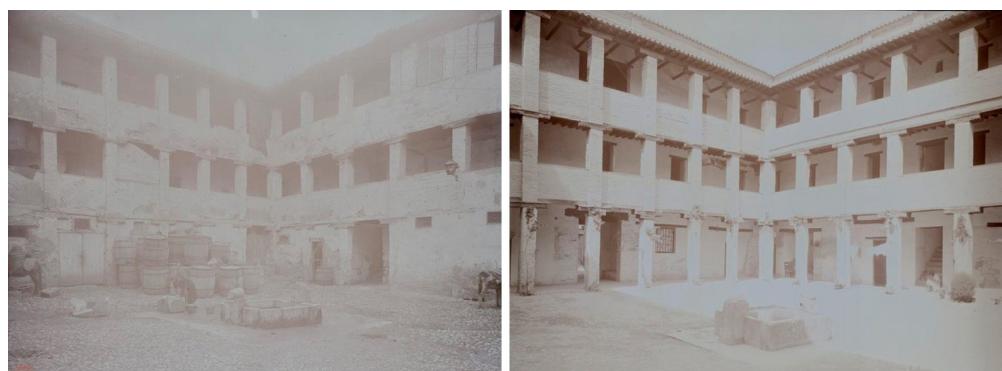
Figure 5. The courtyard before and after the restoration by L. Torres Balbás. Photographs by M. Torres Molina (ca. 1930).

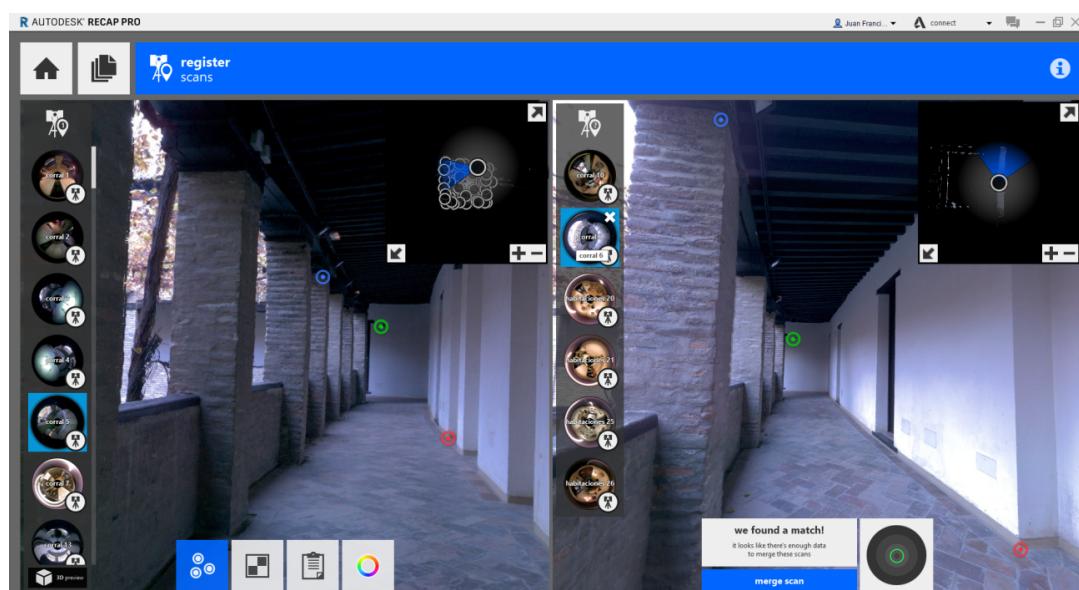
The registration process consisted of including every scan station in the same reference system, so that the final result was a point cloud defining the entire building. The registration could be performed in the field or in the office, and if the scan stations had enough and suitable overlap the registration was automatic. We performed the registration in the office to save time on the scan operations (we were time restricted in the Corral del Carbón so as not to interfere with tourist visits). Even in that case most of the scans were registered automatically in the office but those of the rooms required manual identification of homologous points. Recap Pro was the software used for the registration process. When the scan is imported from the scanner, Recap tries to register automatically all the scans but if a scan cannot be matched then registration must be manual. For this, we had to identify three homologous points (red, green, and blue points in Figure 6) between a reference scan (SREF; left screen in Figure 6) and a scan to be registered (STBR; right screen in Figure 6). When the match had good quality, a green circumference appeared in the right screen and we merged the STBR with the rest of the point cloud already registered (left screen). The scans already registered are represented by black circles (black square in the upper right portion of the left screen in Figure 6).

Figure 6. Manual registration for a scan-station.

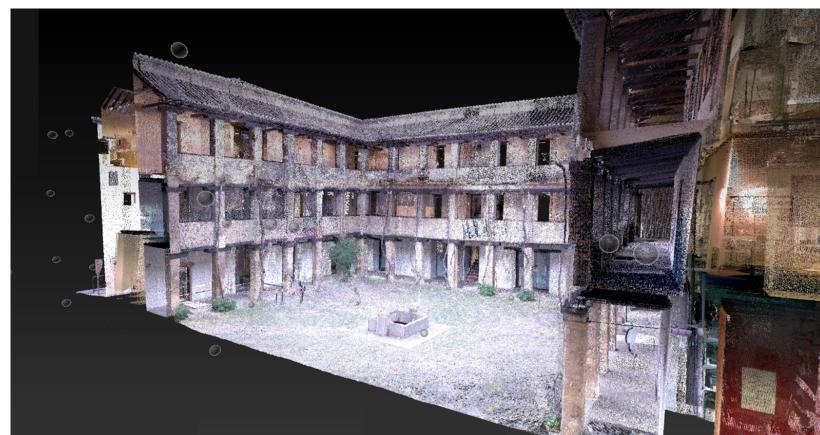
The Corral del Carbón survey consisted of 99 scan stations, some represented by gray spheres in the Figure 8. The spheres are placed in the true spatial position where the scan stations were taken. The spatial distribution for several of the scan stations can be seen in Figure 8, some of them camouflaged in the point cloud. In order to appreciate the structure and the level of detail achieved by the scan process, we show a vertical section from the Corral del Carbón in the Figure 8.

Figure 8. Vertical section applied to the Corral del Carbón point cloud. The scan-station locations are represented by spheres.

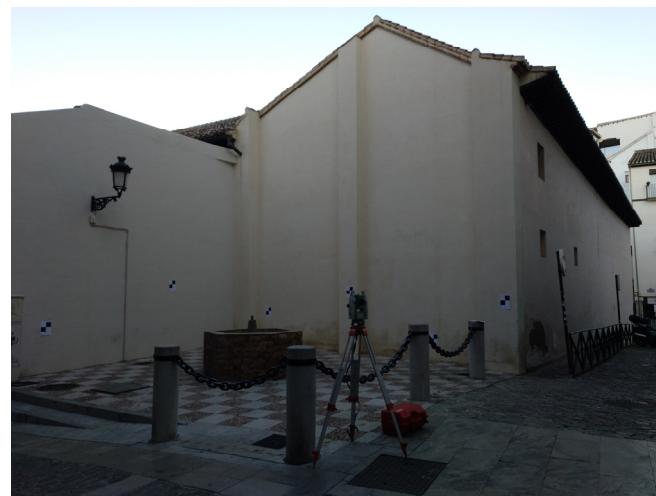
the Corral del Carbón courtyard. To check the scan-station registration accuracy, we used two traverses starting from the E1 station with 1 segment inside the courtyard and two exterior segments (E1–E3, E3–E4). The first scan station was taken inside the courtyard (near the traverse station E2) and the second scan was made near the traverse station E4. There were 6 intermediate scan stations (between the first and last one) in order to register the external walls. After the registration process, we computed the coordinates of six targets (Figure 9) from the E4 traverse and compared them with the point cloud registered, and the mean square error was 5.3 mm.

Figure 9. Targets for checking the registration of the point cloud.

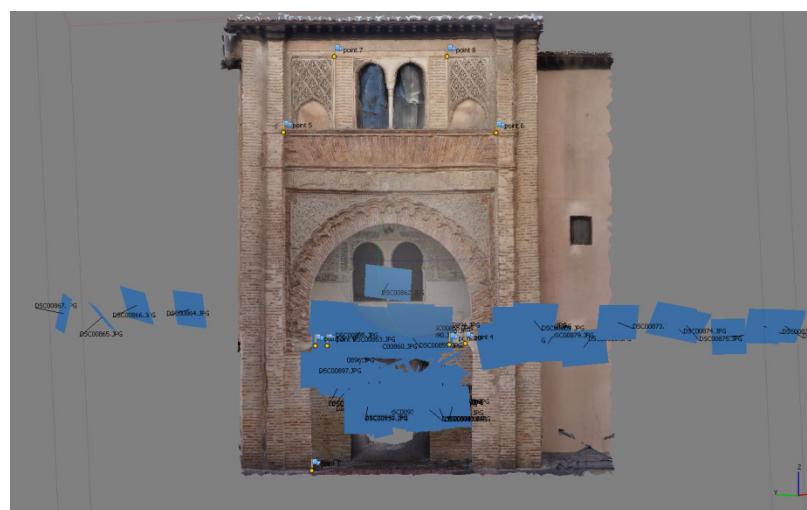
Photogrammetry was used to establish a more detailed textured mesh for the entrance facade, which has decorative geometric shapes in plaster and the mocarabe, widely used in the Nasrid architecture. The decoration has artistic and architectonic interest, so an accurate survey was made. We took 85 photographs for the reconstruction structure from motion (Sfm), some of them captured by the camera mounted on an extensible pole to a height of 5 m. Figure 10 shows the Sfm distribution.

Figure 10. Photogrammetry: structure from motion computed for the Corral del Carbón entrance (every photograph used in the entrance survey is represented by a blue rectangle placed in its 3D position).

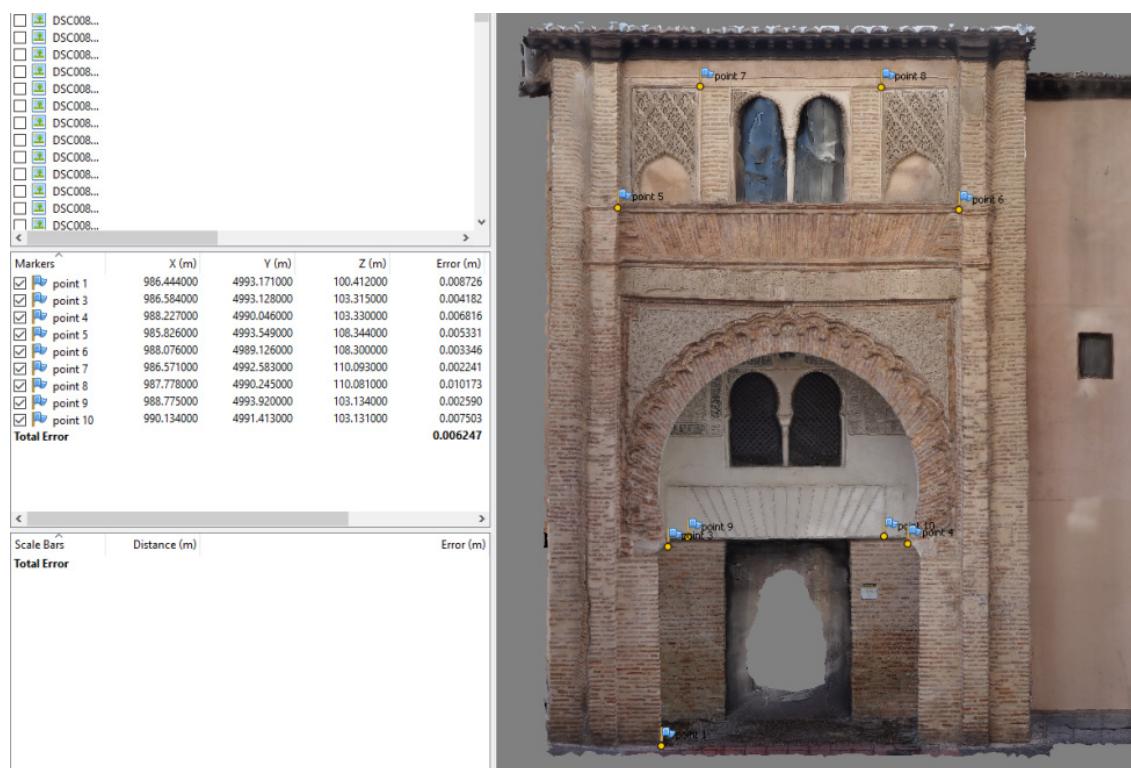
We used an additional product, derived from the photogrammetry performed on the entrance, consisting on the mocarabe mesh and its corresponding texture. For this product, we had to create a dense cloud, a mesh based on the point cloud, and finally the texture for the mesh. The whole process was performed by Photoscan software.

Figure 11. Photographs bundle adjustment and errors obtained in the control points used in the adjustment.

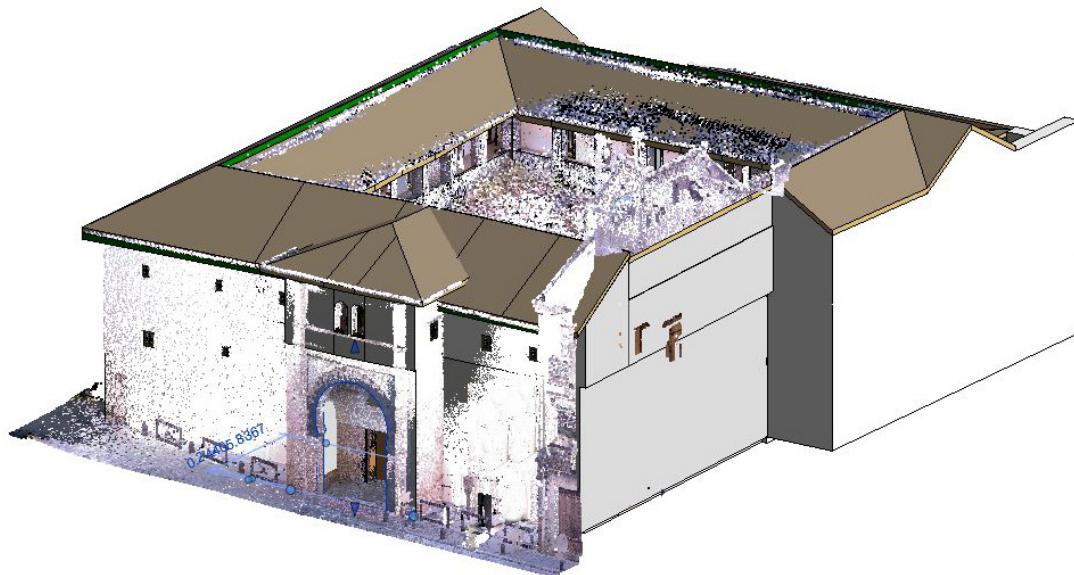
The MEP was not modeled in depth. Modeling a historical building with Revit has some limitations, for example, the walls allow only vertical construction, so we were unable to represent the frequent tilting deformations occurring in some walls. This constraint has to be mitigated adding some attribute to our model. An overlapping image between the HBIM and the point cloud is shown in the Figure 12.

Figure 12. Corral del Carbón Heritage Building Information Modeling (HBIM) overlapping the scanned point cloud.

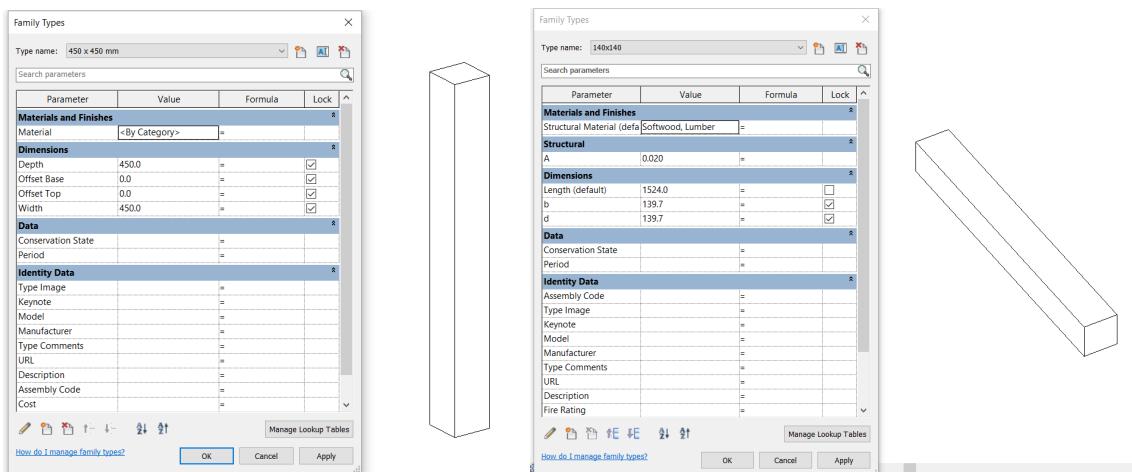
The Figure 13 shows the creation of these families as a step prior to the architectural modeling of the point cloud.

Figure 13. Creation of the families for the different elements identified in the point cloud.

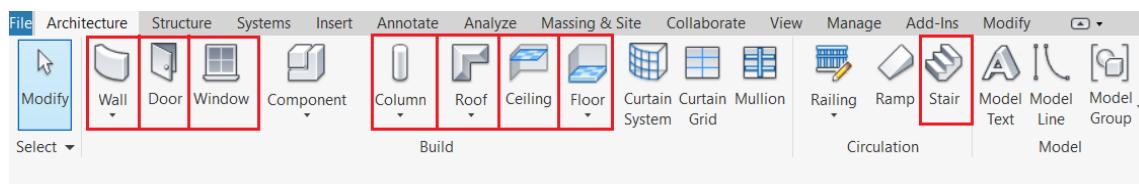
The first task was to define the different levels and slabs of each element. The pillars and walls were the next elements to be modeled, continuing with the parapets, doors, and windows, as well as the stairs. This latter element was not previously existed as a family, since each element was modeled in situ as they were quite different. The last elements to be shaped were the ceilings, beams, and the roof. The tools used are highlighted in the Figure 14.

Figure 14. Tools used in the architectural modeling.

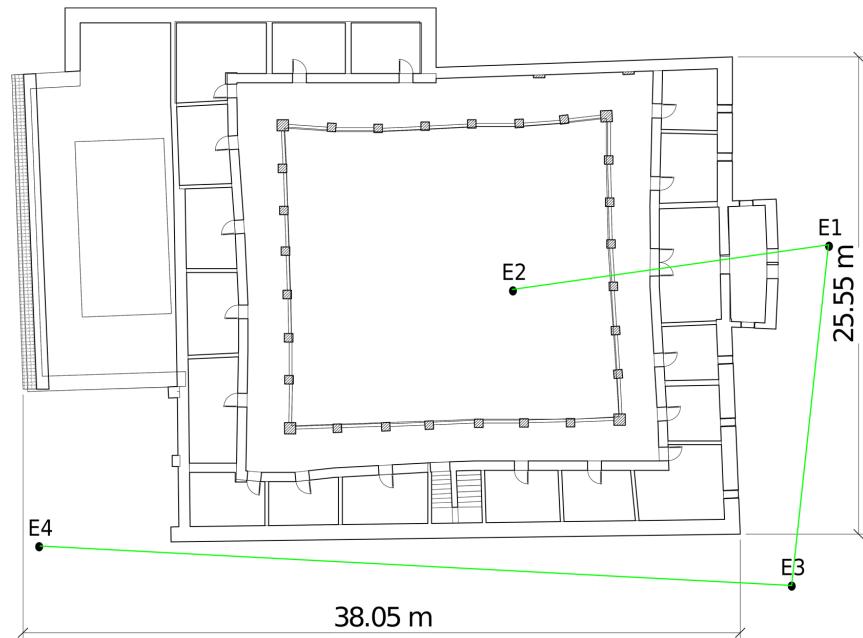
One the most useful drawings we can derive from the point cloud is the floor plan, in Figure 15 you can see the second-floor plan. We can compare this plan with those appearing in Figures 1 and 4 corresponding to years 1815 and 1930, respectively. From the comparison, we observe how in the older plans the technicians drew a building simplification, i.e., they did not delineate the deformation in the

courtyard perimeter. We can see how the edges of the galleries do not follow straight lines but convex curves towards the courtyard.

Figure 15. Second-floor plan derived from the scanned point cloud after registration.

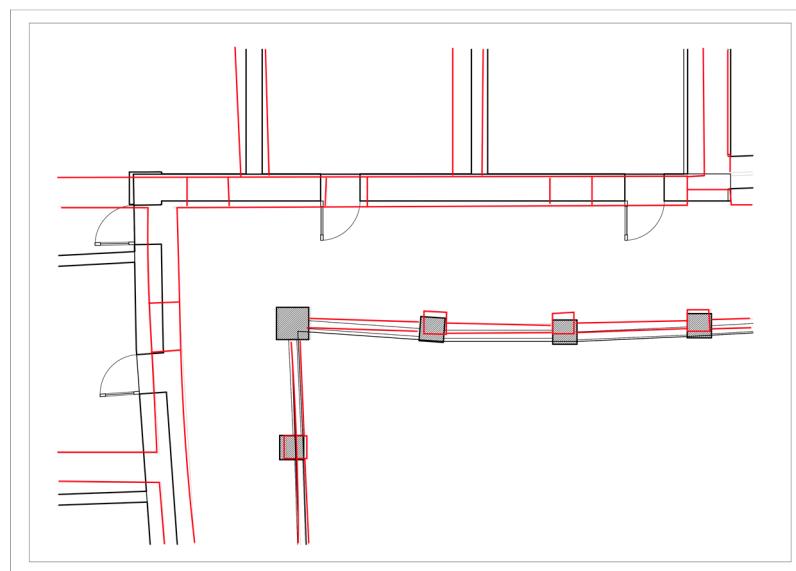
Gallery deformation is evident from the simple visual examination, but there are other structural aspects that are not so evident. For example, the footprint pillars from upper floors would be expected to coincide with those on lower floors, but Figure 16 illustrates the opposite (pillars on different floors being misaligned). Similarly, structural walls located on different floors are not in the same vertical planes (we have drawn in red the pillars and walls located in first floor and in black the pillars and walls in second floor).

Figure 16. Pillars from different floors are not aligned, and walls do not match on the vertical plane.

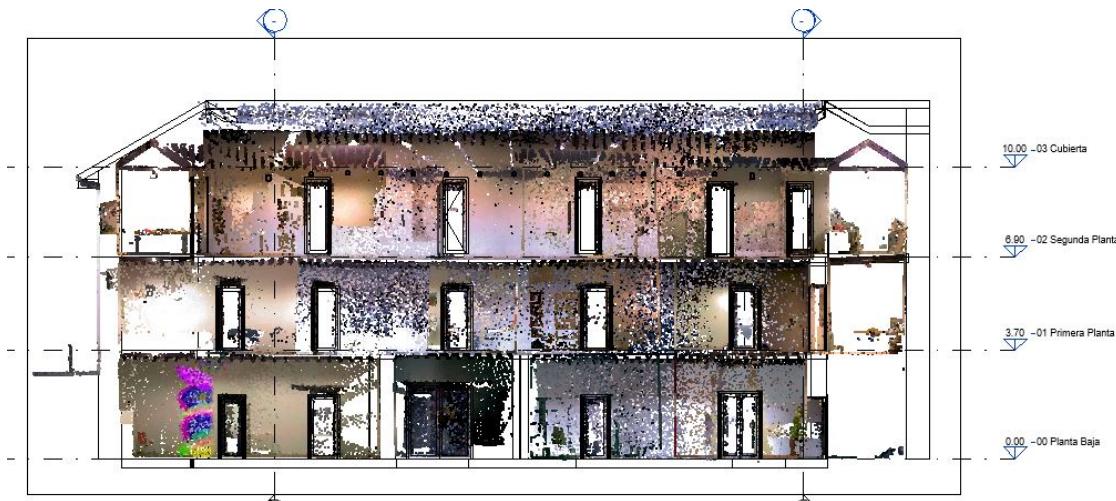
Key plans include elevations, which can be drawn accurately from the point cloud: Figure 17 shows an example of an elevation plan where the levels have been included as objects in the HBIM using Revit.

Figure 17. Elevation derived from the point cloud.

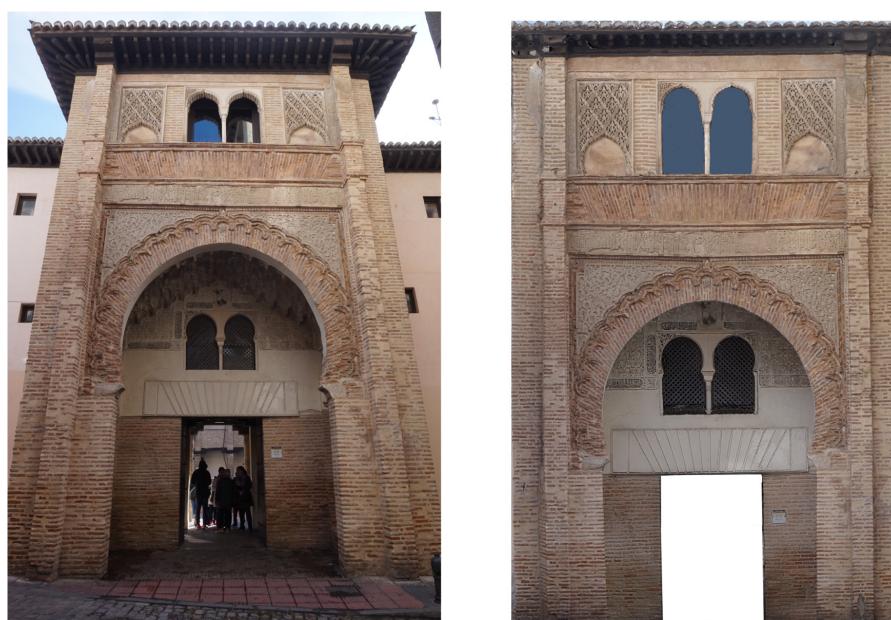
Although point cloud offers abundant details from the building, the scanner camera does not have a particularly high resolution (a sensor with 2592×1944 pixels); therefore, when we need certain features with more detailed textures, we have to perform photogrammetric procedures. Here, we used photogrammetry to reconstruct the 3D structure from the Corral del Carbón entrance gate (Figures 18 and 19). We sought to establish the accurate dimensions and conservation state of the architectonic features comprising the entrance facade. We can discern (Figure 18) how the deformation linked to a perspective view is eliminated in its corresponding orthophoto, which has been derived from its photogrammetric reconstruction. The orthophoto is a valuable graphic document because the measures extracted from it reproduces the real dimensions and geometry of the architectonic features, which could be used in the future for conservation and restoration tasks.

Figure 18. Facade perspective view with typical deformations (**left image**) and orthophoto without deformations (**right image**).

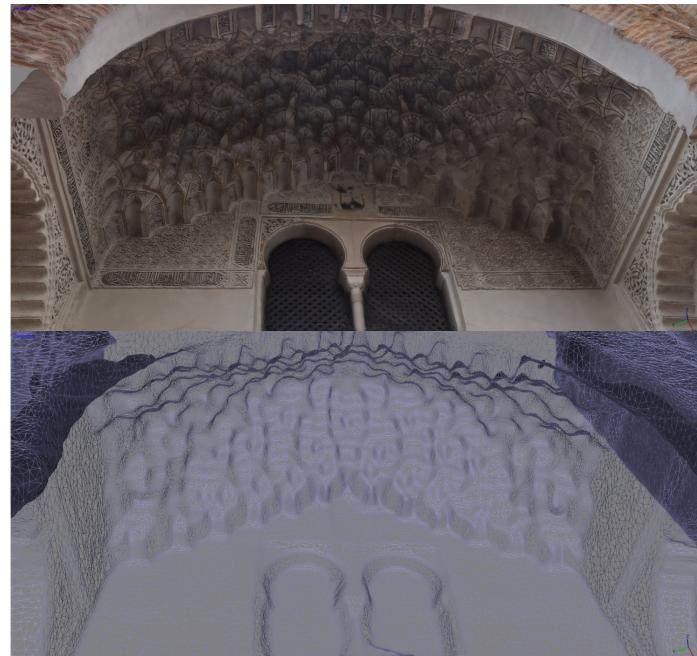
The mocarabe is one of the most representative elements in the Nasrid architecture, so a detailed 3D representation would be fundamental in studying their characteristics: metric properties, distribution, shapes, and images and pigment on it. The most suitable technique would be the photogrammetry because it can reconstruct an accurate 3D mesh and also because provides detailed texture, allowing an optimal interpretation. Therefore, we recreated the mocarabes in the entrance using photogrammetry (Figure 19).

Figure 19. Mocarabe meshed and textured in 3D.

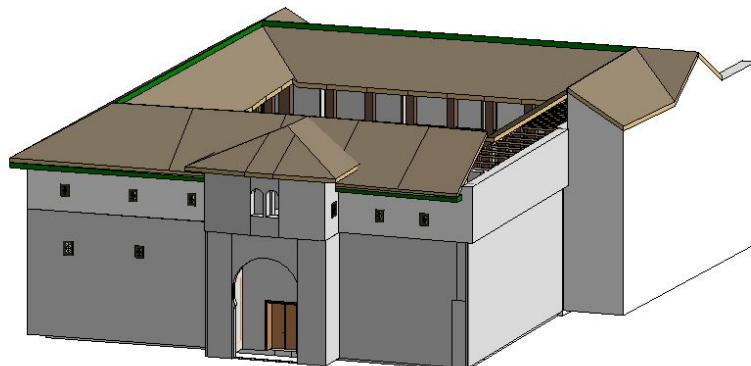
The complete Corral del Carbón HBIM, modeled according a LOD200 specification, appears in Figure 20, displaying windows, doors, roof, pillars, arches and details such as the beams under the roof.

Figure 20. Complete Corral del Carbón HBIM.

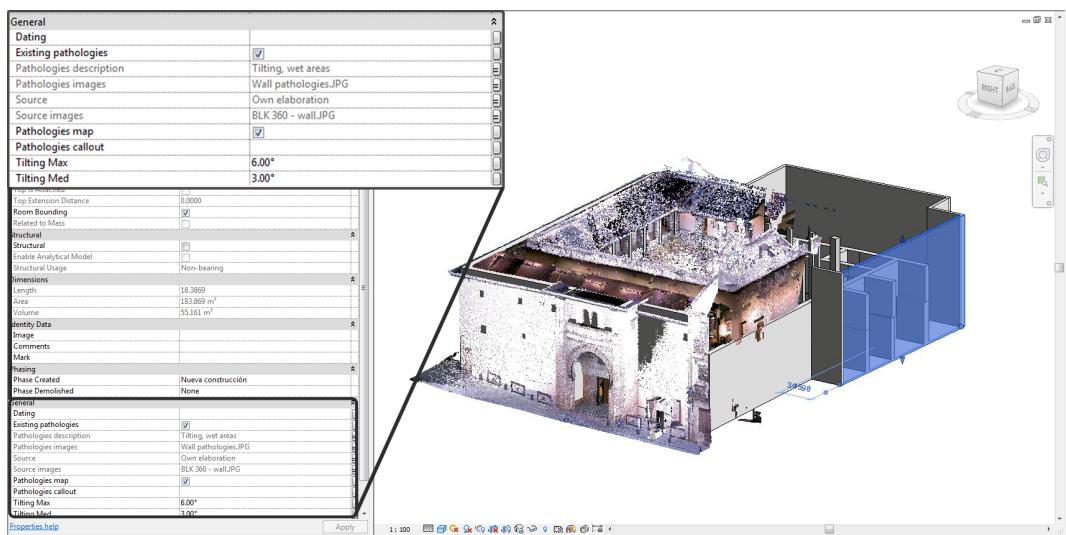
As explained in the Methods section, an HBIM is usually composed of three submodels: structural, architectonic, and MEP. In the structural cases, the BIM software lacked a tool for modeling deformations, particularly the tilting of some walls. Such tools would be necessary in HBIM for structural issues. Hence, we extended the building information by adding some attributes to the structural submodel (Figure 21).

Figure 21. Structural submodel highlighting a wall element.

We added the Tilting Max and Tilting Med attributes to indicate the maximum and medium values for any wall tilting. Additional information of interest for later restoration and conservation tasks included pathologies, so we included attributes such as a Pathology description, Pathology map and images where the pathologies are represented.

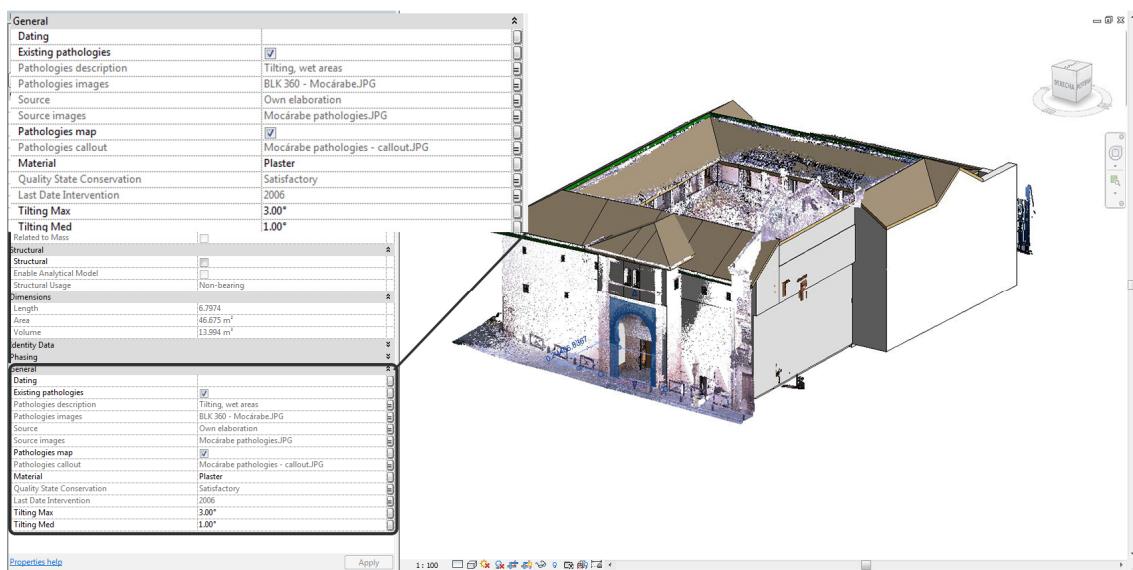
Following the same idea of including some attributes in the structural submodel, we added new attributes to the architectonic submodel (Figure 22). In this case the architectonic element of interest was the entrance arch, which bears geometric features and Arabic script in plaster. Because their importance in terms of aesthetic value and cultural heritage, we established attributes referring to their conservation status and last date they were restored. As in the structural submodel, pathologies were part of the attributes list.

Figure 22. Architectonic submodel highlighting the entrance arch.
