Article

Sustainability and Variability of Korean Wooden Architectural Heritage: The Relocation and Alteration

Abstract: ‘Relocation’ is the most distinctive feature of Korean wooden architecture, since every wooden material can be in most cases completely dismantled and moved to another place. This paper analyzes Cheongju *Mangseollu* that possesses these unique relocation characteristics excellently, because it was relocated twice in 1923 and 1999 and the building’s function was therefore altered during the process. *Mangseollu*, which was once a pavilion, was relocated and altered into a school in 1923 and subsequently relocated into a pavilion again in 1999. Accordingly, there were inevitable changes in terms of function, surface, and structure every time it was relocated. As a result, the surface was utilized as one large space without walls, when it was altered into a classroom and the wall was built around each room. Despite all these changes, *Mangseollu* is recognized as a building of late Joseon period. Therefore, this paper claims that Korean wooden buildings are maintained with unique variability through the relocation process.

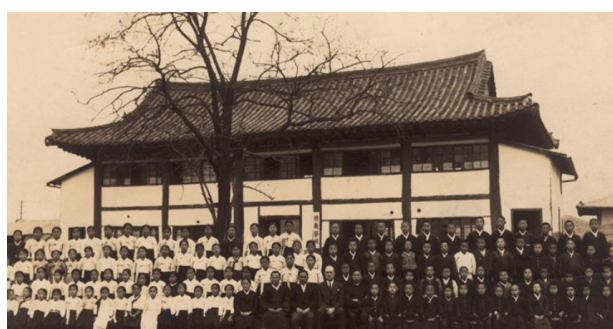
Figure 5. The picture of the year 1935 (source: Cheongju Cityhall).

In comparison with the 1935 picture (Figure 5), the one taken in the 1990s just before the dismantlement (Figures 6 and 7) indicates four different changes as identified below:

First, in the 1935 picture, the exposed wooden columns on the first floor were led to the second floor. Conversely, in the 1990s one, the first floor is made of square-shaped columns and is painted with the same color as the surrounding walls. Second, in the 1935 picture, *toekan* (adjoining outside bay) that seemed to be installed on both sides of the building was added; whereas in the 1990s picture, it no longer disappears. Third, in the 1935 picture, the horizontal timber that differentiates the first floor from the second is visible, while in the 1990s picture it is not visible. Last, the shape of the window notably changed. From these facts, it can be seen that *Mangseollu* underwent a number of changes from 1923 to 1999.

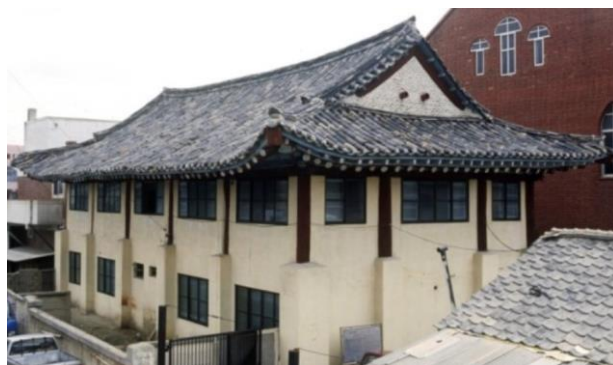
Figure 6. The picture of the 1990s (source: Cheongju Cityhall).

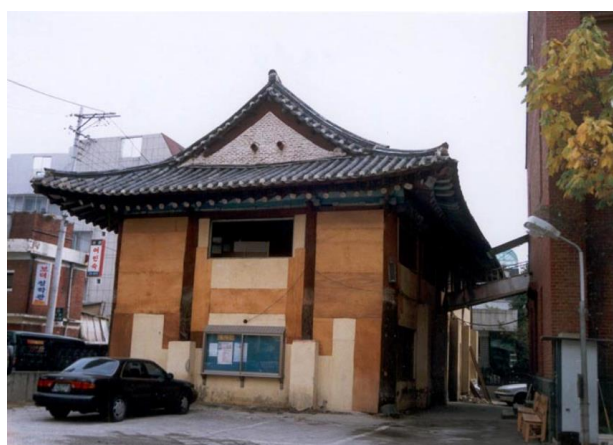
Figure 7. The picture taken just prior to the dismantlement in 1999 (source: Cheongju Cityhall).

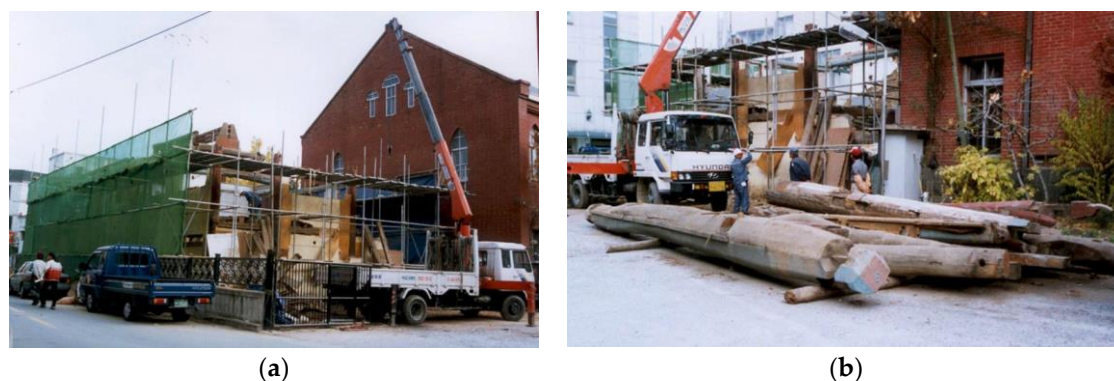
Figure 8. The picture taken during the dismantlement in 1999. (all figures source: Cheonju Cityhall).

In this regard, the walls and internal facilities of *Mangseollu*, which had undergone the first relocation process, have been altered so that it can serve as a school building, changing functionally from the existing pavilion. However, the longitudinal and cross-sectional views reveal that the primary structural sections utilize the existing wood frame structure as it is. Given that the circular wooden column was used while the column section was finished with cement, efforts were made to utilize the existing components as much as possible. Although it is not possible to verify whether individual wood elements were also utilized before the 1923 relocation, it can be assumed that some wood elements were replaced (Figures 8 and 9).

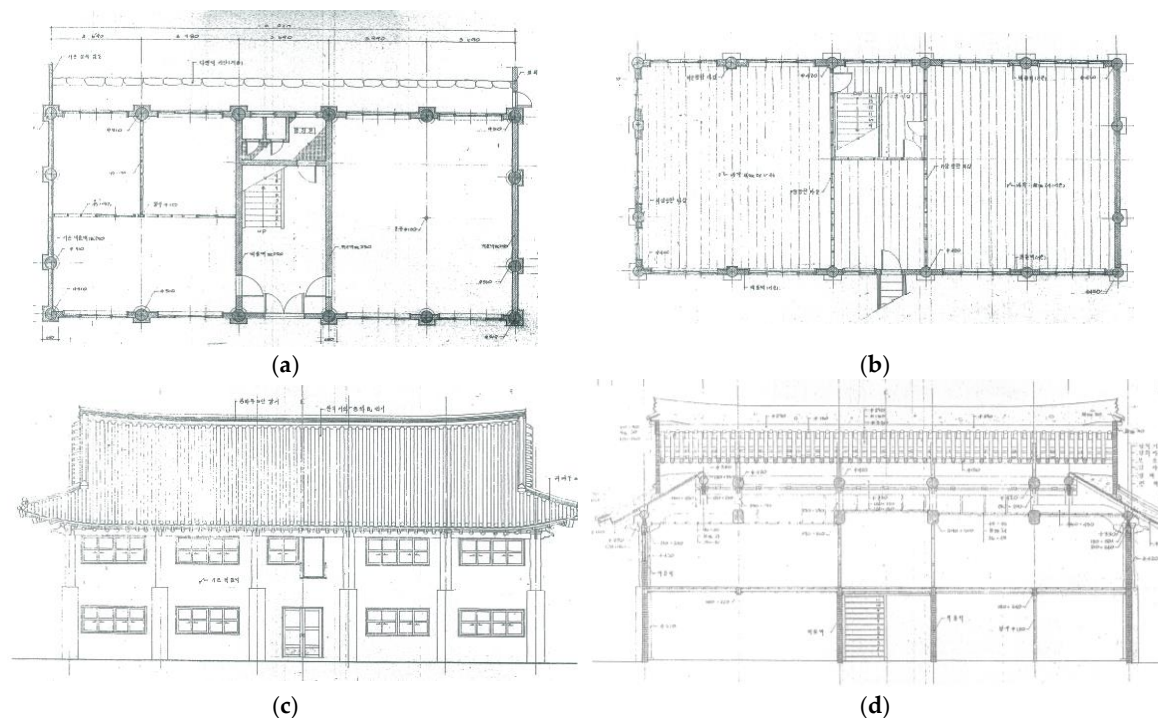
Figure 9. The drawings of *Mangseollu* before dismantlement in 1999; (a) Drawing of the 1st floor; (b) Drawing of the 2nd floor; (c) The front view; (d) The longitudinal sectional view. (source: National Archives of Korea, author edit).

The first floor is designed to enter from the front center, and a hall is formed inside the front central bay. The hall has a staircase up to the second floor and there is a lavatory behind the stairs. A brick wall divides both sides of the central bay. The left-hand column is divided into three spaces by a wooden paneling, and the right-hand column consists of one wide room.

The structure of the first floor is made of a round wooden column, but the periphery of the column was augmented with cement mortar and thus has a square shape. The outer wall is made of brick. No columns are installed on the first floor so that the large space can be utilized. Long windows are installed on the front and rear side. The second floor can be accessed via the central staircase. On the second floor, there are rooms on both sides based on the central bay, with a small room of uncertain purpose in the front. The unique feature is that, given the stairs are painted on the front section of the second floor and the door is drawn on the front view, the stairs were created as a passage to be directly accessed from the adjacent building to the second floor. This passage can be seen in the picture just before the dismantlement in 1999 (Figure 7) as well. The walls of the second floor comprise bricks, and the front and rear sides comprise woods. The circular columns are exposed and thus have a different structure from the first floor.

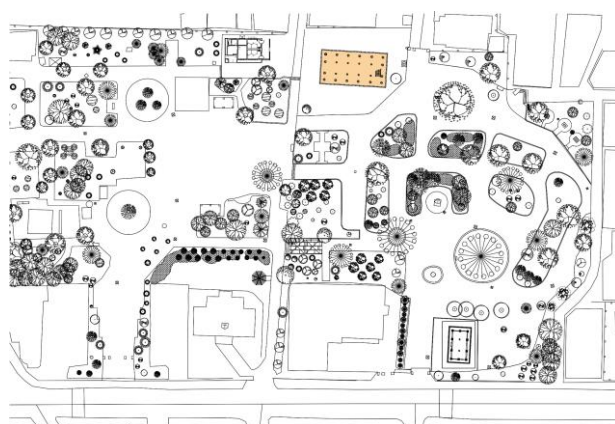
Figure 10. *Mangseollu* that was relocated for the 2nd time into the central park. (source: author).

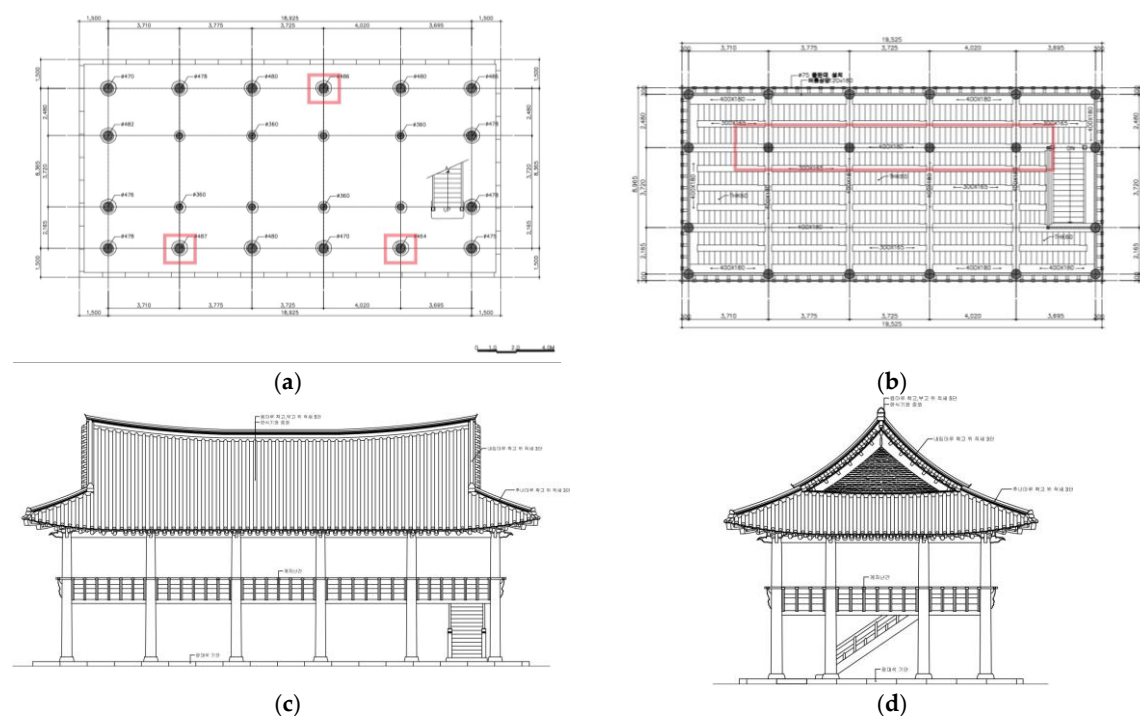
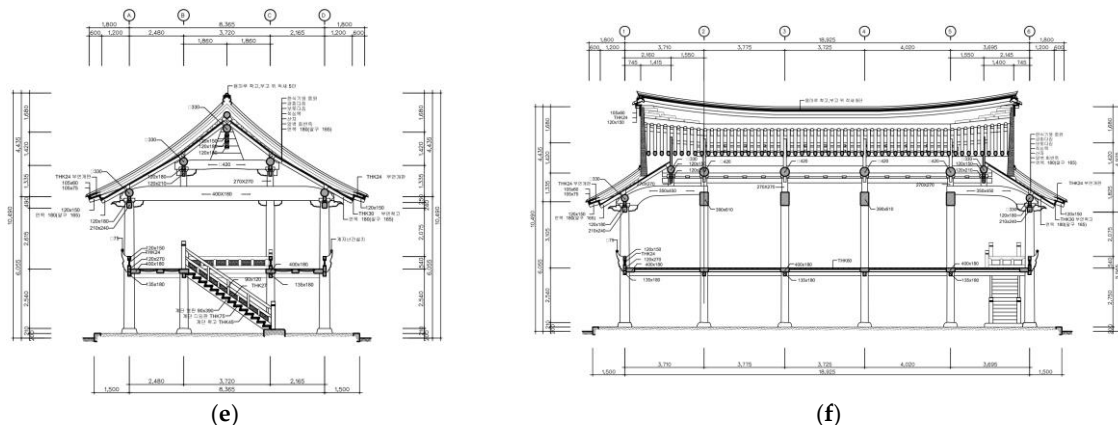
Figure 11. The drawings of present *Mangseollu*; (a) Drawing of the 1st floor (Marks indicate the columns with traces of renovation); (b) Drawing of the 2nd floor (Marks indicate the newly added columns); (c) The front view; (d) The lateral view; (e) The longitudinal sectional view; (f) The cross-sectional view. (all figures source: Cheongju Cityhall).

Today's *Mangseollu* consists of five bays in the front and three bays on the side, comprising an area of 18.9 by 8.4 square meters (This size is the same as before its relocation). The first floor is the lower section of the pavilion and does not have walls, and its bottom floor is made of compacted soil. For the columns facing the outside, a circular column with a diameter of 480 millimeter was utilized and a 360-millimeter column, a smaller diameter than the exterior one, was utilized inside. Therefore, the foundation stone of the exterior column is larger than the one for the interior column. The stairs are installed on the right side. Meanwhile, the second floor is designed to function as an upper layer of the pavilion. The exterior columns begin on the first floor and extend to the roof structure. Hence they are inevitably large, becoming long components that playing an important role, leaving no other choice but to reuse them if possible.

The interior column is installed only along the rear side column and not along the one for the front. The diameter of the interior column is 360 millimeter, which is smaller than the exterior one. The interior column on the second floor is thus provided with a different component than the one on the first floor. The interior column supports the main girder and is simply attached to the upper structure. Moreover, since interior columns are not typically installed asymmetrically in a pavilion, it can be assumed that they were installed recently to secure the stability of the upper structure. The walls are not installed, and the railing with traditional patterns is newly installed along the column line. Therefore, although it has undergone several changes compared to when it was used as a school building, the scale, existing upper structure, primary structure columns, and other aspects have not much changed.

As illustrated in Figure 11a, traces of renovation could be found in three different columns. Among them, two were obtained by repairing the grooves for inserting the components on the column side of the first floor section, and it can be presumed to be a component from before the first relocation. This is because there was no necessity to insert a new component as *Mangseollu* was used as a school building after the first relocation and the exterior column was covered with cement mortar. Moreover, one column had been repaired since the lower section of the column was damaged, indicating that this component was utilized at least before the second relocation. (Figures 12 and 13)

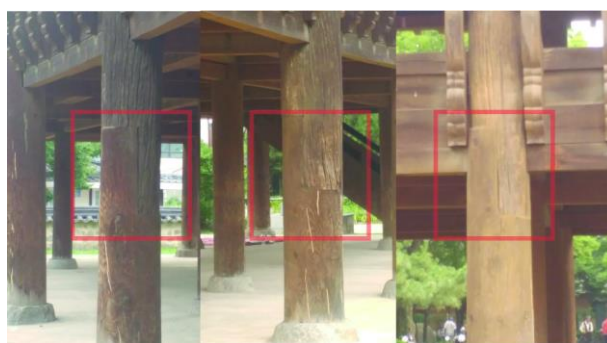
Figure 12. Traces of renovation of the exterior columns on the 1st floor. (all figures source: author).

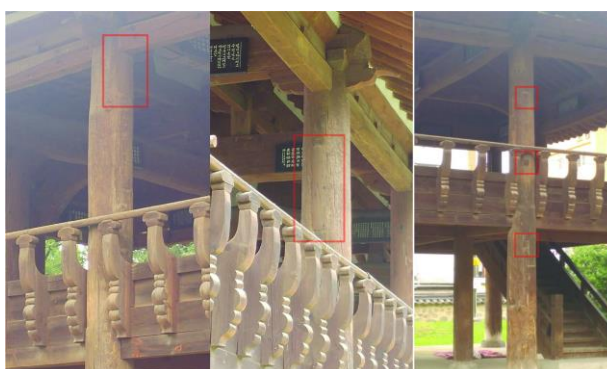
Figure 13. Traces of renovation of the exterior columns on the 2nd floor. (all figures source: author).

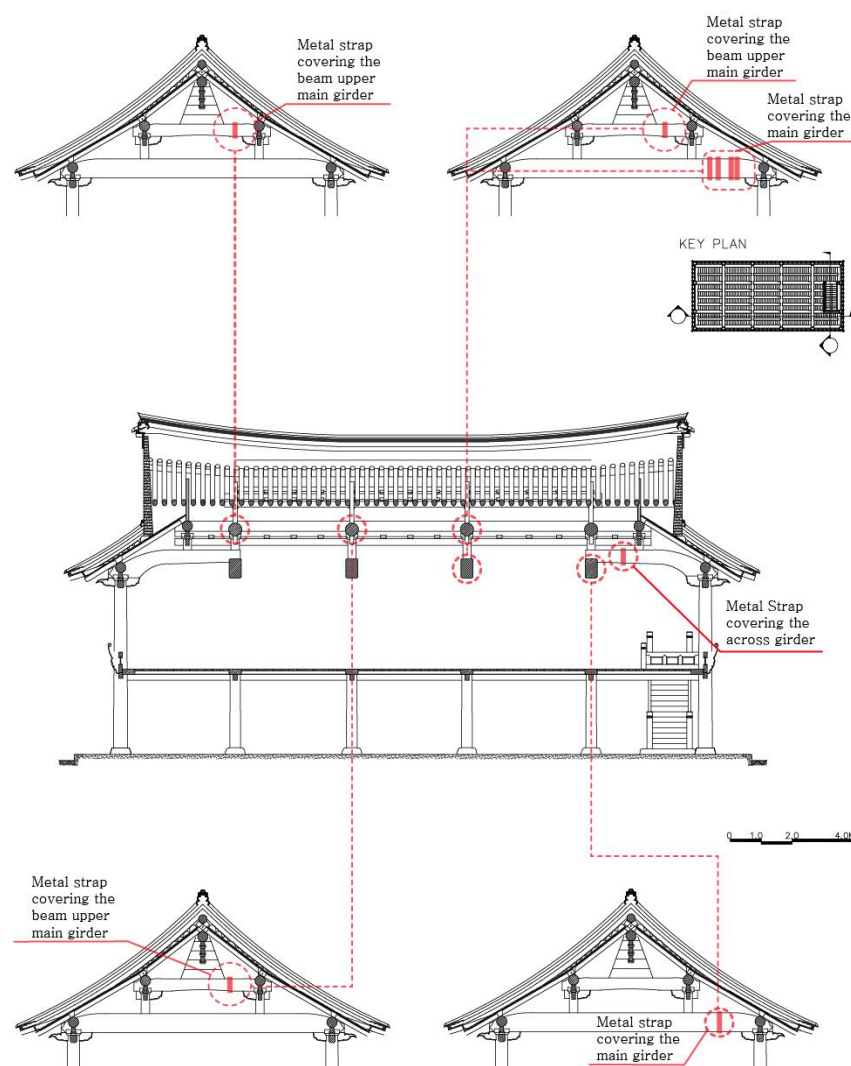
Figure 14. Repaired parts in the main girder and beam upper main girder. (all figures source: author).

Two of the four main girders were reinforced by covering the partially damaged sections with a metal strap; three of the four upper beam main girders were reinforced by covering the damaged sections with a metal strap.

Moreover, the damaged sections that now have metal straps installed thereon are on the rear side of the building, essentially referring to where the interior columns are installed. Given these points, the interior column of the second floor may have been installed recently to reinforce the damaged section of the main girder and upper beam main girders. And the components before relocation were utilized as is for the main girder and upper beam. Finally, as depicted in Figure 15, we found that the *dancheong* color of some rafters were different from others, thereby confirming that some rafters were replaced during renovation or relocation.

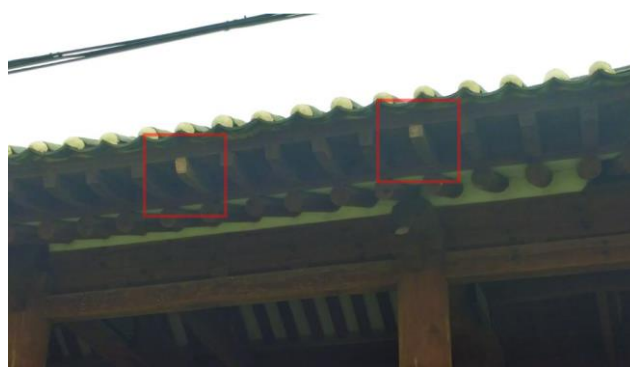
Figure 15. Traces of the reuse of wood elements. (source: author).
