Article

# Comprehensive Assessment for Post-Disaster Recovery Process in a Tourist Town

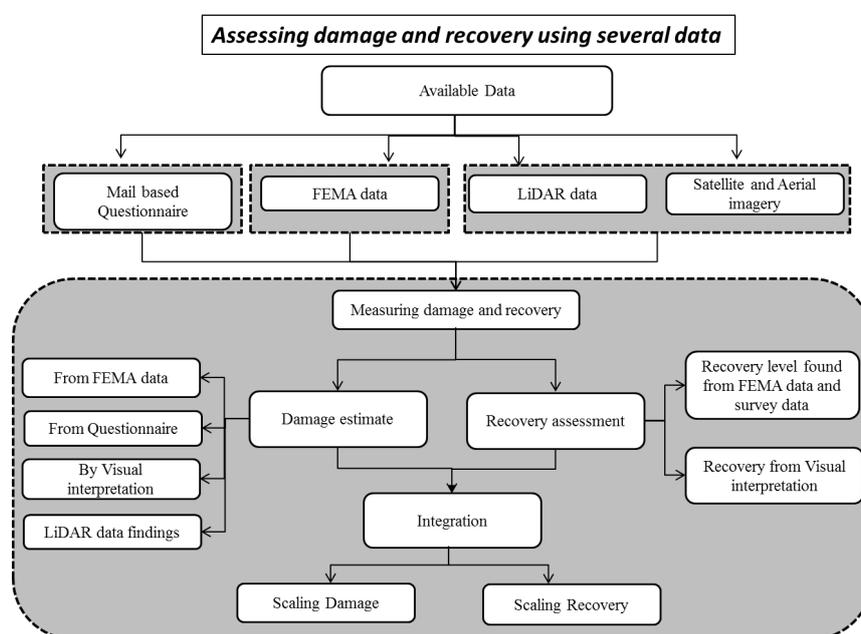
**Figure 2.** Schematic diagram of workflow. FEMA: Federal Emergency Management Agency; LiDAR: light detection and ranging.

Our research assembles and uses data from different sources and then integrates these data to document the recovery of damaged properties over time. The recovery rates, over time, of damaged structures in the affected area were studied based on quantitative methods supported by the literature. Figure 2 shows the schematic diagram of our workflow.

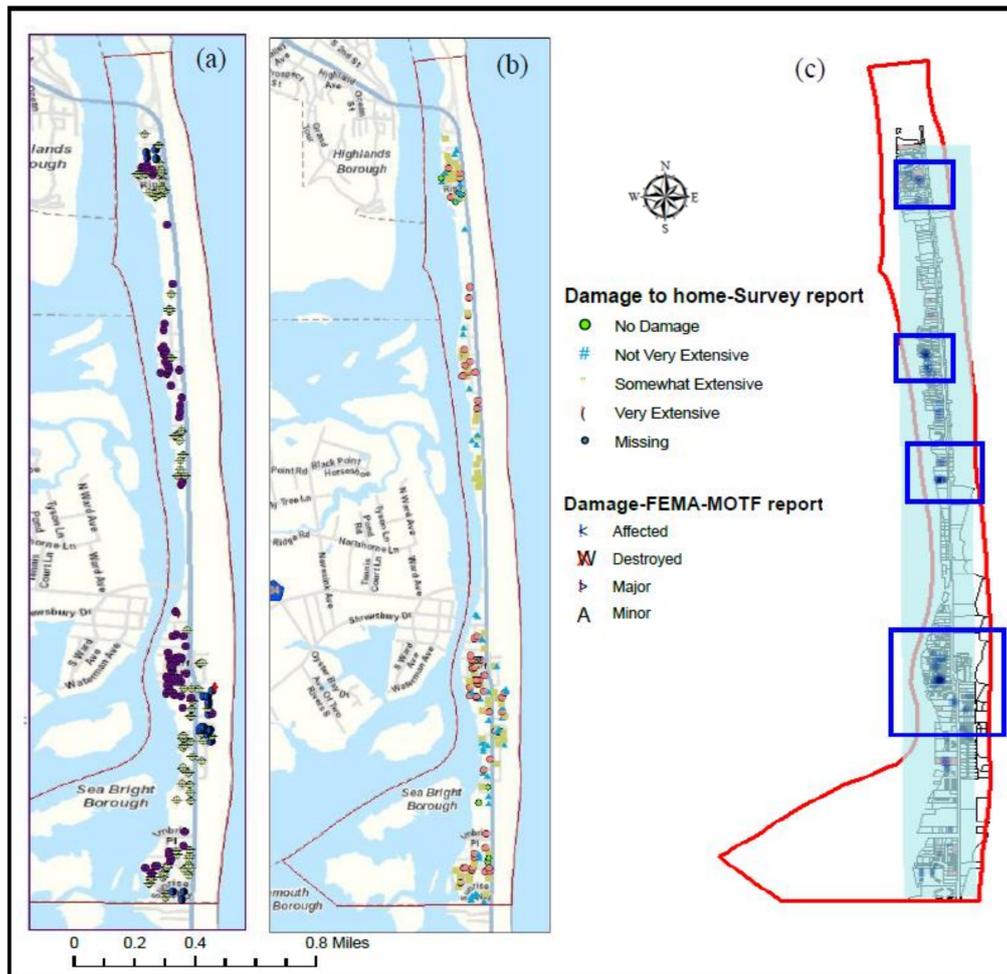
Figure 3 spatially compares survey response results and FEMA data with respect to damage conditions perceived by the households and as assessed by FEMA. The map shows that the southern part of the island experienced more damage regarding major, minor, and destroyed structures than the northern part of the island. While the northern section had no destroyed buildings, the damage is not negligible, because there were many structures with major and minor damage.

**Figure 3.** Damage condition recorded from (a) the questionnaire; (b) the FEMA-MOTF data; and (c) the distribution of estimated damage from the survey in kernel density analysis.

Based on the damage estimates from survey responses, kernel density analysis was performed to create a continuous surface surrounding damage concentrations based on people's perception. Here damage cost in dollars was the count or quantity to be spread across the landscape. Kernel calculates a magnitude per unit area using a kernel function to fit a smoothly tapered surface to each point or polyline. Figure 3 also highlights the area with more damage concentration as the southern section of Sea Bright.

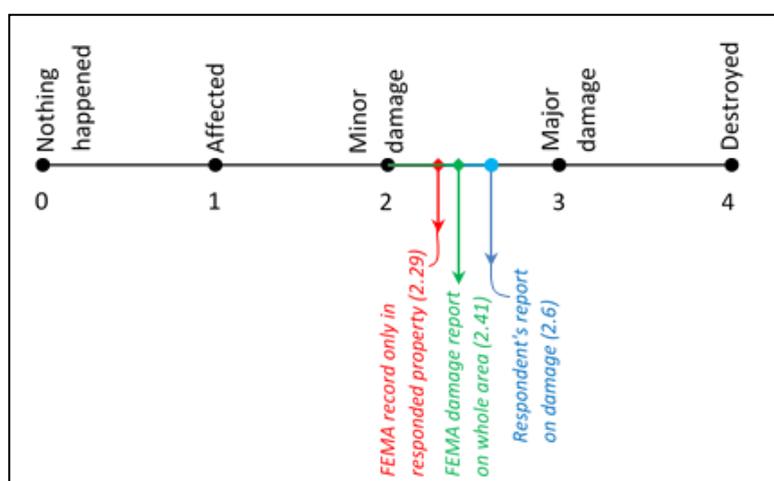
The average values found from FEMA damage data for whole study area, survey responses within the study area along with damage data, and the overall survey are shown schematically in Figure 4. From this diagram, it is obvious that, on average, the whole community experienced minor to major damage. This result illustrates the importance of selecting Sea Bright as the primary study area for assessing recovery over time.

**Figure 4.** Schematic diagram showing the average damage from different data sources.

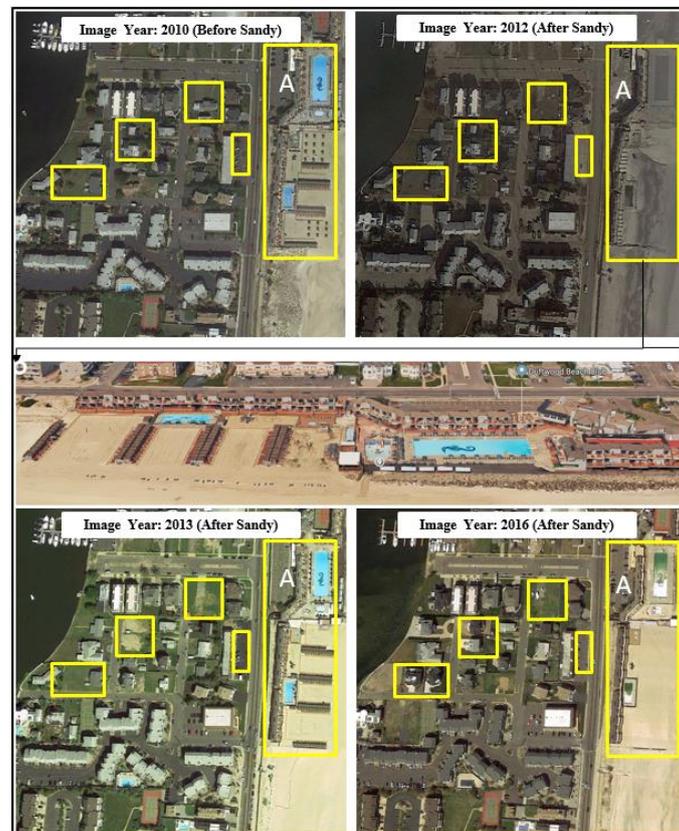
**Figure 5.** Visually identifiable changes in structural features (buildings) over time after Hurricane Sandy impact in 2012 (major impact on the Driftwood Beach Club).

Chronologically, comparing the building structures from the site images, it is found that 48 points had some change. Among them, 18 locations were fully destroyed, 18 had major damage, 9 had minor damage, and 3 were affected in that disaster. As of 2013, there was little activity to repair the destroyed properties, with only four properties rebuilt. This number increased to seven in 2014, while the remaining locations were still vacant plots. In 2013, eight plots with major damage were found vacant where building structures previously existed. In 2014, the number of vacant lots increased to 16, despite the reconstruction of houses on two of the previously vacant lots. Sites with minor damage also experienced demolition; for example, in 2014, seven of these locations were found to be unoccupied. The damage sites which were reconstructed and demolished, along with their damage condition

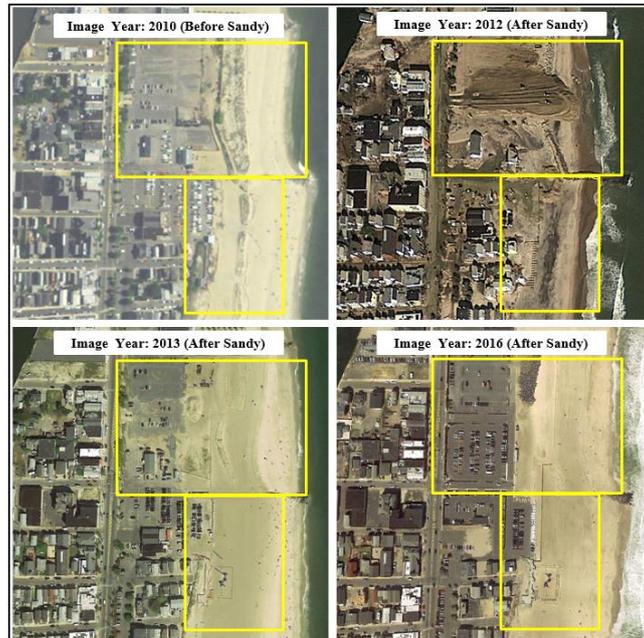
from Hurricane Sandy, are shown in Figures 5 and 6. Figure 6 shows the Sea Bright Public beach, which offers lifeguards, rescue personnel, parking, restroom facilities and seasonal locker rentals. From the visual observation of the number of unoccupied plots and changes in use patterns shown in Figure 7, we can conclude that as of 2014, the southern section of Sea Bright was still undergoing the recovery process.

Figure 6. Condition of sandy dunes (Sea Bright Public beach) after Hurricane Sandy from 2010 to 2016.

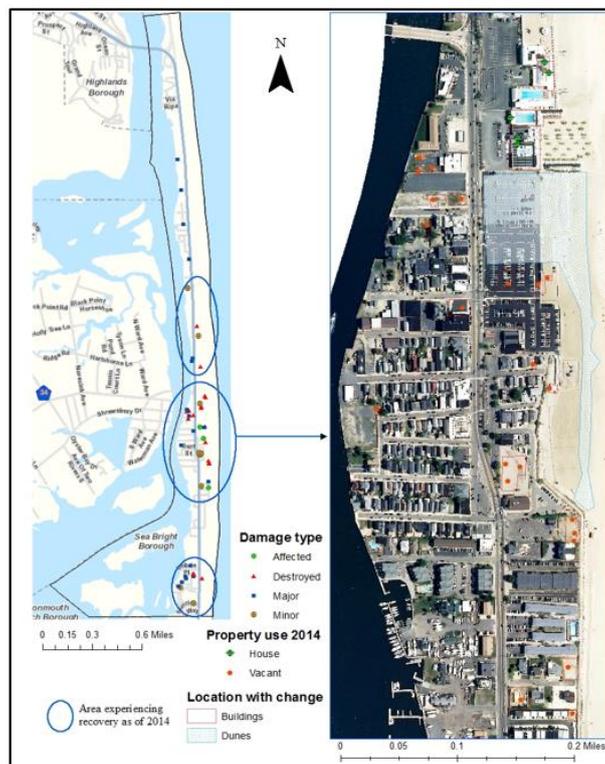
Figure 7. Locations of 48 damage points that showed changes after Hurricane Sandy, up to 2016. The concentration area identifies the location experiencing housing recovery.

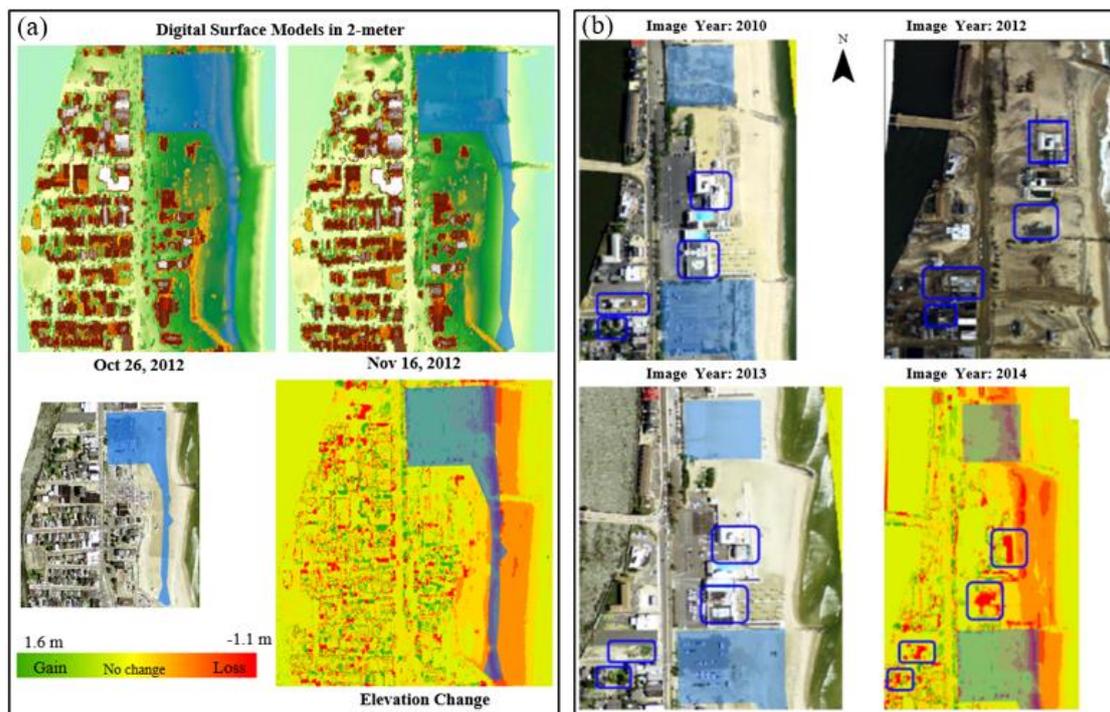
**Figure 8.** (a) Change detection in dunes pre- and post-Hurricane Sandy; (b) Change detection in building structures in pre- and post-Hurricane Sandy.

Figure 8 shows the visual interpretation from the LiDAR data analysis of change detection in pre- and post-Hurricane Sandy in natural dunes and building structures. To determine this change, the analysis tool “change detection map” in the QTM software was used to create a continuous surface showing elevation differences. These maps are useful in visually identifying the areas with gain or loss in elevation due to impact from Hurricane Sandy. This type of LiDAR data analysis is effective in damage estimation of an area when considering its physical properties.

The Quick Terrain Modeler (QTM) software was used to produce a 2-m resolution digital surface model (DSM) based on point spacing in pre- and post-disaster scenarios. Here 2-m was chosen to provide a good result, as it is greater than the point spacing in both data sets, and all points were covered in the surface creation. The surface models created from pre- and post-Hurricane Sandy elevation were used to identify the locations with differential change in elevation, thereby using loss or gain in elevation as an indicator of damage or debris accumulation in the area (Figure 8).

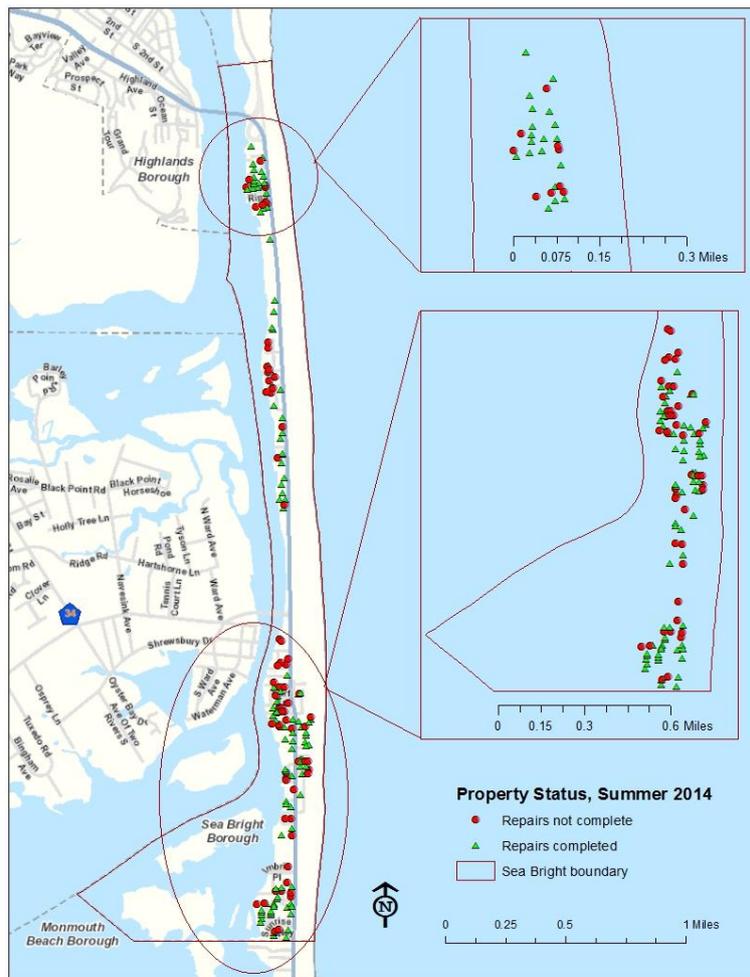
The repair status of the buildings in the survey, as of August 2014, were compared to the initial damage reported by FEMA in order to determine the recovery level of the study area (Figure 9). Based on responses considering building repair, from addresses located within Sea Bright, 62% of the total damaged area was recovered in terms of building repair, and 38% of the area was in the process of recovery. Significant improvement was found in properties with minor damage, whereas 72% had completed repairs. The sites with major damage, along with destroyed plots, were experiencing slow recovery in 2014. As of August 2014, data showed 51% of major damaged sites and 67% of all destroyed structures were still in the process of repair.

Figure 9. Recovery level of the study area based on repair status of the damaged buildings.

According to the damage category reported in the survey, 66.43% of repairs were completed, while the FEMA damage category and response of household survey showed 62% of the area under “repair complete” and were considered as fully recovered. These values are close enough to suggest consistency in the results, despite being calculated in different ways. Figure 9 shows the distribution of survey results on “repair completion” and locations where repair was still needed. From Figure 9, it is apparent that there were no patterns in the progress of recovery based on location. Recovery had a mixed pattern throughout the borough. So, it cannot be said definitely which geographical location had fully recovered or had more recovery. If some damaged properties in one block had completed repairs, others may still have been waiting for repairs.

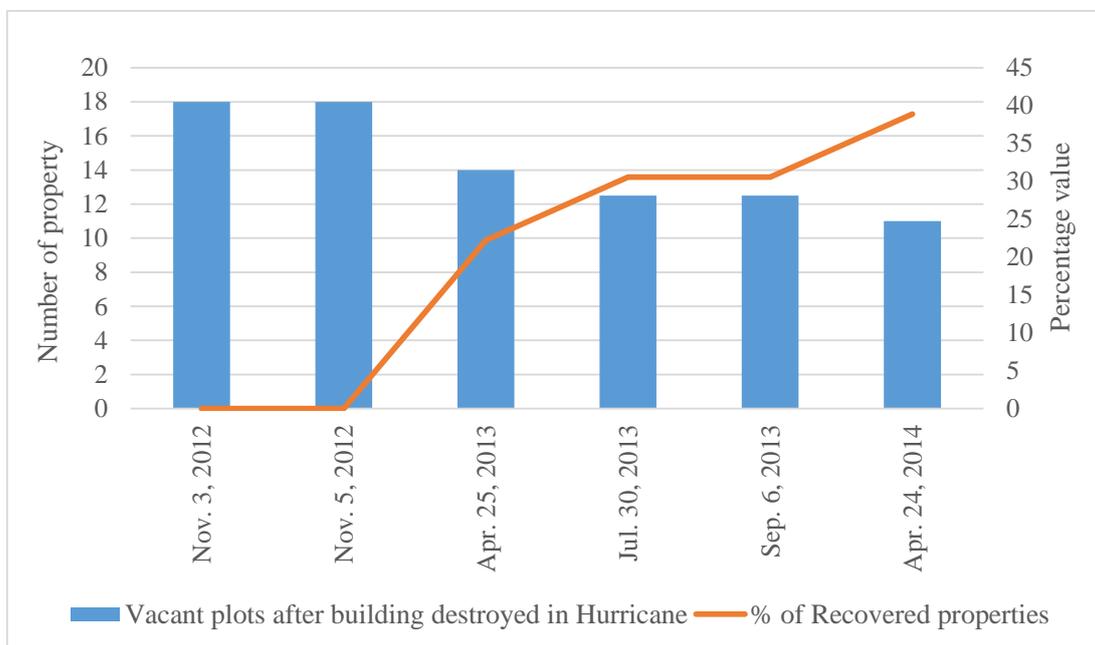
Comparing the recovery among the damaged properties showed that the destroyed properties experienced slow recovery; although this observation is based on a small sample (from the survey, only 1 destroyed plot out of 3 reported completed repair). Examination of the satellite images from Google Earth, from October 2012, to 21 April 2014, showed 7 out of the 18 destroyed plots were in use (i.e., 38.89%). The remaining destroyed plots were vacant, with no use. Figure 10 shows the trend line with percentage of recovery progress over total destroyed structures in the study area. The bar shows the number of vacant plots after Hurricane Sandy.

**Figure 10.** Recovery progress (%) of the destroyed property with their status (vacant) in different time period in Sea Bright after Hurricane Sandy.

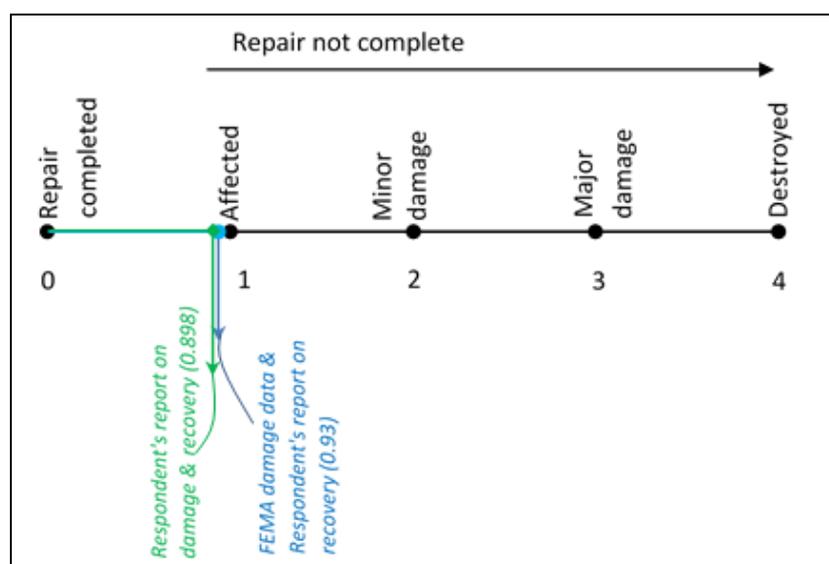
Figure 11 schematically shows the position of the weighted recovery level considering FEMA damage categories and the survey responses' classification of damage. The responses related to repair completed or repair not completed was weighted to determine the status of the area as a whole. It is seen from the weighted result in Figure 11 that the whole area was very close to "affected". It is assumed that when the value reaches "0", it can be said that the recovery is complete for the moment, considering the structural damage in the area.

**Figure 11.** Schematic diagram showing the weighted recovery from different data sources.
