# Rapid Retrofit of Reinforced Concrete Frames after Progressive Collapse to Increase Sustainability

**Abstract:** A structural progressive collapse is usually a local failure, in which the damage is concentrated at beams that bridge the removal column and the column itself. In many cases, retrofitting the damaged structure is more economical and more sustainable than reconstructing the entire structure. A progressive collapse test of a 1/3 scale, four-bay by two-story reinforced concrete (RC) frame was conducted, after which the structure was retrofitted with carbon fiber reinforced polymer (CFRP) wraps and retested. The center column in the first story was removed and the frame was pushed down quasistatically under displacement control to investigate the progressive collapse performances of the retrofitted RC frame. The test results were represented systematically at different areas in terms of the resistance forces, crack developments, and local and global failure modes. Numerical models were built to verify the test frame before and after the retrofitting. A design method was proposed to retrofit an RC frame using CFRP wraps after a progressive collapse. The test frame was red

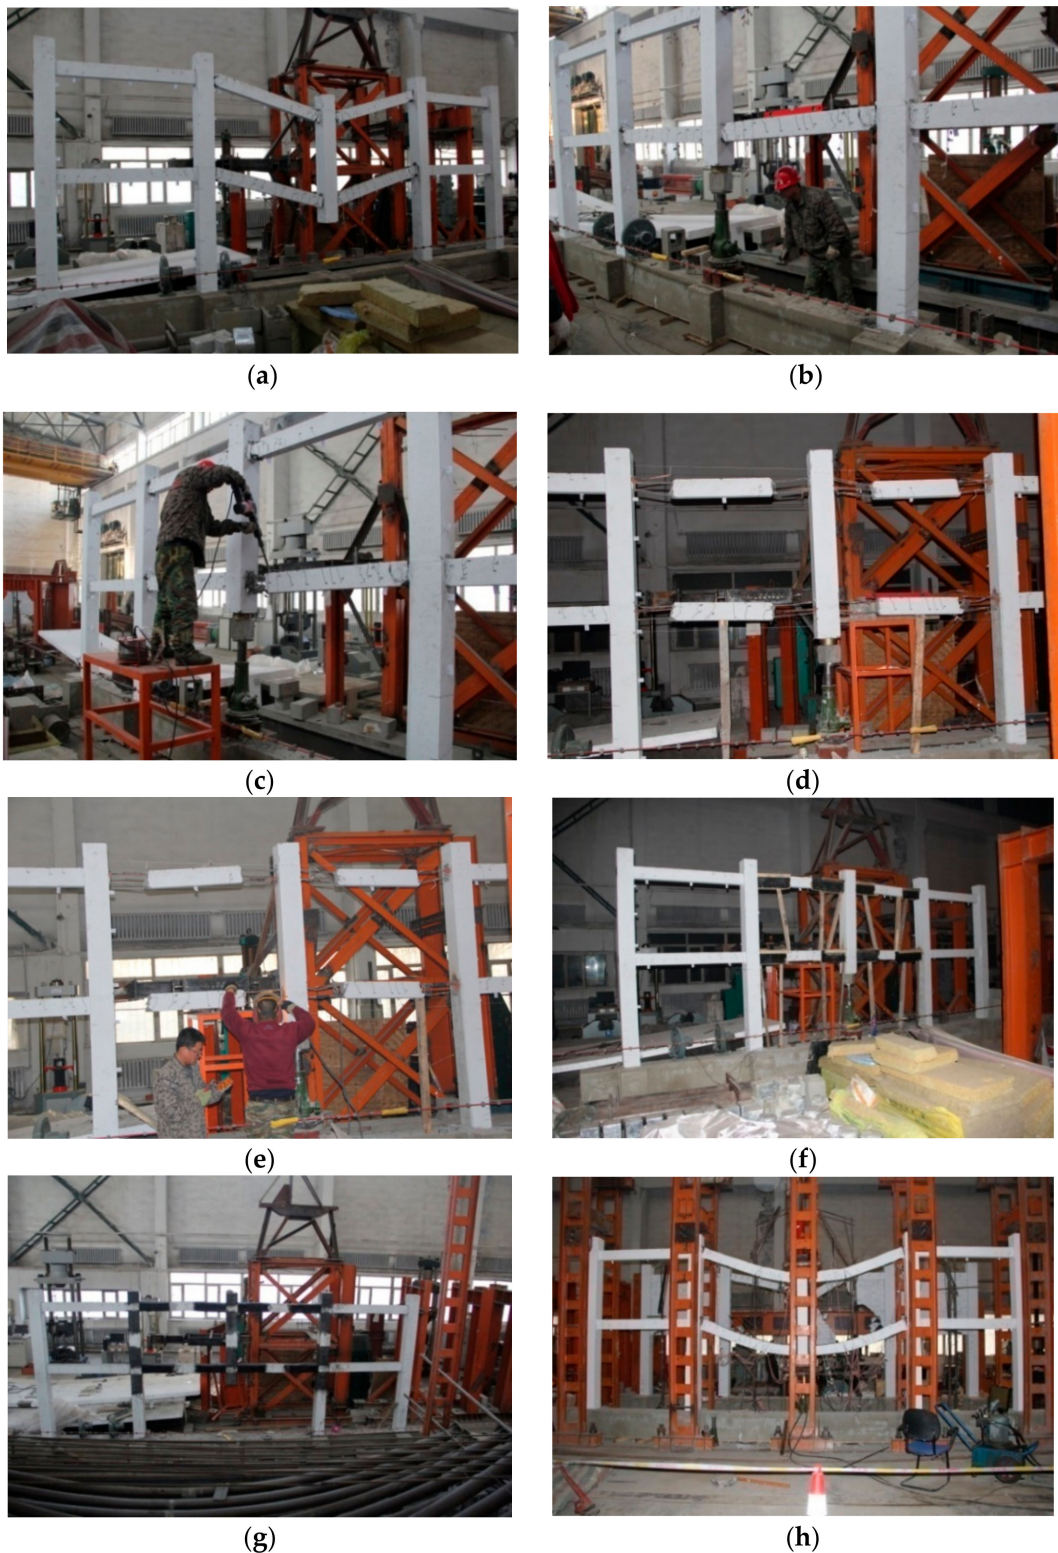
**Figure 7.** Retrofit procedure of the frame: (a) Frame after progressive collapse; (b) Restore to undeformed status; (c) Remove damaged concrete and straighten rebars; (d) Brace frame to keep its undeformed status; (e) Replace damaged rebars; (f) Build molding board and pour high strength CGM; (g) Remove molding board and bond CFRP wrap; (h) Retest on retrofitted frame.

- (1) After the first test, the frame was damaged and deformed to a specific vertical displacement (Figure 7a). Push the frame upward from the progressive collapse state to return to the undeformed state (Figure 7b).

- (2) Remove the damaged concrete near the beam–column joints in bays B and C (damaged bay) and straighten the rebars if their diameters did not show obvious shrinkage (Figure 7c). In this test, the extent of the removed concrete was 250 mm from the column surfaces. This range was determined because it was slightly larger than the plastic hinge length (set as one beam height of 150 mm in this case) plus the required weld length between the new and original rebars (smaller than 100 mm in this case). The stirrups within this range were also removed. After removing the damaged concrete and stirrups, the beam segment in the center region of the beams could deform downward due to the gravity action of the beam segment. At this moment, the resistance force of the frame in the damaged bay was only provided by the dowel action of the rebars. Therefore, if necessary, braces could be installed below the beam segment in the center region of the beam to prevent the potential downward movement of the beam segment (Figure 7d).

- (3) Replace the rebars that were fractured and those whose diameters showed obvious shrinkage within the range of the removed concrete (Figure 7e). These replacements were implemented using new rebars instead of the fractured or shrunken segments of the original rebars. In this test, the length of the new rebar was 450 mm, with one end planted in the column with a length of 200 mm (larger than the required anchor length) and the other end welded to the original rebar with a weld length of 100 mm. The original rebars, which needed to be replaced, were cut within a range of 0–150 mm from the column surface. Because uncertainty existed in the performance degradation of the unreplaced rebars, the new rebars had a diameter of 10 mm, which was slightly larger than that of the original rebars (8 mm).

- (4) The molding board was built within the range of the removed concrete (Figure 7f) and high-strength CGM was poured into it. The molding board was removed after one day, when the strength of the CGM had developed. In order to use the CFRP wrap, the four edges of the beam cross-section in the damaged bays were ground to obtain rounded edges in the area where the wrap was used. In this test, the edge was ground up to 500 mm from the column surface, which was two times the length of the removed concrete.

- (5) Bond the CFRP wraps as shown in Figure 7g. Figure 8 shows the detailed dimensions of the bonded CFRP wraps and their positions. To provide a flexural-resistance capacity, two layers were bonded at the top and bottom surfaces of the beams along the beam's axial direction and extended to column surfaces. Thereafter, to provide an anchor action and a shear-resistance capacity, two layers that encircled the beams and columns were bonded.

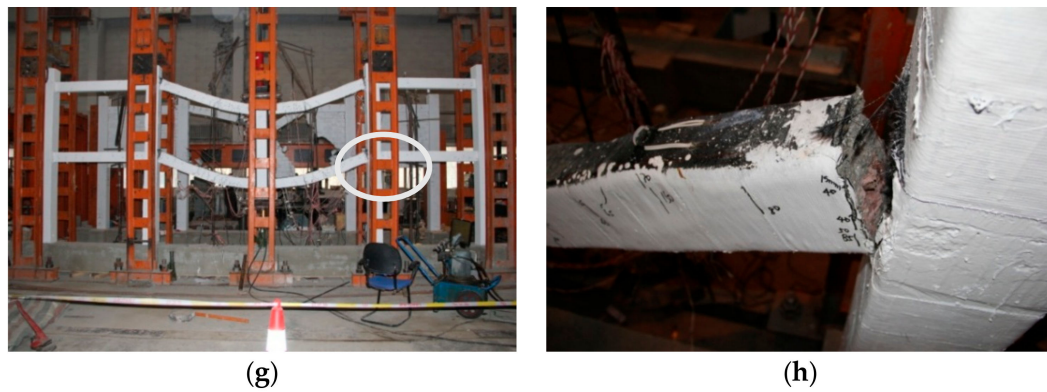
**Figure 11.** Progressive collapse process of retrofitted frame: (a) Vertical displacement at 30 mm (frame); (b) Vertical displacement at 30 mm (joint); (c) Vertical displacement at 130 mm (frame); (d) Vertical displacement at 130 mm (joint); € Vertical displacement at 230 mm (frame); (f) Vertical displacement at 230 mm (joint); (g) Vertical displacement at 420 mm (frame); (h) Vertical displacement at 420 mm (joint).

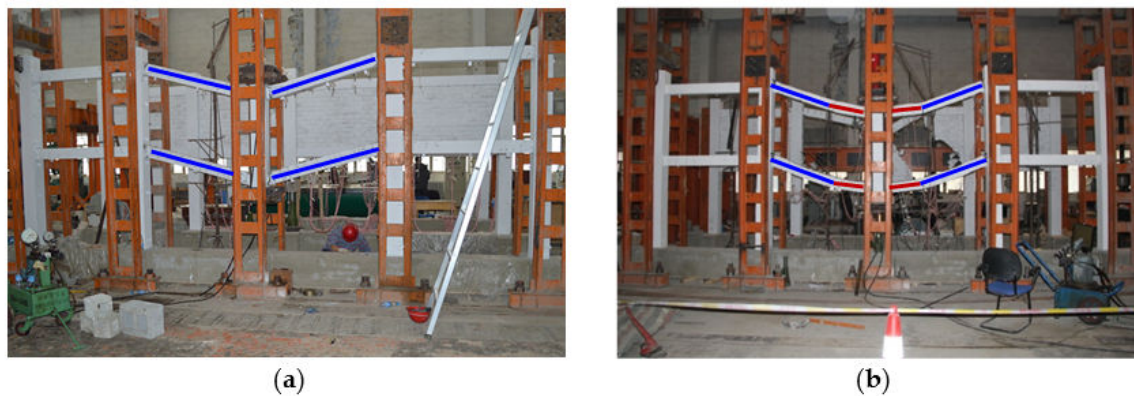
**Figure 12.** Comparison of failure modes of retrofitted and initial frames at end of tests: (a) First test [18]; (b) Second test.
