# Identification of Quality Failures in Building Energy Renovation Projects in Northern China

Yuting Qi \*

Faculty of Architecture and the Built Environment, Delft University of Technology, Julianalaan 134,  
2628BL Delft, The Netherlands

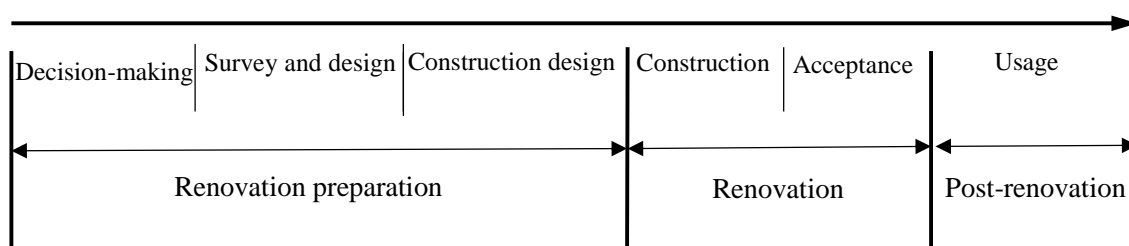
**Figure 1.** The stages of renovation projects (Modified from Wu et al. [50]).

According to previous studies, complete building energy renovation processes are arranged with three stages, renovation preparation stages, renovation stages, and post-renovation stages [50]. These stages are divided into particular sub-stages, including a decision-making phase, survey, and design phase, construction design phase, construction phase, acceptance phase, and usage phase by the administrative regulations, as shown in Figure 1 [50].

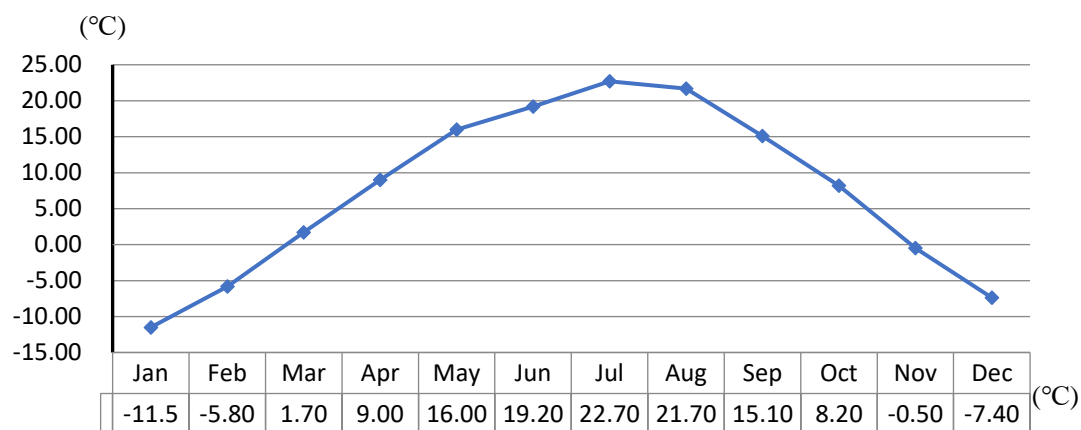
Figure 6. Average temperature in Hohhot (by the authors).

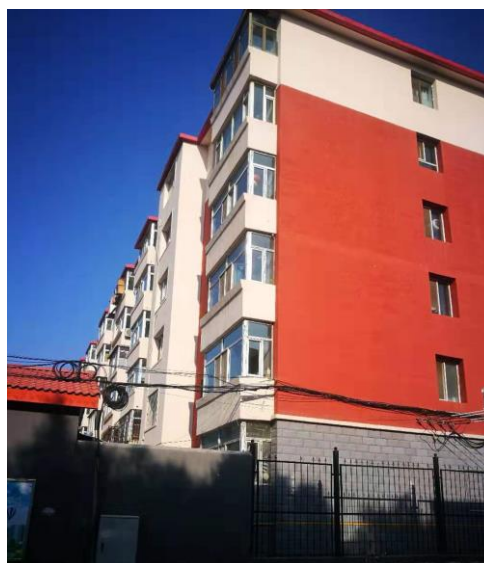
Figure 7. The residential building renovated in the case study (by the authors).

The five cases of building renovation projects were selected to be representative of the residential building renovation situations (Figure 7). They cover a broad diversity of different construction conditions such as location, contract value, renovation size, construction companies, supervision companies and the current status of building energy renovation projects (the details are illustrated in Table 1). The diversity of project characteristics is intended to know what and how quality failures occurred, based on their particular context and conditions.

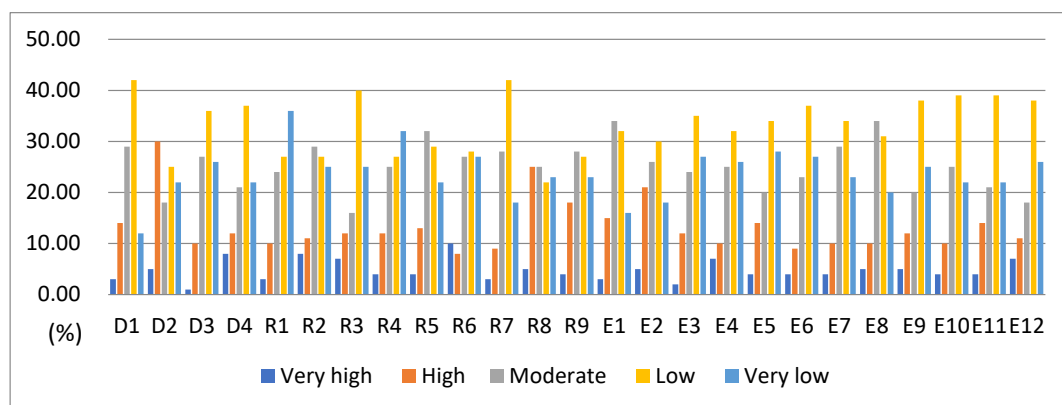
**Figure 8.** The percentage graph of respondent evaluation of the quality failures.

Table 6 and Figure 8 show the percentage of the respondents’ evaluation of the quality failures concerning the occurrence frequency according to the different linguistic variables.
