Article

Experimental Study on Seismic Behavior of Masonry Walls Strengthened by Reinforced Mortar Cross Strips

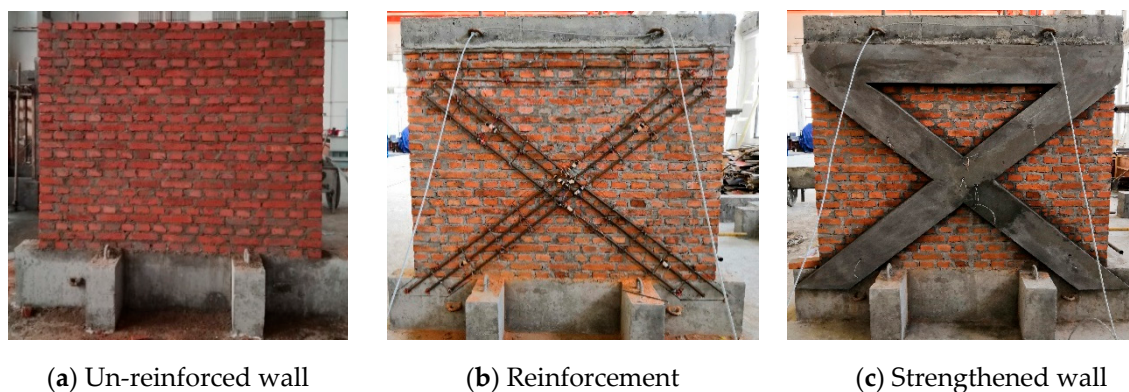
Figure 2. Reinforcement construction process.

According to the related technical specification and experiences, effective control measures on construction quality were applied to ensure the quality of un-reinforced masonry wall. The bricks of each layer have the same arrangement and were orthogonal with the adjacent layers. When the bricks were under construction, the thickness of masonry mortar in the vertical and horizontal directions was limited in 10 ± 1 mm, and the wall dimensions were strictly controlled with the position scale. All the specimens were built by two professional masons using the streamline method to ensure construction equality. Figure 2a show a typical photograph of the un-reinforced masonry wall in this test.

During the construction process of smearing overlay mortars, layered construction was used to obtain greater uniformity. The thickness of each layer did not exceed 15 mm in one-day construction. So that the mortar strip construction was completed in two days. After strengthening construction, all the specimens had been wet cured for 28 days. The strengthening procedure is shown in Figure 2b,c.

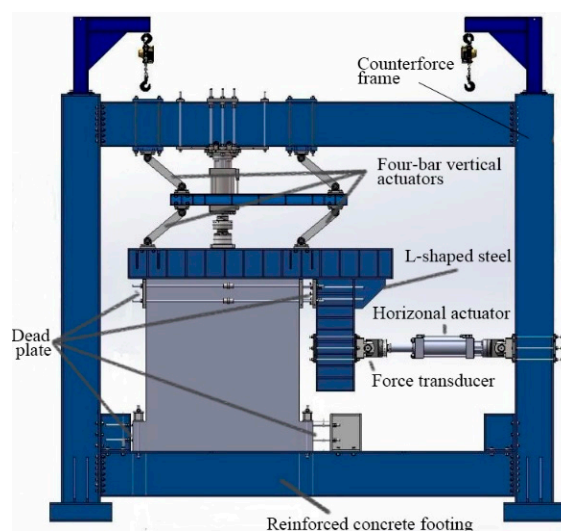
Figure 3. Four-bar loading device.

All specimens were tested under lateral cyclic loading, simultaneously with a vertical constant load on the top face. Both lateral and vertical loading was applied on the loading beam by a four-bar linkage loading device, shown in Figure 3. This loading device consisted of a counterforce frame, a four-bar linkage, an L-shaped loading steel beam and two hydraulic actuators. The L-shaped steel beam could effectively restrain the top of the wall from rotating, so that the specimens would eventually fail due to only shear load rather than bending load. In order to transfer the lateral force effectively, a fixing device, composed of four threaded steel rods and two bolted end-plates, was used to integrate the concrete loading beam and the L-shaped steel beam. When the installation is complete, a preloading test was carried out to check whether the test devices can work properly. In this process, fifty percent of the requested vertical load was applied, then 20 kN was used as a lateral cyclic load for three times.

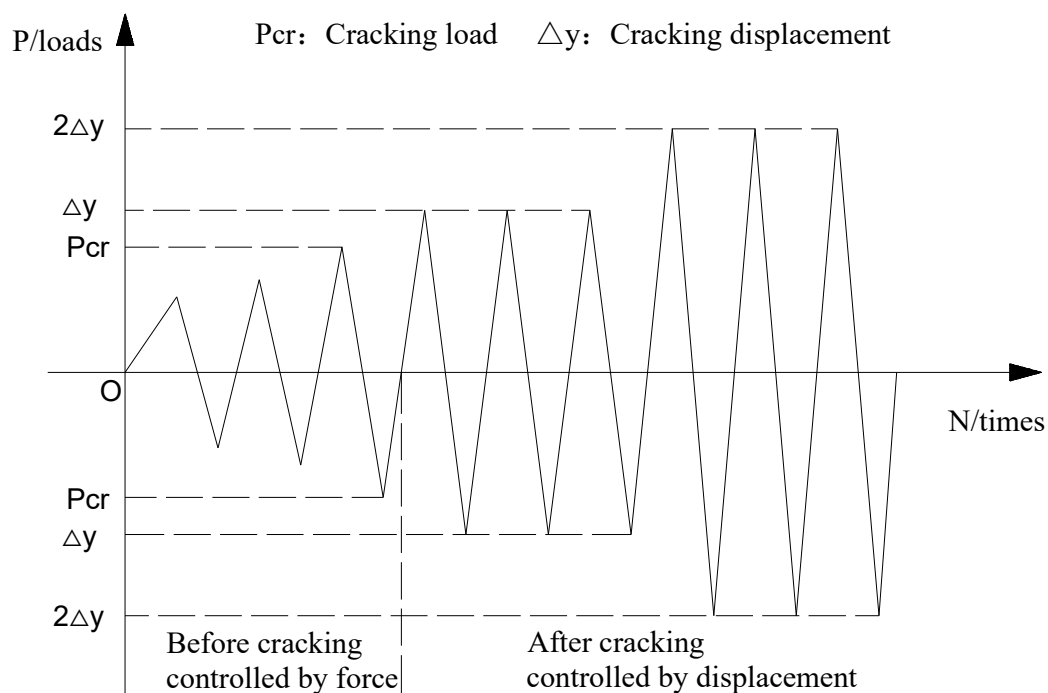
Figure 4. Experimental loading mode.

After the check work was finished, the seismic test began. First, the requested vertical load was applied with a 1000 kN capacity actuator and kept constant during the whole test. Thereafter, the lateral cycle load was applied with a 500 kN capacity actuator, according to the Chinese Code JGJ/T 101-2015 [42], specification for the seismic test of buildings. Plotted in Figure 4, the control method consists of a series of reversed force and displacement cycles, and each cycle was four minutes. The force control, with increment by 20 kN per cycle, was used until the first crack appeared. At that moment, the horizontal load and displacement of loading point were defined as cracking load and cracking displacement, respectively. After that, the displacement cycles began with increment by the value of cracking displacement. For each displacement increment, three cycles of the same amplitude are applied. This loading mode can be controlled manually and modified as needed. When the recorded lateral force decreased to 85 percent of peak load, the test was terminated.

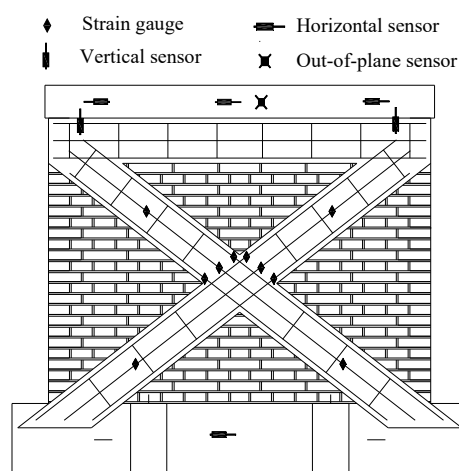
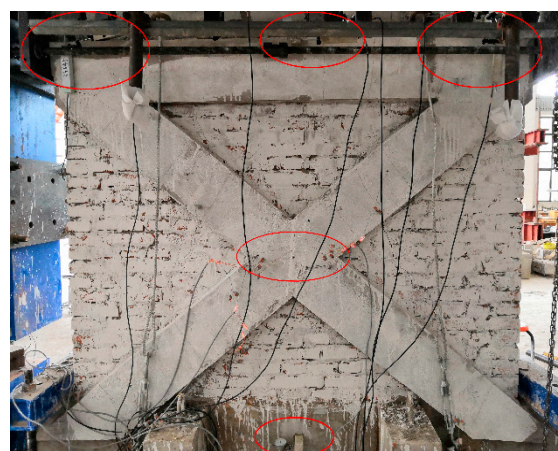
(a) Sketch

(b) Photo on the site

Figure 5. Sensors and stress gauges position.

Various transducers have been employed to record the structural responses, including the horizontal and vertical displacement in-plane, the displacement out-of-plane, the loading force and the strain of steel bars. The displacement transducers were placed at both edges of the loading concrete beam to measure the vertical and horizontal displacement in-plane. Additional two transducers at the mid-span of upper and bottom concrete beams were assigned for collecting the relative horizontal displacement. The last transducer was located at the middle of the upper loading beam to measure the out-of-plane displacement. The average horizontal displacement of three measure points on the upper beam was defined as the horizontal displacement of loading point for the test specimen. Besides, the horizontal and vertical loads were also received by the force transducers, which were integrated into the actuators. In order to access the conditions of steel stress development, the ten strain gauges were stuck on the middle and quarter span of the diagonal reinforcement bars. The position of transducers and strain gauges are illustrated in Figure 5.

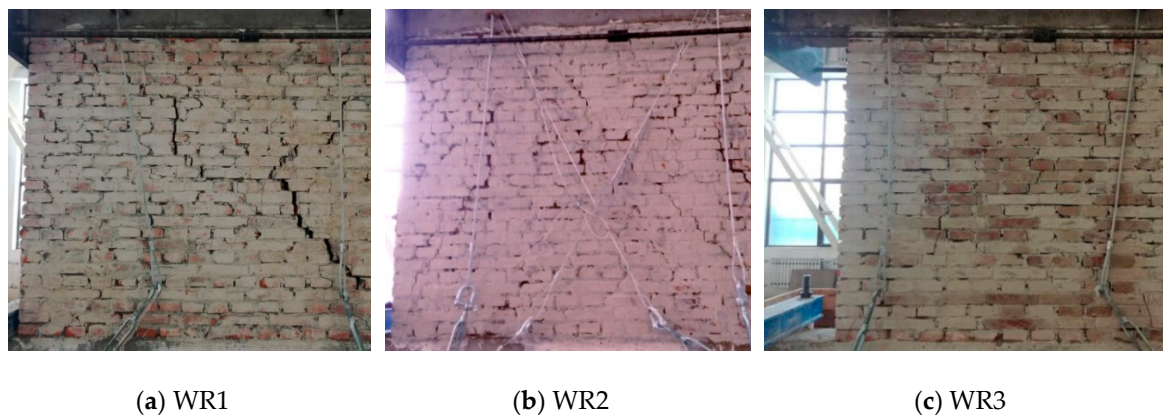
Figure 6. The crack distribution of un-reinforced masonry walls at the ending of tests.

A shear failure mode was observed for the three un-reinforced walls, the behavior of which were similar. Take specimen WR2 for example (Figure 6b), the test response was described as follows. In the force cycling stage, the deformation increases linearly. When the horizontal load reached 97 kN, the first crack appeared in the center of the wall. It was a diagonal oblique cracking from the upper left to the lower right. The crack propagated mainly along the horizontal and vertical mortar bed joint, and few bricks fractured in the middle. Thereafter, as the control displacement increased, the maximum horizontal load did not increase, and the first crack extended to the bottom and top of the wall. When the displacement of loading point reached 8 mm, another oblique crack appeared along the other diagonal direction of the wall. While continuing to load, the main oblique crack gradually enlarged until the test ended, at which the bearing capacity of the wall decreased to 85 percent of the peak load. The crack distribution of WR1, WR2, WR3 at the ending of tests are shown in Figure 6a–c.

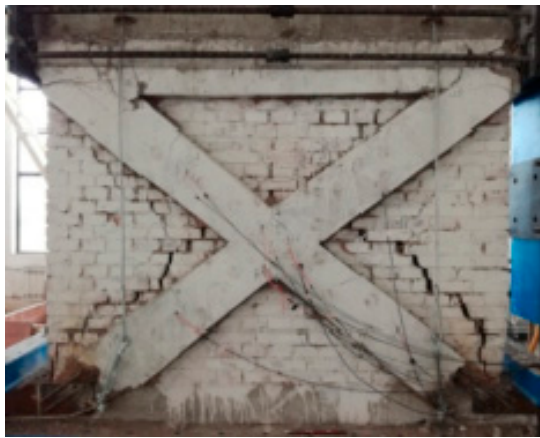
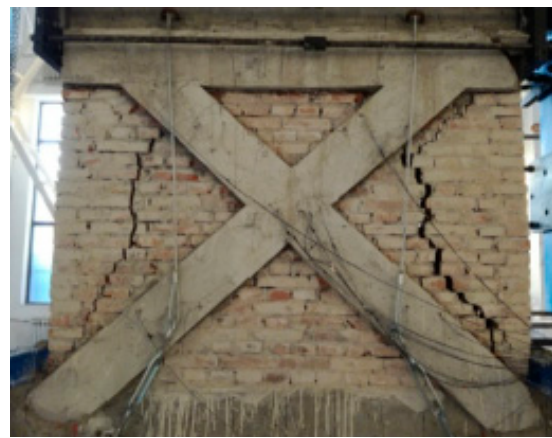
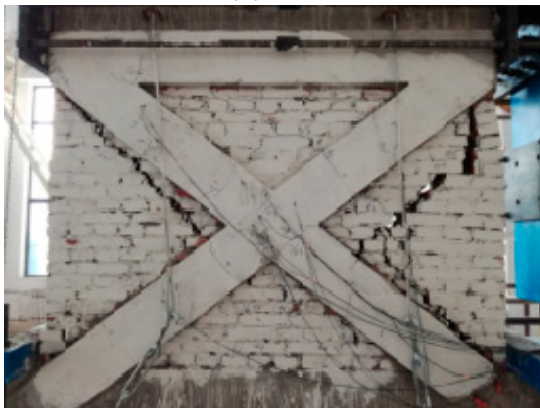
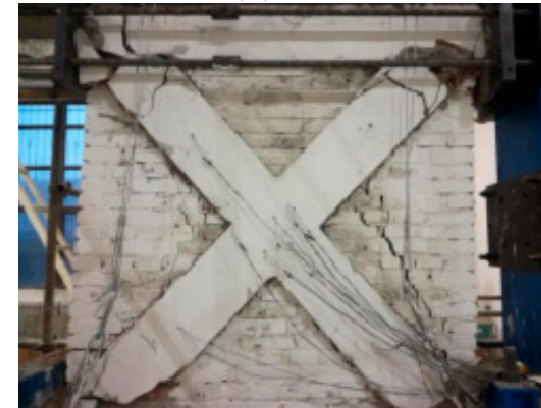
Figure 8. The crack distribution of strengthened masonry walls W5–W8 at the ending of tests.

The failure mode of specimens W5–W8 were all shear failure, shown in Figure 8a–d. Take the single-faced strengthened specimen W5 for example (Figure 8a). With the horizontal load increasing, the first two cracks appeared at about 160 kN. One crack appeared on the mortar strip in the lower left corner, while the other crack occurred at the junction of the two cross strips. Meanwhile, slight cracks appeared at the joint of the masonry wall and overlay mortar. Horizontal fracture in the back side showed up along the lower mortar bed when the horizontal force exceeded 190 kN. At the same time, vertical cracks appeared on the left side of the masonry wall. Oblique crack appeared on the back of the wall until the horizontal force reached 200 kN. So far, it is considered that the wall entered the stage of elastoplastic deformation. Loading mode turned to displacement control. In the following stage, some vertical cracks appeared on the upper triangular region (the mortar strip divided the wall into four triangular). After that, oblique cracks came out in all the triangle areas except for the lower one. These oblique cracks were located close and parallel to the strips. Visible crossing cracks were discovered on the back side of the specimen (the un-strengthened face). With the increase of horizontal displacement, more cracks appeared on the back of the wall, parallel to the main diagonal cracks. Then the bearing capacity of the wall descended, and the final horizontal displacement of loading point was 9.67 mm when the test ended. Removing the overlay mortar, the observation of end anchorage for

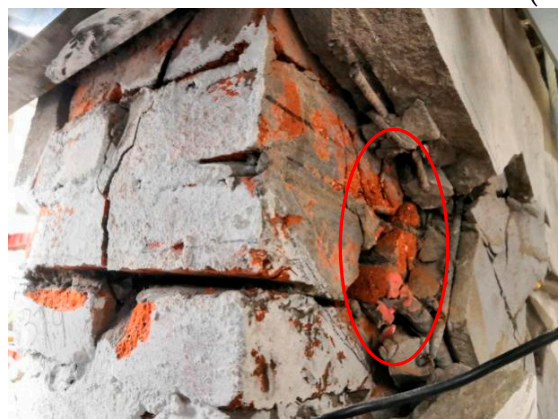
(e) The end anchorage of rebars

diagonal rebars is given in Figure 8e. The bricks around anchorage point were crushed with no rebar separation from the wall.

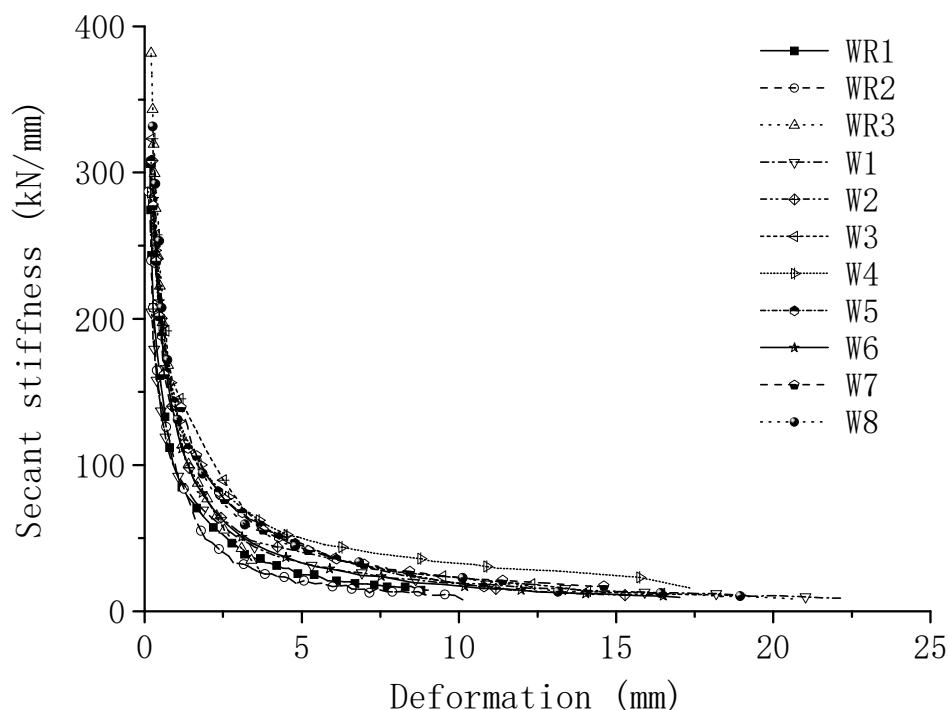
Figure 11. Stiffness degradation curves.

From Figure 11, stiffness degradation tends to be basically the same for all the specimens. It is worth noting that the stiffness degradation rate of strengthening specimens is lower than that of un-reinforced specimens, which is more obvious after cracking. That's because RM cross strips can effectively restrain the enlargement of diagonal cracks, and slow the degradation of structural stiffness. As a consequence, the structure has better seismic performance after retrofitting. Unlike un-reinforced walls, RM cross strip strengthening wall has more factors affecting the structural stiffness of the strengthened wall. By comparison, strengthening on both faces and increasing the vertical load can effectively reduce the degradation rate of stiffness, as well as using steel bars of larger diameter and strip mortar of higher strength.
