Article

Sustainable Improvement of the Crack Resistance of Cohesive Soils

Keywords: sustainable materials; ground improvement; image analysis; desiccation cracking

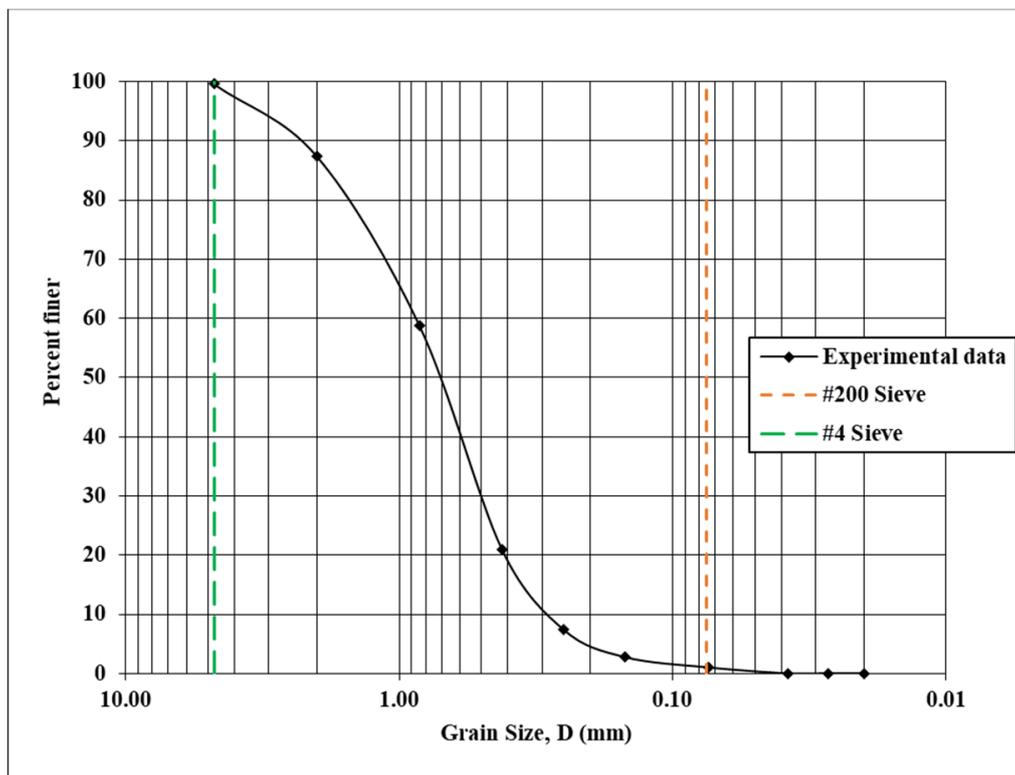
Figure 1. Grain size distribution curve of the base soil used in this study.

The base soil material used for experimentation was residual Piedmont soil that had been sieved through the No. 40 sieve (0.425 mm). Piedmont soils have the reputation of not being particularly well categorized by the Unified Soil Classification System (USCS) [23]. The soil behaves almost as a hybrid soil type, exhibiting characteristics of the fine-grained silt in undrained conditions and the coarse-grained soil silty sand in drained conditions when loading is applied [23]. Figure 1 depicts the grain size distribution curve for the base soil. The soil was tested for its Atterberg Limits in accordance with ASTM D4318 [24] and the liquid limit and plasticity Index were determined to be 49 and 20, respectively. Therefore, according to the USCS, the fine particles are classified as silt with low plasticity. The overall classification of residual Piedmont soil that was used in this study was well-graded sand with silt (SW-SM).

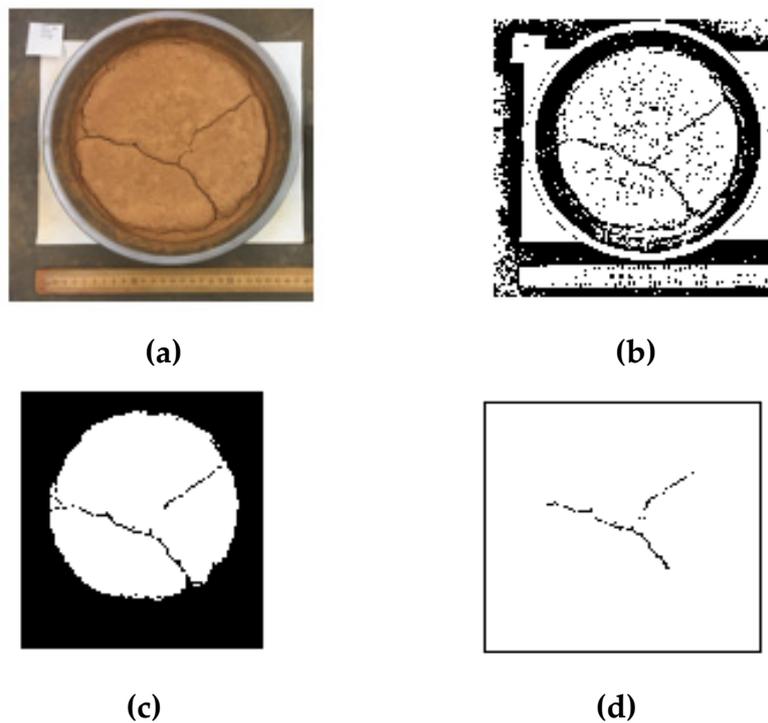
Figure 2. Image processing: (a) original sample photo; (b) original binary image; (c) clay surface binary image; (d) isolated crack binary image.

The first step, image conversion, converted the original digital image (Figure 2a) first into a grayscale image and then further still into a binary image (Figure 2b). The second step was segmentation which isolated the clay surface and removed blemishes from the indentations in the clay surface (Figure 2c). The image was then given real dimensions by converting a known distance in the image to a pixel distance, giving the image data context. The surface area of each specimen was collected and the initial area ($Area_i$) for each specimen was stored and compared to each subsequent image. The change in the area at each stage ($\Delta Area$) in comparison with the initial area ($Area_i$) was used to determine the ARF:

To accurately analyze the crack parameters, the binary image of the crack needed to be isolated such that the desiccation crack was the only black portion of the image remaining (Figure 2d). This final image was analyzed using a VBA code to return values for the maximum crack width (w_{max}) and the average crack width (w_{avg}).

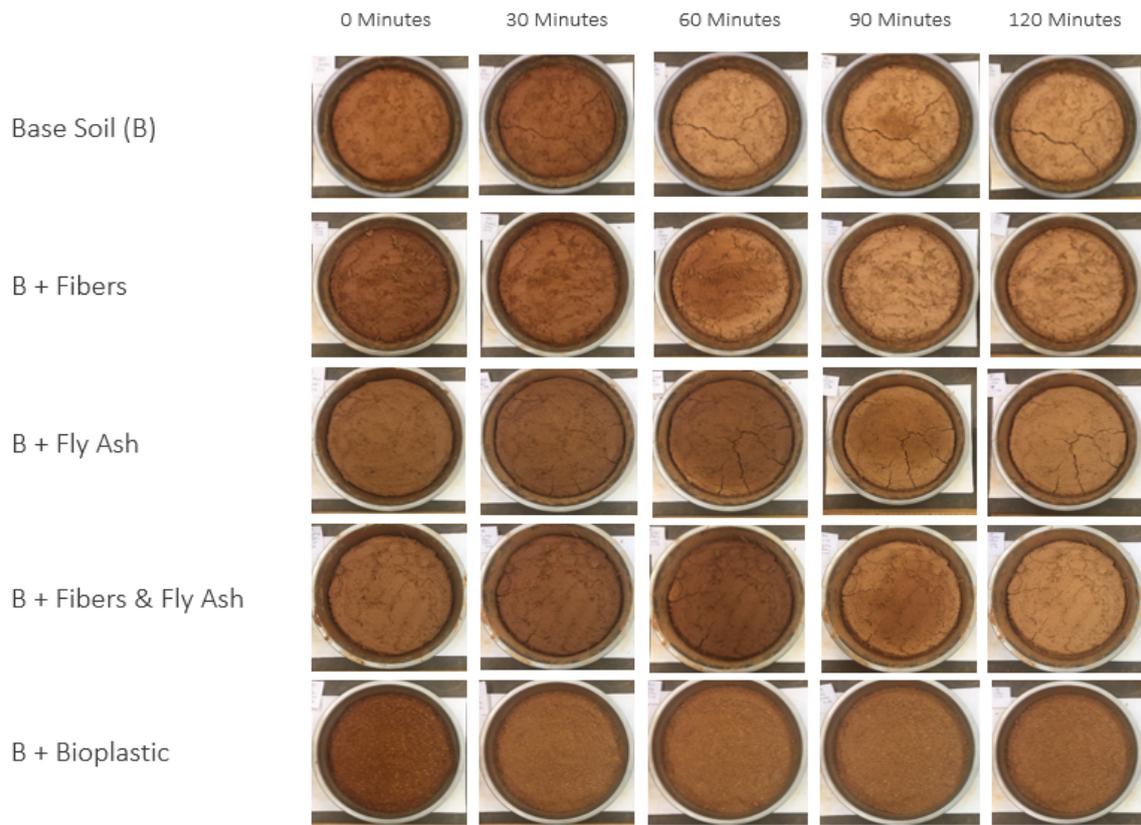
Figure 3. Desiccation crack test results for accelerated test after two hours of drying.

Using the data obtained from the image analysis, the performance of each soil improvement technique was examined. The final crack count, w_{avg} , and w_{max} were recorded at each time frame during the accelerated desiccation test. In general, the cracks developed rapidly, with the samples often going from no cracks to a fully-realized crack network in one photocycle (15 min time frame). The development of the desiccation cracking throughout the first drying cycle of the accelerated test can be seen in Figure 3. The figure shows that the cracking pattern of the base soil sample propagated in a three-pronged, letter Y-like shape (Figures 3 and 4). However, the specimens with the ash and fibers sometimes deviated from this shape. Once the samples with the added fiber cracked in the second cycle, they took on a more circular manner like the letter C with smaller segments radiating out to the edges (Figure 5). This was most likely due to the transverse isotropic fiber distribution as a result of the clay mixing process. As the clay was mixed in a circular motion, many of the fibers became orientated in the same pattern. Consequentially, the cracks formed parallel to the fiber alignment because of the lack of reinforcement oriented perpendicular to the crack. The fly ash samples tended to have a more lopsided shape and propagated in a more clustered manner.

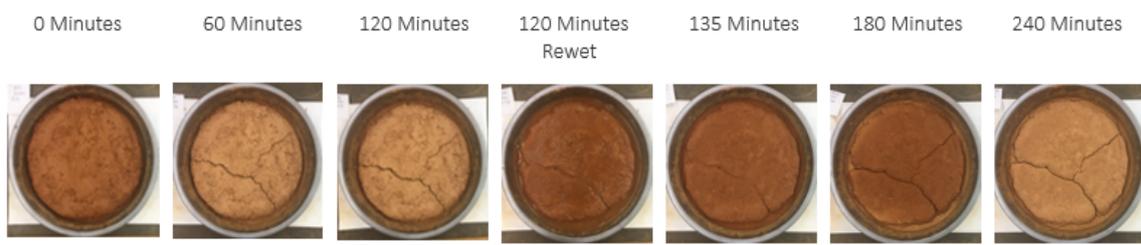
Figure 4. Desiccation crack test results for accelerated test for base soil.

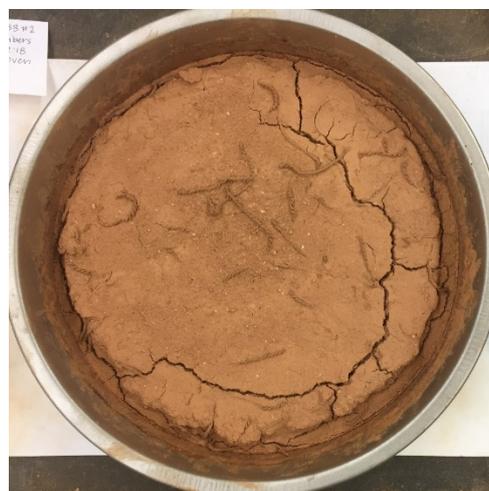
Figure 5. Accelerated test final crack distribution for fiber-aided soil.

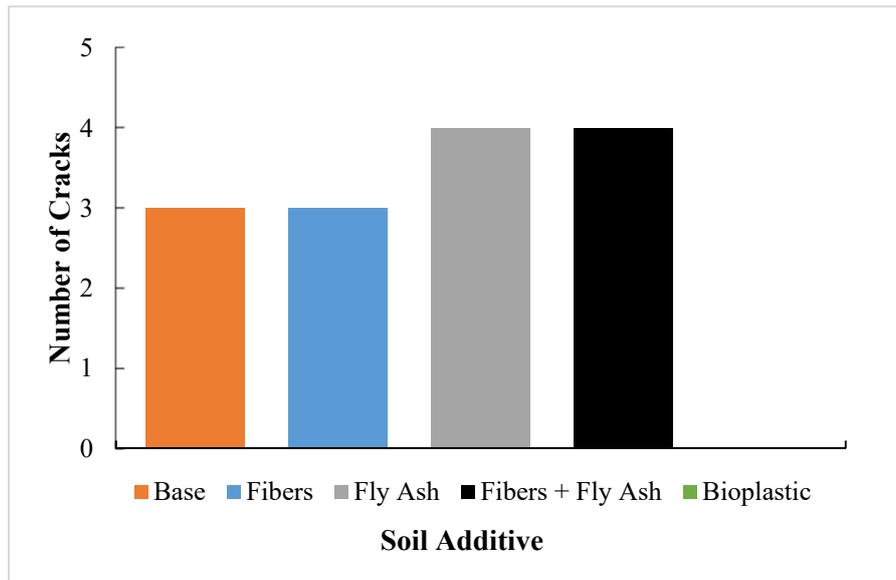
Figure 6. Number of cracks developed in standard desiccation test after 24 h at room temperature.

The crack count was recorded in order to quantitatively analyze the crack network morphology. The results from the standard desiccation test can be seen in Figure 6. The figure shows that aside from adding the gelatin-based bioplastic, the soil additives did not materially affect the total number of crack segments after 24 h of drying at room temperature. Both samples that included fly ash developed an additional crack segment over the untreated soil.

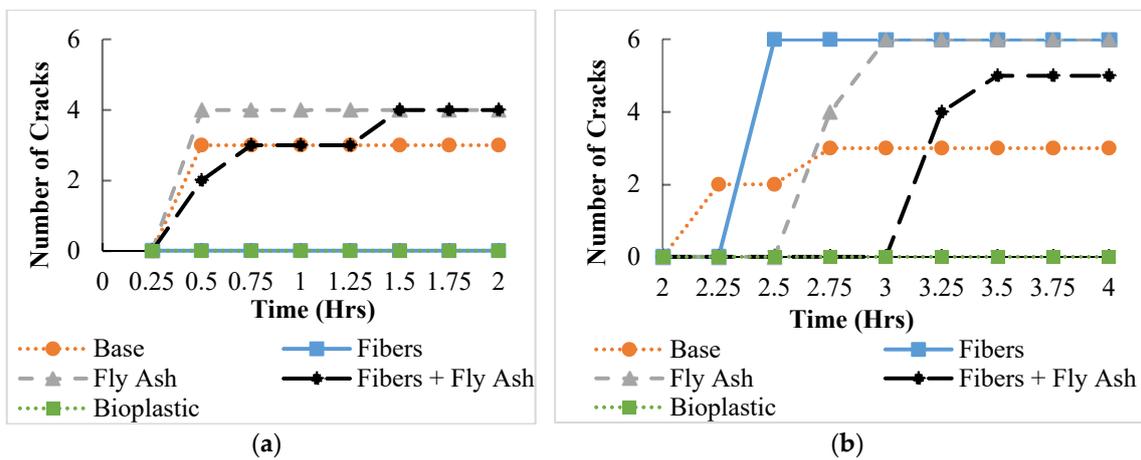
Figure 7. Development of the desiccation cracks in the accelerated test: (a) first drying cycle; (b) second drying cycle.

The crack count data for the accelerated desiccation test can be seen in Figure 7. The figure shows that in the first drying cycle (Figure 7a), no cracks developed in the samples mixed with the bioplastic and with the carpet fibers only. In the samples where cracks did develop, they generally appeared between the 15- and 30-min marks. After the rewetting process (Figure 7b), the bioplastic-improved soil sample was the only sample that did not develop any desiccation cracks. Each of the other additives developed more cracks than the base soil at the end of the second drying cycle. After rewetting, the timing of crack formation varied to a much greater degree with the plain soil cracking after 15 min, the fiber-aided soil cracking after 30 min, the fly ash sample developing cracks at the 45-minute mark, and the hybrid additive preventing cracking up until 75 min after rewetting occurred.

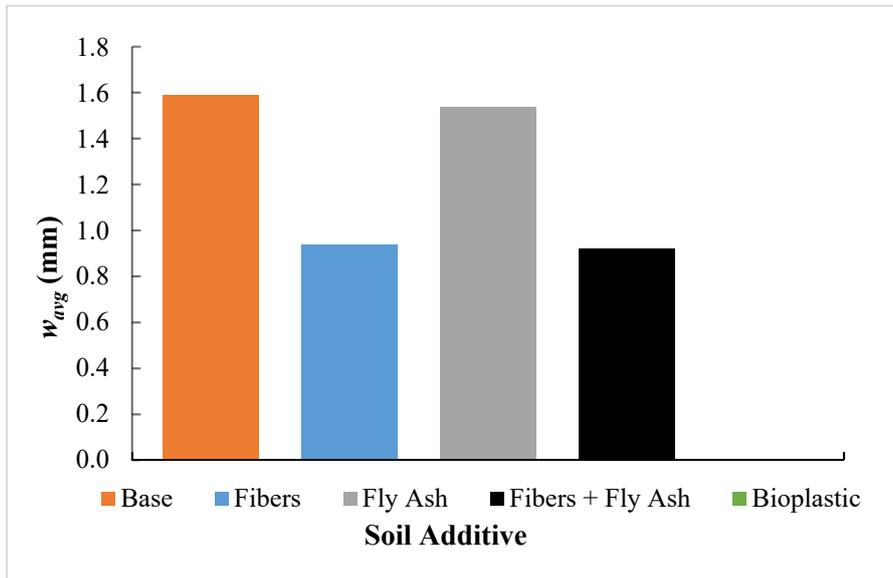
Figure 8. Average crack width of soils under standard desiccation test at 24-hour mark.

The w_{avg} was calculated so that each soil improvement method’s ability in solely reducing crack growth could be examined. The effect of the different soil improvement type on the w_{avg} for the standard desiccation test can be seen in Figure 8. The average crack width after 24 h for the base soil was found to be 1.59 mm. The sample with fly ash showed almost no improvement over the plain specimen. The samples improved with only carpet fibers and the carpet fibers-fly ash combination developed

cracks with smaller average widths of approximately 0.9 mm at the end of testing. The sample with the bioplastic had no average crack width as it did not develop cracks during the standard desiccation test.

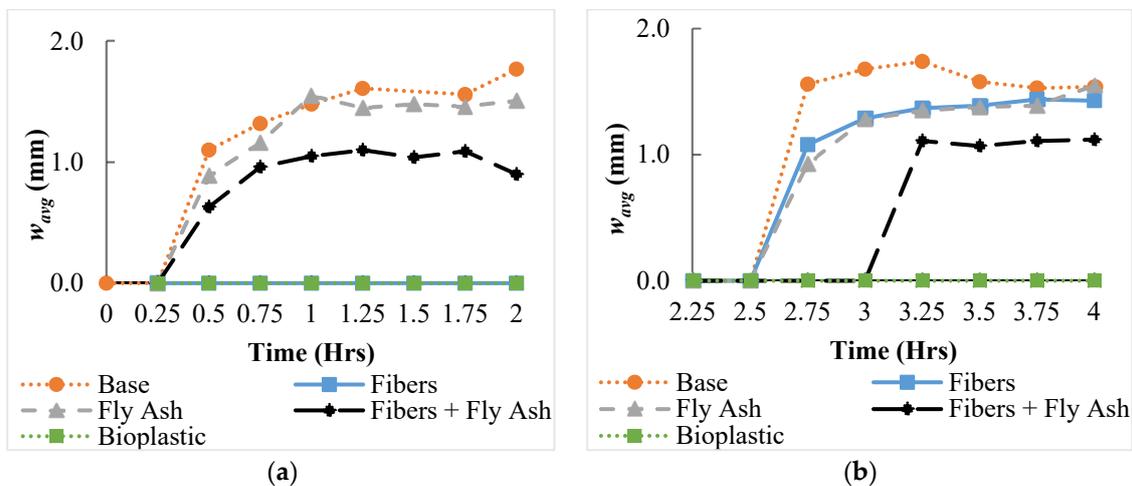
Figure 9. The effect of the soil improvement type on the development of the average crack width, w_{avg} in the accelerated test: (a) first drying cycle; (b) second drying cycle.

The effect of different soil improvement types on the w_{avg} for the accelerated desiccation test is depicted in Figure 9. The average crack width at the end of the wetting and drying process for the base soil was found to be 1.54 mm (Figure 9b). The samples with fly ash and carpet fibers showed almost no improvement in comparison with the non-treated soil. The samples with carpet fibers-fly ash combination developed cracks with smaller average widths at the termination point. The sample with the bioplastic did not develop cracks during the test and therefore had no average crack width. It is worth noting that the crack width after rewetting was assumed to be zero. Though some soil damage can be observed, the full depth cracks were not present at the time. In addition, in some time periods, the average crack width was shown to decrease. This was not due to the cracks shrinking, but as a result of the image processing software reading darker, wet spots in the soil near the cracks as parts of the actual crack. As the soil dried out more, the wet spots disappeared, causing the cracks to appear to be narrowing.

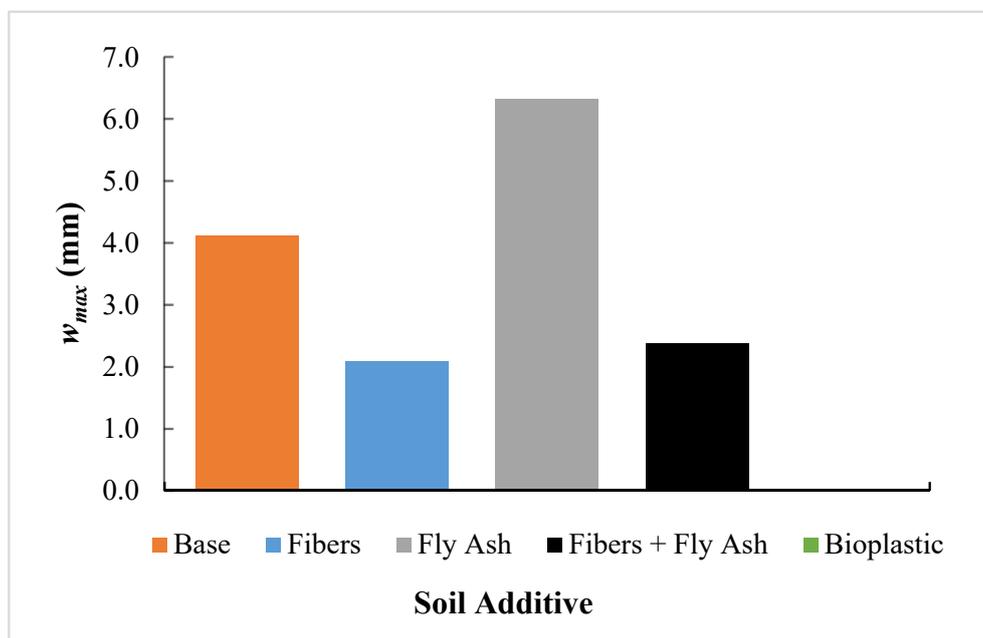
Figure 10. The effect of different soil improvement types on the maximum crack width, w_{max} at the 24-h mark.

The effect of the different soil improvement types on the maximum crack width, w_{max} for the standard desiccation test can be seen in Figure 10. The reasons for finding the maximum crack width in each sample were twofold. First, the wider cracks have a greater potential to cause structural damage, meaning the maximum crack width represents the greatest potential for failure. Second, it provides context for the average crack results. For example, the fly ash sample possessed a w_{avg} similar to that of the untreated soil, however, the w_{max} of the fly ash was approximately 2 mm greater than the base soil. This suggests that the fly ash most likely had a segment with an abnormally large crack with the remainder of the cracks being narrower than the cracks in the base soil. The maximum crack width at the end of the test for the base soil was found to be 4.11 mm. The sample with fly ash developed a crack system with a wider maximum crack width than the base clay (6.32 mm). The samples with just carpet fibers and the carpet fibers plus fly ash developed cracks with significantly smaller maximum widths of approximately 2.08 mm and 2.38 mm, respectively, at the end of testing. Again, the sample treated with the gelatin-based bioplastic never cracked during the desiccation test.

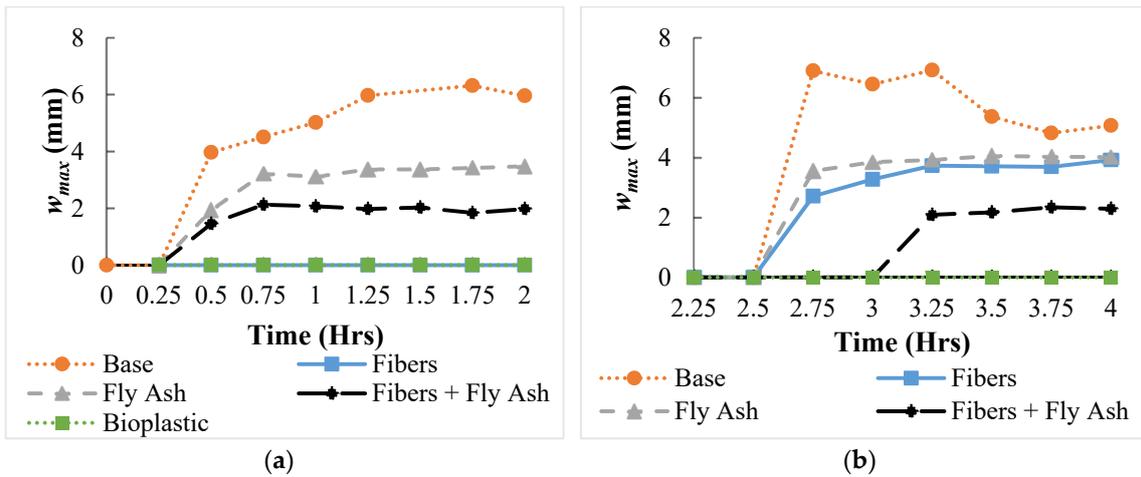
Figure 11. The effect of the soil improvement type on the development of the maximum crack width, w_{max} in the accelerated test: (a) first drying cycle; (b) second drying cycle.

The maximum crack widths over both drying cycles for each soil improvement type are shown in Figure 11. Each of the additives reduced the maximum crack width at the end of the testing process in comparison to the base soil but to varying degrees. Again, the sample with the gelatin-based bioplastic exhibited no changes and no cracking occurred. The samples with each of the fly ash only and the recycled carpet fiber showed approximately the same level of maximum crack width reduction, while the sample with the combined additives provided further crack reduction. In the second cycle, the plain soil's maximum crack width exhibited the same soil drying phenomenon that affected the average crack width results and led to the appearance of crack narrowing.

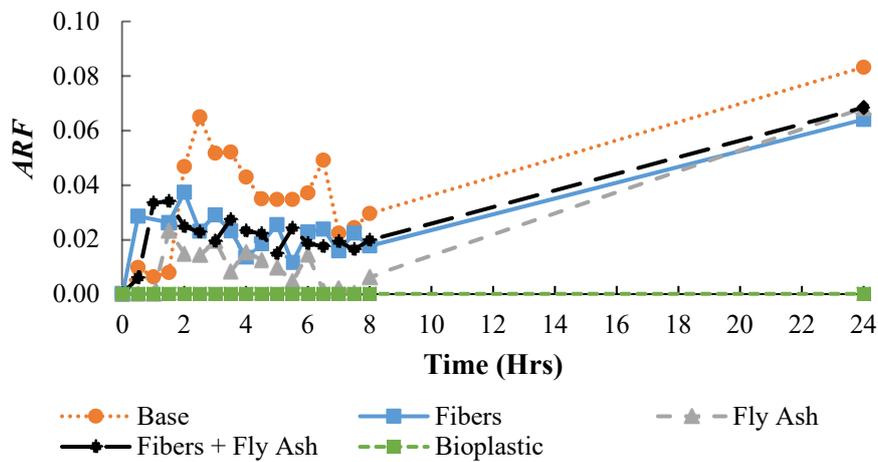
Figure 12. The effect of the different soil improvement type on the development of the *ARF* in the standard desiccation test.

The *ARF* parameter was introduced to quantitatively measure the effectiveness of each soil improvement technique in reducing desiccation cracking as well as the overall soil shrinkage. The efficacy of the respective additives for the standard desiccation test can be seen in Figure 12. The figure shows that the base material exhibits the greatest *ARF* and the bioplastic exhibits virtually no shrinkage and did not crack after 24 h. Even though no cracks developed in any specimens until the 24-h mark, the samples still had *ARF* values due to lateral shrinkage of the samples before cracking. By analyzing the images, it was determined that the variations in the short-term were caused by discoloration in the clay surface as a result of uneven drying.

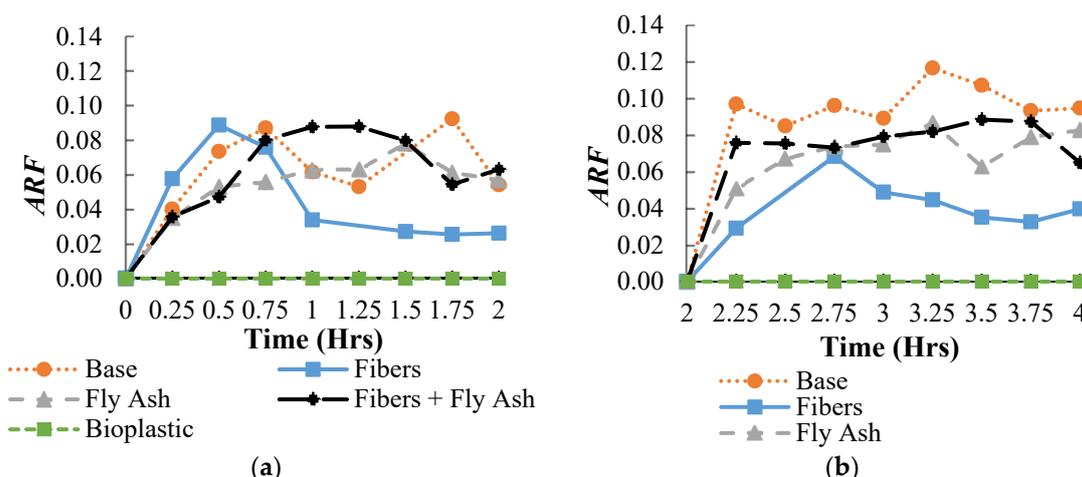
Figure 13. The effect of the soil improvement type on the *ARF* in the accelerated test: (a) first drying cycle; (b) second drying cycle.

For the accelerated desiccation test, the results from before and after the rewetting process were analyzed. The *ARF* data for both the initial drying cycle and the drying cycle after rewetting are displayed in Figure 13 a and b, respectively. The results showed that the samples including the fly ash provided little improvement when exposed to higher temperatures. Again, the sample mixed with the gelatin-based bioplastics showed no change in the surface area even when exposed to higher temperatures.
