Discussion on the Reinforcement of Reinforced Concrete Slab Structures

Keywords: reinforced concrete; structural repair and retrofit; epoxy resin; carbon fiber

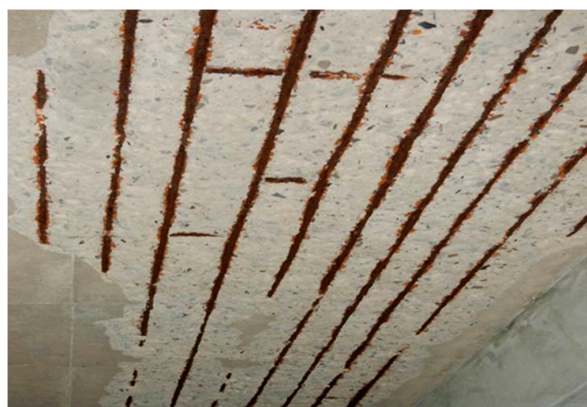
In the RC structure, if the floor tiles are applied by cement mortar, the bonding layer is not high in strength and poor in water tightness. Moreover, floor tiles are vitreous and feature water impermeability, impeding moisture evaporation and causing the floor to remain humid in the long-term. Furthermore, because the floor is subject to tensile force, it tends to crack and moisture and air can easily permeate the structure through the crevices, causing rebar oxidation at locations where the protection layer is insufficient, further leading to concrete spalling (Figure 2).

Figure 2. Concrete spalling as a result of rebar oxidation.

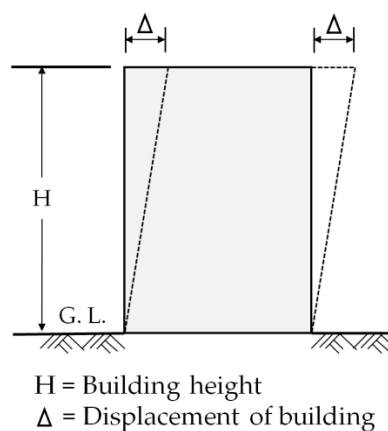
Typically, after earthquakes, some buildings tilt (Figure 3). The process of assessing subsequent damage and the corresponding structural repair and retrofit is illustrated in Figure 4, which contains four types of responsive measures.

Figure 3. Building tilt caused by an earthquake.

- A. House tilt $394/H > 1/50$: Demolition and reconstruction are required, regardless of the damage level.
- B. House tilt $1/100 \leq \Delta/H < 1/50$: Although the damage to the main structure has not threatened safety, a structural seismic resistance assessment must be conducted. The assessment project includes structural systems, structural details, structural status, and quantitative analysis. After the safety is confirmed by the structural seismic resistance assessment, the repair and reinforcement assessment are performed.

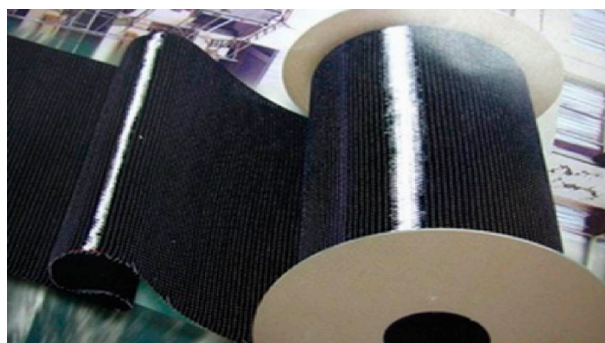
- A. CFRP patches: Externally bonded reinforcement (EBR) appeared in the 1980s [27]. In the last decades, fiber reinforced polymer (FRP) materials have been increasingly proposed to strengthen RC structures [28]. Significant investigation has been carried out in order to predict the bond strength of EBR systems with CFRP materials in concrete and, as a consequence of those studies, many analytical expressions can be found in the literature, including in standards [29]. Different strengthening techniques have been developed for applying FRP. Based on the above research, it is found that the reinforcement application has been proven to have a good effect on increasing the bearing capacity of the concrete plate, where the FRP laminate is glued onto the tensile face of the RC element [29]. A CFRP composite was obtained by extracting black organic materials from acrylic resin, petroleum, and coal, transforming these organic materials into fibers, and subjecting them to a special heat treatment. Table 2 presents the physical properties of the CFRP patches used in this study (displayed in Figure 5).

Figure 5. CFRP material.

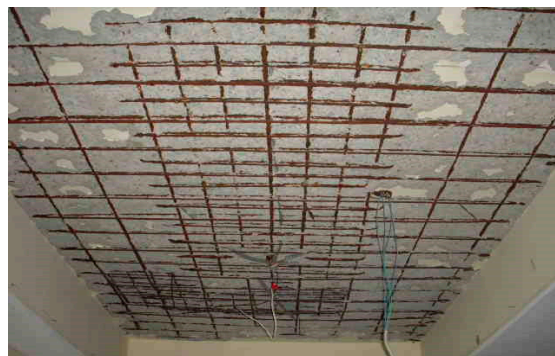
Figure 6. Concrete surface after rust removal and cleaning.

- A. The research team removed furniture in the house to prevent it from becoming dirty or damaged during construction. Sheets were paved on the floor for protection.
- B. The research team removed all loose and spalled parts of the concrete, used a grinder and other descaling tools to remove corroded parts on the rebar surface, and removed the entire stucco layer on the cement grout (Figure 6).
- C. The research team removed the stucco layer on the cement grout on the bottom and sides of the RC beams, performed a steel-plate retrofit where necessary, fastened steel plates to the beams with chemical anchors, and filled the gap between the steel plates and beams with an epoxy resin grout.
- D. Applying a rust-conversion agent to the rebars exposed from the slab for derusting and using antirust paint to protect the rebars from further corrosion.

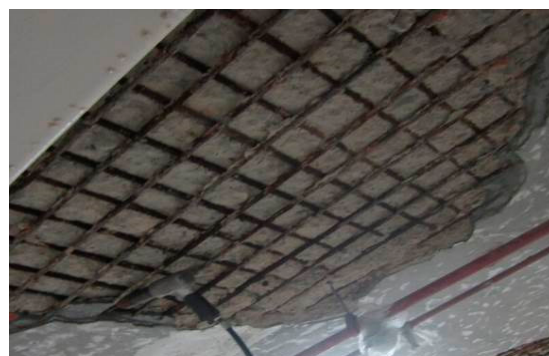
Figure 7. Coating grout crevices at the slab base with low viscosity epoxy resin.

- E. Applying a low viscosity epoxy resin to the slab base to enable it to completely infiltrate the structures (Figure 7).
- F. Where crevices were present in the slab, low-pressure grouting was employed when pouring the epoxy resin to ensure that all crevices were completely filled.

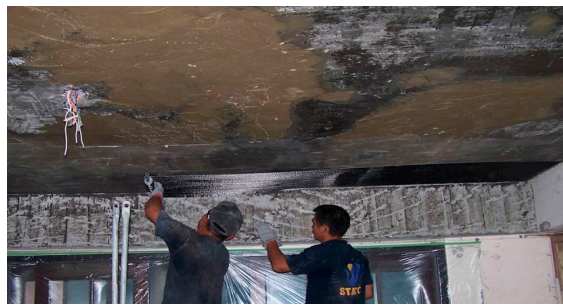
Figure 8. Slab surface after repair and flattening.

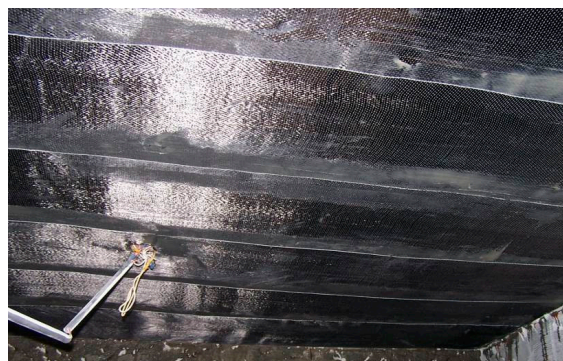
Figure 9. After CFRP patch attachment.

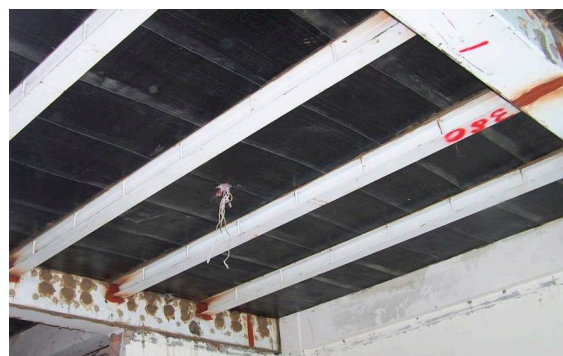
Figure 10. H-beams welded onto steel beams.

- I. Placing H-beams (150 mm \times 150 mm) perpendicular to the CFRP patches and welding the H-beams (small beams) onto the steel beams to brace the entire ceiling. Filling gaps between the H-beams and slab with nonshrinkage cement or epoxy resin grout (Figure 10). Epoxy resin expands when hardened; this property enabled CFRP patches to more closely adhere to the slab. In combination with the newly added H-beams, a satisfactory retrofitting effect could be achieved.

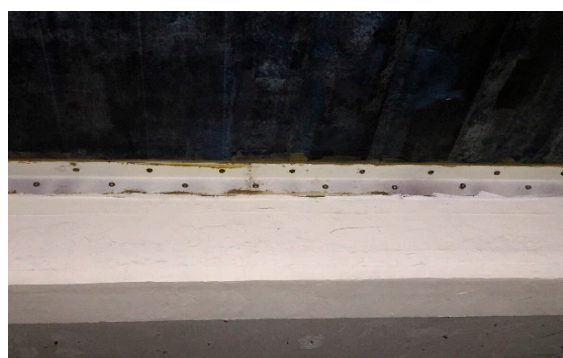
Figure 11. Affixing CFRP patches using angle steels.

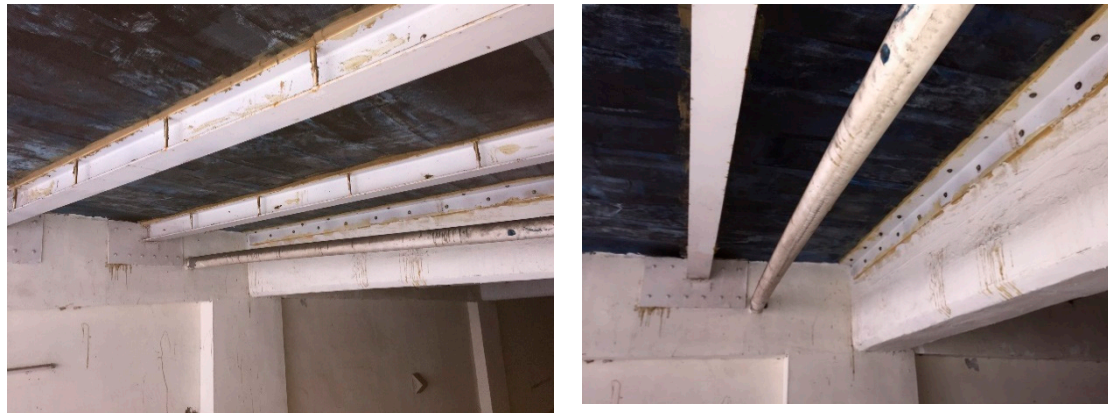
Approximately 10 years elapsed since the repair and retrofit of the cases discussed in this study. All buildings that applied this repair and retrofit technique remained structurally intact; no spalling, swelling, or cracking has been detected (Figure 12). This proves that the proposed technique can solve

Figure 12. Current state, photographed 10 years after repair and retrofit.
