# Analysis of the Influence of Dynamic Load on the Work Parameters of a Powered Roof Support's Hydraulic Leg

**Abstract:** One of the basic tasks of powered roof support is to protect the longwall excavation against deformation of the rock mass during the underground exploitation of hard coal. The behavior of the rock mass during mining is difficult to predict. Therefore, the loads acting on the support are diverse in terms of nature, direction and force. The dynamic load resulting from rock bursts, relaxation and tremors may lead to particularly dangerous consequences involving the functionality of the workings and the safety of the crew. The powered roof support will function properly only if the elements dynamically loaded are under control at the moment of impact. The article presents the results of tests of the basic powered roof support's element – a hydraulic leg impacted by dynamic load. The source of the load was a free falling impact mass dropped from a certain height. The tests covered the actual hydraulic leg with all hydraulic equipment used in the powered roof support. During the tests, the original measurement-recording system developed by the authors was used, in w

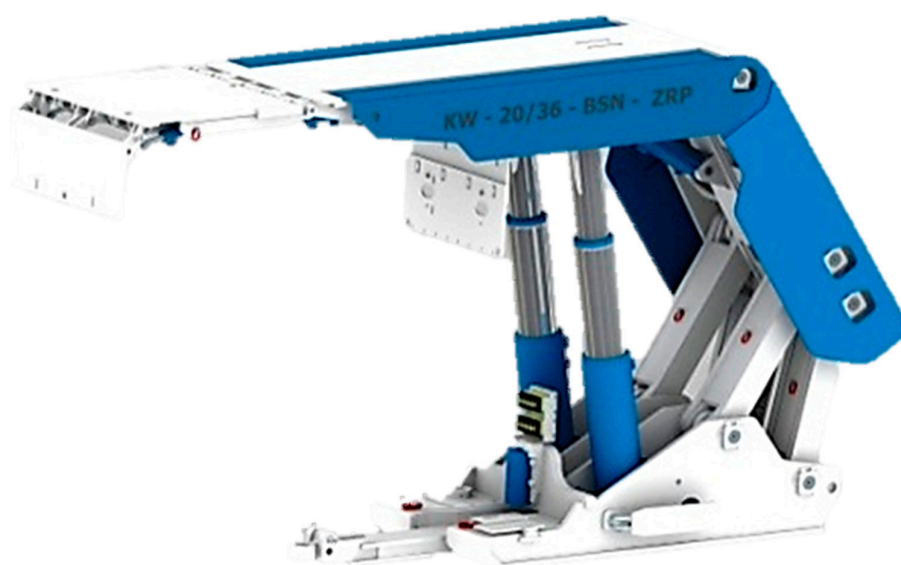
**Figure 1.** A powered roof support section in longwall working during operation. Modified from [20].

In the case of longwall workings in which the main mining process is carried out, the basic type of support is a powered roof support. It consists of powered sections. Figure 1 [20] presents the powered roof support section in a longwall working with its main mechanical, hydraulic and control elements.

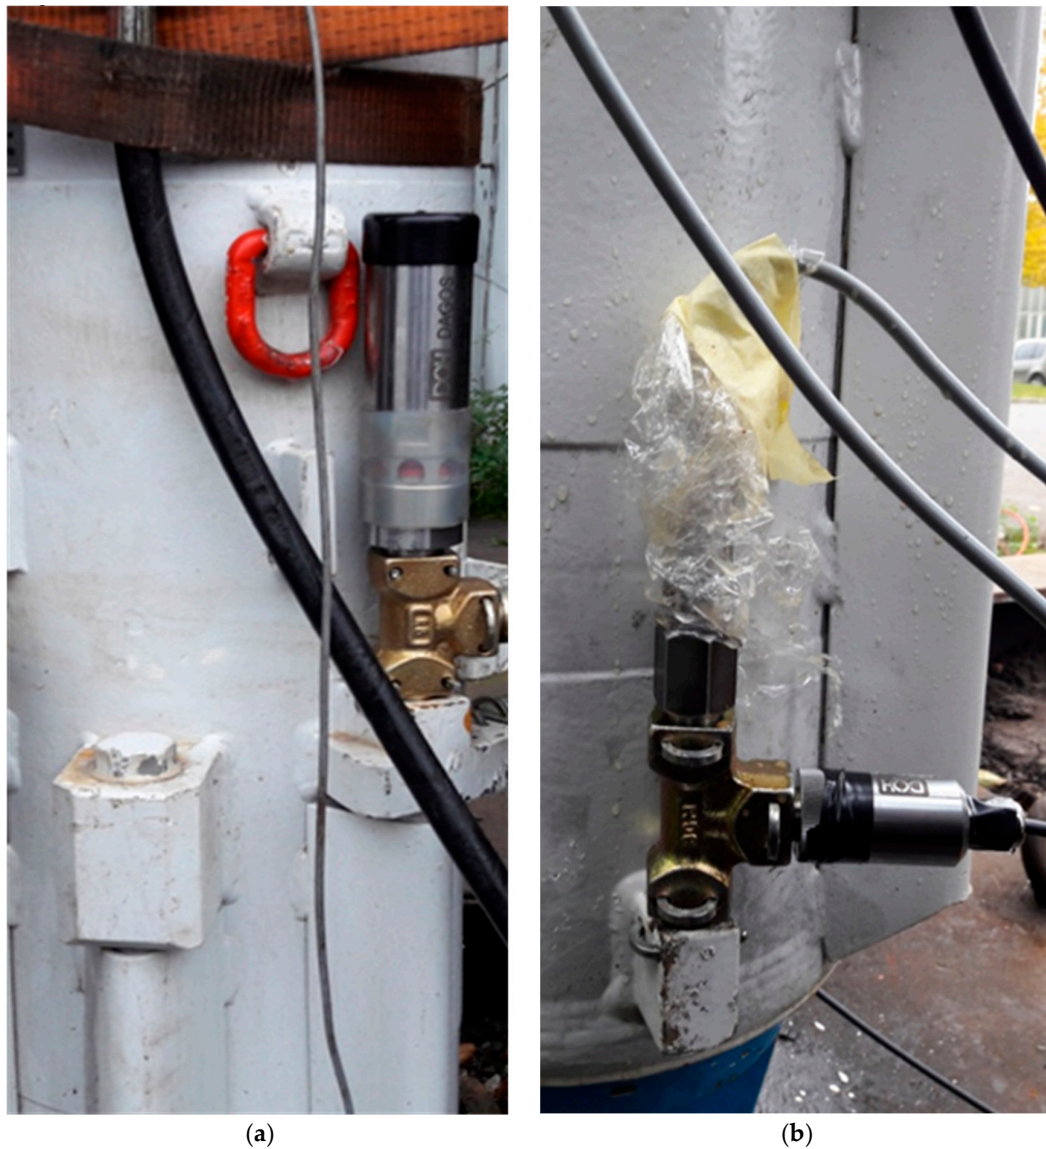
**Figure 3.** A safety valve (a) installed in the tested hydraulic leg and the pressure sensor (b) for measurements in the space under the piston.

One of the sensors for measuring the pressure in the under-piston space of the leg (its results are presented later in the paper) and the mounted safety valve are shown in Figure 3.
