Article

Effect of Inappropriate Binder Grade Selection on Initiation of Asphalt Pavement Cracking

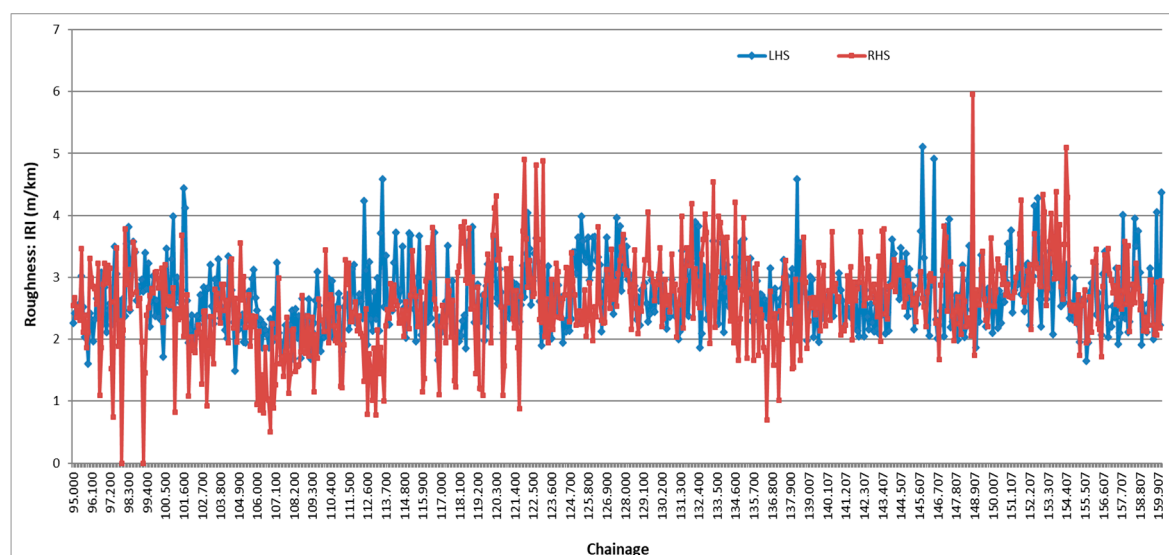
A roughness survey was conducted on the road in both directions and analysed using the International Roughness Index (IRI). Generally, a big portion of the road had IRI less than 6 which is indicative of a very good road condition. As shown in Figure 1, minor variations were observed between the left- and right-hand side probably because of inlay patches on the road.

Figure 1. Roughness trend along the road.

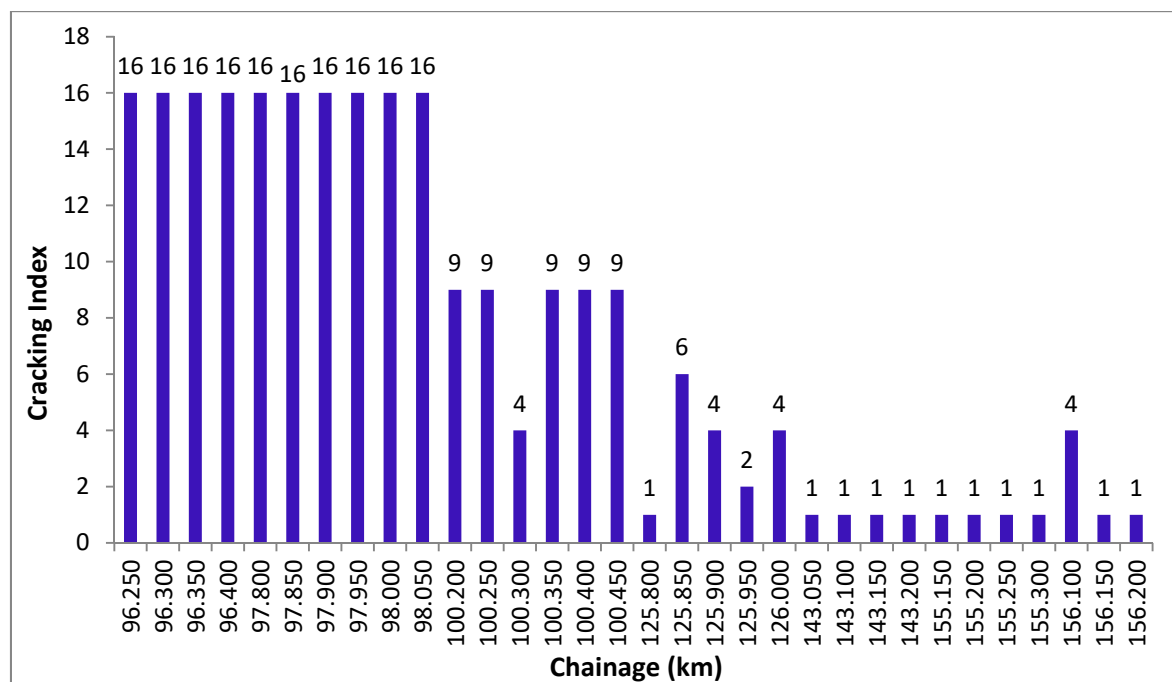
Cracks on the road were evaluated based on their type, width, intensity, extent and position. As shown in Figure 2, cracking index (i.e., a product of crack intensity and extent) generally showed that the road had severe cracking especially in Sections 1 and 2.

Figure 2. Cracking Index for the road.

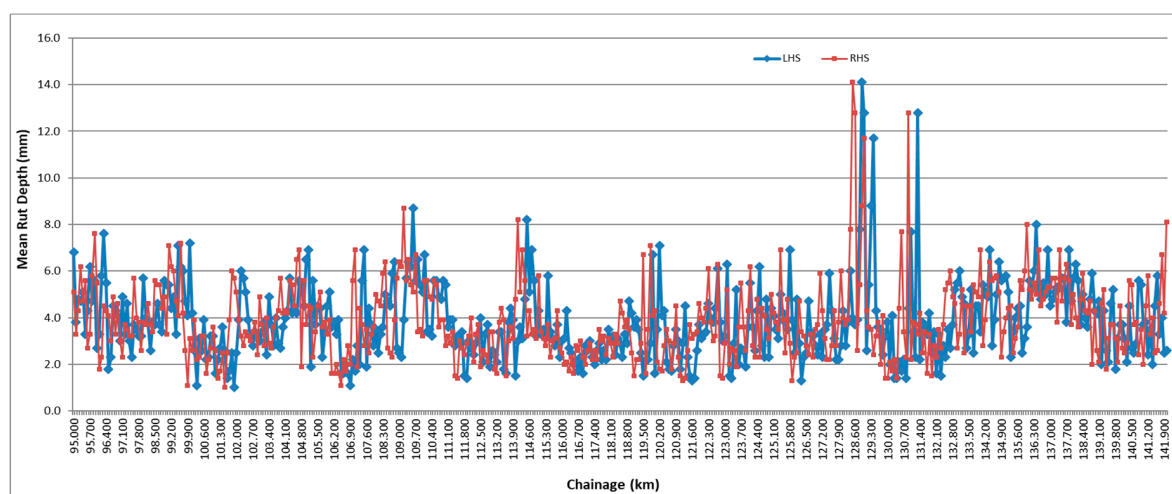
Rut measurements were carried out in both directions and processed in terms of mm of rut depth. As shown in Figure 3, highly variable rutting was experienced with occasional peaks indicating variability in performance either as a result of construction or traffic behaviour.

Figure 3. Rutting trend along the road.

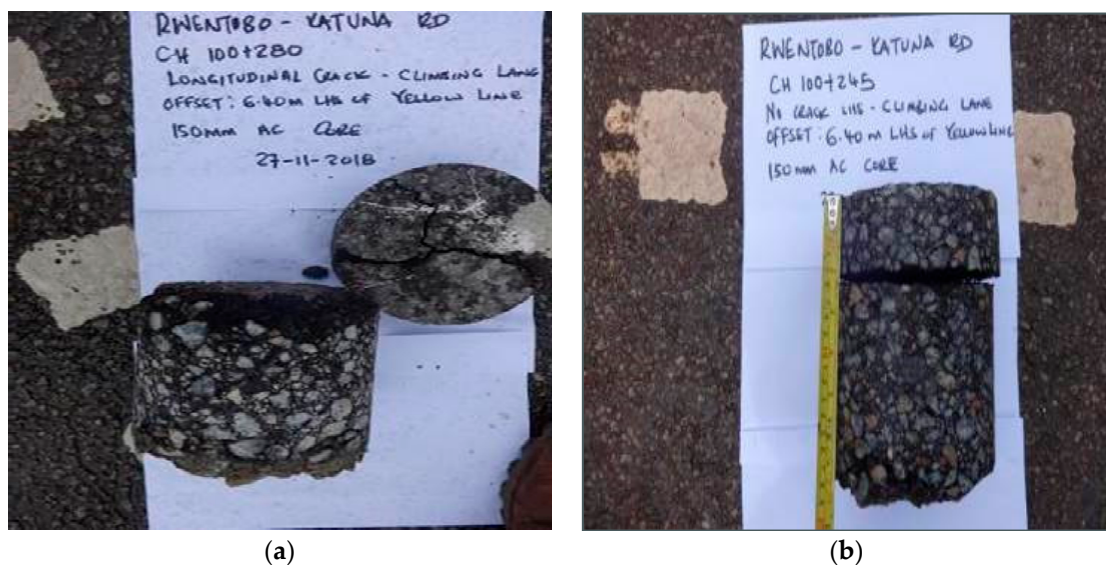
Cores were extracted from the asphaltic surfacing before excavating test pits, with ones from cracked sections of the road being visually evaluated. As shown in Figure 4a, cracks were predominantly observed in cores obtained from the wheel path and were only confined to upper portions of the surfacing. It was further observed as shown in Figure 4b that the wearing course layer had de-bonded from the binder course. Construction records showed that the tack coat type used to bond the binder

and wearing courses was a stable 57% bitumen emulsion (grade CSS-1h) type and was applied at a rate of 0.55 L/m². It should, however, be noted that de-bonding was only experienced in cores obtained from the cracked sections of the road. Cores from sections with no or minimal cracking generally did not experience de-bonding hence ruling out the deficiency of the tack coat and cracking was also of lesser severity and intensity. However, as illustrated in Figure 5, cracking along longitudinal and transverse joints was observed and was widespread along the road. It must be emphasized that no cracking was observed in the binder course for all cores from both control and failed sections. This simply demonstrated that the cracking on road was confined to the surfacing layers and did not propagate throughout all layers of the pavement. A more detailed understanding of the causes of the cracking observed in the surface course is discussed in the results of laboratory testing section.

Figure 4. (a) Cracking confined to upper portions of the surfacing; (b) De-bonding of wearing course from the binder course.

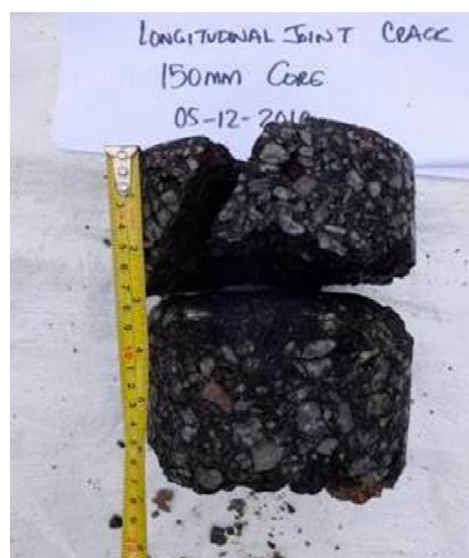
Figure 5. Dis-jointed longitudinal joint.

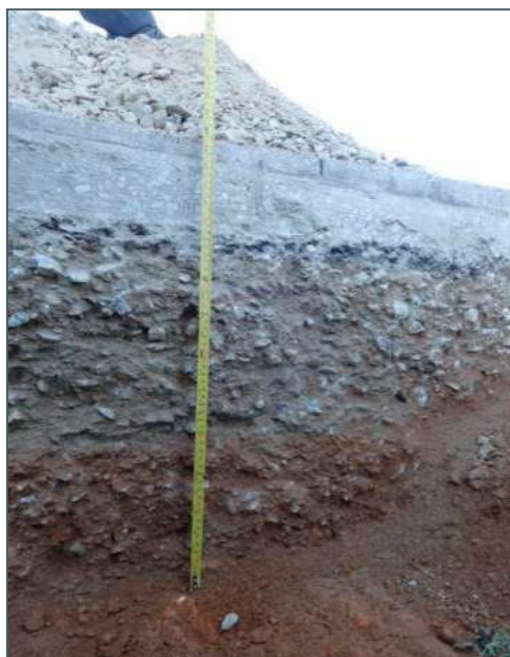
respectively. Furthermore, minimal rutting was observed to be occurring on the road. As shown in Figure 6, test pits excavated clearly had a constant thickness of the pavement layers across the wheel path. This agreed with results from Falling Weight Deflectometer (FWD) tests carried out that showed the differences in deflection of the subgrade being negligible for the sections. The above finding indicated that rutting did not contribute significantly to the pavement deteriorations experienced on the road.

Figure 6. Test pit excavated in Section 1.

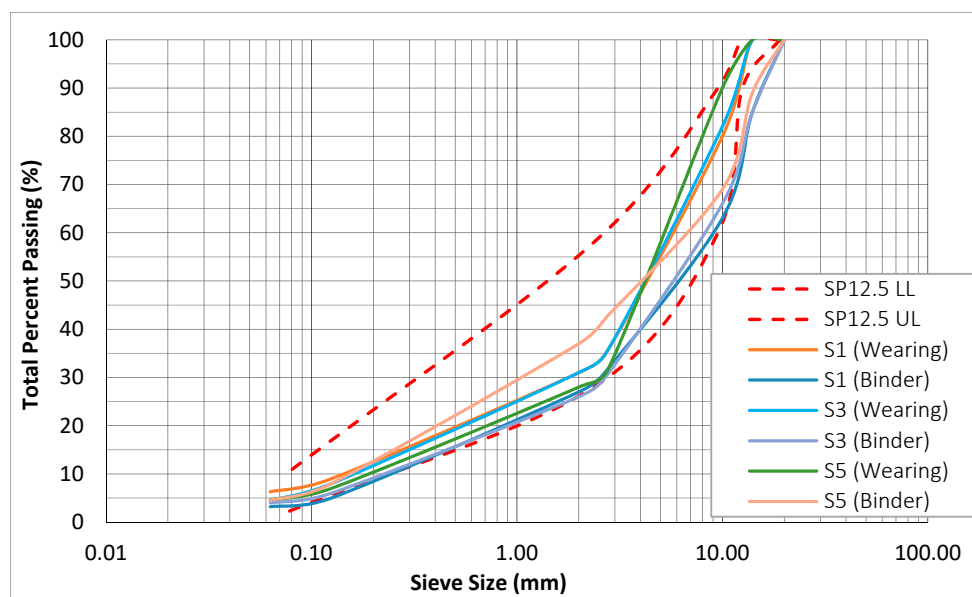
Materials obtained from the test pits were tested for moisture contents, densities and particle size distribution (PSD). Additionally, cores extracted from different sections of the road were tested for Indirect Tensile Strength (ITS) and Marshall characteristics of Stability and Flow. Test results from control and failed sections were all found to be very similar and within the acceptable specification requirements. This clearly showed that failures observed did not originate from the underlying layers below the asphalt surfacing. Furthermore, observations from PSD of aggregates recovered from the binder and wearing courses after extraction of bitumen showed that the recovered aggregates complied with the control points for Superpave nominal 12.5-mm mixes, as shown in Figure 7. This clearly indicated that aggregate gradation of the asphalt mix was not responsible for the observed deteriorations on the road. Therefore, the test results could not be used to identify potential failures or to isolate their causes on the road.

Figure 7. Particle size distribution of Binder and Wearing Course aggregates.

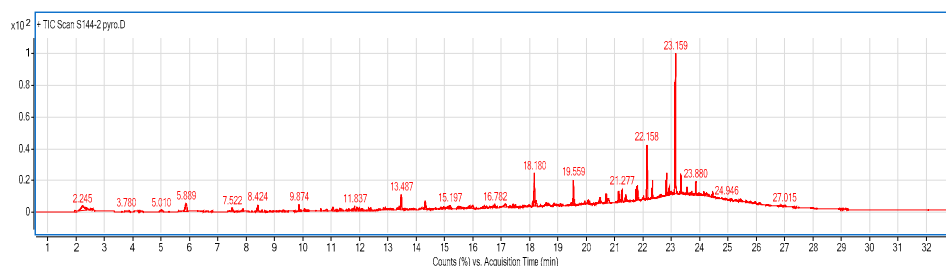
Additionally, Gas-Liquid chromatography was carried out on the recovered bitumen from the road as well as the representative 15/25 pen bitumen from the UK, as shown in Figures 9 and 10,

respectively. It was observed that the peaks chromatogram trace for the recovered bitumen showed a lower hump than that of the 15/25 pen bitumen, which indicated that the quantity of volatiles in the recovered bitumen sample was very low probably due to early ageing/oxidation.

Figure 9. Chromatogram for bitumen recovered from the road.

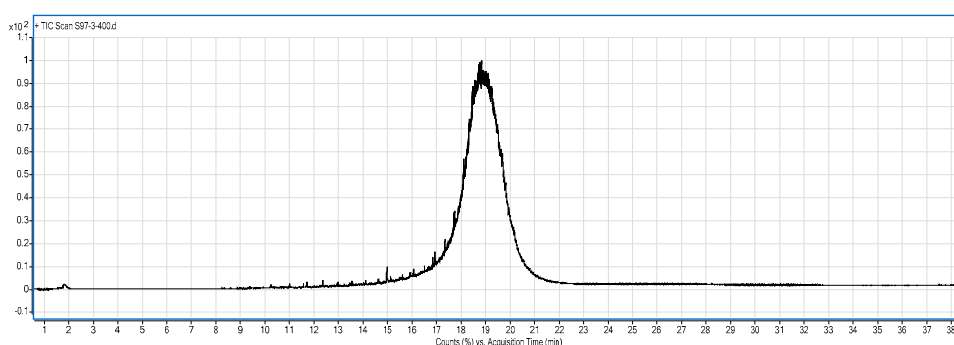
Figure 10. Chromatogram of 15/25 pen bitumen from the UK.
