Article

Advanced Intervention Protocol in the Energy Rehabilitation of Heritage Buildings: A Miñones Barracks Case Study

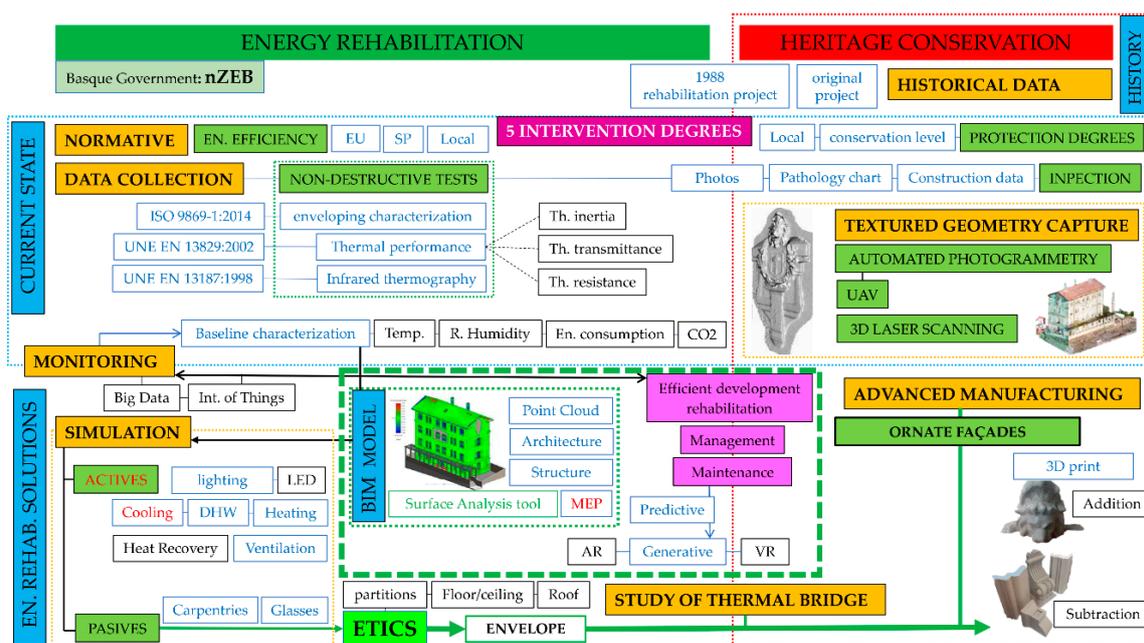
Figure 1. Diagram of proposed intervention protocol. (Source: Authors).

Hence, it is considered that the most adequate energy intervention in built heritage is the solution that combines energy improvement of each building and respect for its original configuration [11]. This leads us to propose that each intervention must be specific for each specific case. In this applied study, a protocol consisting of different stages is proposed (Figure 1):

- (1) Collect historical documentation
- (2) Data collection of the current state
 - Analysis of existing regulations on energy efficiency
 - Analysis of building protection regulations (study case). Establish the degree of intervention (0-IV)
 - Building inspection
 - Non-destructive testing, extraction of data from the baseline

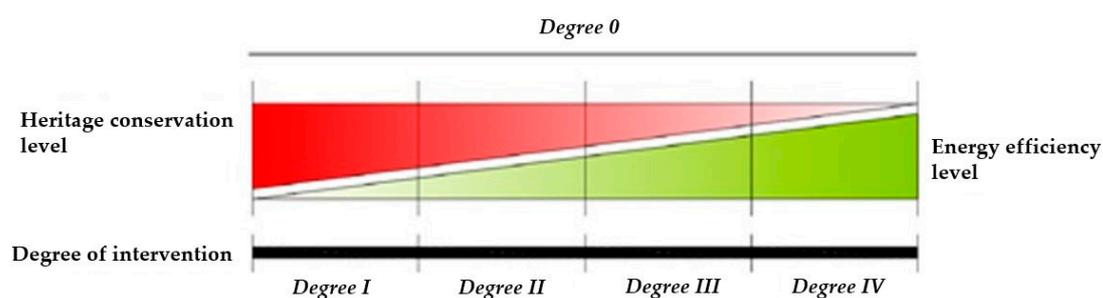
Figure 2. Diagram of configuration of the 5 intervention degrees. (Source: Authors).

After analyzing many residential buildings, a 5-degree theory was determined for energy intervention in heritage. This theory must cover the entire spectrum of buildings considered to form part of the built heritage, and even those that are not protected, but that may have some value that must be protected. This classification in degrees must contain two basic values to be considered: On the one hand, the degree of building protection value, and on the other, the level of energy improvement that can be reached, bearing in mind the first value. Both values must form part of one single concept. The different degrees are going to be presented, starting with Degree 0, which is the study of the property as it is today, continuing until Degree IV, which would be the case of the most intervened building. Within these degrees, there is a progressive energy efficiency improvement level, and a regressive heritage protection level (Figure 2) [14].

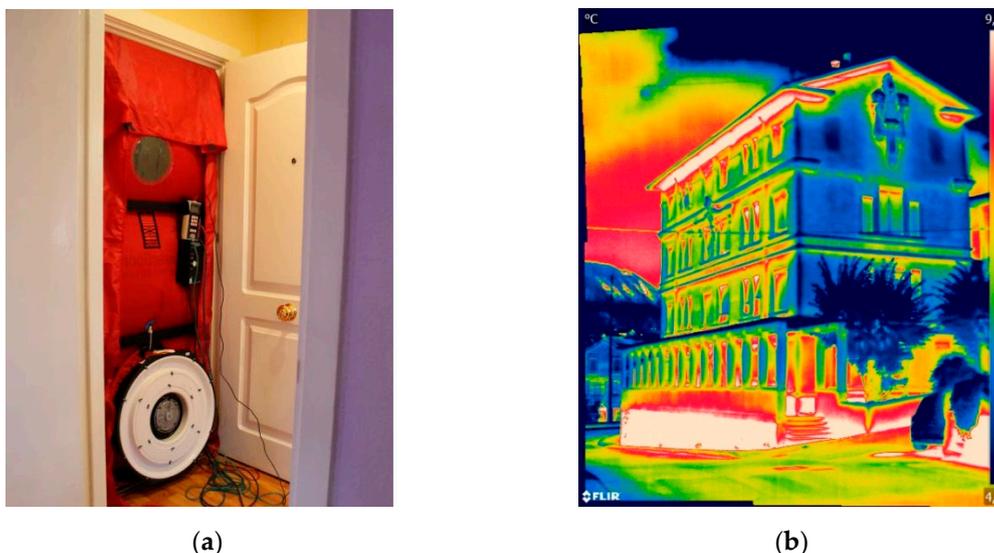
Figure 4. (a) Installation of the fan to test the permeability of the windows; (b) Thermography of the main facade. (Source: LCCE).

Following this, the recesses and carpentry were analyzed. The windows are made with wood carpentry, with 4 mm double glazing and 6 mm air chamber. The air permeability of the windows was determined by means of tests conducted on site, following UNE EN standard 13829:2002 “Thermal performance of buildings. Determination of air permeability of buildings—Fan pressurization method” [29] (Figure 4a). The test findings point to very low infiltrations for a building of this type: 2.3 renewals an hour at 50 Pa. It was concluded that the wooden windows are in good conditions, and that there are no filtrations through false ceilings or installations.

Finally, a study of the irregularities of the thermal envelope of the house was conducted, by means of thermographic test EN 13187:1998, “Thermal performance of buildings. Qualitative detection of thermal irregularities in building envelopes. Infrared method”. We also used a simplified method for building envelopes (ISO 6781:1983 modified). The outer images were captured on 15 November 2017, between 8 and 9 am, to analyze the steady-state effect after a cold night, and minimize solar effects (Figure 4b). The thermal images have been processed by means of FLIR Tools+ software, adjusting the images based on on-site verifications. A FLIR E60bx, 320×240 resolution camera was used. Both camera and software were manufactured by 2020 FLIR®Systems, Inc., and were sourced by the Basque Government’s Quality Control in Building Laboratory (Spanish acronym, LCCE).

The surface temperature performance of the opaque sections of the facade is similar in all dwellings. No significant differences were noticed between the floors of the original construction and the upper floor, which was built at a later date. However, the ground floor facades do have higher temperatures and there were hotter localized areas, such as the contours of recesses, the fronts of forging slabs, and on the eaves. The thermal bridges can be identified from the analysis of the thermographic photographs, as well as those points of the envelope where a greater heat loss occurs. These points are the window panes—especially those with one single sheet of glass—, the blind boxes, given that they have no built-in insulation on the inside, and the eaves, which are a prolongation of the attic deck, which has no insulation. On the other hand, it was deduced that the larger-sized ornamental elements, such as the Vizcaya shield and the lion that protects it, do not represent considerable thermal bridges, in contrast with the rest of blind walls of the envelope. However, they do represent an interruption insofar as the constructive characteristics of the envelope are concerned, which are the source of a series of difficulties, in the event that an improvement of the envelope, entailing the incorporation of insulation on the outside, was proposed.

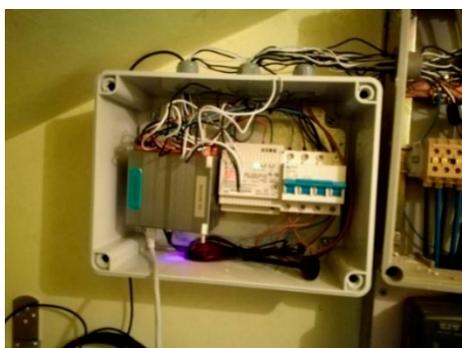
Figure 5. Installation of the datalogger (Source: Ekitermik Efizientzia Energetikoa).

The measurement system, whose composition is described below, was installed to carry out the monitoring (Figure 5). A data controller permitted the capture and local filing of data, as well as their transmission to a data management server for later display on a web platform. Regarding data capture, the following communication interfaces will be available: RS485, Ethernet, Wireless Network, GSM/GPRS; compatible with a variety of protocols, MODBUS RTU/TCP, MBUS, IEC870-5-102, KNX, IEC62056. In view of the age of the building, and in order to minimize the wiring work, data capture by means of the MBUS Radiofrequency protocol was selected. The captured data were sent from the datalogger to the external server by GPRS.

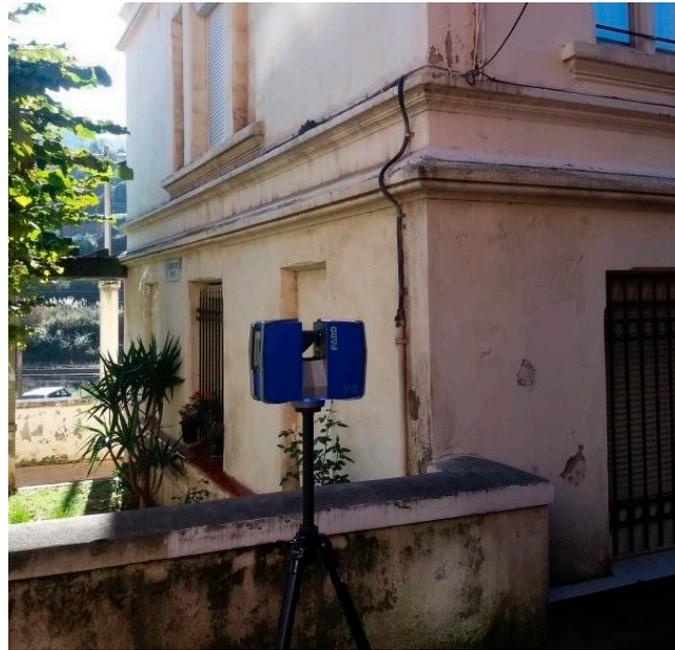
Figure 6. FARO Focus 3D×330 scanner on a tripod (Source: Urquizo Ingenieros&NorthBIM).

Capture with 3D laser scanner requires defining the positions of the device location at each scanning point, as an initial step. These positions were located both on the inside and outside of the building, to be able to model with an accuracy of less than a square centimetre of surface area. The scanner used for the work was FARO Focus 3DX330, manufactured by FARO® Technologies, Inc., due to its light weight, precision, speed, resolution, and above all its scope range (Figure 6). Scanning

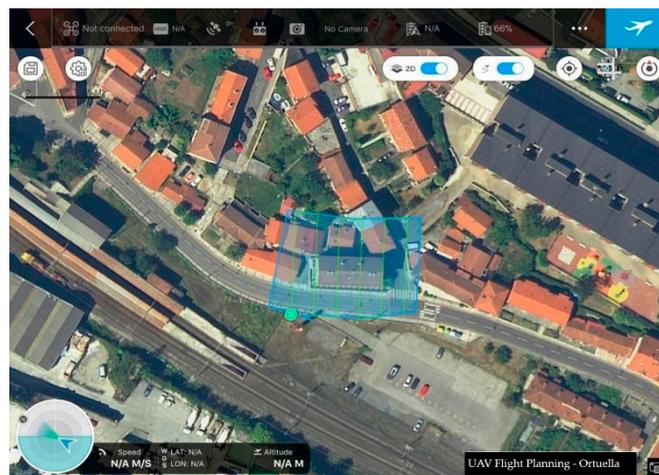
Figure 7. Planning of the unmanned aerial vehicles (UAV) flight. (Source: Urquizo&NorthBIM).

The UAV-assisted capture complemented the work of the laser scanner, to accurately represent the roof and the side ornaments of the building. The capture of the ornaments required a better definition than 5 mm between points on all sides and orientations, sufficient to generate an exportable grid to formats that can be integrated into additive manufacturing systems (3D printing). The flights were planned automatically with the DJI Ground Station Pro application (Figure 7). The equipment used was Phantom 4 Pro, manufactured by DJI®, with 20 megapixel and one-inch camera. To obtain the Digital Elevation Model (DEM), a photogrammetric flight was planned to cover an area of 2.28 Ha, at a flight height of 70 m, and a resolution on the terrain of 2.69 cm/pixel, taking 89 images. A network of 10 bases distributed over the coverage area was estimated [37]. These points are necessary in the topographic referencing at UTM coordinates both for processing data obtained with the UAV, and for the data captured with 3D laser scanner. A GNSS system in RTK was used to observe the points materialized on the terrain around the building studied in this project. Thus, both mappings could be superimposed and unified in one single dense point cloud.

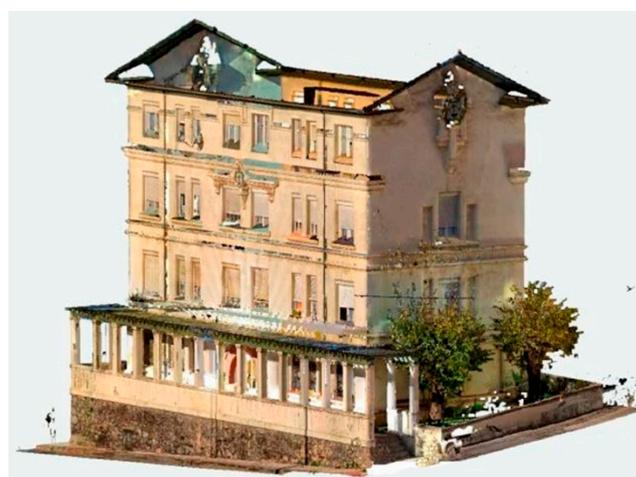
Figure 8. 3D Model produced by the laser scan (Source: Urquizo&NorthBIM).

The second phase of the 3D digital elevation method was the data processing [38]. Work on the data from the scanner and from the UAV was also carried out independently in this phase, to finish by combining the work into one single georeferenced and coherent model [39]. Regarding the 3D laser scanner data processing, a series of steps must be followed to obtain a consolidated, coherent, and precise dense point cloud [40], that can be used to generate the definite 3D model. The first step entails filtering all the scans to optimize the point cloud. Then, the different scans were accurately combined and consolidated in one single block, in relative coordinates. The third step was the application and offset of the cloud color, unifying the differences between scans. Finally, taking the points materialized in the terrain with topographic technology as reference, the coordinate system was transformed to fit the 3D scanning model in the UTM global topographic system (Figure 8).

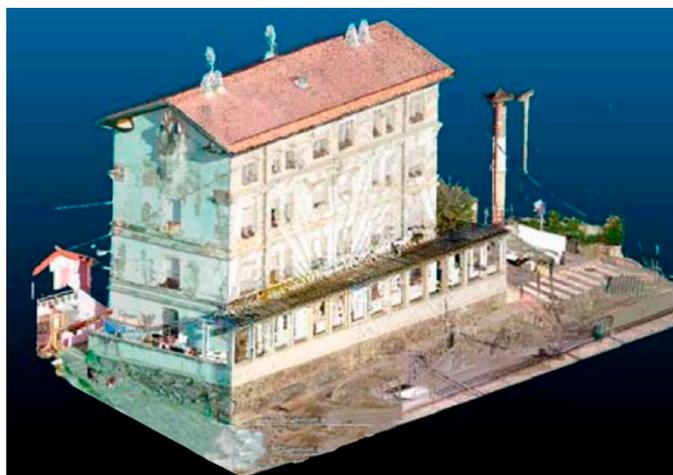
Figure 9. Final 3D Model, combining both clouds (Source: Urquizo&NorthBIM).

The 3D products, both from the laser scanner and the UAV, obtained separately, have used the same georeferenced points as reference to give coherence to the final model. Although, the precision and quality of the results were verified in each of the two partial models, it is in this last step when they were combined in one single 3D model, verifying the correct relative location of some data with respect to others (Figure 9).

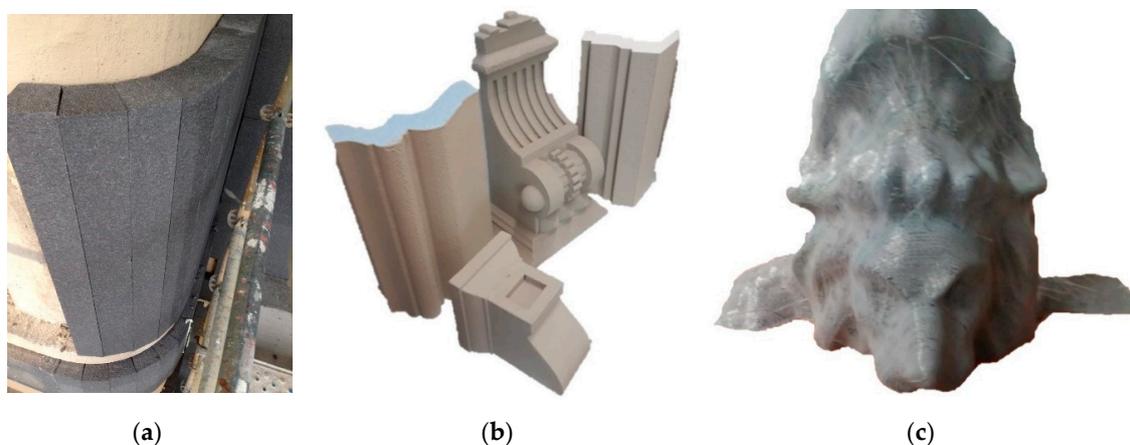
Figure 10. (a) Artisanal adaptation of polystyrene sheets by means of faceted cut (Source: FRL Arquitectos); (b) Advanced manufacturing of ornamental motifs after 3D scanning (Source: FRL Arquitectos); (c) Printed part of the shield in 3D after scanning (Source: 3R3D Technology Materials).

Certain ornamental elements are difficult to reproduce with prefabricated products, in the form of moldings or other types of parts (Figure 10a). If these elements are artistic with sculptural, plant, or animal motifs, and the solution requires their reproduction, the method must be 3D scanning, for subsequent printing (Figure 10b,c). The 3D printer reproduction technique, after scanning the element, has been applied to one of the ornamental elements of the Miñones Barracks of Ortuella. This consists of a lion on the shield of Vizcaya, situated on the side facade, on the top floor, under the side pinion. To this end, the facade, as well as the ornamental elements, were scanned, by means of UAV flights and fixed scanning stations. After scanning the ornamental elements and modeling them in 3D, they were printed on a 50 cm Creality printer in three dimensions. To this effect, the choice made was to reproduce the shield in 6 parts that were later joined together (Figure 10c). The printing material of the prototype was recycled PLA (Polylactic Acid) with plant origin and biodegradable material. A technical polymer such as ASA (Acrylonitrile Styrene Acrylate) is proposed for the definite solution on the exterior.

The first option studied is Rehabilitation with ETICS from the exterior. This consists of removing all the ornamental elements, such as moldings and shields, and replacing them with reproductions in plastic materials. The insulation thickness would be 6 cm, in polystyrene (XPS) (Figure 16). The improvement of the thermal transmittance of the opaque envelope of the building would be 63%. It affords an obvious improvement from the thermal viewpoint, as all the thermal bridges are avoided. However, it is not compatible with the protection of the facade. The solution can be improved by advanced manufacturing of the ornamental elements at a larger scale in insulating material, covering the original motifs and not eliminating them. This would make the solution compatible with the protection. Nowadays, it is a feasible, but very complex, option (see Figure 10b).

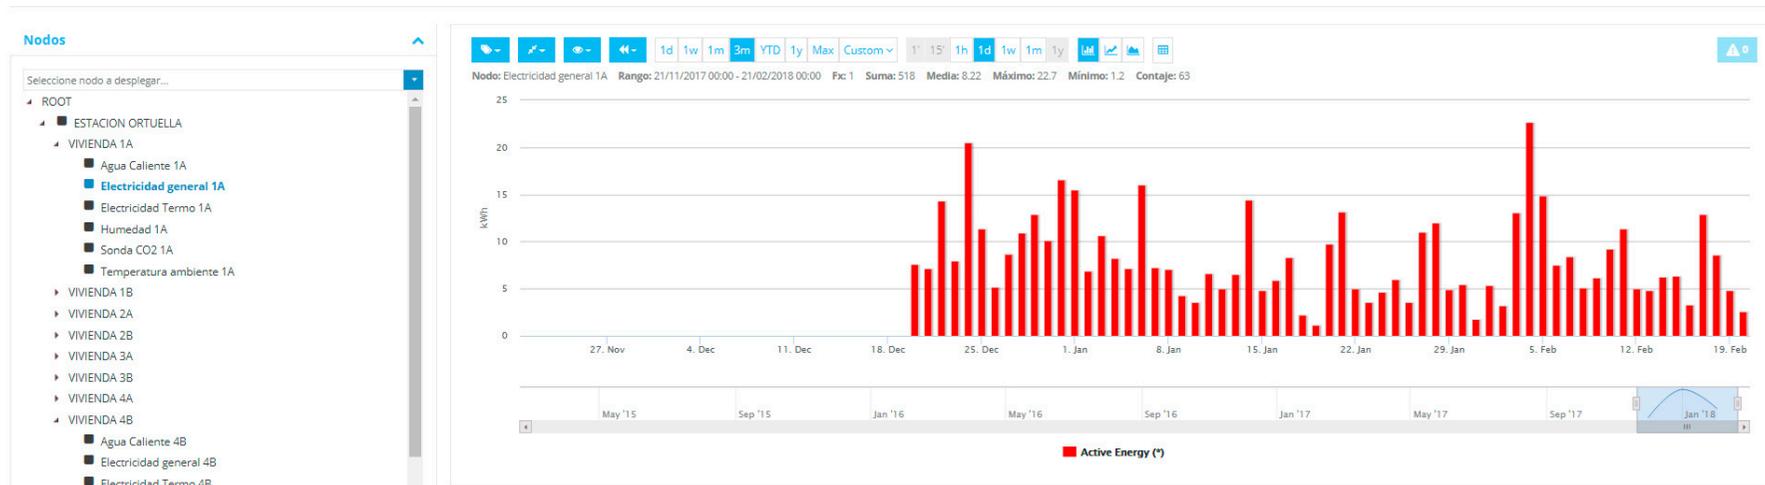
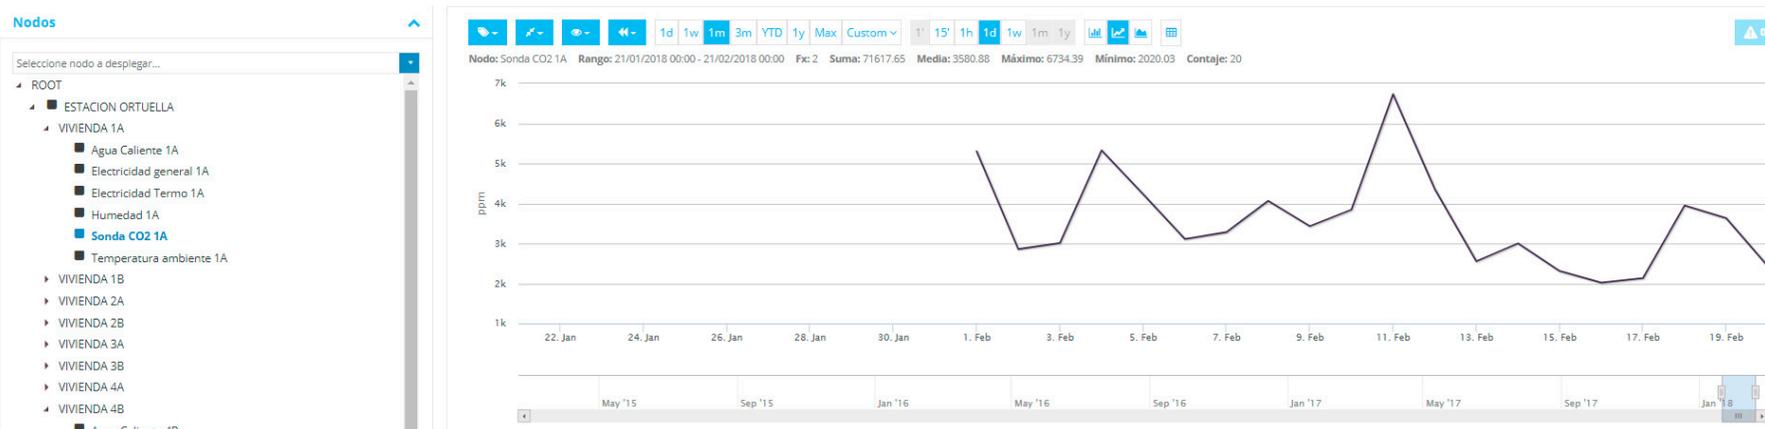
Figure 12. (a) Monitoring and obtaining of data relative to electricity consumption; (b) Monitoring and obtaining of data relative to atmospheric CO₂. (The data of the 2 images are not relevant, they serve to see the graphical options for displaying the monitored data). (Source: Ekitermik).

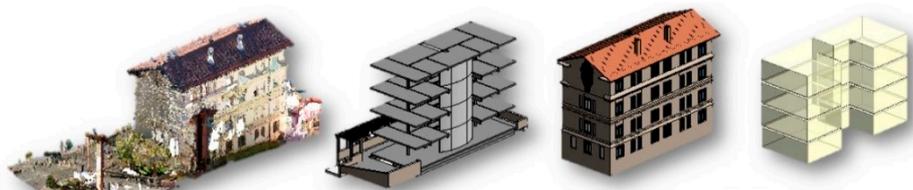
Figure 13. The four Autodesk Revit models. (Source: Urquiza&NorthBIM).

In the basic project modeling (initial state of the building), the families were identified based on the information collected on site, and the information was obtained through the study of the reform project underwent by the building in 1988. These families have been collected for the Structure model, on the one hand, and the Architecture model, on the other hand. The following families were identified in the latter model: partitions (several types: inner partitions, separation between dwellings, etc.), doors, enclosures (facade, facade to inner courtyard), outside carpentry, roof, and stairs. A flow was developed to optimize the modeling work by way of federated models, as follows: one general or central model, which includes the masses by dwelling, and a URL link to external data, such as, for instance, the monitoring data. The following models were federated to this general model: A model with associated Point Cloud in .rcp format, Structure discipline model, and Architecture discipline model (Figure 13).

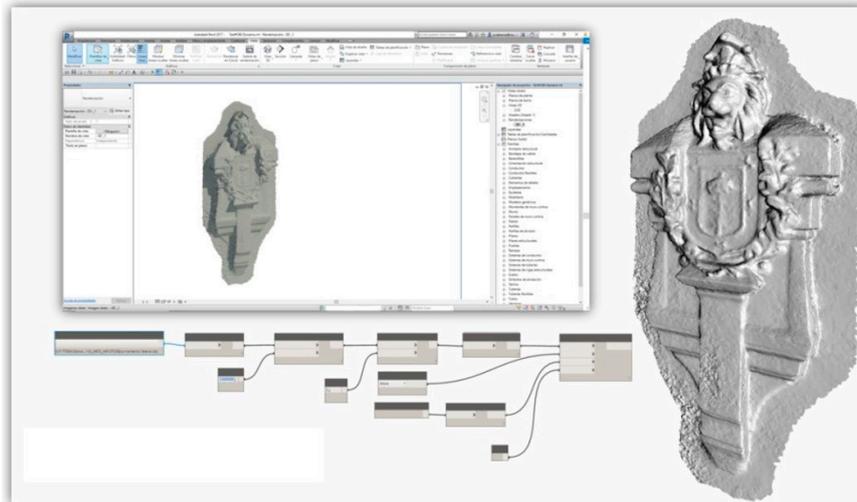
Figure 14. Volumes of the side shield for 3D printing (Source: Urquizo&NorthBIM).

There are ornamental elements on the facade that have a complex geometry and make manual modeling difficult. For these cases, a routine for Autodesk Dynamo, a visual programming tool compatible with BIM methodology that has been used through Autodesk Revit, was applied (Figure 14). This enables generating the volumes in the model.

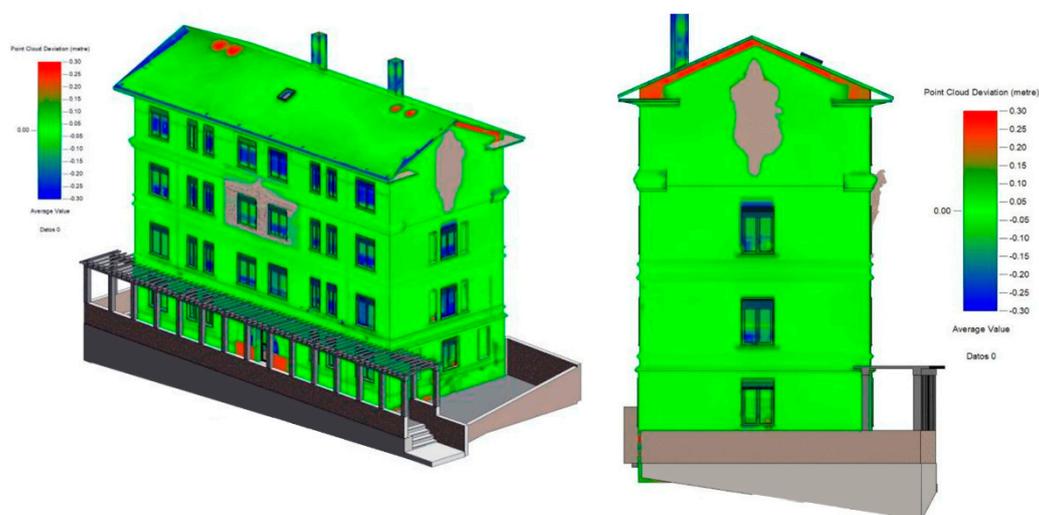
Figure 15. Inspection of the differences between the Cloud and the Model (Source: Urquizo&NorthBIM).

After modeling the building, the point cloud was used to measure the accuracy of the model compared with the reality include in these clouds. Pointsense Surface Analysis Tool for Revit, created for FARO scanner solutions, permits generating a 3D inspection map, and analyzing these differences (Figure 15). The analysis was performed in 2 stages: a first analysis at the half-way point of the first modeling phase, when the ornaments or moldings still have to be generated, and a second analysis when the model is finished. Based on the superimposition of the point cloud on the definite model, it has been possible to analyze the modeled surfaces by means of objects with generic surfaces (portions of drawings, cylinder, torus, cones or spheres, etc.). Further, it has permitted correcting deviations in a first iteration of the model, specifically on the roof: after correcting its slopes, the analysis shows optimal results (roof in green). Also, thanks to this tool, some differences were detected in the contours of the roof (in blue) between the point cloud and the model. However, the conclusion was that, in this case, it is due to the capturing uncertainty of the farthest contours, so the model was not adapted.

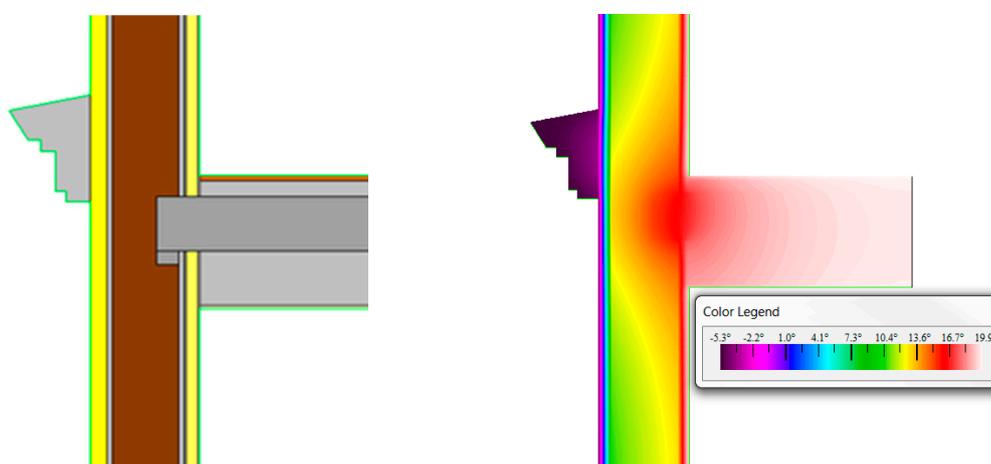
Figure 16. Diagram of the analyzed insulation and temperature profile for the case of ETICS on the exterior with 6 CM XPS insulation (Source: Tecnalia Research & Innovation).

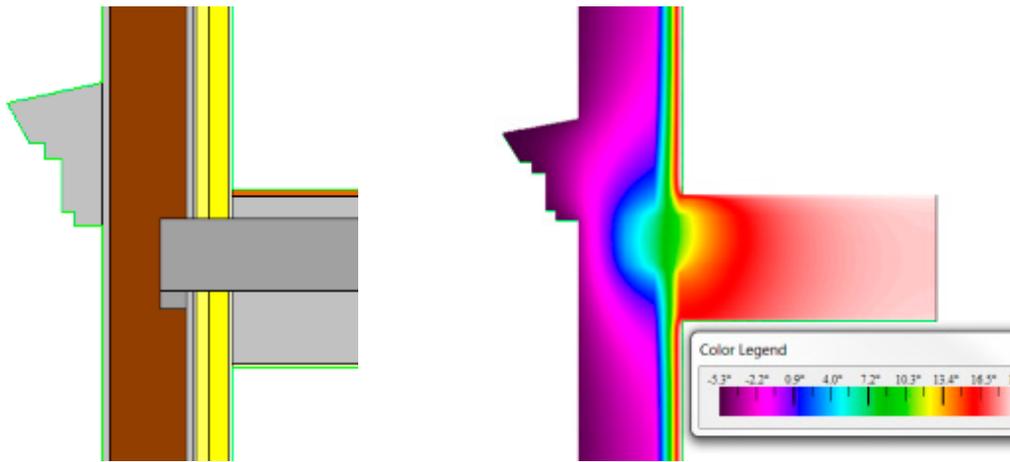
Figure 17. Diagram of the analyzed insulation and temperature profile for the case of vertical cladding insulation (Source: Tecnia Research & Innovation).

The second option presented is the interior rehabilitation solution. This would consist of applying 6 cm polystyrene (XPS) insulation on the existing cladding (Figure 17). Different interior insulation options with different combinations of walls, ceiling, and floor, have been studied. However, only the two options that represent the extreme cases analyzed are included below. The improvement of the thermal transmittance of the opaque envelope of the building would be around 43% for the vertical cladding, which may increase to 55% if the insulation were to be placed on the floor and ceiling, in addition to the walls (Figure 18). This solution would preserve the ornamental elements, but however, the impact of the work inside the building would be high.

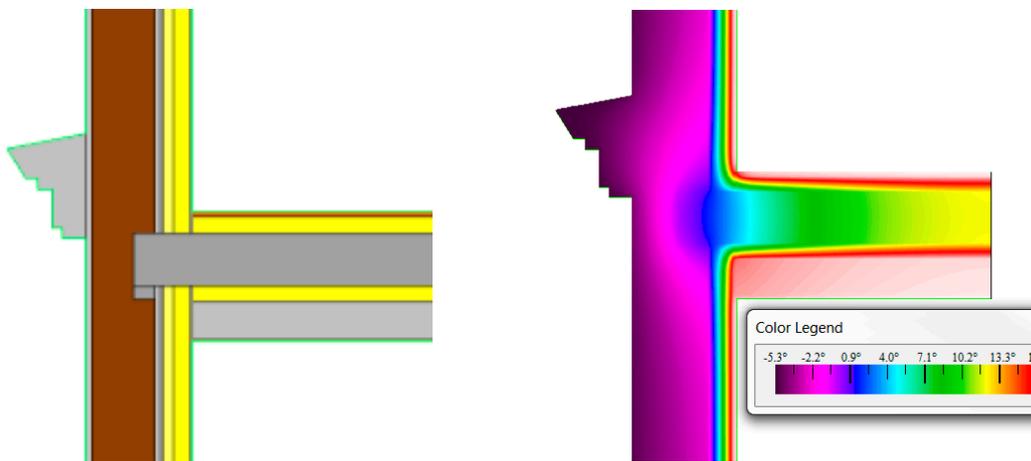
Figure 18. Diagram of the analyzed insulation and temperature profile for the case of vertical cladding insulation and insulation on floor or ceiling (Source: Tecnia Research & Innovation).

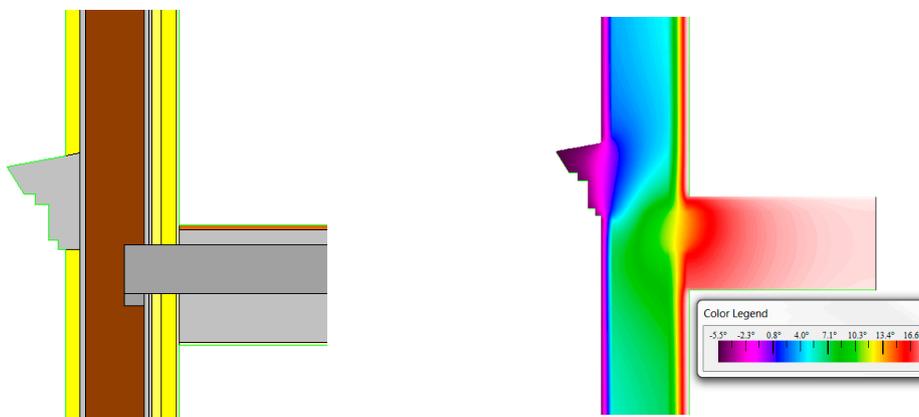
Figure 19. Diagram of the analyzed insulation and temperature profile for the case of vertical cladding insulation on the outside and inside (Source: Tecnia Research & Innovation).

The next option presented is the mixed rehabilitation solution. This would consist of applying 6 cm thick polystyrene (XPS) ETICS on the outside, without removing ornamental elements, in addition to occasionally placing another, 6 cm thick XPS, insulation on the inside, in order to eliminate the thermal bridges in affected areas (Figure 19).

As we can observe in the graphs, the improvement of thermal transmittance of the opaque envelope of the building is between 63% for the vertical cladding, both on the outside and on the inside, increasing to 69% if the insulation is also placed on the floor and ceiling, in addition to the vertical insulation (Figure 20). The results obtained are not comparable with those obtained from the two previous hypotheses, from the viewpoint of the economy and performance, as the insulation thickness is doubled on being placed both on the outside and the inside. The ornamental elements of the facade would be saved, although there would be a possibility of condensation building up at critical points. This is an intrusive action, however, which affects the inside of the dwellings, and which would cause inconvenience to the tenants.

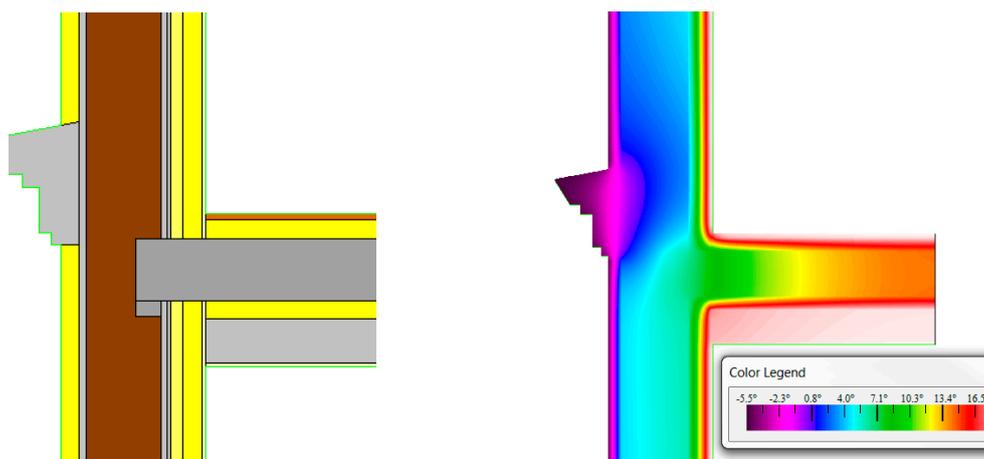
Figure 20. Diagram of the analyzed insulation and temperature profile for the case of vertical cladding insulation on the outside and inside, and insulation on floor or ceiling (Source: Tecnalia Research & Innovation).

In view of the results, it can be verified how the thermal bridges are a critical point in the intervention of the opaque envelope, especially in those cases where action on the outside is advised against, as is the case of buildings with protection degree on the facades. Thus, after defining the solution to be implemented, the constructive details must be included in the execution project. To this end, a detailed analysis will be required of the points where thermal bridges may occur, so that the proposed solution does not cause pathologies, such as surface or interstitial condensation at those points.
