## Article

# Constructability Criteria for Farmland Reclamation and Vegetable Cultivation Using Micro-Dam Sediments in Tigray, Ethiopia

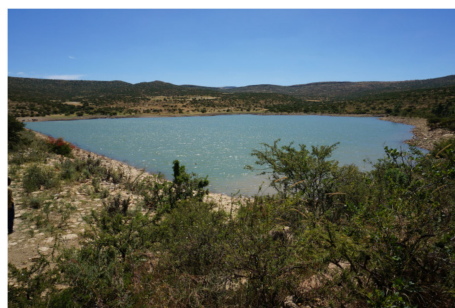
**Figure 2.** Adizaboy micro-dam (photo aspect, NW-SE).

The Adizaboy micro-dam is situated at the exit of the Adizaboy micro-watershed (Figure 2). The Adizaboy micro-dam was built in 2009 with local soils and rocks taken from an upland field near the dam site. It is labeled as a zoned rockfill type, which has a crest height of 9.06 m from the bottom pipe and is somewhat smaller than the average of other micro-dams in Tigray [8]. The water surface of the Adizaboy micro-dam seasonally changes. It sometimes becomes dry in March–April. The upstream slope of the Adizaboy micro-dam embankment (H3: V1) is gentler than the downstream slope (H2.55: V1). The trail for farmers in the micro-watershed traverses in a north–south direction over the embankment. The reclaimed farmland that used the micro-dam sediments is situated near the Adizaboy micro-dam and is above the micro-dam crest.

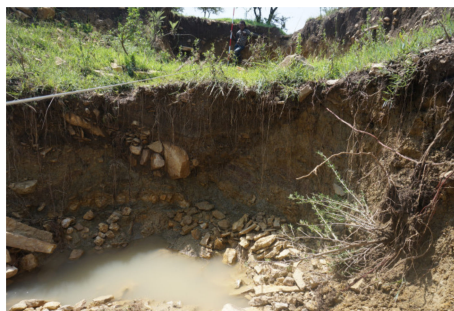
**Figure 3.** The starting point of gully erosion in the upper reaches of the Adizaboy micro-watershed (photo aspect, NE–SW).

Four major gullies formed in the upper reaches of the Adizaboy micro-watershed as a result of surface outflow and underground infiltration caused by rainfall. At the starting point of the gully, the depth of the surface collapses and a valley-shaped topography formed of about 2 to 2.5 m height (Figure 3). At this point, water entered through rill erosion due to intense rainfall. Even after rainfall stopped, permeated water continued to enter the gully erosion channel. The starting point of gully erosion then gradually extended upwards.

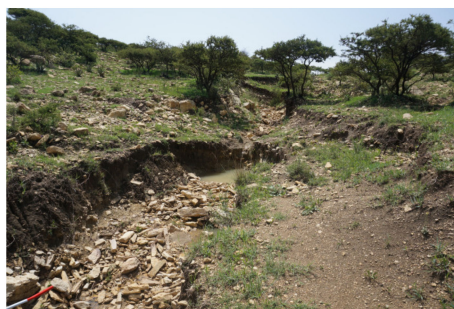
Figure 4 shows gully erosion in the upper reaches at the observation point. The shape of the cross-sectional views of the gully was deeper around the outside part because the water velocity was relatively faster there. Sand, stone, and gravel collapsed at the slopes of the gullies and this material was transported downstream. Inflows of sand and stone were greater than the outflows in the gully from the starting point to 60 m, although outflows were larger than inflows in other parts. The soil erosion volume depended on the distance from the starting point of the gully because of the slope collapse and water velocity effect.

**Figure 4.** Gully erosion upstream of the Adizaboy micro-watershed (photo aspect, NE–SW).

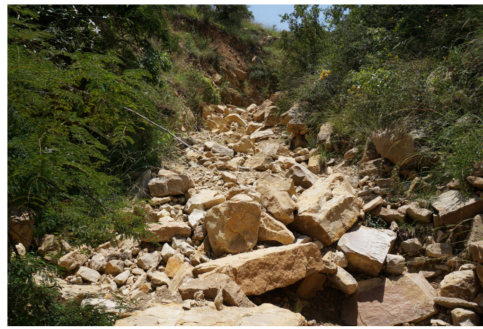
#### 2). Middle reaches (Figure 5)

The water velocity was higher in the middle reaches of the Adizaboy micro-watershed and the depth of gully erosion was about 1.0–1.5 m. Gullies in the middle reaches were slightly wider than in the upper reaches. The slope in the middle reaches was often steeper than the one in the upstream, and many boulders existed as well. The widths were sometimes very narrow and, at depths of more than 2 m, the soft geological layers were eroded.

**Figure 5.** Gully erosion in the middle reaches of the Adizaboy micro-watershed (photo aspect, S–N).

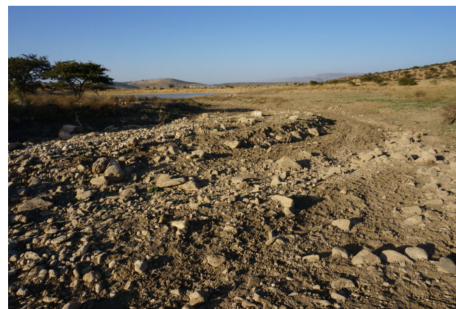
The gully near the micro-dam is gently sloped (Figure 6) but wider, with a width from 8 to 10 m. The depth is under 0.5 m. The shape of gravel and stone transported is rounder and smaller but there are still some big pieces of stone with a diameter over 0.5 m. As sand, silt and clay are smaller and lighter, they are transported to the micro-dam. Some of them go down-stream in the irrigation canal through the bottom pipe, and some of them stay in the micro-dam and accumulate at the bottom of the micro-dam.

**Figure 6.** Gully erosion near Adizaboy micro-dam (photo aspect, S–N).

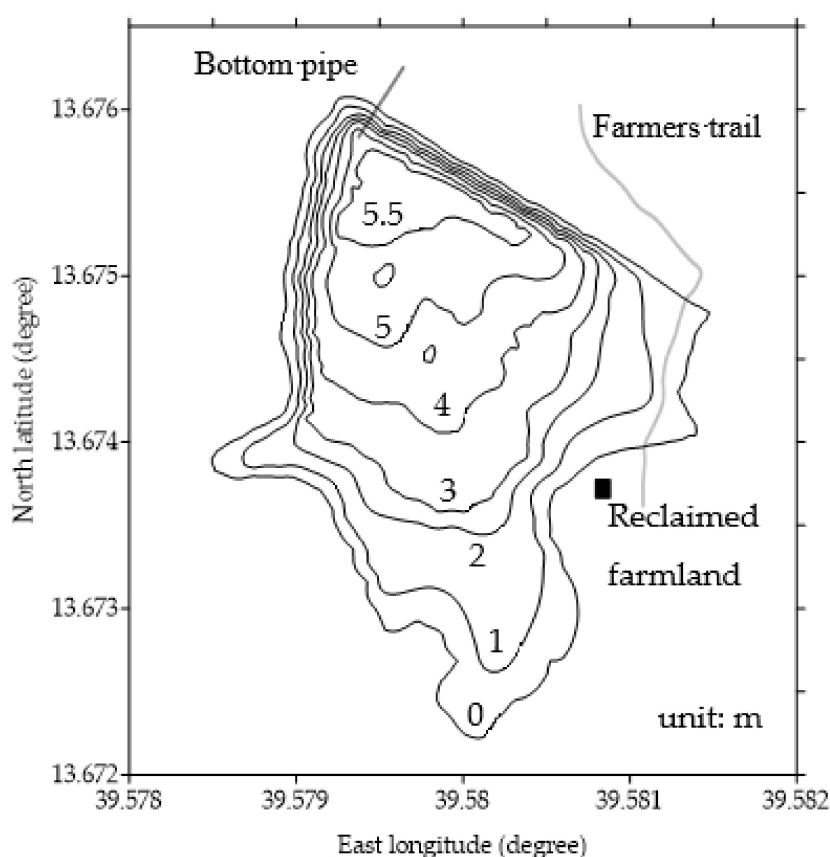
**Figure 7.** Sediment survey results for Adizaboy micro-dam. The micro-dam depth contour map was measured with an echo-sounder; numerical characters show the water depth (m) compared to the full water level.

The new bathymetric survey method (topographic survey) was applied to estimate the sediment volume for a short period [19]. An echo-sounder was used to measure the sediment surface depth from a boat. The coordinates around the perimeter of the micro-dam and the water depth were recorded (Figure 7). The sediment volume between the measured sediment surface and the estimated bottom was calculated to be 6400 m<sup>3</sup>. Table 1 shows the sediment characteristics versus the bare land.

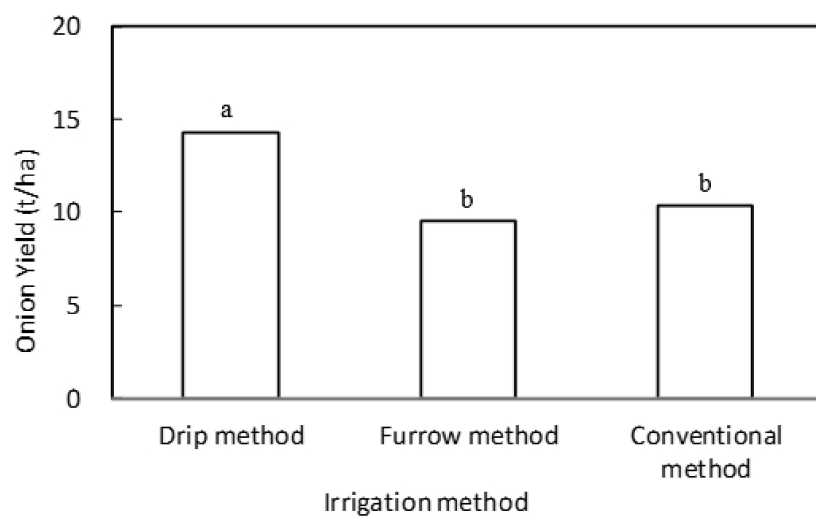
Figure 8 shows the onion yield on reclaimed farmland. Micro-dam sediments are classified into cohesive soil, which holds nutrients, fertilizer, and water, but does not have good air permeability. Abundant irrigation water naturally moved out through the stone bund, which surrounded the perimeter of the reclaimed farmland. The drainage problem did not occur on reclamation farmland. According to the Tukey–Kramer method (multiple comparison procedure for statistical analysis),

the onion yield on reclaimed farmland with drip irrigation was significantly higher than that on reclaimed farmland with furrow irrigation and that of the national average (2006 to 2017).

**Figure 8.** Onion yield on reclaimed farmland for different methods. Letters above onion yields show significant differences ( $p < 0.01$ ) among treatments.

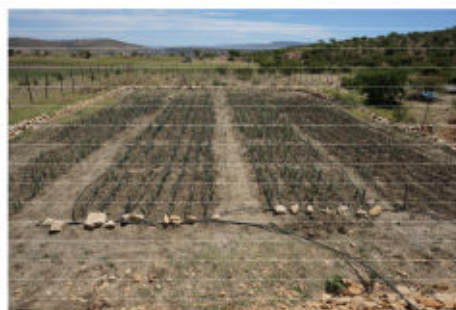
**Figure 9.** Drip and furrow irrigation were conducted on the reclaimed farmland (photo aspect, S–N).

The selection of suitable sites for reclaimed farmland comes at the beginning of the implementation planning process (Figure 9). It is especially important for the sustainability of farmland reclamation works to consider engineering factors from a farmer's perspective. For example, the dimensions of reclaimed farmland should be consistent with the farmer's capacity and demand. Distance, as well as height difference, between micro-dams and reclaimed farmland, should be kept to a minimum because it is difficult to transport sediment and to pump irrigation water from micro-dams to reclaimed farmlands if the distance becomes too great. Farmland should not have steep slopes, so as to prevent soil loss and retain the sediment thickness.
