# Response of Organic Lime Mortars to Thermal and Electrical Shocks Due to Lightning Strikes

**Abstract:** Lightning strikes are prevalent and inevitable natural phenomena that might cause damages during interaction with building structures and, in some cases, culminate in fires. During the last decades, several lightning strikes have caused considerable damages to cultural and heritage buildings. Furthermore, recent studies indicated a plausible connection between climate changes due to global warming and variations in the frequency and intensity of lightning. The evaluation of the structural efficiency and resilience of cultural buildings to global changes and natural risks appears significant in the light of the current scientific debate. This research aims at the assessment of lightning strikes' effects on ancient heritage binding materials through the characterization of their thermal and electrical conductivity properties. This study focused on the performance evaluation of green and low-cost mortars based on the use of organic additives. Lime samples were reverse engineered by using a mixture of organics (fig, jaggery, black grape, banana, kadukai), which comprises the most

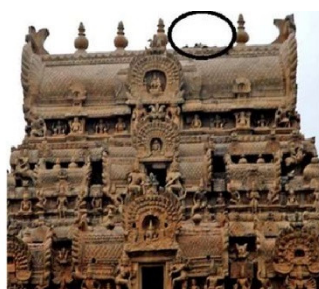
**Figure 1.** Lightning strikes on heritage sites in India: (a) Brihadisvara Temple, (b) Jameswar Temple, (c) Ratneshwar Mahadev Temple, (d) Nilamadhav Temple, (e) Jagadambika Temple, (f) Se Cathedral. The ovals mark the structural element hit by lightning strikes and the produced damages.

Figure 1 depicts snapshots of the damages caused to some important United Nations Educational, Scientific, and Cultural Organization (UNESCO) world heritage monuments that have been struck by lightning in India. In Brihadisvara Temple (Big Temple), in Thanjavur, one of the five spires (called kalasam) atop the Rajarajan gopuram (called also Thiruvayil), which is the middle gopuram from the entrance of the temple (Figure 1a) was damaged by a lightning strike [6]; the kalasam made of brick and lime mortar fell and broke into several pieces. Another example is the Jameswar Temple (Bhubaneswar) (Figure 1b), which experienced extensive damages from a lightning strike that caused a deep crack on the 11th-century temple's wall on its exterior ornament [7]. In 2013, a lightning strike hit the Ratneswhwar Mahadev temple in Varanasi [8] (Figure 1c), which was extensively damaged and required a significant refurbishment. The Nilamadhab temple was hit by a lightning strike that caused damages to the sanctuary's spire [9] (Figure 1d). Furthermore, a lightning strike hit the famous world heritage UNESCO site of Khajuraho, damaging the top part of the Devi Jagadambika temple (Figure 1e), inside the western group of temples [10]. Another important monument, the Charminar, was recently hit by a lightning strike. It was reported that the building was damaged several times by lightning strikes on its south-western minaret [11]. Reports have also mentioned that one of the 35 m high bell tower of the Se Cathedral (Goa) was extensively damaged by a lightning strike in 1776 (Figure 1f) [12].

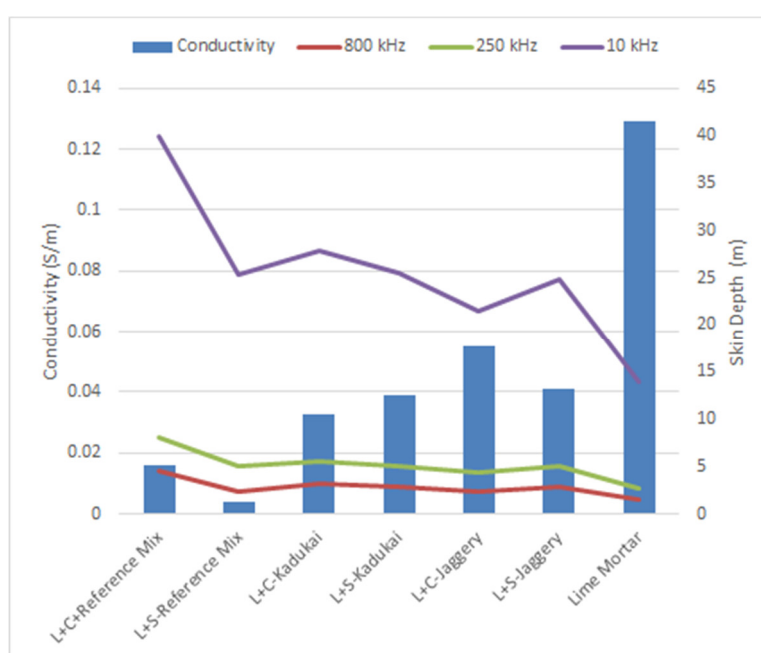
**Figure 11.** Values of electrical conductivity and computed skin depth for varying frequencies simulated during a lightning strike. L+C: lime + clay; L+S: lime + sand.

Computed values of the skin depth for the various lime mortars at different frequencies are presented in Figure 11. The obtained results suggested that at a frequency of 10 kHz, skin depth is higher than those for frequencies at 250 and 800 kHz; all the samples of skin depth displayed the same trend. Lime mortar from heritage monuments showed the maximum value of conductivity but minimum skin depth penetration at various frequencies.
