Wooden Buildings in Market Squares of Polish Small Towns: Bielsk Podlaski and Kleszczele—The Issue of Preserving and Restoring Historical Values of Market Spaces

Aleksander Owerczuk

Citation: Owerczuk, A. Wooden Buildings in Market Squares of Polish Small Towns: Bielsk Podlaski and Kleszczele—The Issue of Preserving and Restoring Historical Values of Market Spaces. *Sustainability* **2021**, *13*, 6779. <https://doi.org/10.3390/su13126779>

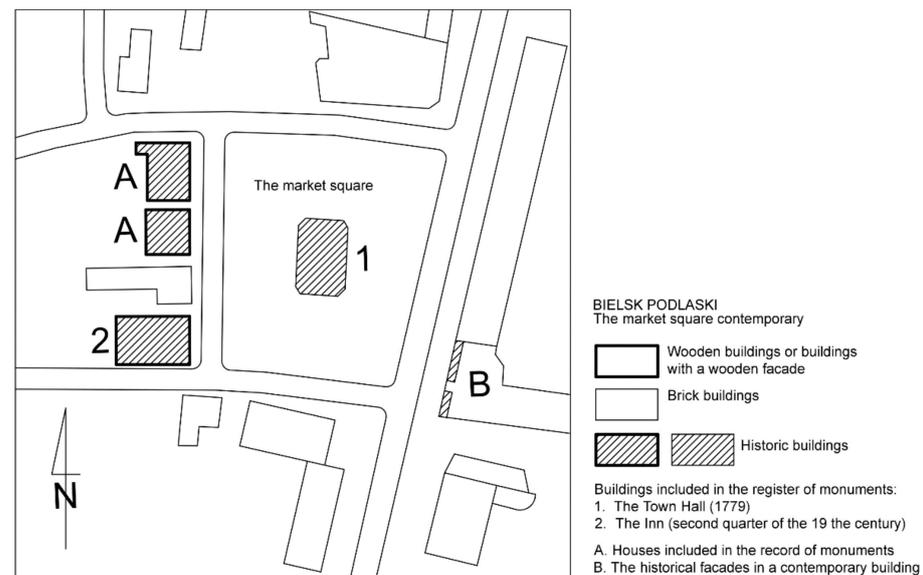
The only evidence of the historical shape of the buildings at the market square in Bielsk Podlaski is the western frontage (Figure 2). Its importance is confirmed by the inclusion of a roadhouse building in the register of monuments [57], as well as two houses in the provincial register of monuments (No. 7 and No. 9 Town Hall Square) [58]. The square is also located within the boundaries of a fragment of the urban layout entered in the register of monuments.

Figure 2. Bielsk Podlaski. The market square with surrounding buildings (Source: author (used maps from the website: geoportal.gov.pl; accessed on 17 March 2021)).

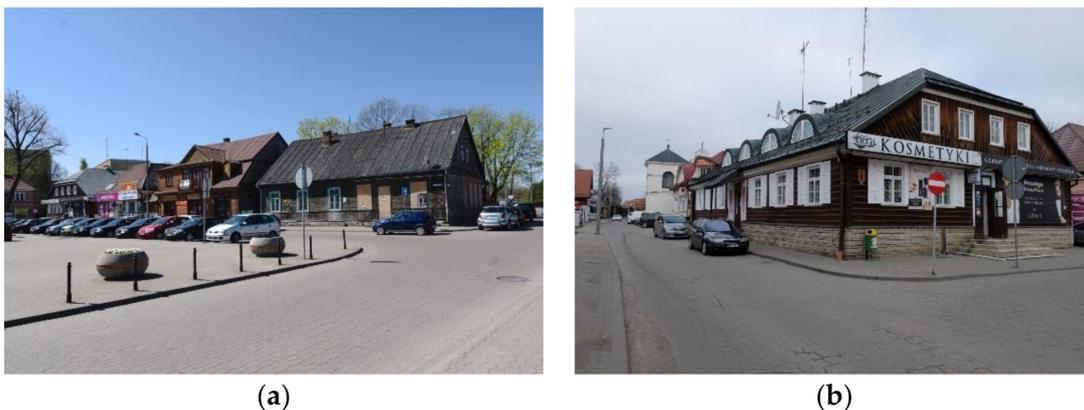
However, the current condition of buildings in the frontage differs from that of the interwar period. The most important building is the roadhouse. It had its historical form in the early 1960s [54] (p. 128). The roof was covered with shingles. In it, on the side facade, there were dormers and a canopy over the entrance, smoothly integrated into the roof slope. In later years, the roof was covered with asbestos, and the dormers and canopy over the entrance were modernized into simplified and historic forms [45]. The wooden roadhouse was demolished in the 1980s and replaced with a reconstruction (Figure 3b). However, the architectural form of the reconstructed building differs in detail from the original. The main change was the use of brick construction. Wood still remained a facade material and the object preserved its general historical form. The roof was covered with sheet metal and several dormers, much larger than the historic ones, were placed in the roof slopes. Some of the deviations from the original were probably due to the desire to achieve the functional qualities of the recreated roadhouse. The wooden house adjacent to the tavern was replaced with a new brick one, with a form similar to the original but on a larger scale (Figure 3a, third building from the right). The other two buildings retained their general architectural form (Figure 3a, the first and second buildings from the right). The facade and roofing materials have been replaced. Nowadays, a serious problem is the placement of an excessive amount of advertisements with aggressive artistic expression on the building, which hinders the perception of their architectural values (Figure 3a,b).

Figure 3. Bielsk Podlaski: (a) The western frontage (2018); (b) The historic inn (2021). (Source: author).

The conducted analyses indicate the basic directions of conservation activities which would allow, to a large extent, to restore the historical values of the only preserved frontage of market square in Bielsk Podlaski. The activities should focus on appropriate facade and roofing materials, taking care of details and the general building appearance. The main recommendations are as follows:

- historical shuttering of the building No. 7 should be restored;
- roofing materials should be replaced with historic ones in buildings no. 7 and 9, (ceramic tile), perhaps in the future in the roadhouse building, replace the tile roofing with shingles; due to the overall architectural expression replacing tile roofing with ceramic tile in building no. 5 would be beneficial;
- the existing wooden window frames should be retained; and
- advertisements in their current form should be removed—new ones should be less aggressive and inscribed in the historic character of the buildings.

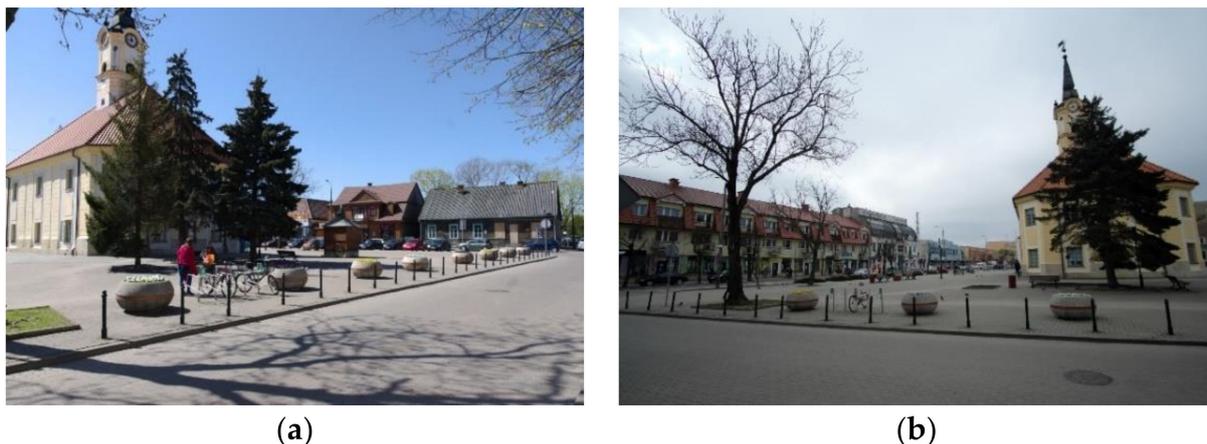
Figure 4. Bielsk Podlaski: (a) The town hall in the foreground. In the background, a part of the western frontage is visible (2018); (b) The town hall in the foreground. The eastern frontage is visible on the right (2021) (Source: author).

The Market Square—in general, the market space is maintained in an appropriate form. However, consideration should be given to removing conifers from the market square (Figure 4a,b). These elements are historically unreasonable, randomly located and hinder the perception of the market space, especially the western frontage. Ecological considerations and opinions of the local community should also be taken into account when making decisions.

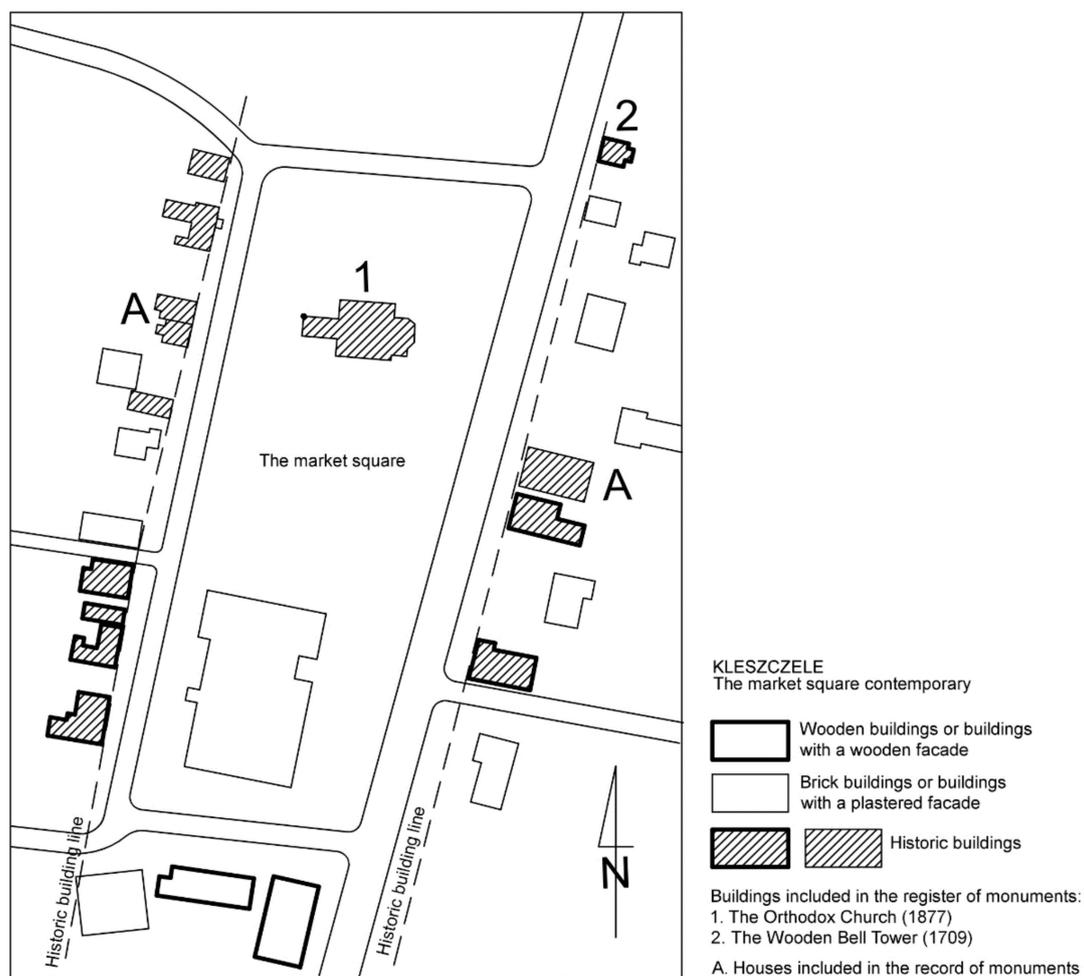
The market square in Kleszczele (Figure 5) is an element of the urban layout dating back to the 16th century which has been entered into the register of historical monuments [57]. The western frontage is the best preserved in its historical form (Figure 6). The provincial register of monuments lists three buildings there. These are houses no. 10 and 12 (adjoining each other with their gable walls, wooden and plastered) [41] (p. 27) and house no. 22 (Figure 7a), which is listed along with a barn located deep within the plot [58]. There are no objects listed in the register of historical monuments. The existing buildings mark the historic building line. Despite the loss of buildings and their partial replacement, the historic building line is still legible. The preserved houses form architecturally consistent buildings on longer sections (Figure 6a,b). Most of them are wooden. These houses have both gable and ridge positions. At least two wooden buildings are plastered. In terms of architecture, their frontage should be treated as brick buildings. Most of the houses, which were constructed after the war, do not refer to the historical buildings with their form. Usually, they are set back from the historic building line (Figure 5). Despite the unfavorable changes, the western frontage has to a large extent retained its historic character.

Figure 5. Kleszczele. The market square with surrounding buildings (Source: author (used maps from the website: geoportal.gov.pl; accessed on 25 March 2021)).

In order to preserve and restore the lost historical values of the western frontage, it is necessary to:

- maintain the general character of the development;
- in case of new buildings, the scale and form should refer to historical houses;
- use facade and roofing materials of traditional character—in the case of existing buildings, replace them with traditional ones (wooden shuttering referring to historical ones, ceramic tile roofing);
- use wooden window frames in the existing buildings;
- ensure that fences are kept in the line of market facades (within historical building line); fences should be wooden; and
- newly built houses should have the form, scale and finishing materials referring to the historical model and should be located along the historical building line.

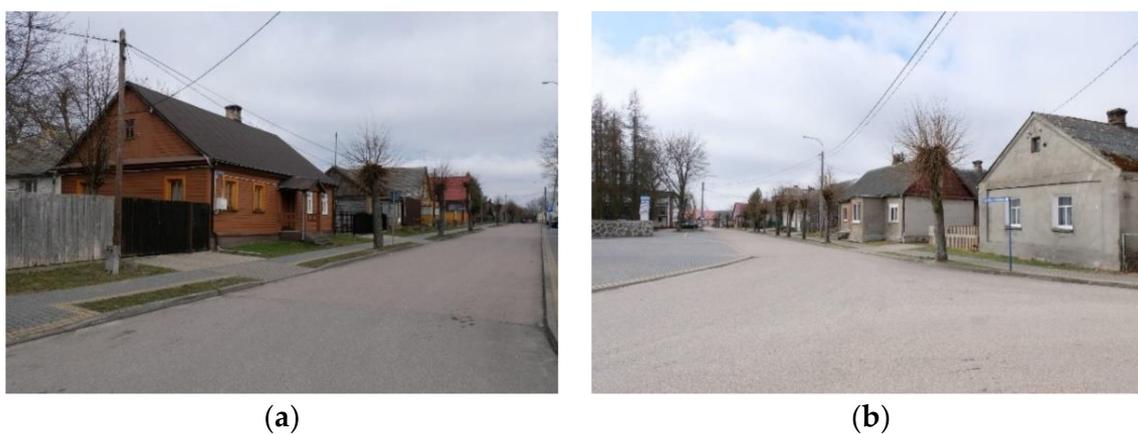
Figure 6. Kleszczele: (a) The western frontage. View from the south (2021); (b) The western frontage. View from the north (2021) (Source: author).

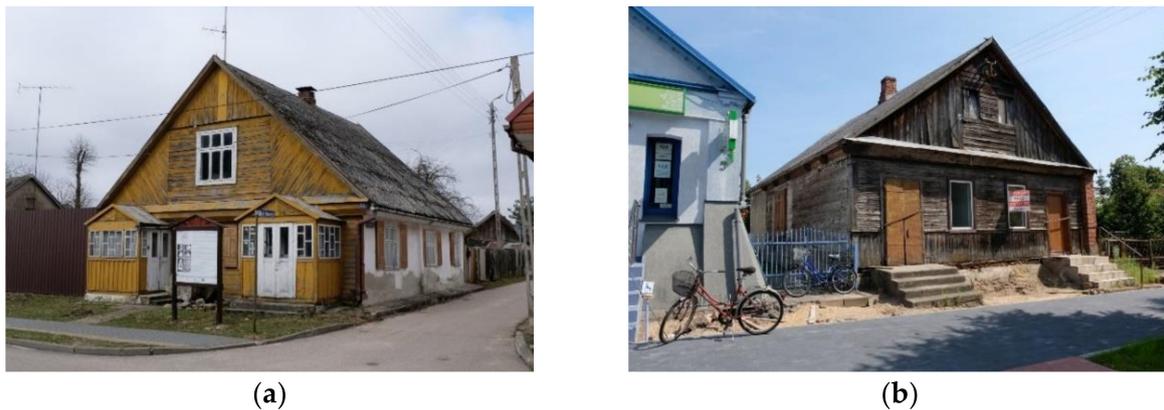
Figure 7. Kleszczel: (a) The market square. A wooden house in the western frontage (number 22) (2021); (b) The market square. A wooden house in the eastern frontage (2020) (Source: author).

Despite the irretrievable loss of its historic character, the eastern frontage also deserves attention. Historically, it was the most impressive frontage. It was probably influenced by its location along the main street crossing the city. At the northern end of the eastern frontage, there is a wooden bell tower dating back to the beginning of the 18th century (Figure 8a). It is a remnant of the complex consisting of a church and a bell tower. The wooden church was destroyed during the First World War. The bell tower is located slightly north of the northeastern corner of the market square. However, together with the brick fence, it is actually the beginning of the eastern frontage on the northern side. It also marks the historic building line. Further along the frontage, the building line is determined by two preserved buildings (no. 5 and 7) and a building at Kościelna Street (Figure 8b, two houses in the foreground). The buildings constructed in the post-war period were situated deep within the plots at a distance of 6–7 m to even over 20 m from the historical building line. Several plots remained undeveloped (Figure 5). As a result, the frontage does not have a legible historical building line and a uniform architectural character. The remains of old buildings are two adjacent buildings: the brick building no. 5 (registered in the provincial monument records) (Figure 8b) and the wooden building no. 7 (unregistered). Building no. 7 is the last preserved wooden house in its historical form in this frontage (Figure 7b).

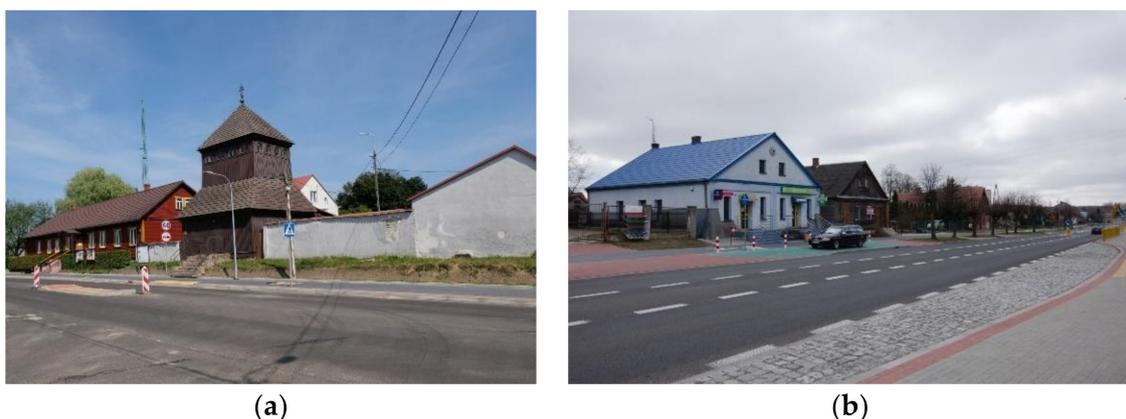
Figure 8. Kleszczel: (a) A part of the eastern frontage. View from the north. The wooden bell tower in the foreground (2020); (b) A part of the eastern frontage. View from the south. The two historic houses in the foreground (2021) (Source: author).

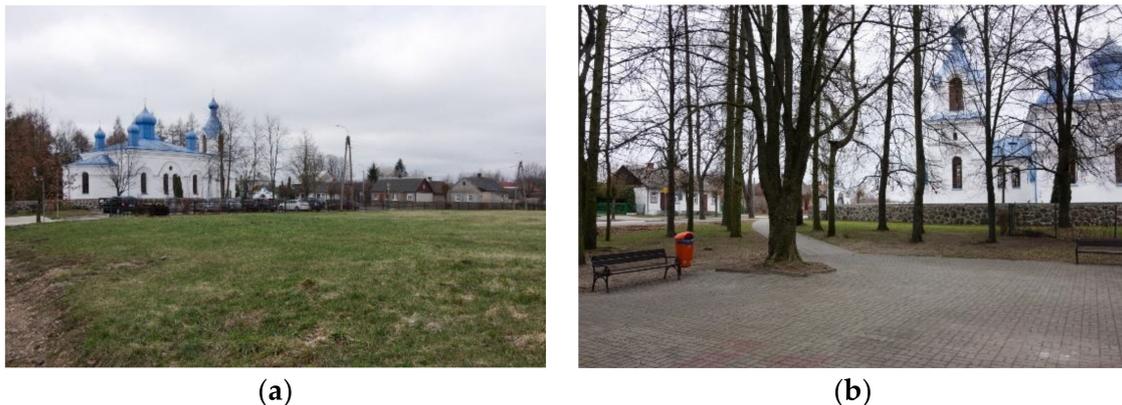
Figure 9. Kleszczel: (a) View of the market square with the orthodox church (2021); (b) The market square. View through the trees on a part the western frontage. The orthodox church is visible on the left (2021) (Source: author).

The Market Square—currently, in addition to the church located in the northern part of the square (Figure 9a), the large southern section of the market square is occupied by a school building constructed in the second half of the 1990s. The space between these buildings is filled with tall greenery planted in the 1930s and 1940s (Figure 9b) [62]. As a result, the square as a single space is illegible. The frontages are invisible or poorly visible from the market square. It is reasonable to leave the old trees around the church. However, in the future, the high greenery in the undeveloped part of square should be only partially removed. In this way, at least in some parts, the square would be perceived as a single space.
