Article

Strategies for Structural and Energy Improvement in Mid-Rise Unreinforced Masonry Apartment Buildings. A Case Study in Mestre (Northeast Italy)

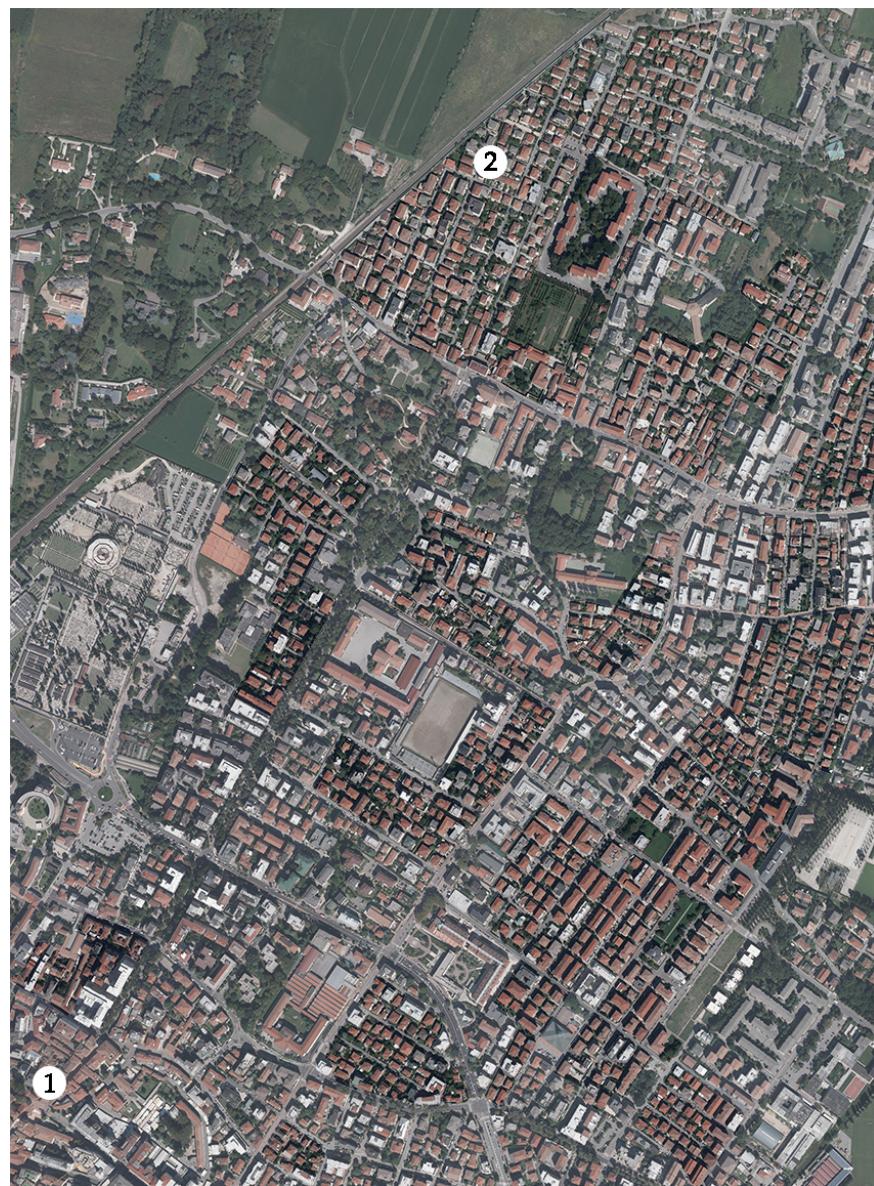
Figure 1. Aerial view of the northern area of Mestre showing the neighbourhoods where 20th century URM buildings are predominant: (1) historical centre; (2) location of the case study. (Adapted from <https://idt2.regione.veneto.it/portfolio/aereofototeca/>, accessed on 30 June 2021).

Mestre is a case study of sure interest in relationship to the aforementioned themes (Figure 1). After originating as a fortress at the borders of Treviso and Venice territories, it later became and obliged passage between the mainland and the latter, as five major roads meet there [40]. It gained some importance at the beginning of the 20th century with the creation of factories connected to the several military bases that existed there until recent times. In the late 1920s, Mestre was annexed to Venice and a large industrial facility was created in its territory, comprising a harbour, steel mills, petrochemical and chemical industries [40,41].

A sampling in those neighbourhoods built after the Second World War and the following economic boom showed that about 70% of the stock corresponds to URM buildings (Figure 1).

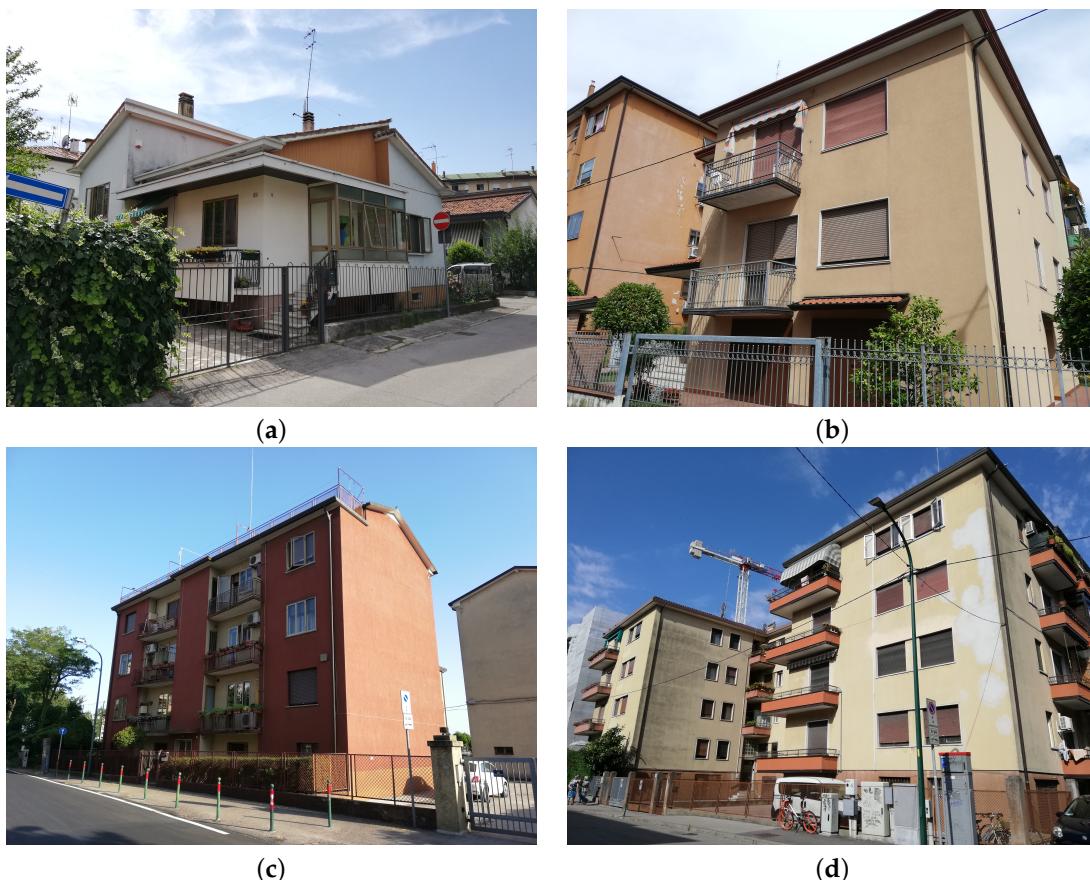
Figure 2. Typical URM buildings in Mestre: (a) Working-class detached house. (b) Middle-class small detached house. (c) Apartment building with regular plan. (d) Apartment building with irregular plan.

- One- or two-storey working-class detached houses. Walls are made of clay bricks or blocks; later (since the 1970s), these latter were replaced by hollow concrete blocks. Floors consist of rib-and-slab, semi-rigid r.c. structures (see Section 3.2), and roofs are composed of timber beams and clay tiles. This type is common from the 1950s to the 1980s (Figure 2a);

- Three- to four-storey apartment buildings, with regular plan, generally rectangular, with one or two staircases and two or four flats per floor, respectively. Floor slabs are similar to those of the previous types but r.c. roof structures are widespread, especially in more recent buildings (1950–1970). As the ground floor hosts garages, ware rooms or shops there are often large openings at this level, and sometimes a r.c. frame is used, although only on the street façade (since the late 1950s; Figure 2c);

- Apartment buildings similar to the previous type but irregular in plan (L or C shape), taller (up to 5 storeys) and with more than two staircases (since the 1960s; Figure 2d)

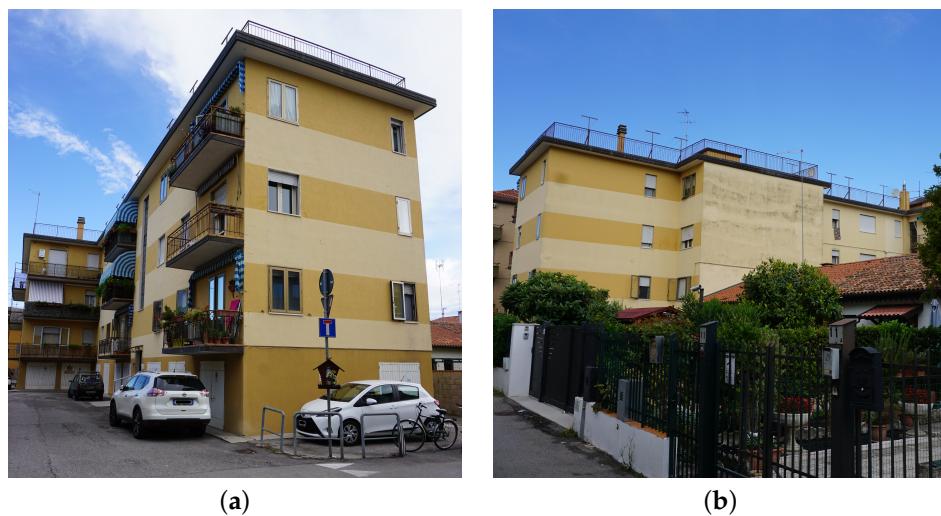
Figure 3. CSG building: (a) south view; (b) west view.

The model building, henceforth referred to as 'CSG building' (Figures 1 and 3), is a four-storey apartment building in the north residential zone of Venezia–Mestre belonging to the fourth building type (Figure 2d). It was built in 1962–1963, and the perusal of the original documents shows some differences in finishing and the roof with the actual building, probably owing to a financial shortage in the final stages of construction. The external metric survey, however, confirmed that most of the measures given in original blueprints and internal inspections showed a good conformity of the present flats' layout to that authorized in the 1960s as well. Therefore, this latter was assumed as valid for the entire building. The construction site is placed at the borders of the neighbourhood, close to a railway line.

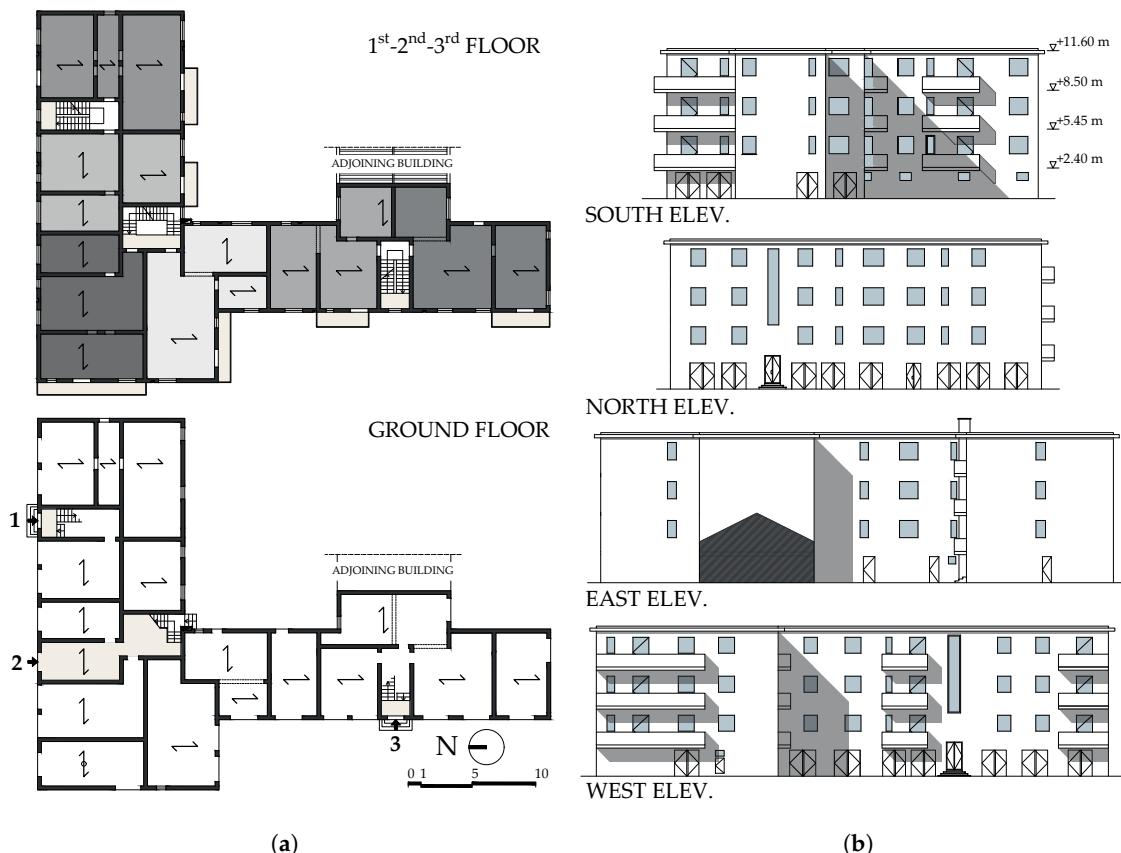
Figure 4. CSG building: (a) floor plans with bearing walls and joist's direction; each shade of grey corresponds to a flat. (b) facades.

The CSG building has a L-shaped plan reaching about 29.10×28.60 m: the north wing is 11.50 m deep and the western one is 7.1 m. The ground floor hosts garages, storage and technical rooms, whilst in upper storeys there are six apartments per floor, served

by three separate staircases (Figure 4). The internal layout of the flats is different, and their commercial surface ranges between 85 and 90 m² (6 flats) and 105–110 m² (12 flats). The four-storey CSG building is 11.60 m tall, with an inter-storey height equal to 2.20 m and 2.80 m at the ground floor and the upper storeys, respectively; floor slabs are 25 cm thick. It covers a surface of about 580 m² for a total of 6728 m³.

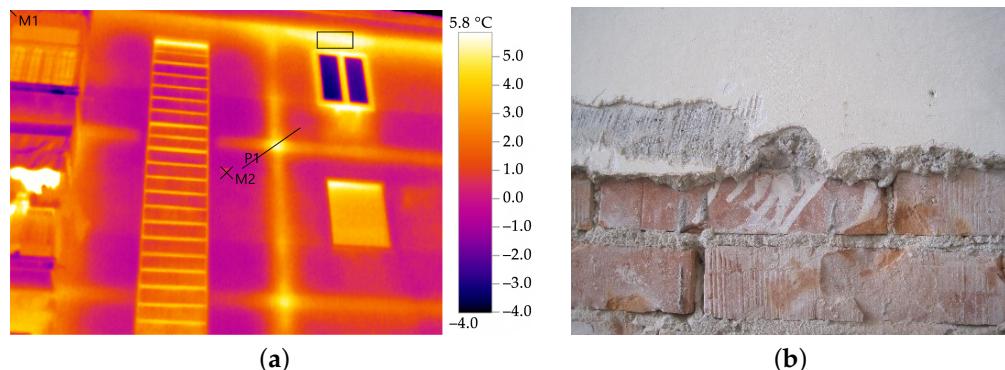
Figure 5. Wall characterization of CSG building: (a) Thermogram of the north facade showing the traces of internal walls and floor slabs, hotter than the façade wall. (b) Masonry units.

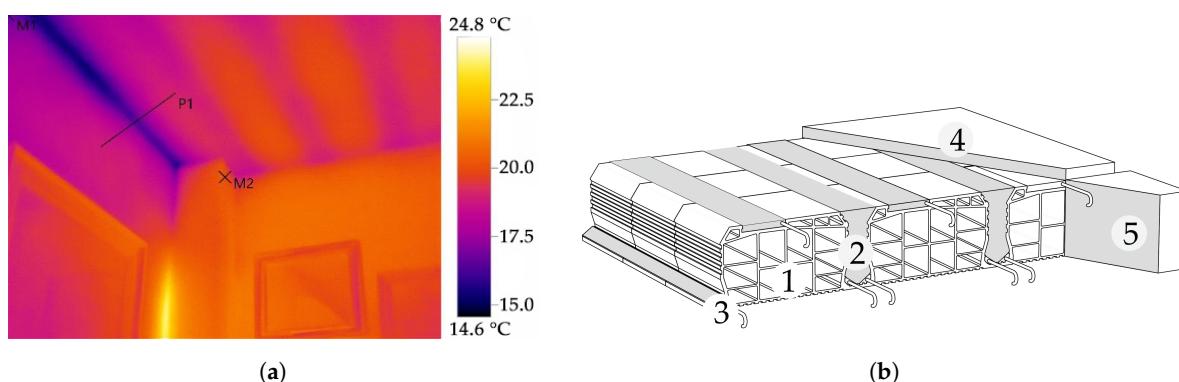
Figure 6. Floor slab characterization of CSG building. (a) Thermogram of a floor slab. (b) Axonometric scheme of its composite structural system: (1) hollow clay blocks; (2) r.c. joist cast in situ; (3) longitudinal rebar; (4) unreinforced concrete slab; (5) unreinforced tie beam at the support (adapted from [51]).

It was not possible to inspect the horizontal diaphragms in the same way. However, according to the documents, the period of construction and thermograms (Figure 6a), they were most probably obtained from a composite system made of lightweight hollow clay

blocks bound with cement mortar and reinforced with steel rods, thus forming the load bearing joists, alternating with unreinforced lightening ones [48,49]. In the space between load-bearing and replenishment joists, the resulting thin r.c. rib (<7 cm width) could host an additional rebar; a thin concrete slab, without the steel mesh (3 cm), completed the system on top (Figure 6b; [50,51]). According to [52] the clay top layer of joists could be considered as the compression slab and the concrete one served as a finish, as in this case. The rule of thumb of those times suggested a slab's structural thickness about a 25th of the structural span, which is about 20 cm in CSG building.

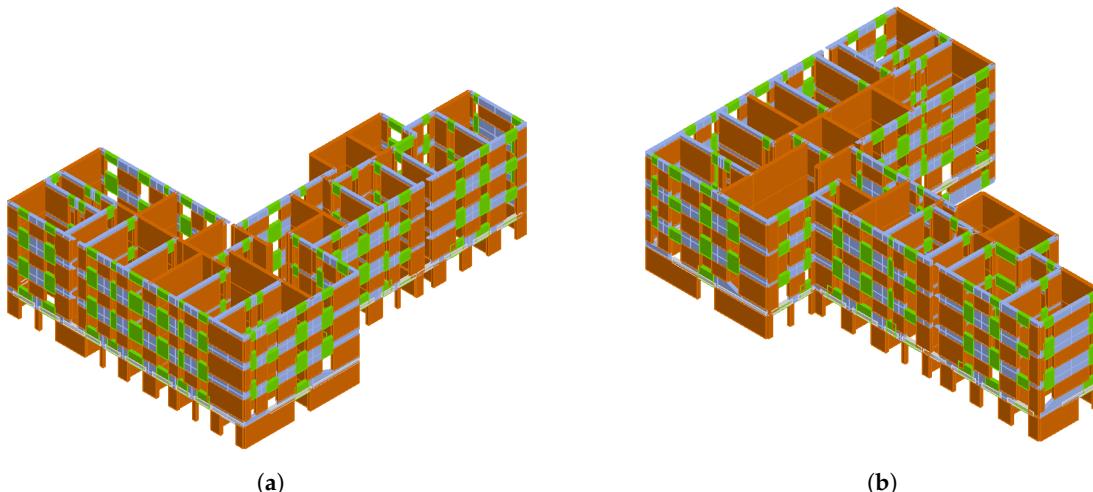
Figure 7. Three-dimensional view of CSG's analytical model: (a) north wing; (b) west wing. Spandrels in green, piers in brown, rigid nodes in light blue.

an old-fashioned floor tiling and a distributed load equivalent to non-structural partitions as allowed by [43], and in 50 kg/m^2 on the flat roof, considering a simple waterproof layer. Live loads were assumed equal on each slab, as the roof is commonly accessible by inhabitants. Table 3 resumes floor loads and the combination coefficient valid for seismic conditions. Figure 7 shows the equivalent frame model of CSG building.

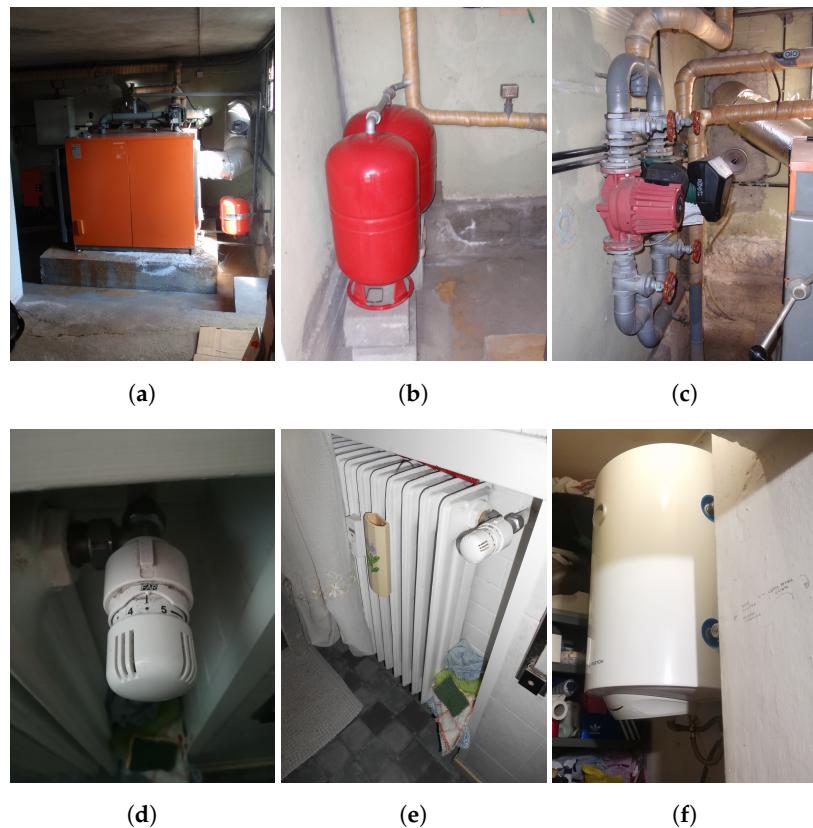
Figure 8. CSG building, components of the hydronic system. (a) Burner. (b) Expansion tanks. (c) Recent repairs and additions. (d) Thermostatic valve. (e) Radiators. (f) Hot water tanks and electrical boilers inside flats.

At the time of construction, central heating systems and radiators were not mandatory in flats and, consequently, heat was supplied by fuel oil or coal powered stoves. In CSG building, a central hydronic heating system, connected to the public methane network, was only installed in 1978 (Figure 8). Radiators were placed in niches below windows, carved in the walls on that occasion; they have recently each received thermostats, in compliance with European standards [56]. In fact, the distribution piping was vertically shared among the flats, and it ran mostly on the facades. The central heating also warmed tanks in individual flats during winter, for the supply of hot water for sanitary uses. In summer, such tanks served as electrically operated boilers. Piping was not insulated, and the gas supply system did not comply with present standards any more.

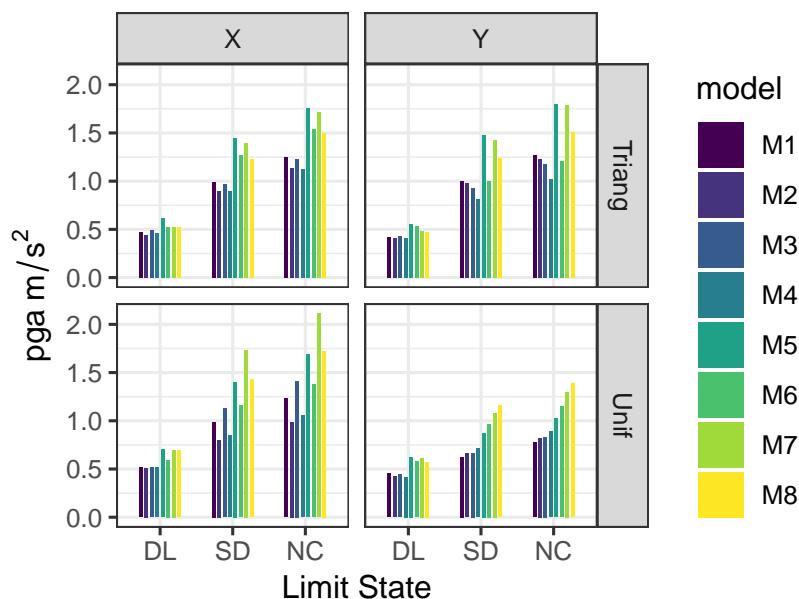
Figure 9. Peak ground acceleration (*PGA*) that determines the NC, SD and DL limit states in the CSG building.

On the pushover curves, the main overall limit states (*LS*) were determined according to the criteria given by [18], that is: (a) Near Collapse (NC), when a 20% shear strength decay happened; (b) Severe Damage (SD), as 75% of NC displacement; and (c) Damage Limitation (DL) at the yield displacement. For each *LS*, the corresponding capacity Peak Ground Acceleration (*PGA*) was obtained through the application of the N2 method [62] (Figure 9).

One may observe in Figure 9 that (a) the models with solid bricks masonry had a poorer performance than those with clay blocks; (b) the influence of the masonry type was greater than the coupling degree allowed by spandrels in the two models; (c) the Y direction was weaker than the X one; (d) uniform analyses led to lower *PGA* values at each *LS*, owing to the large openings at the ground floor; and (e) in-plane shear stiffness of floor diaphragms worsened the building's seismic performance, as *PGA* was generally lower for these models (compare, e.g., M1 and M2).

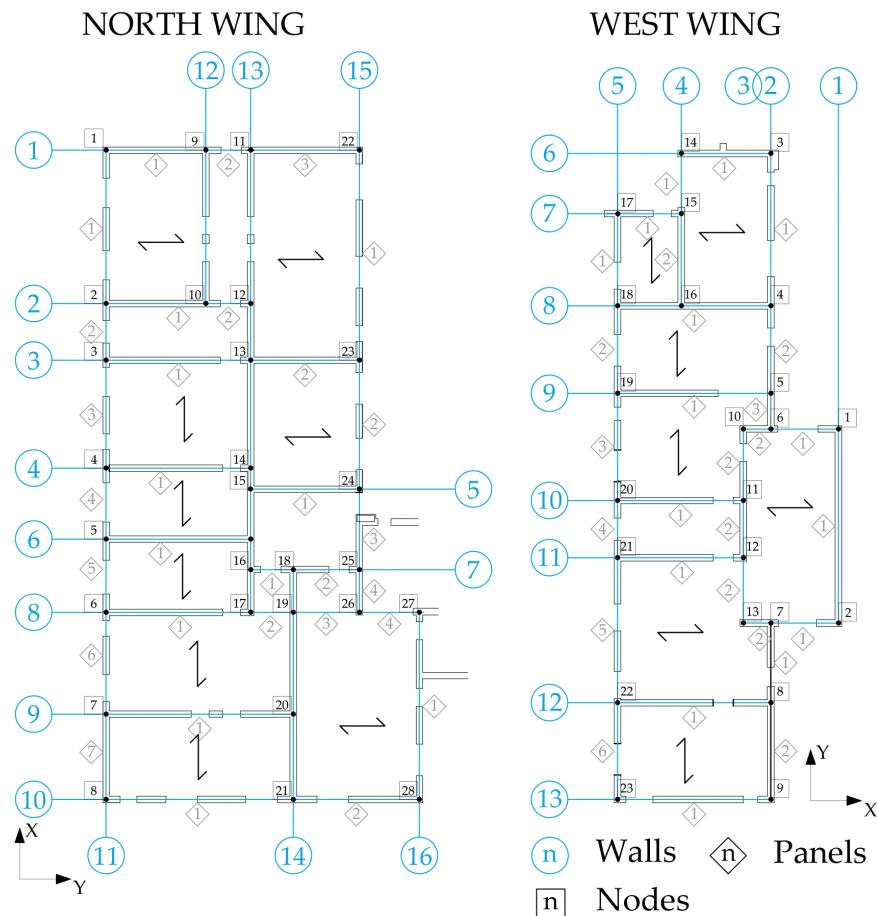
Figure 10. Residential level schematization for the analysis of local mechanisms.

Vulnus software [24] can evaluate the load multiplier *c* of seven local mechanisms, distinguished in 'vertical' and 'horizontal' mechanisms, also considering openings (i.e., doors and windows) and their distance from corners and walls' intersections. A building is idealized into walls, which are subdivided into panels delimited by nodes at the two ends (Figure 10).

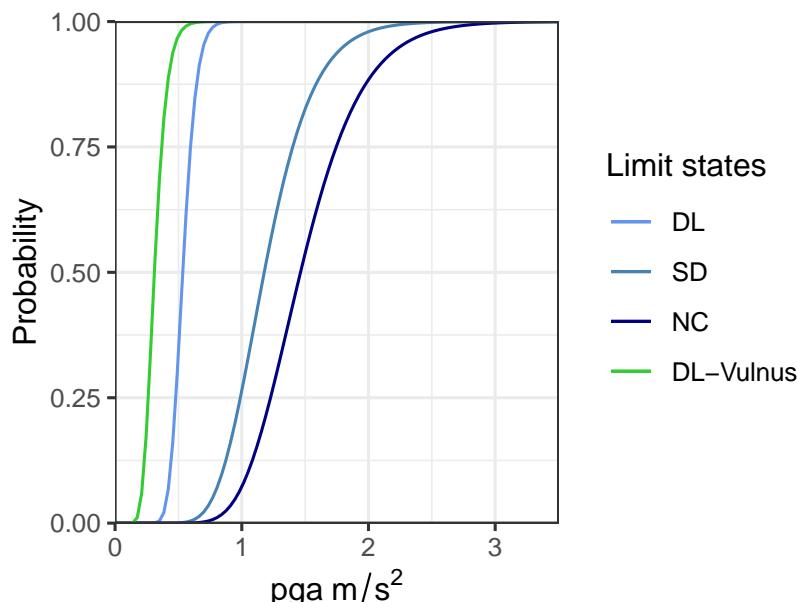
**Figure 11.** Fragility curves for the reference limit states, before the interventions.

Fragility curves were obtained from pushover analyses according to the procedure proposed by [22,67], starting from the *PGA* (Figure 9) values that determined the reaching of each limit state (Figure 11).

The fragility curves obtained from the overall assessment were compared to the only one automatically calculated by Vulnus by the means of fuzzy sets [24]. As this curve

(green line in Figure 11) describes the activation of local mechanisms, it corresponds to a damage state D2–D3 (moderate damage, [68]) and, in terms of safety verification [43], to a DL limit state. Indeed, the ‘Vulnus’ fragility curve is moved to the left of the graph, and it is comparable to the DL curve of the global assessment. For the PGA at SD limit state expected in Mestre, CSG has a moderate probability to exceed the SD limit state (about 20%) but a high probability to reach and exceed the DL, on either local mechanisms or the overall shear behaviour.

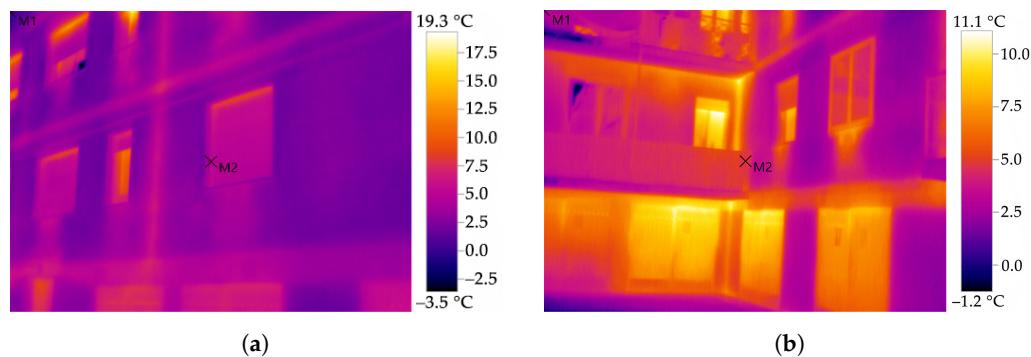
Figure 12. Thermographic analysis of CSG building. (a) North facade. (b). Corner between north and west wing.

On-site surveys revealed the considerable amount of heat dispersed by external walls, especially in the niches below windows (where radiators were placed) and in corners; the traces of floor slabs on internal walls were also clearly visible in thermograms (Figure 12). The heat dispersion, combined with the high RH measured (65–72.2%) inside the flats at the time of the surveys (February 2019), determined an extensive presence of dew and mould on internal surfaces. These conditions were a proxy of the uncomfortable indoor climate in CSG’s flats.

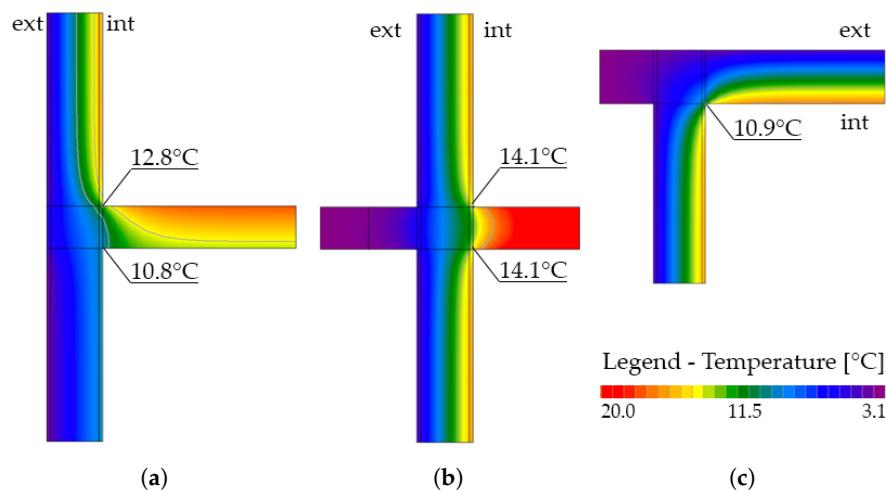
Figure 13. Thermal finite element analysis in current conditions of junctions. (a) Floor to wall. (b) Balcony to wall. (c) Roof to wall.

Indeed, thermal finite element analyses with IRIS software package [69] confirmed low temperatures on internal surfaces (10–14 °C) close to the dew temperature, especially in the junctions between floor slabs and walls and between the roof and the walls. Due to the high internal RH, the software confirmed the possible presence of mould on cold surfaces (Figure 13).

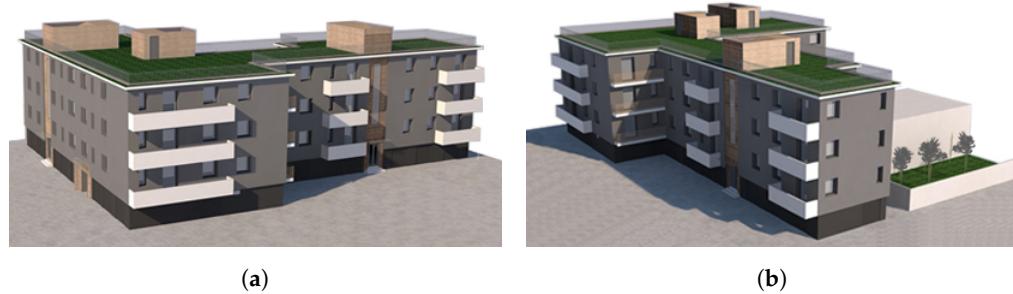
Figure 14. External render views. (a) Northeast view. (b) Southeast view.

To the general end of conveying a new image of CSG building, a rainscreen system was applied to the added cladding of the walls. The material chosen for the screen were ceramic tiles, durable and available in a wide variety of renders and colours. Consequently, tiles with a different texture and lighter colour marked the staircases of the building, whereas a darker colour in the ground floor characterized it as a pedestal for the building upon it; moreover, as there was no thermal cladding on the walls of the ground floor, the small recess emphasized this effect (Figure 14).

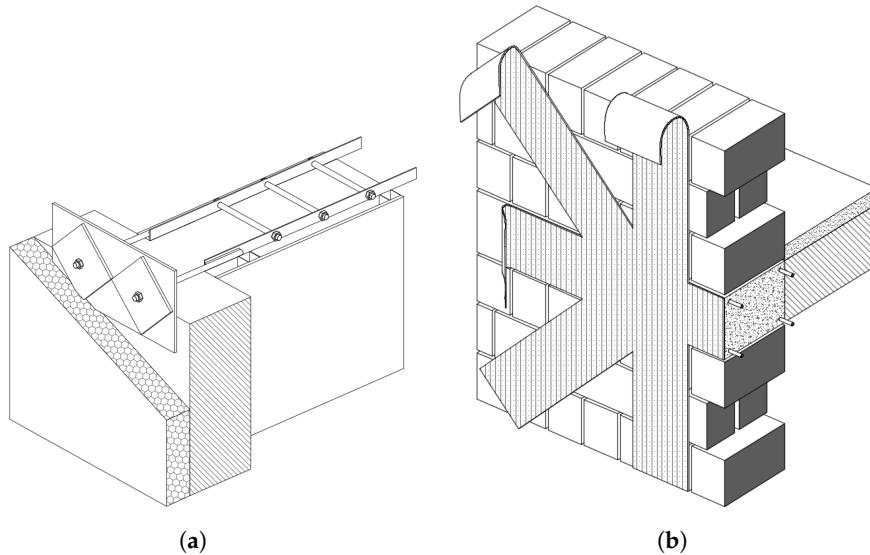
Figure 15. Schemes of proposed structural interventions. (a) Steel ties and anchor plates. (b) Fibre reinforced polymer braced frame.

The overall seismic assessment showed the weakness of masonry piers at the ground floor as well a concentration of damage in those walls with an unfavourable geometrical configuration, such as the south façade of the west wing. Therefore, the strengthening solution, compatible with the thermal cladding, was the application of fibre-reinforced

polymer strips bounded with organic resins to masonry walls. Strips would compose a ‘braced frame’ spanning over the inter-storey height (Figure 15b), adding the required shear strength to walls, with a limited interference with moisture diffusion from the indoor air.

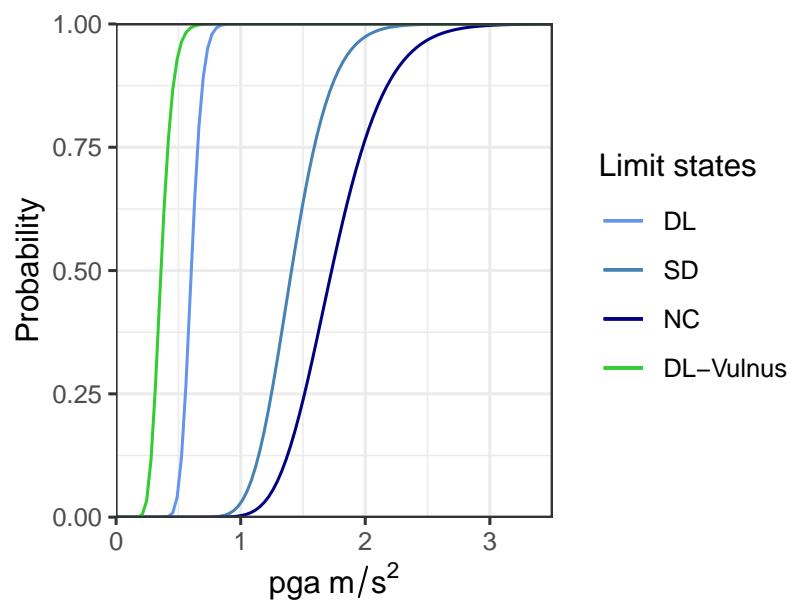
Figure 16. Fragility curves for the reference limit states after interventions.

Fragility curves were also computed in design conditions, revealing a limited vulnerability reduction (Figure 16), in both the local and overall behaviour. Indeed interventions were concentrated in common parts of CSG buildings, and they were limited to the essential in individual flats, in order to minimize the impact on flat’s usage. Moreover, interventions were constrained by the low seismic input, which reflected on both the little amount of reinforcement needed to meet the seismic safety requirements [43] and the impossibility of tax deduction (see Section 6) for such interventions.

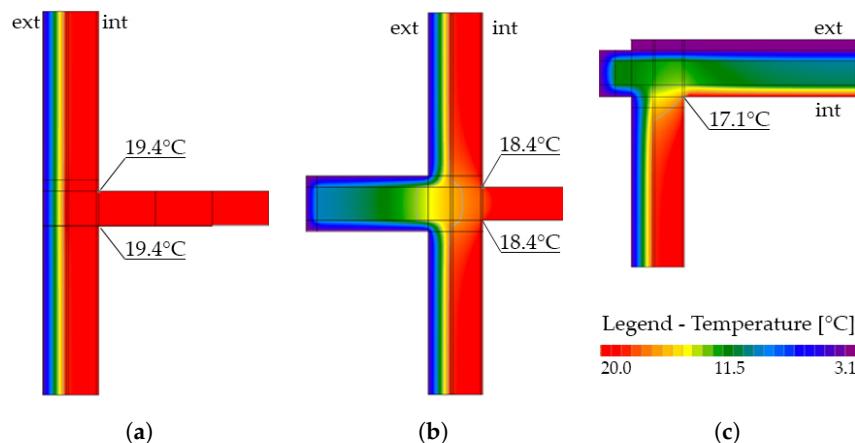
Figure 17. Thermal finite element analysis of junctions after interventions. (a) Floor-to-wall. (b) Balcony-to-wall. (c) Roof-to-wall.

In order to deliver a complete intervention, minimizing cold bridges, the intrados of floor slabs on the ground floor was covered with a low-thickness, high-performance insulating panels (e.g., aerogel); walls of staircases were treated in a similar way. Balconies were insulated from the intrados with rock wool (Figure 17).

The design stratigraphy of the envelope complied with the code requirements with $U = 0.16 \text{ W/m}^2 \text{ K}$ and, in both winter and summer, the superficial temperature on the internal side of the walls was 20°C , i.e., a comfort condition.
