Article

Resistance of ETICS with Fire Barriers to Cyclic Hygrothermal Impact

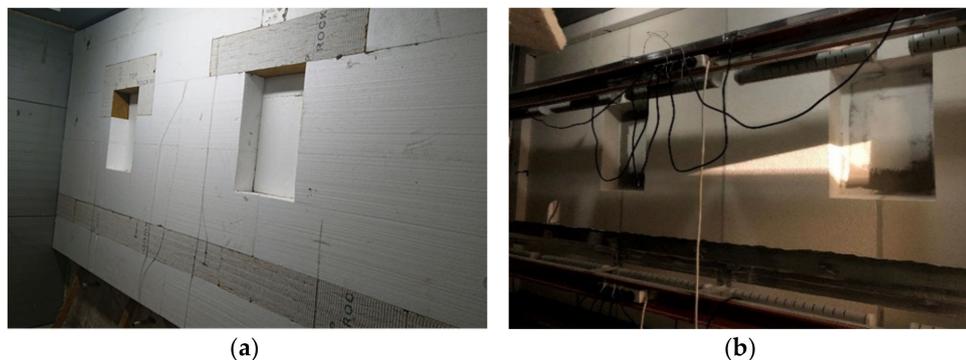
Figure 1. (a) EPS thermal insulation with mineral wool fire barriers; (b) test rig with 4 types of plastering during the test.

A silicate brick wall was constructed (3.0 m wide by 2.2 m high) with installed ETICS panels (Figure 1) in accordance with 5.1.3.2.1 ETAG 004 [19]. Four different types of thermal-insulation systems were applied on the wall, namely, with acrylic, silicate, mineral, and silicone finishing coats (of whitish color). Mineral rendering was painted with silicone paint. The thickness of the basecoat was 3–5 mm. In order to examine the worst-case scenario of ETICS, 1 mm thickness finishing coats were selected except for a 2 mm thickness mineral coat. Thermal-insulation boards were mechanically fixed with plastic anchors (4 pcs./m²) with supplementary adhesive.

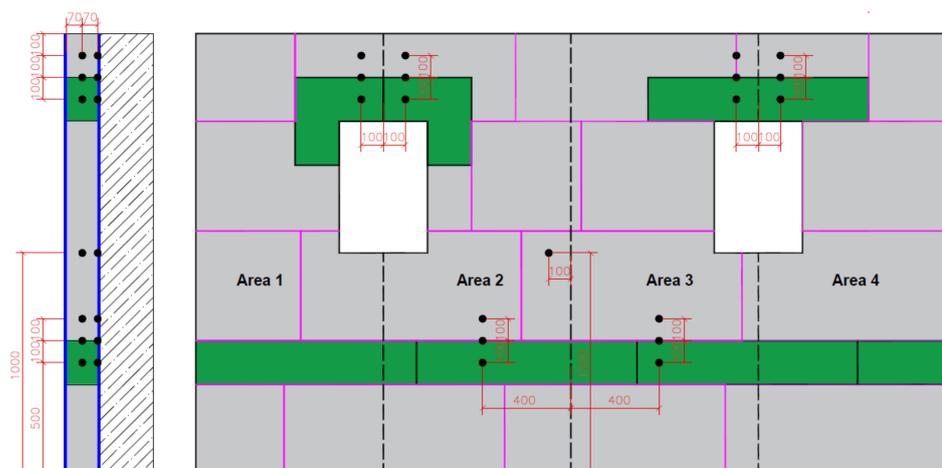
Figure 2. Temperature-sensor placement, cross-section, and elevation (area 1, acrylic render; area 2, silicate render; area 3, mineral render; area 4, silicon render).

In order to follow the temperature in different layers of ETICS and in the junction between EPS and MW, 38 pieces of temperature sensors were installed (see Figure 2). Duplex insulated Omega TT-T-30 T-type thermocouples were used. Measuring ranged from -200 to 350 °C, and accuracy was ± 1.0 °C or $\pm 0.75\%$. Temperature sensors were installed at each of the assumed heights. One was at the junction of the thermal insulation with the structural layer, and the other in the middle of the thermal-insulation thickness. This is depicted in Figure 2. The rig was divided into four vertical areas (dotted lines). Pink lines reflect the EPS boards, and green areas the mineral wool.

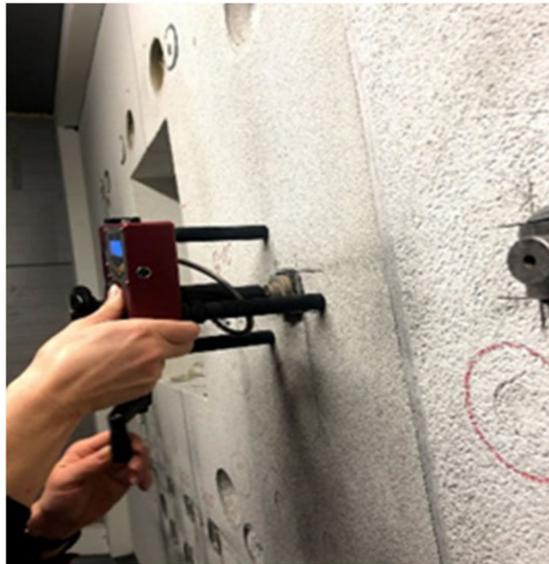
Figure 3. Testing of the bond strength of ETICS.

Furthermore, hard-body impact (as per ETAG 004 5.1.3.2.1 [19]) and bond-strength (as per ETAG 004 5.1.4.1.1 [19]) tests were performed. The test was performed with adhesion tester CONTROLS 58-C0215/T (Figure 3). The plates were pulled at a speed of 1 to 10 mm/min. Individual and average values were recorded and are expressed in MPa. The pull of the test was performed at 18 ± 2 °C at SD = $50 \pm 5\%$.

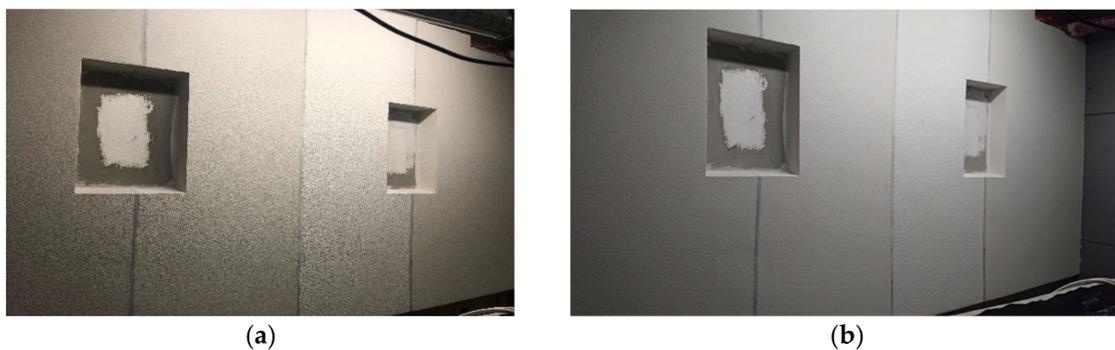
Figure 4. Photo fixation set of the ETICS (a) before and (b) after testing.

Following the conclusion of the heat–rain and heat–cold cycles, on the basis of macroscopic tests, no irregularities were found on all analysed types of thin-layer rendering surfaces. No cracks, scratches, or hairline superficial crevasses of any kind were observed; this implies that the joints of the EPS/MW remained intact, suggesting that there was no water penetration into the insulation layer (Figure 4). Therefore, the above-mentioned ETICS are resistant to hygrothermal cycles neglecting to absence of additional reinforcement mesh over MW fire barriers.

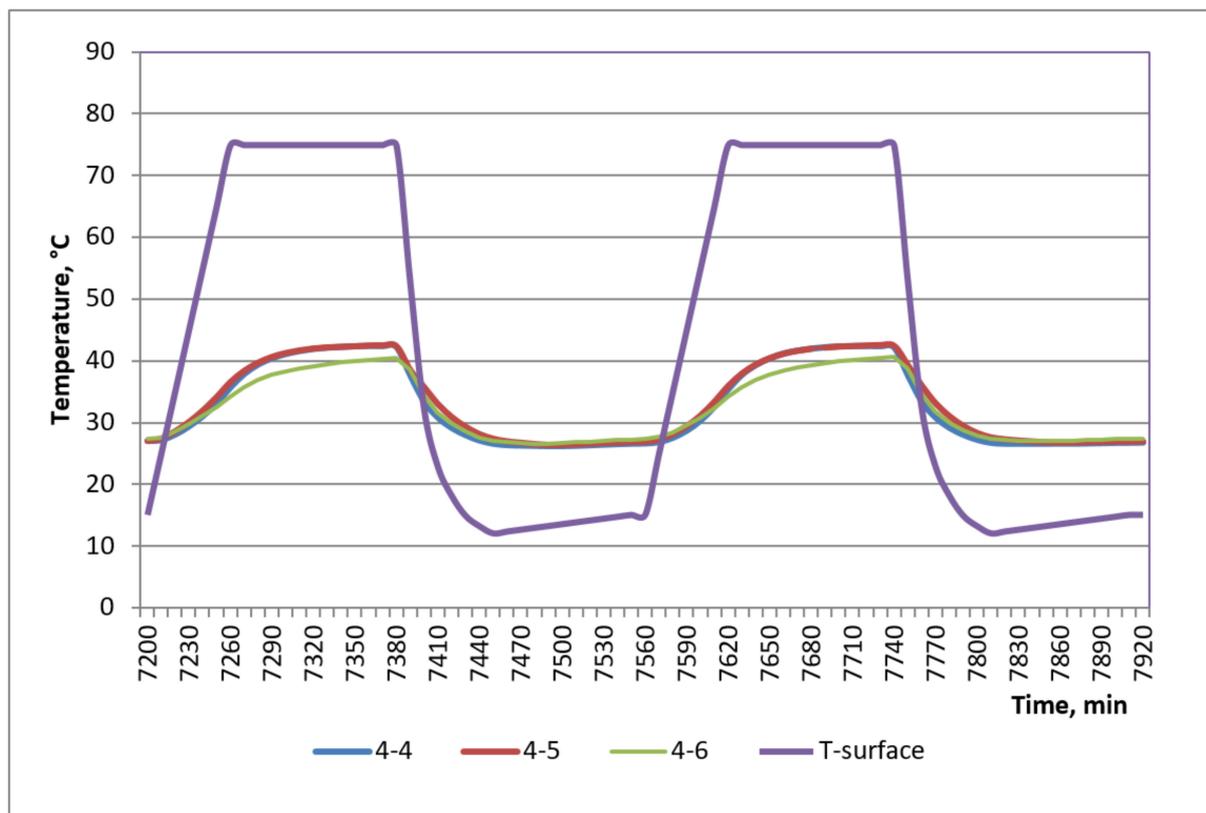
Figure 5. Temperature variation in ETICS fragment layers during hygrothermal cycles: (4-4) temperature in the middle of mineral wool; (4-5) temperature at the junction of mineral wool and polystyrene foam, (4-6) temperature in the middle of polystyrene foam.

the hygrothermal cycle, remained similar, and did not depend on the type of thermal-insulation layer. The typical profile of temperature variations is given in Figure 5 (ETICS no. 2/silicate). The trend of temperature differences at different measuring locations on surface finishes and in the middle of insulating layer are very similar; these had a rectangular plateau-wave shape. The temperature at the masonry base ranged from 26 to 27 °C. The temperature in the middle of the thermal-insulation materials (7–8 cm from the surface) ranged from 26 to 40 and 42.5 °C. Temperature at the junction of EPS/MW had a value closer to that of the temperature in the middle of MW than to that of the temperature in the middle of EPS. The heterogeneity of the material structure can cause local thermal anomalies. Temperature differences on the EPS and base-wall interface, and in the junction of EPS/MW were insignificant and amounted to $\Delta t_{\text{average}} = 0.2$ °C.

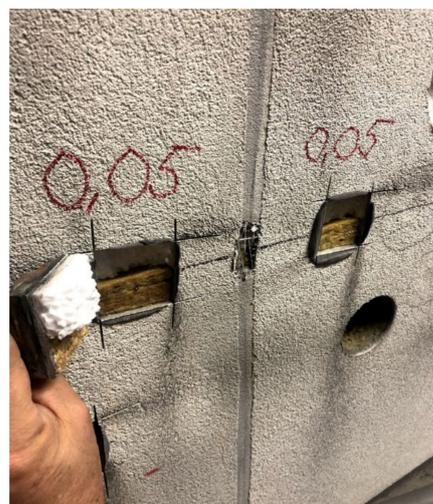
Figure 6. Testing of the bond strength of ETICS: an example of the typical pull-off at the joint of EPS/MW.

After the hygrothermal cycle had ended, the obtained adhesion strength was 0.11 MPa. This was measured at the points where pulling was performed from the polystyrene foam; at the points where pulling was performed from the mineral wool, adhesion strength was 0.1 MPa; when measuring connections between polystyrene foam and mineral wool, such pulling pressure stood at -0.05 MPa (Table 3, Figure 6). Test results showed that the joints of EPS/MW had approximately half the bond strength of that of EPS. This was evident at the intersection of the two substances, polystyrene and mineral wool.

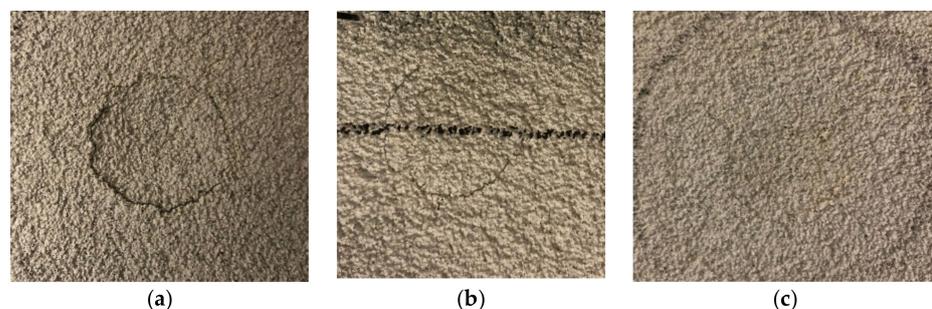
Figure 7. Hard-body impact testing: example of typical hard-body impact on (a) ETICS no. 2: EPS, (b) joint of EPS/MW, (c) MW.

were connected (EPS/MW)—impacted the ETICS samples, caused less damage compared to the impact where only polystyrene foam was used. In the case of ETICS no. 3 (mineral render), damage was greater when the base layer was applied on EPS, and in places where there is mineral wool and at the joints, the damage was smaller or nonexistent. The results of impact-resistance testing are given in Table 4; examples of the typical hard body impact on EPS and on the joint of EPS/MW are shown in Figure 7.
