Resilience of Raw-Earth Technology in the Climate of Middle Europe Based on Analysis of Experimental Building in Pasłęk in Poland

Abstract: The article concerns the experimental building in raw-earth technologies situated in Ecological Park in Pasłęk, in the northeast part of Poland with rather severe climate characteristics for middle and east Europe. The purpose of the designing and realization of the building was to demonstrate the methods of construction in traditional raw-earth technologies with current modifications and then to create the possibility for long-term research and observations at the site visits during the buildings' exploitation. The building was designed as energy efficient with a passive solar system, green roof, and space arrangement. Construction effects of exploitation were checked. Also, physical aspects were analyzed and thermal-humidity environmental parameters were measured with specialized equipment. Examples of such measurements with appropriate conclusion are presented. Based on the analyses, the authors evaluate the resilience of the applied technology under the given climate conditions, as one of the possible sustainability technologies that can b

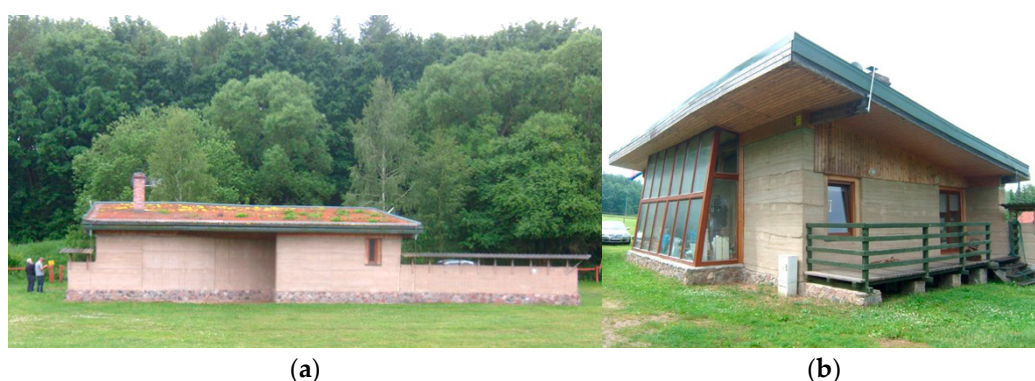
The building is situated in the Ecological Park at the south-east part of a flat green area where outdoor events are organized. It is one-story detached, covered with a single pitched roof building. It has an irregular plan with a longer axis in the east-west direction. Thus, principles of energy-optimal design are achieved: the southern wide elevation has a big, glazed surface, in this case in the form of a fully glazed veranda (green house). The northern wall is practically solid. The main entrance to the building is located on the western side and is connected through the vestibule with the one-spatial didactic and exhibition hall located in the eastern part of the building. This area is connected with an external terrace on the east side of the building and through two glazed doors with a veranda on the south side. A kitchenette and toilet are attached to the main space in the western part. The usable internal space is 75.5 m² and the cubic capacity 250.0 m³ (Figure 1).

Figure 1. View of the building (a) from northern side (b) south-east side.

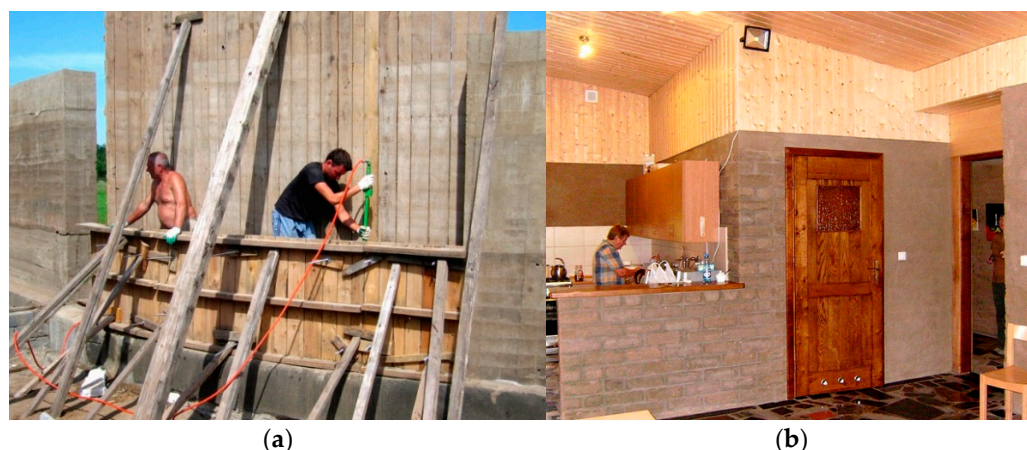
The energy-efficient construction was a leading idea. Rammed earth in the formwork was chosen for the structural and external walls. In order to reduce costs of transport the soil from excavations on the plot was used. Some of the walls have an irregular curved layout to check technological possibility and difficulties of such arrangements and also to enrich the final visual effect. To achieve necessary thermal performances, the external walls were supplemented with additional layers. Traditionally the internal layer has a structural function and thermal additions are on the external side. The external walls were designed and constructed as three-layer partitions but in an experimental way we decided to situate the load-bearing layer outside. It is in the form of rammed earth monolithic walls compacted in formwork using a pneumatic compactor and our task was to check how the exposed earth surface will behave in the severe climate of northern Poland (Figure 2a). An

additional task of such an arrangement was to show the natural surface of the compacted earth wall as an illustration and presentation of an unusual technology. The internal layer of the external wall was made of clay and straw compacted mass blocks. They are finished with earth plaster to regulate the humidity of the interior and partly with a natural surface impregnated with varnish in order to stop the material from chipping (Figure 2b). The space between the structural external layer and the internal blocks is filled with thermal insulation material—here mineral wool [10].

Figure 2. Building under construction and completed: (a) Compacting of raw earth mixture with pneumatic compactor in wooden formwork (b) Internal walls: pressed earth blocks with no finish (left side). Clay and straw compacted mass blocks finished with earth plaster (right side of door) and with natural finish (right side).

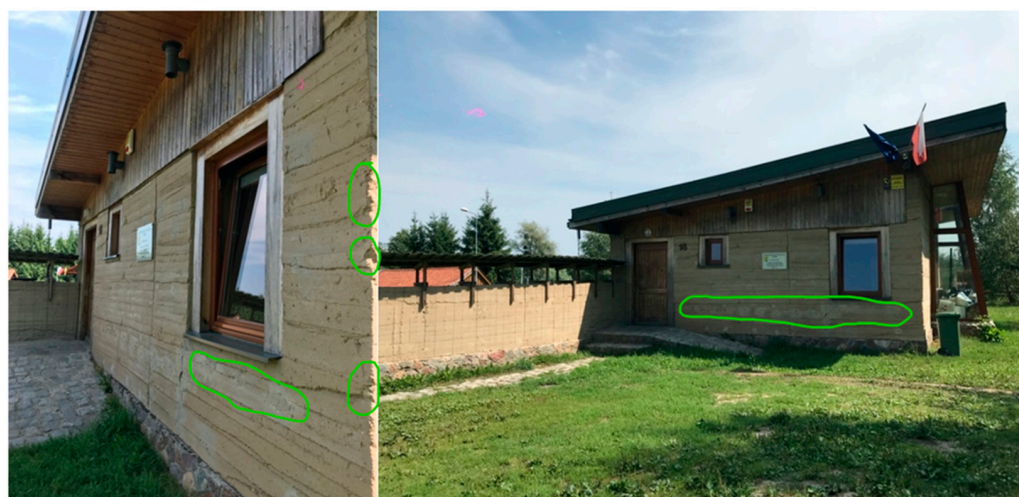
During the architectural and technical site visit, observations of the resilience of raw-earth technology to the climate conditions were conducted. The biggest danger for this technology is water. Observations are shown on the photos for each elevation with visible defects on the wall after tie bars were used during wall construction, after raining water in the plinth zone and defects on some corners (Figures 12–15).

Figure 12. View on the western elevation with visible points after tie bars were used during wall construction and defects in the corner of the wall. Photos taken during architectural and technical site visit on 1 August 2018.

Durability of raw-earth technology is enough to conclude that this technology can be used in the climate of middle Europe under some conditions. Architects should design eaves to protect external walls against the raining water. Also, in all zones connected

with the flat, external surfaces (landings, flights of stairs) or the ground should be made using plinth made from materials that allow the raining water to drain, e.g., stone. The esthetic view after 6 years of usability is very good. The texture of the raw-earth is very well-maintained. Drawings after formwork and differences due to other technologies are clearly visible also after the period. Architects and investors should remember that some points after tie bars were used during wall construction could be visible on some sites. Interior walls made in raw-earth technology do not have any defects.

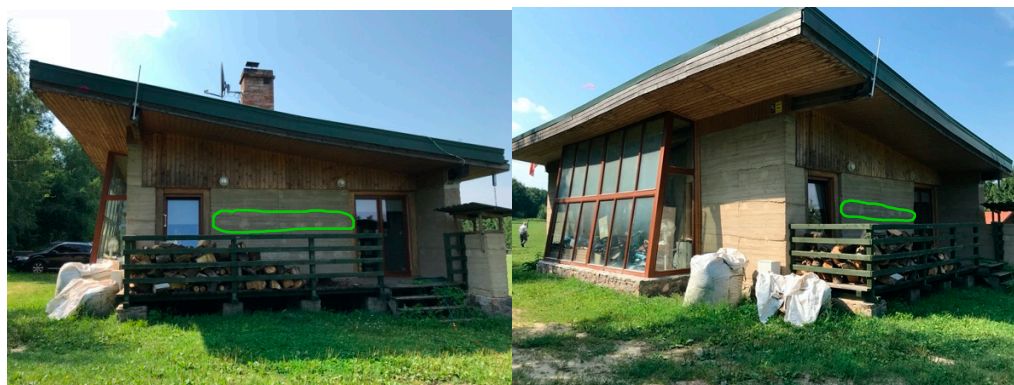
Figure 13. View on the eastern elevation with visible points after tie were bars used during wall construction. Photos taken during architectural and technical site visit on 1 August 2018.

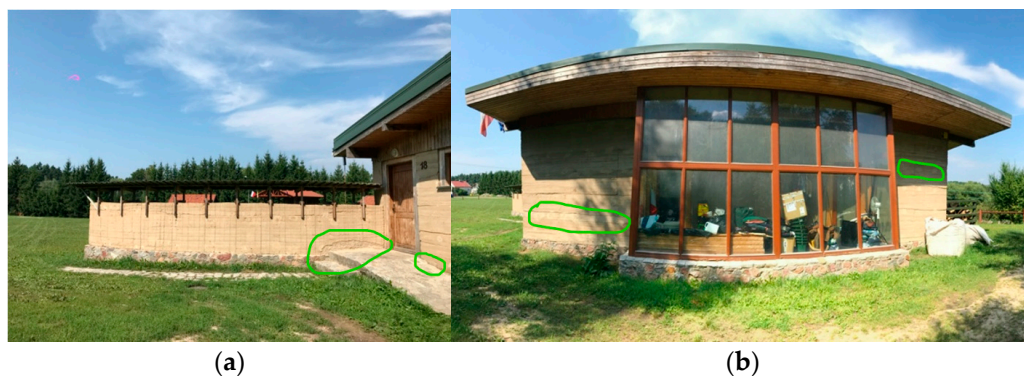
Figure 14. View on the south elevation (a) with visible defects on the screen wall in the plinth zone near landing and flight of stairs. (b) On south elevation points after tie bars were used during wall construction are visible near veranda. Photos taken during architectural and technical site visit on 1 August 2018.

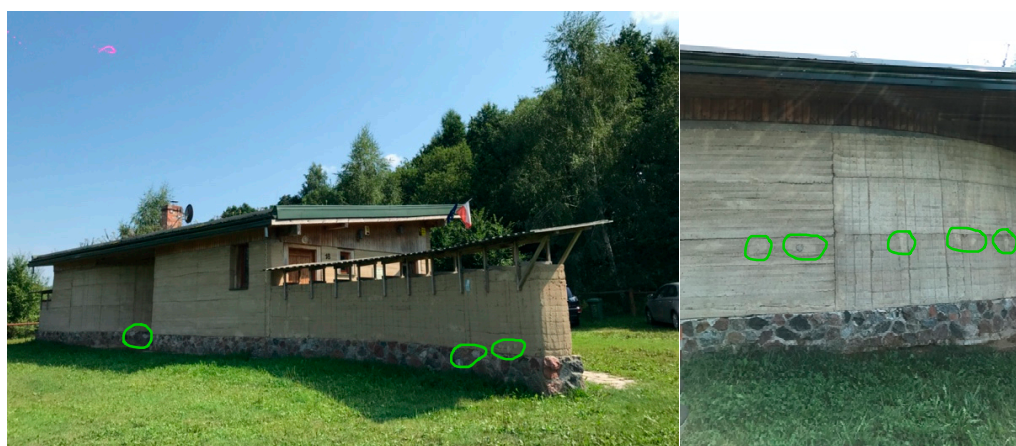
Figure 15. View on the north elevation with visible defects in the stone plinth zone and visible points after the tie bars were used during construction. Photos taken during architectural and technical site visit on 1 August 2018.

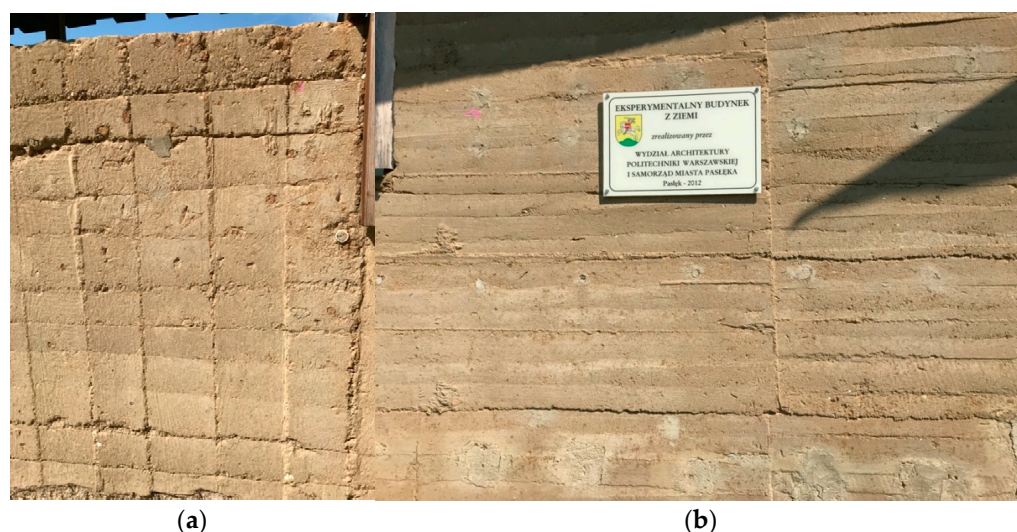
The texture of the walls built using different technologies are still clearly visible (Figure 17).

Figure 17. Texture of the external walls built with raw-earth technology (a) screen wall built from raw and straw blocks (b) external wall built as rammed earth in formwork. Photos taken during architectural and technical site visit on 1 August 2018.
