Article

Analysis of Roof Collapse Cases Caused by Snow Loads in Russia (2001–2021)

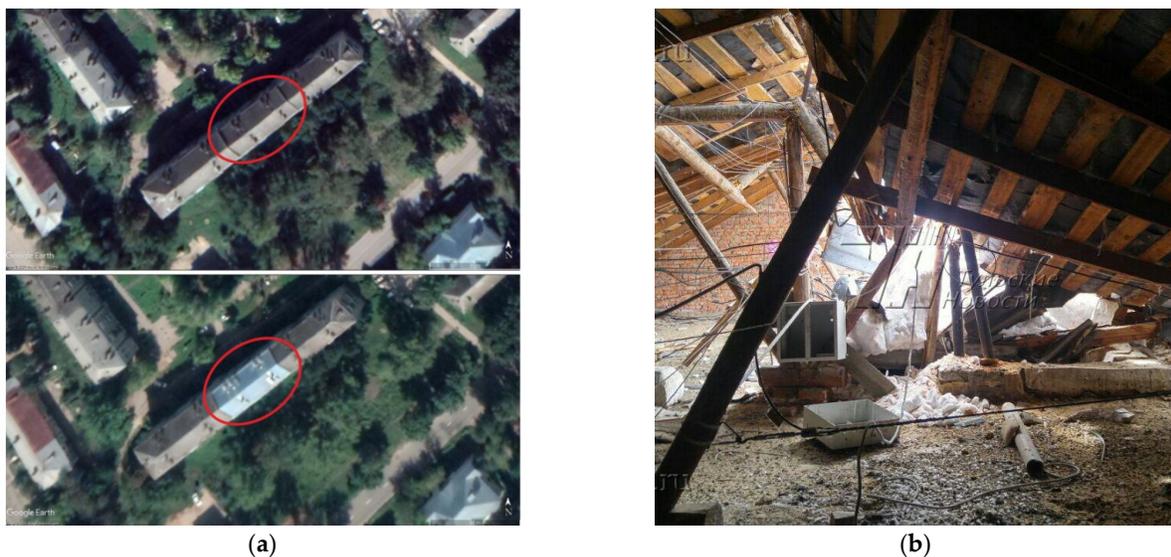
Figure 1. Partial roof collapse of a residential apartment building (15/2 Rihard Sorge Str., Tula) on 23 March 2018: (a) Google snapshot before the collapse on 15 September 2017 (**top**); snapshot after the collapse and a partial repair of the damaged roof on 24 August 2019 (**bottom**). The snapshot dated 12 October 2018 has worse quality. The affected part is outlined. (b) General view of the destruction. Photo from the site of IA Tula News (https://newstula.ru/fn_349771.html (accessed on: 24 August 2021)).

The collected collapse data were analyzed according to the following characteristics: collapse date, collapse location (region of Russia), building type, roof shape, roofing material, collapse area, and number of floors (Table 1). The collapse area, when specifying the address of the building location, was checked with Google Images, and it was possible to decode the collapse location via changes in the color and type of coating on the images of different periods (Figure 1).

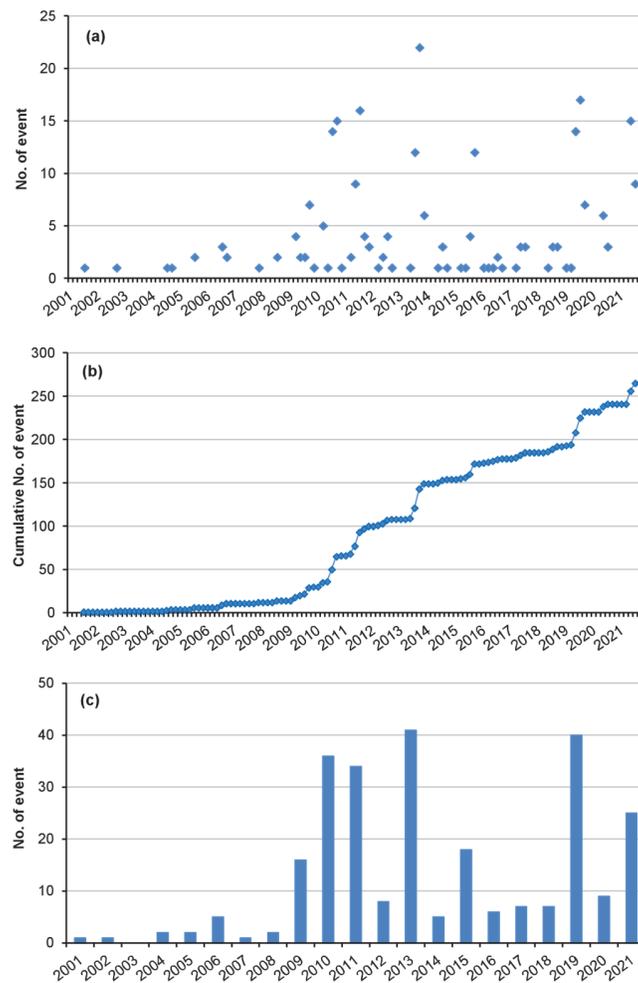
Figure 2. (a) Monthly (November–April) distribution of the cases of roof collapse under snow loads in Russia between 2001 and 2021. (b) Cumulative number of roof collapse. (c) Number of cases by year.

From 2001 to 2021, 266 roof collapses caused by snow loads occurred in Russia. The distribution of the number of cases is shown in Figure 2. Data on 14 collapses only were found for the period from 2001 to 2008, and no data were found in 2003, i.e., 95% of all analyzed cases occurred after 2008. The increase in the number of cases after 2008 could be associated with the increase in the number of Internet users in Russia and the development of social networks and blogs, which have become a new source of information for official news agencies. As a result, information on not only catastrophic cases in the large cities of Russia but also data on small collapses from districts remote from the administrative centers began to appear.

The largest number of collapse cases occurred in 2013 (15.4% of the total number of cases), followed by 15% cases that occurred in 2019. On average, 13.3 cases of roof collapse caused by snow loads occurred in Russia per year. Most of the buildings affected were civil, with a predominance of residential buildings in both years.

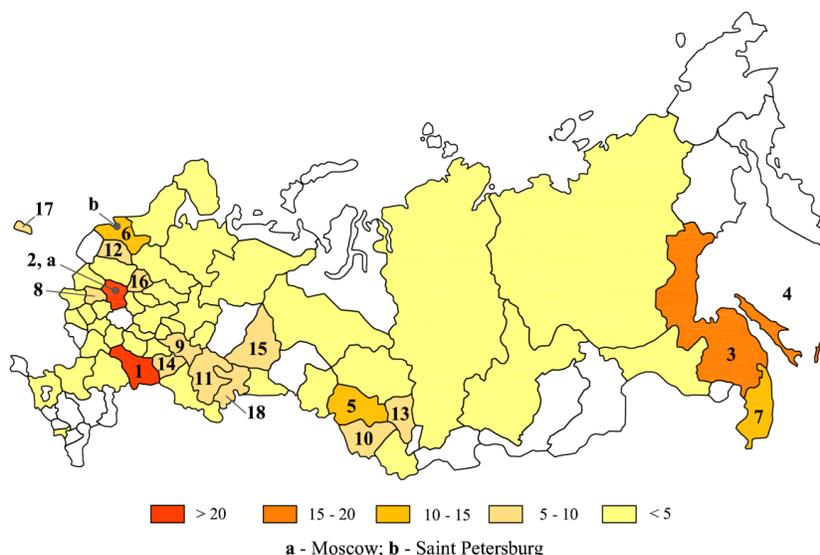
Figure 3. Distribution of collapse cases number over the territory of Russia.

The geography of the collapses included 58 out of 85 regions of Russia (including the federal cities of Moscow and St. Petersburg). Figure 3 shows the ranking of Russian regions by the number of roof collapse cases caused by snow loads over the past 20 years. The intensity of color increases with the number of collapses. The numbers in Figure 3 show the regions where five or more collapses occurred. The number of cases is given in the Table 2. Regions with fewer than five collapses are also listed in the Table 2 without designation in Figure 3. The territories of the regions with no collapse data for the period under consideration remained empty.

The main number of collapses occurred in the Saratov and Moscow regions (including Moscow), with approximately 17% of the total number of cases (Figure 3). The regions

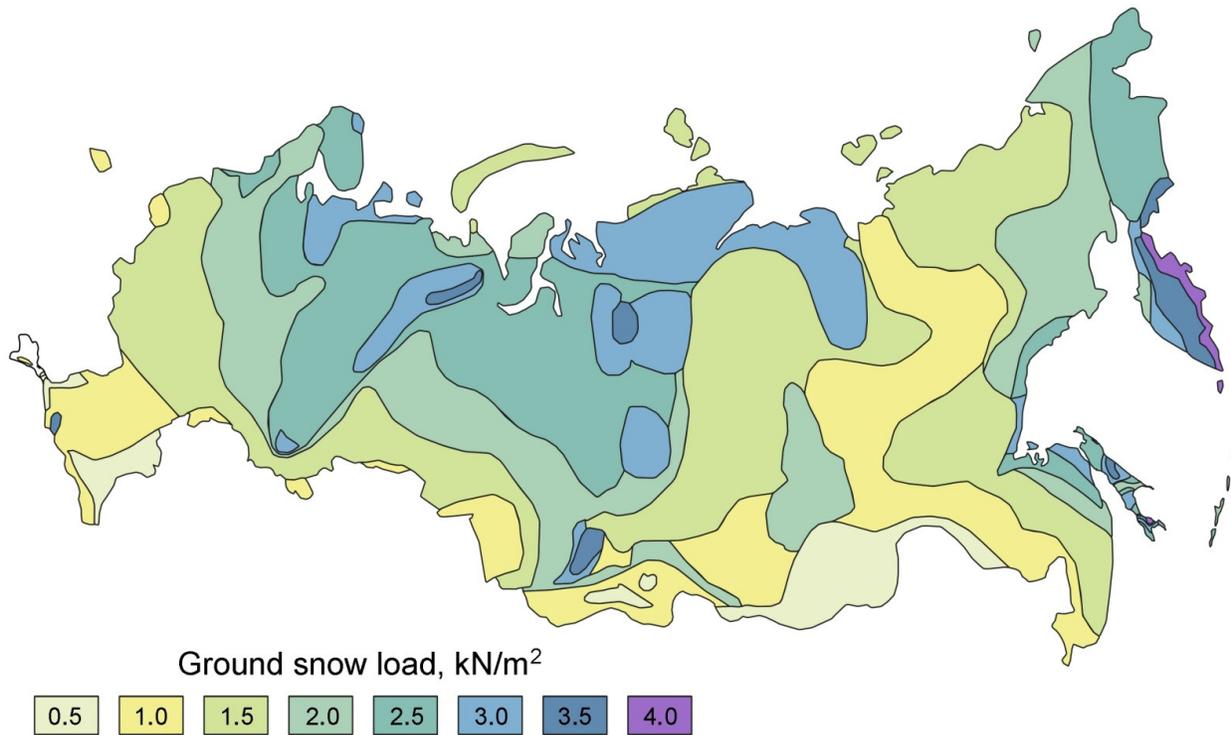
Figure 4. Distribution of the snow loads on the ground in Russia [13].

Figure 4 shows the distribution of snow loads on the ground in Russia, indicating the danger faced by the affected regions. The official edition can be found in [13].

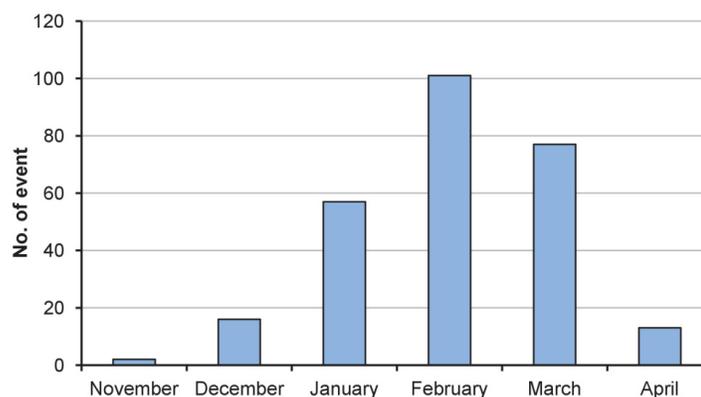
Figure 5. The period of excessive snow load formation with the distribution of the number of cases of collapse by month.

Roof collapses under the influence of snow loads were noted from November to April; this period corresponds to the average dates of snowfall formation over the territory of Russia. Appendix A (Figure A1) contains the monthly average precipitation values related to the studied period of the year when the collapses occurred, according to the site data [16]. The distribution of cases of collapse during winter is shown in Figure 5.

The period of excessive snow load formation coincided with the calendar winter period and lasted from November to April. Moreover, the most dangerous months were February and March. During these months, the largest SWEs were observed across most parts of Russia. The overwhelming number of roof collapses (38%) occurred in February (Figure 5).

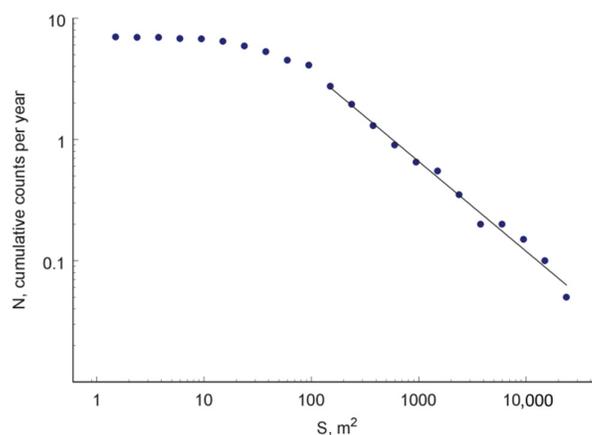
A frequency graph was constructed based on the available collapse area data (Figure 6), apparently resembling the well-known Gutenberg–Richter magnitude–frequency relation [23], which is actively used in assessing the frequency of earthquakes (e.g., [24]). The observed graph curvature from a collapse area ≤ 150 m² is most likely due to missing data. We assume that collapses with an area of ≤ 150 m² occur much more often; however, data on these cases do not always appear in open publications, so it is impossible to take them into account. The frequency of collapses with an area >150 m² has a linear relationship of the form:

$$\lg N(\geq S) = (-0.74 \pm 0.2) \times \lg S + (2.04 \pm 0.2), \quad (1)$$

where S is the collapse area and N is the cumulative number of cases.

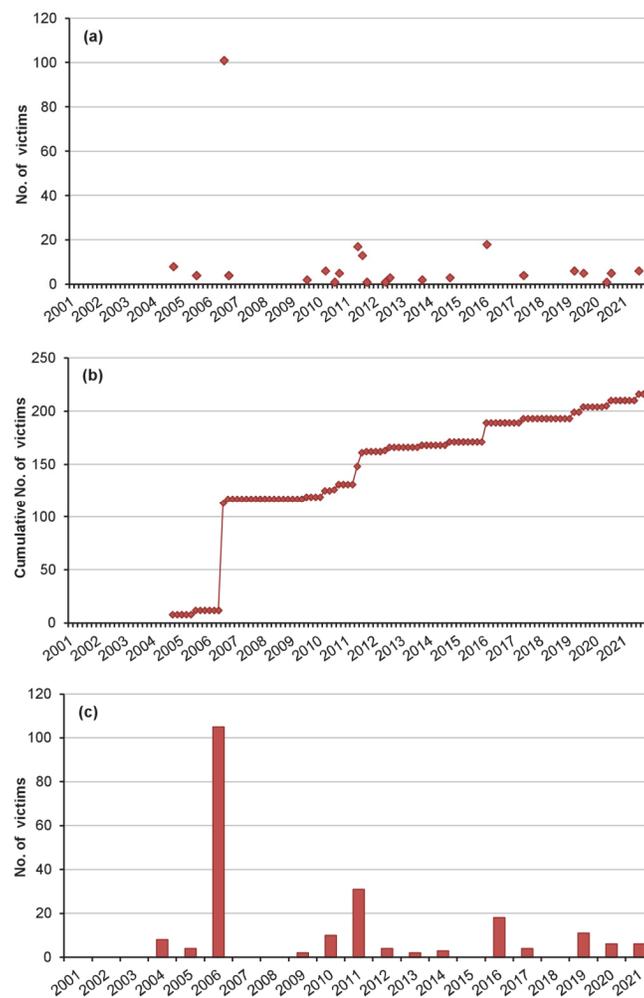
Figure 7. (a) Monthly (November–April) number of victims (injured and fatalities) from roof collapses caused by snow loads in Russia between 2001 and 2021. (b) Total number of victims. (c) Number of victims by year.

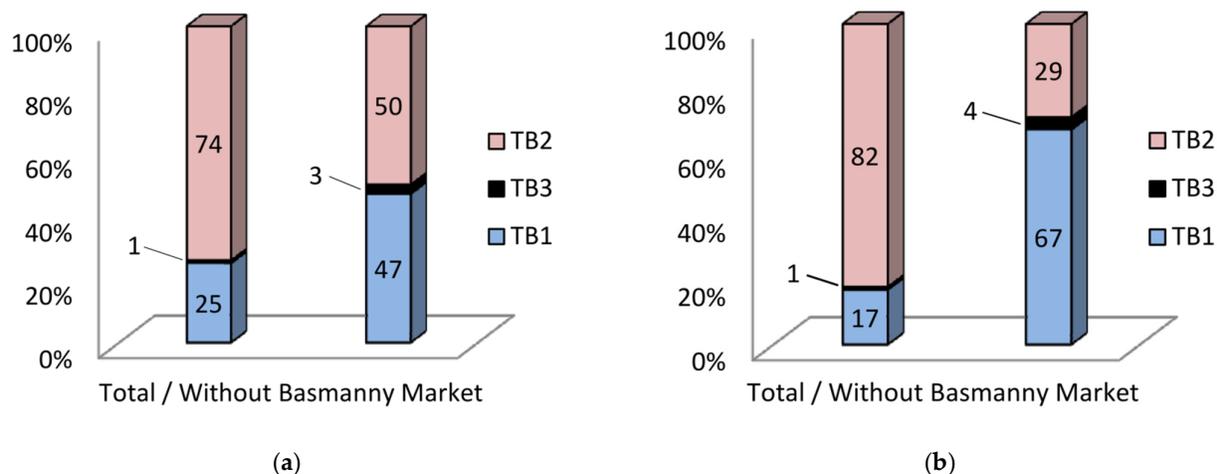
Figure 8. Percentage of victims (a) and fatalities (b) depending on the type of building.

By analyzing all of the victims (Figure 8a), it can be noticed that the majority were harmed by the collapse of civil buildings (74%). If we exclude from consideration the emergency in Basmanny market (Figure 8a), as the only case in the sample with more than 100 people injured, then the distribution of victims between the collapse of civil (50%) and industrial (47%) buildings is almost equal, despite the fact that the number of cases of collapse of civilian buildings is significantly higher than industrial buildings (208 vs. 40). In cases with fatalities (Figure 8b), a strong influence of a single event was also seen; when excluded, it turns out that the largest number of deaths occurred when industrial buildings collapsed (67%). The high mortality rate in industrial buildings can be explained by the fact that, unlike civilian buildings, they do not have an upper technical floor and the roof falls not on the beams of the technical floor, but directly into the working area where the people are.

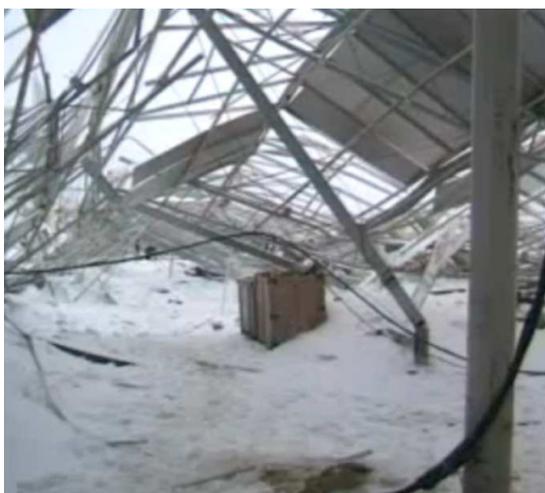
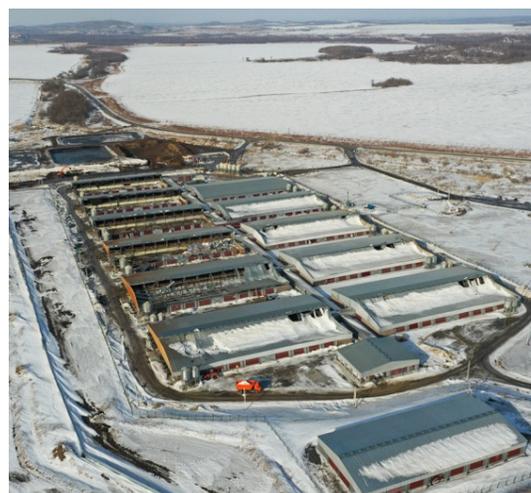
Figure 9. Consequences of the destructive impact of snow load: (a) An agricultural enterprise for growing roses, 2010. Photo from the site of Renzainform (https://www.penzainform.ru/news/incidents/2010/02/02/penzenskaya_oblast_poteryala_150_millionov.html (accessed on: 18 June 2021)). (b) The Mikhailovskoye pig farm, 2021. Photo from the VL News website (<https://www.newsavl.ru/society/2021/03/05/197518/> (accessed on: 11 March 2021)).

The largest building in terms of area, destroyed under the impact of snow loads over the past twenty years in Russia, is the greenhouse of an agricultural enterprise for growing roses (Figure 9a), located in the village of Mokshan (Penza region). A collapse with a total area of 30,000 m² (two greenhouses of 20,000 and 10,000 m² each) occurred on 01 February 2010. In addition to the partial destruction of the greenhouse itself, the specialized equipment and boiler room of the enterprise were damaged. The work covered an area of 75,000 m². The damage to the enterprise amounted to 4.9 million dollars (at the rate of exchange of 2010).

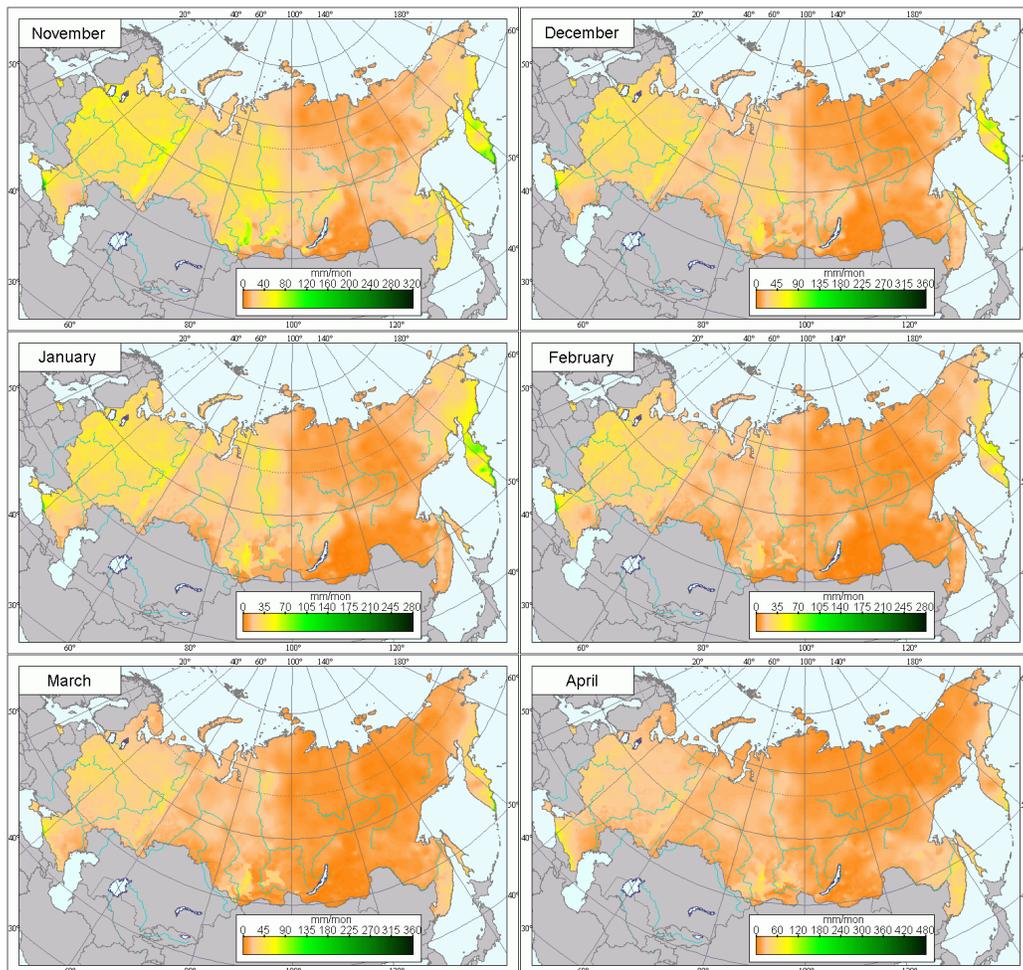
Figure A1. The monthly average precipitation values related to the studied period of the year, according to the data [16]. (The archives of meteorological data can be found in [17].).
