# Durable Steel-Reinforced Concrete Structures for Marine Environments

Robert E. Melchers

**Citation:** Melchers, R.E.; Chaves, I.A. Durable Steel-Reinforced Concrete Structures for Marine Environments. *Sustainability* **2021**, *13*, 13695. <https://doi.org/10.3390/su132413695>

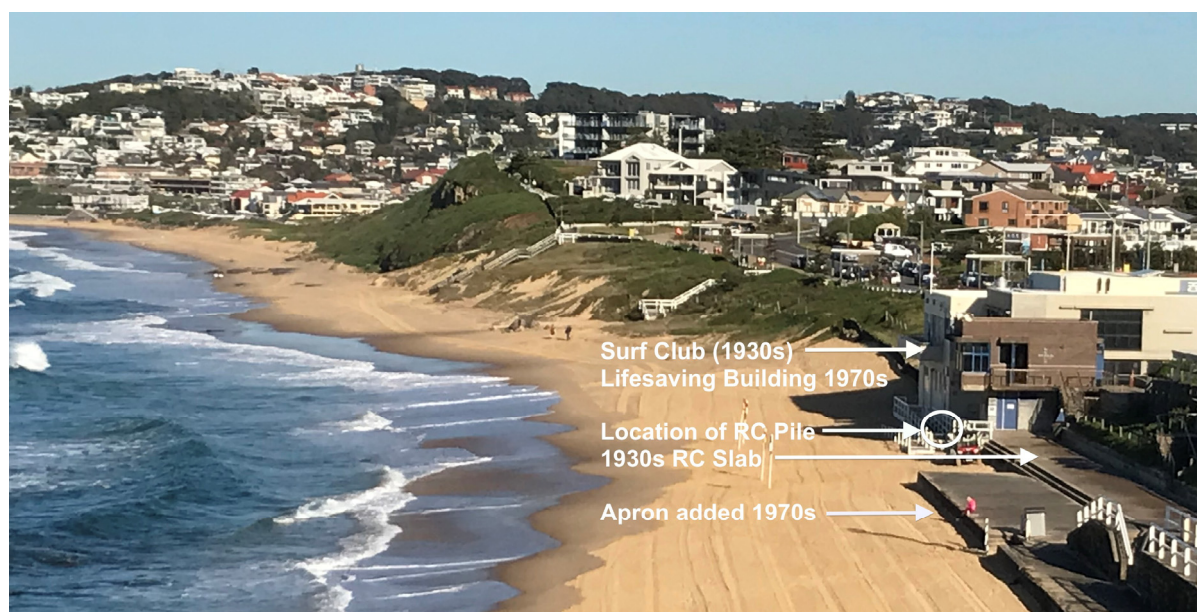
**Figure 2.** Location (circled) of the reinforced concrete pier observed during 1987–2017, relative to the Pacific Ocean (at left) and the RC slab it has supported since about 1930. The bitumen and stone apron was added after the severe storm of 1974 (see text).

The structural system consists of a number of cast-in-situ reinforced concrete piers along the upper part of the beach along Pacific Ocean at Bar Beach (NSW, Australia) supporting a 200 mm thick RC slab (Figure 2) with a 40–50 mm concrete cover (top and bottom) to the reinforcement and located some 1–2 m above the beach sand. The site is about 5 km south of Newcastle harbor and subject to occasional very intense storm conditions. An example of this in May 1974 can be seen by comparing Figure 2 to a historic photograph (<https://i0.wp.com/lostnewcastle.com.au/wp-content/uploads/2013/05/bar-beach-may-74-jeffrey-fergusson.jpg?ssl=1>; last accessed 28 June 2021). This online photograph also shows the original 1930s pavilion in reinforced concrete construction, considered outdated and demolished in the mid-1980s and replaced with the current, more modest constructions (Figure 2). Local surfers who had surfed at the beach for decades (i.e., since their pre-teenage years and then known colloquially as ‘grommets’) noted that, as best they could recall, there had been no renovation or maintenance of the piers or of the concrete slab at any time. Although the local council archives hold a few photographs of the original area around the pavilion, no records, such as maintenance records, could be located.

The concrete slab (Figure 2), when viewed from above, showed little or no evidence of surface cracking (other than some hairline temperature and shrinkage cracks) or of reinforcement corrosion. However, the underside of the slab, where it could be inspected during low tide and when much of the sand had been washed away by storm conditions, showed, along the ocean-side edge region, a quite different state of affairs (Figure 5). There was much loss of under-slab concrete cover to the reinforcement, evidence of voids, typically around 6 mm in size, in the remaining concrete, including around the reinforcement bars. Exposed reinforcement showed clear evidence of corrosion and corrosion products. As for the pier, over the 30 years of observation the degree of deterioration of the slab did not appear to change to any noticeable degree.

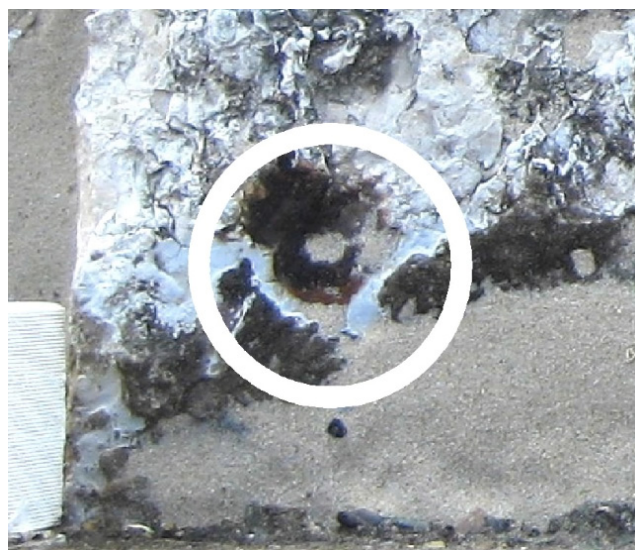
**Figure 4.** Detail (in 2013) of typical end of exposed vertical reinforcement bar (32 mm dia.) showing severe corrosion all around the periphery.

At least from about 1987, and probably from much earlier, at the top of the RC pier (Figures 3 and 4), the ends of the vertical reinforcement bars were not protected with cover concrete. The ends were exposed directly to the local high-chloride marine atmosphere and, as noted, often covered with (chloride-rich) beach sand and also periodically wet from sea-spray and occasionally from extreme high tide and storm waters and wet from rain. This is an aggressive environment and makes the pattern of corrosion (Figure 4) particularly interesting. It very clearly is not more or less uniform corrosion over the ends of the bars. Rather, all the bars show, to varying degrees, a truncated conical pattern of corrosion, with most metal loss at the outer periphery and least metal loss at the center of the bars. This pattern almost certainly is the result of corrosion, despite the lack of evidence of rust staining.

The corrosion pattern in Figures 3 and 4 has been seen before. It was observed at the intersection of a deep, fine (hairline) crack intersecting the reinforcement for 80-year-old, void-free, highly impermeable, high-strength concrete columns exposed in warmer temperature Pacific Ocean seawater [23]. That corrosion was attributed eventually to the aggressive action of ferrous chloride, the only marine corrosion product that is highly soluble in water and that has a low solution pH. It can form only under very low oxygen and anoxic conditions [24]. Each of the reinforcement bars that outcrop at the concrete surface would have been subject to ‘differential aeration’ [25] around the periphery of the bar where it meets the concrete. It is a phenomenon often noted at sealed edges around a steel element or for sealants around the circumference of a steel pipe [26]. Similarly, for the steel bar surrounded by concrete, likely at elevated pH, at least in the earlier stages, a ring of more severe corrosion can be expected (Figure 8). Under initial corrosion conditions, the cathode is in the central zone of the end of the bar and, thus, not subject to significant corrosion. As the corrosion increases around the peripheral zone, the central zone remains the cathode, although as corrosion increases, the cathodic corrosion process moves from oxygen reduction in Mode 1 to the cathodic hydrogen evolution reaction in Mode 2 (Figure 1). Any rust depositing on the cathodic region initially will be weak and easily eroded by occasional, discontinuous atmospheric wind and seawater wave action. The relatively severe corrosion in the periphery region (Figure 8 right) occurs under essentially anaerobic conditions. Further, the presence of chlorides from the external environment, together with the pitting involved, allows generation of soluble ferrous chloride [18]. This can leach out and, under the action of seawater and rainfall, wash away, leaving little or no trace. Similar scenarios have been reported for deep cracks in concrete columns and beams that, after many years of exposure in wet chloride-rich marine conditions, leave reinforcement corrosion loss patterns very similar to that in Figure 4 [12,24].

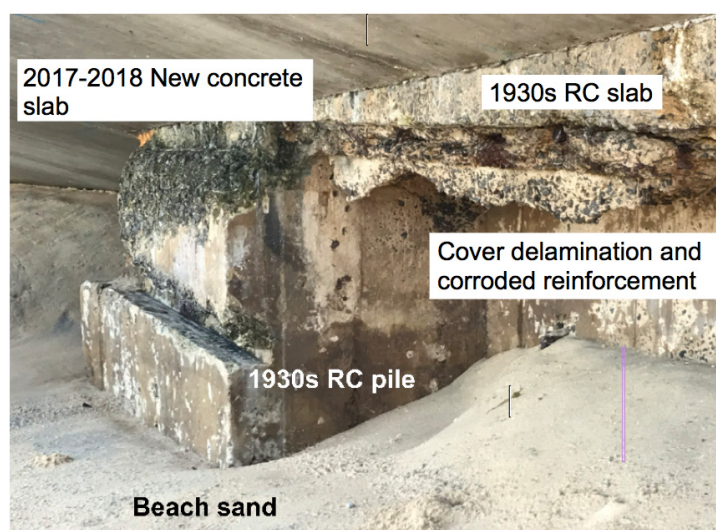
**Figure 5.** Example of a typical RC pier located at the edge of the 1930 slab in Figure 2, showing lack of concrete cracking and no evidence of reinforcement corrosion (in 2021). Note the typical recess around the pier (about 100 mm deep and 80–100 mm high). For the concrete slab (at top center right) there is clear evidence of significant loss of concrete cover, poor concrete compaction and of reinforcement corrosion. The new concrete slab at top left and the support structure at the far left were added in 2017–2018.

The condition of the pier and the slab was examined irregularly over some 30 years from 1987 to 2017. Throughout that period, remarkably little changed in the visual appearance of the pier and of the concrete slab, including the part of its underside exposed on the occasions when beach sand had been washed away. For the pier, there was no evidence of concrete cracking, concrete spalling or visual evidence of corrosion products, despite the obviously high-chloride environment and the relatively high mean annual rainfall (1020 mm/year). This was also the case for other, similar piers located at the edge and also directly exposed to the atmosphere until 2017–2018, when there were significant construction works during which an additional RC slab with support structure was added (Figure 5).

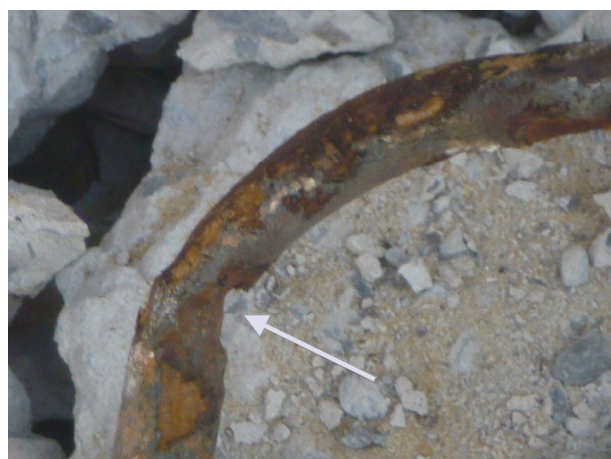
**Figure 7.** Very localized corrosion (at white arrow) in the curved section of the horizontal hoop steel reinforcement (16 mm dia.) at the location of the corners of the piers, as observed during demolition in 2017.

is entirely consistent with recent laboratory observations for 14-year-old concretes that showed only minor amounts of rust on the reinforcement bars despite very high chloride concentrations. However, the localized corrosion seen in Figure 7 is consistent with the occurrence of very localized, severe corrosion at air-voids in the concrete immediately adjacent to the steel [17]. In the case of Figure 7, such air-voids almost certainly were present at the intersection between the hoop and the longitudinal reinforcement. The aggregate was seen to be slightly green in color, typical for crushed blast furnace slag, a waste product material from the (then) local iron and steel mills. It was at one time widely used as a coarse aggregate for concretes. It is a product known to be hard and brittle and high in calcium carbonate content. Over the 30 years of observation, the condition of the pier did not appear to change to any noticeable degree.

The only exception to this generally favorable situation was the hoop reinforcement in the pier (Figure 3) that showed, during demolition, highly localized corrosion in the bend region (Figure 7), where it had been in contact with vertical reinforcement. As noted, it is likely that concrete compaction in this small region was not sufficient to completely eliminate one or more local air-voids. Their presence would have permitted highly localized pitting and differential aeration of the steels but only under chloride-rich conditions. Consistent with laboratory observations [17], this undoubtedly is the reason for the observed deep, localized corrosion. Similarly, along the bottom of the slab, the concrete visible after the loss of the concrete cover showed clear evidence of the presence of larger air-voids, undoubtedly due to poor concrete compaction along the bottom of the bars. For beams and slabs, this is common problem in practice (e.g., [22]).
