# Empirical Study on Weather Resistance of White Artificial Stones in Subtropical Island Climate

**Citation:** Chiu, Y.-C.; Chen, P.-H.; Liao, W.-C. Empirical Study on Weather Resistance of White Artificial Stones in Subtropical Island Climate. *Sustainability* **2021**, *13*, 1509. <https://doi.org/10.3390/su13031509>

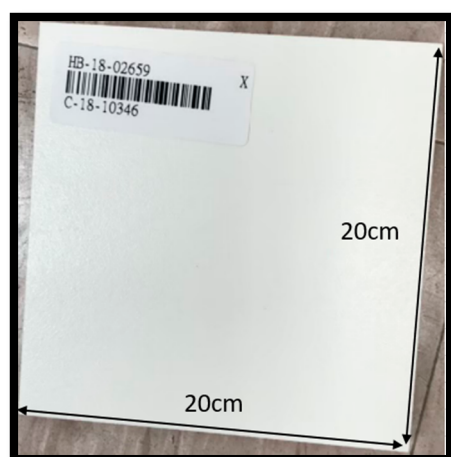
Figure 2. The Spanish artificial stone sample.

Composition analysis was conducted on a Spanish white artificial stone sample of 20 cm × 20 cm (Figure 2). From the test results, the elements of the Spanish artificial stone are calcium (Ca), magnesium (Mg), aluminum (Al), boron (B), barium (Ba), iron (Fe), potassium (K), sodium (Na), phosphorus (P), silicon (Si), strontium (Sr), zinc (Zn), and zirconium (Zr) (Table 1, Figure 3). The composition of zircon is the highest, accounting for approximately 10%.

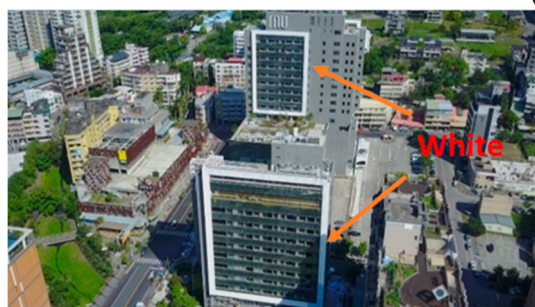
**Figure 4.** Mu Jiao Xi Hotel in Yilan. Both buildings use Spanish artificial stones as decorative materials: (a) white, (b) white, and (c) black.

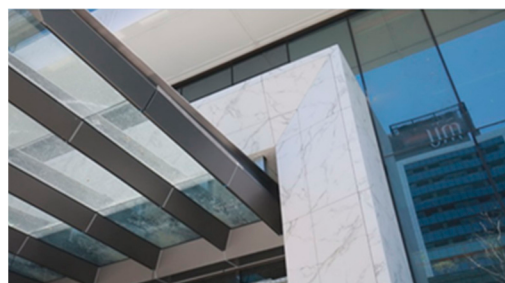
**Figure 5.** Photos of the completed building façade with white artificial stone showing no observed color changes: (a,b).

The exterior wall project for Mu Jiao Xi Hotel was completed in February 2018. As of September 2020, no color change has yet been observed (Figure 5a,b and Figure 6). In addition to the confirmation of weather resistance obtained by the laboratory indoor weather resistance test, this shows that the artificial stone of an exterior wall shows no changes after two years of outdoor exposure. The paper proposed a new protective coating for use on building stone materials that can prevent the stone from changing color and improve the hydrophobicity [39]. Therefore, in this study, an oily stone material protective agent was used on the black artificial stone. Over time, interactions between the coating and the surrounding environment generated a matte surface on the stone materials, and dirt and stains due to weathering were observed (Figure 7). Therefore, it is not advisable to add a stone material protective agent to Spanish artificial stones that already possess natural compositions and weather resistance. Under typical conditions, Spanish artificial stones display sufficient weather resistance.

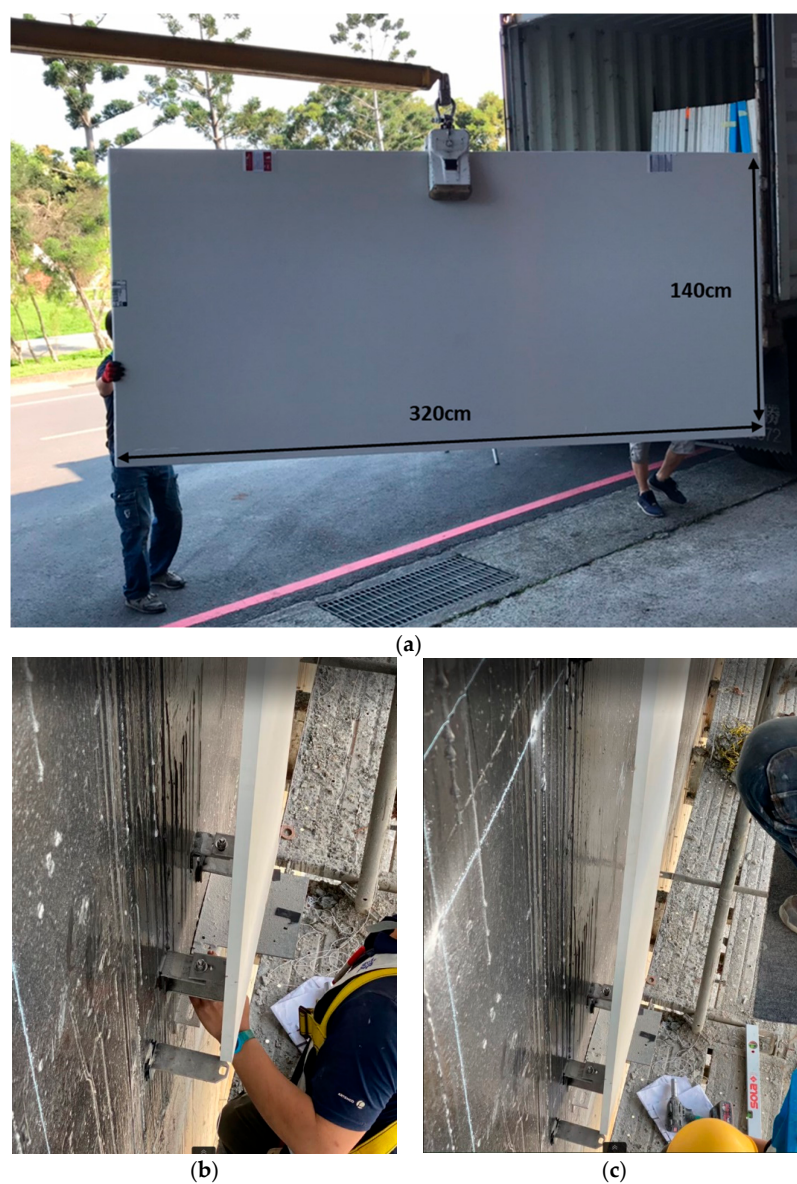
**Figure 8.** Photos of construction on 14 February 2020: (a) moving, (b) installing, and (c) installed.

The second case is the Culture, Leisure and Social Education Center for Taipei City, located next to the Miramar Shopping Center in Taipei. It has eight floors above ground and four levels of basements, with a building area of 18,996 m<sup>2</sup>. It can accommodate 2300 people and includes bookstores, offices, wedding halls, multi-functional assembly halls, and dormitories. White Spanish artificial stone pieces of size 320 cm × 140 cm were cut into various sizes for use, as shown in Figure 8.

The installation of stone material in the exterior wall was completed on 14 February 2020, as shown in Figure 8. On 15 September 2020, it underwent various inspections, including measuring widths of seams between segments and the flatness of the cuts, and finally a waterproofing test on the exterior wall. The building at the time is shown in Figure 9.

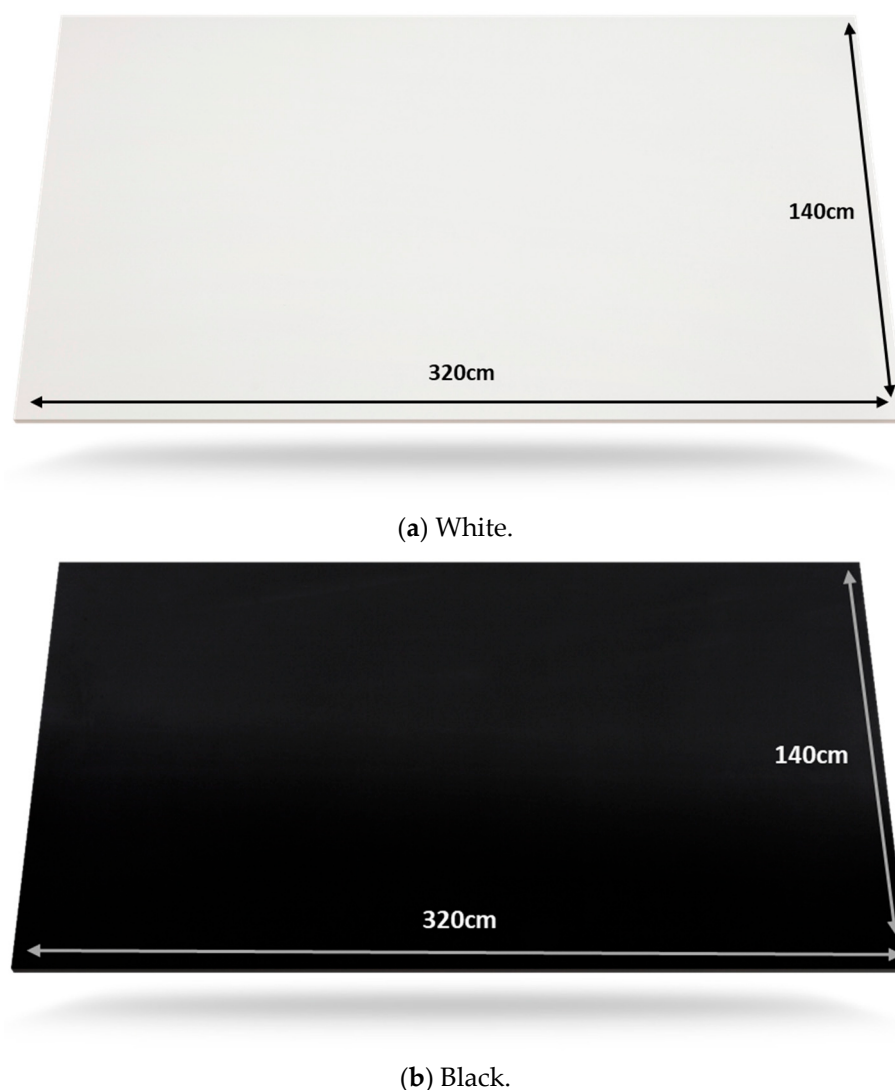
**Figure 12.** Spanish artificial stones (a) white, (b) black used in this study.

A series of tests on the original Spanish artificial stones were conducted by the manufacturer in a weathering chamber using a xenon arc lamp to test the stability of the ultra-compact surfaces against UV light. Both the white (Figure 12a) and black (Figure 12b) artificial stones were tested as they represent the full range of colors and they were expected to be the most sensitive to the experimental conditions.
