Article

Stability of Treatment from Earth-Based Mortar in Conservation of Stone Structures in Tanais, Russia

Ewa Sobczyńska *, Wojciech Terlikowski and Martyna Gregoriou-Szczepaniak

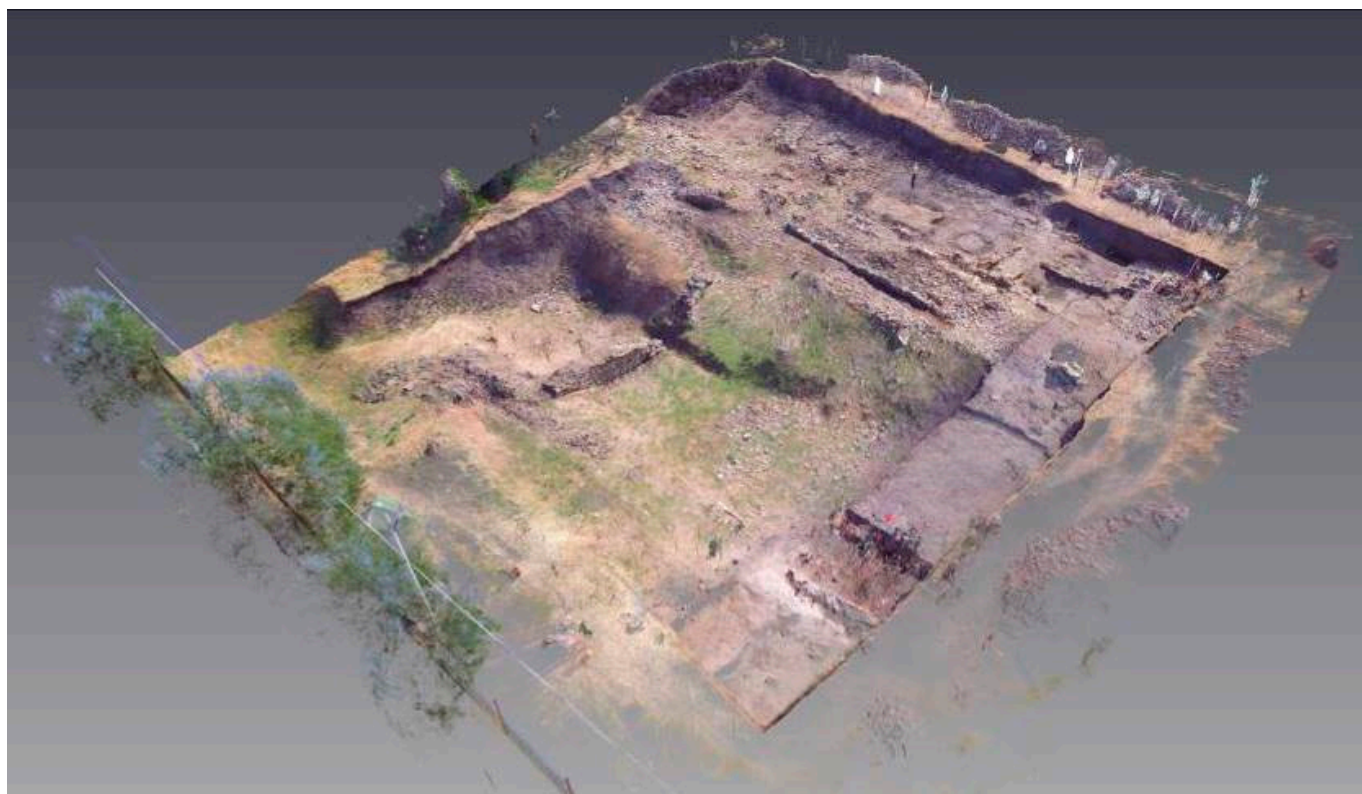
Figure 1. Three-dimensional model of the excavation in Tanais, Russia.

of the University of Warsaw and the Antiquity in South-eastern Europe Research Center. The first season was oriented on detailed documentation with a 3-d scanner. One of the outcomes of that documentation is a three-dimensional model of the trench XXV, which allows performing precise measurements of structures located inside (Figure 1) [33].

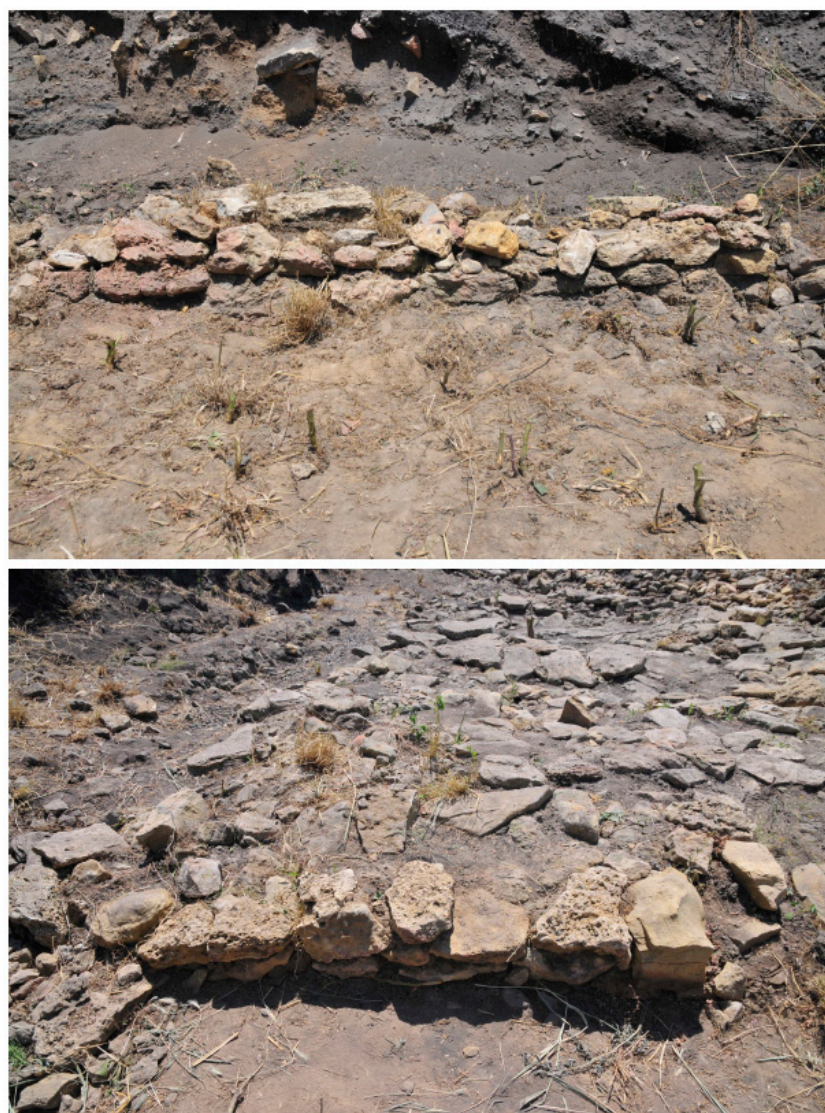
Figure 2. Masonry wild stone wall before conservation works, Tanais, Russia.

These are antique masonry structures made of ashlar and stones from various limestone rocks, shaped or broken, mostly unsorted, of different structure, degree of sedimentation, porosity and absorbability and, what is associated with it, humidity. An earth-based mortar was used as the binder [34,35]. Such a wall has low strength, internal cohesion and, as a result—low durability [36,37]. The structure of the walls is degraded to a large extent, which in addition to possible conscious human impact, results from centuries-long environmental processes, including long-term moisture and biological aggression in the ground and destruction caused by exposure to rainwater. The example of irregular stone masonry before conservation works in the Tanais are shown in Figure 2.

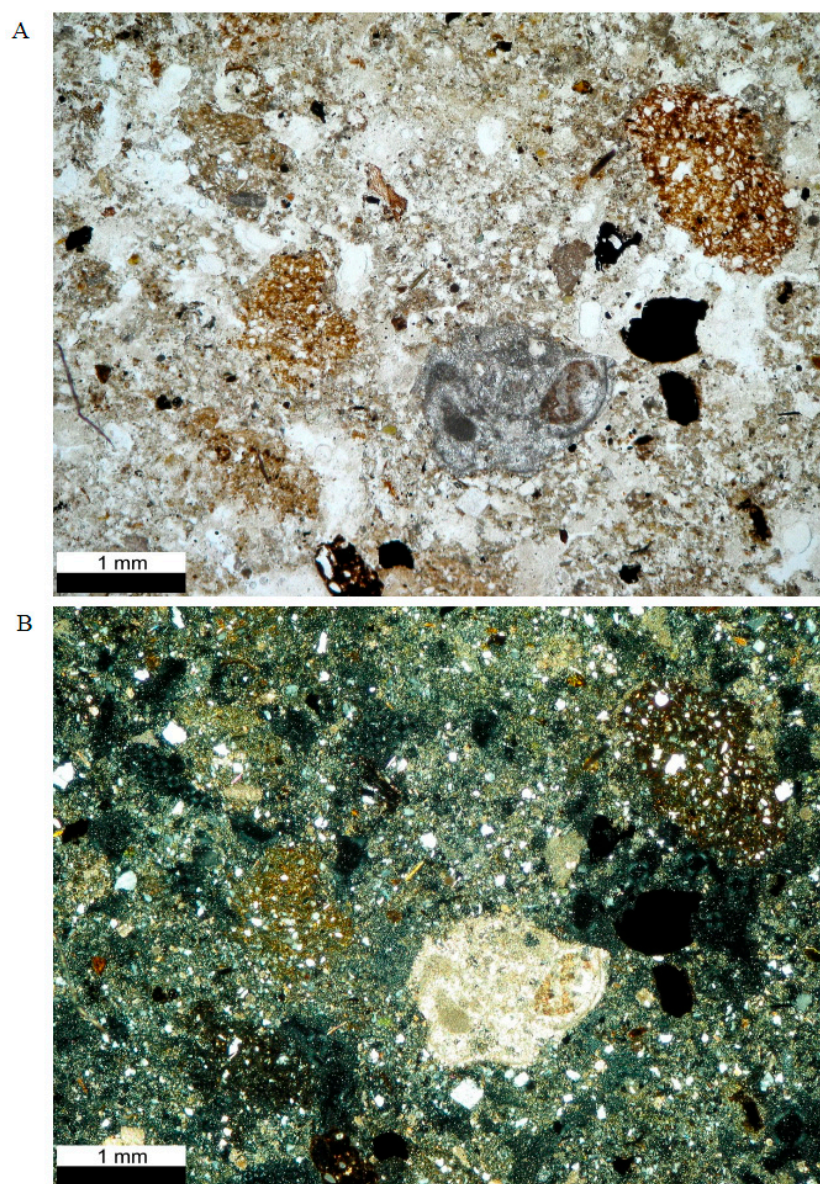
Figure 3. Microscopic image seen with one polarizer (A) and two crossed polarizers (B) [40].

As a next step, the properties of earth-based mortar made on the base of substitutive material have been tested. Substitutive material was chosen after studies of original earth-based mortar from the Tanais described in paragraph 4. As first comparison sieve and aerometric analysis was performed—cl = 6%, si = 64%, sa = 28% (type of soil—sasiCl). Then the petrographic, X-ray and thermal analysis were carried out, which results are shown in Figures 3–5. Based on the petrographic studies, it can be concluded that the substitutive sample also consists of crumb components of the psammite to aleurite fraction and the material of the pelitic fraction. The aleurite fraction dominates, while the psammite fraction is in a small amount. The main mineral that is part of the crumb components is also quartz. Minerals from the feldspar group, both alkaline and sodium–calcium varieties, are of minor importance. Based on X-ray diffraction examination, it can be stated that the clay fraction is also dominated by illite. Along with illite, the pelitic fraction also includes kaolinite and trace amounts of chlorite. Substitutive material also has a similar course of thermogram.

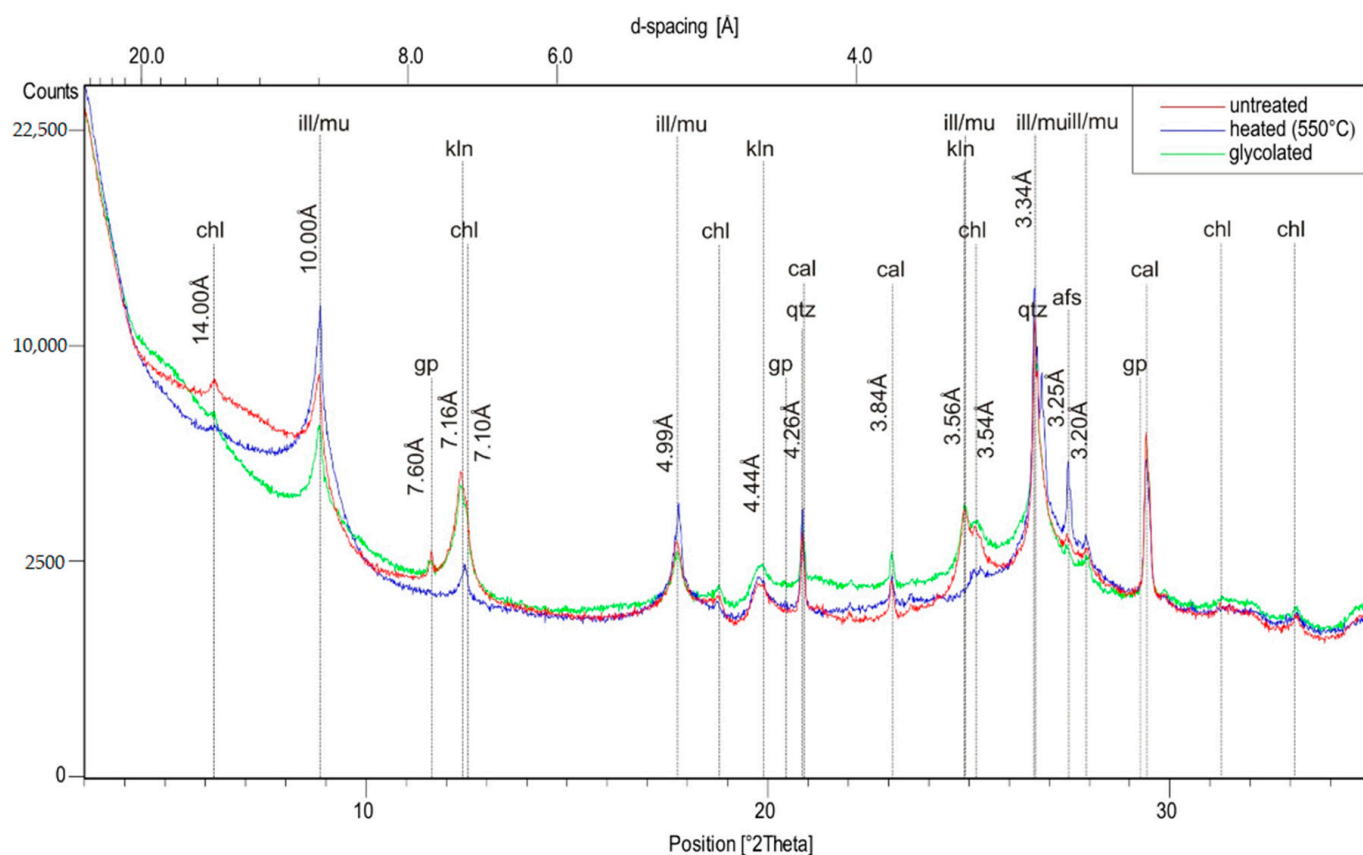
Figure 4. X-ray diffraction examination of clay fraction [40] (chl—chlorite, ill/mu—illite/muscovite, kln—kaolinite, qtz—quartz, afs—alkaline feldspar).

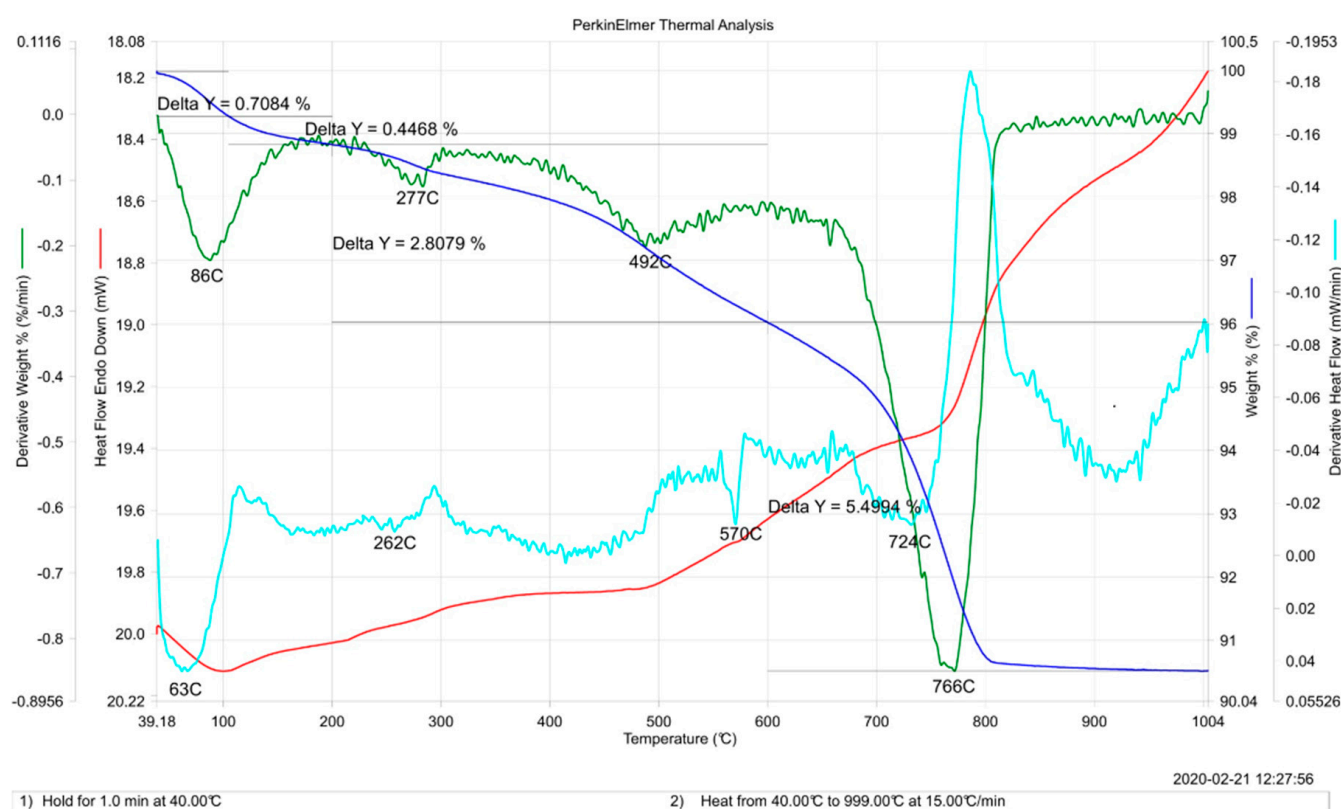
Figure 5. Thermogram of the sample [40] (TG—the weight curve—navy blue; DTG—first derivative of the weight curve—green; DSC—heat flow curve—red; DDSC—first derivative of heat flow curve—turquoise).

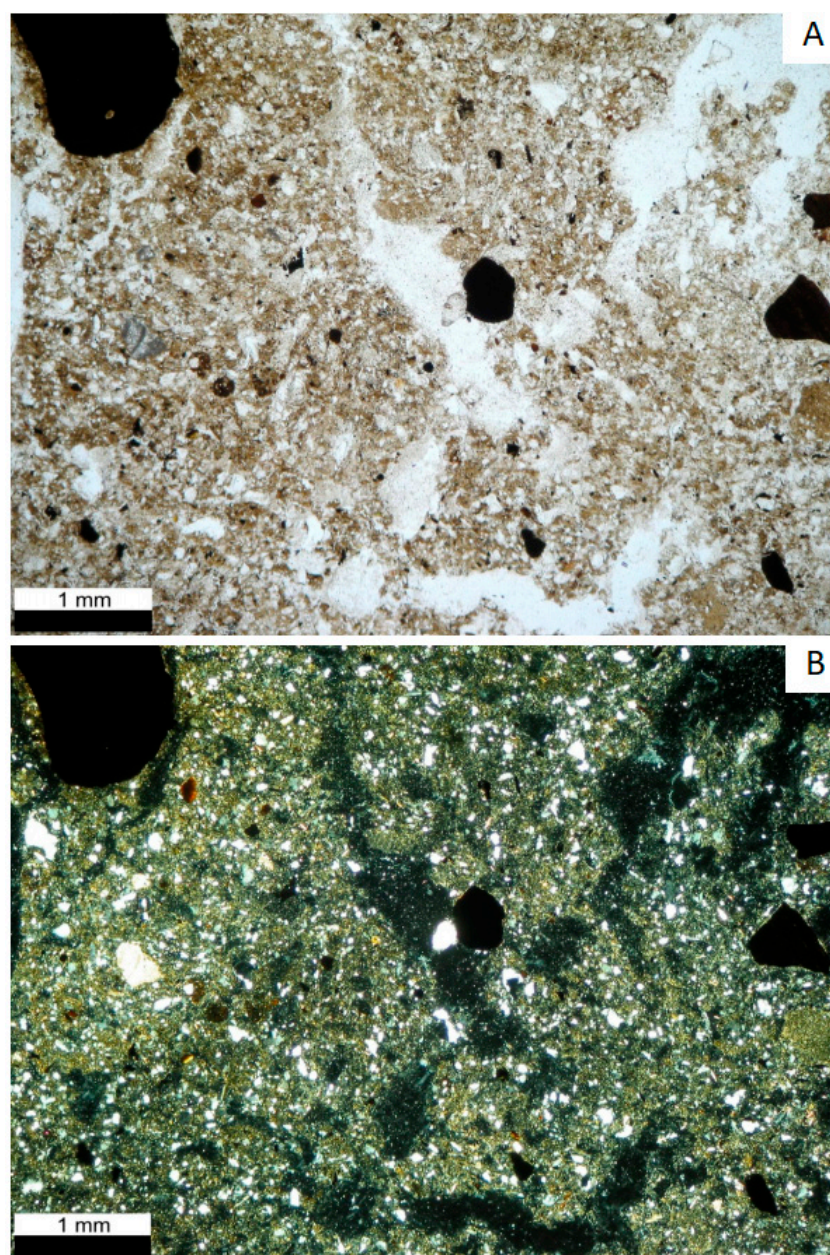
Figure 6. Microscopic images are seen with one polarizer (A) and two crossed polarizers (B) [40].

Based on the petrographic studies (Figure 6), it can be concluded that the analyzed original earth-based mortar sample consists of crumb components of the psammite to aleurite fraction and the material of the pelitic fraction. The aleurite fraction dominates, while the psammite fraction is in a small amount. The main mineral that is part of the crumb components is quartz. Minerals from the feldspar group, both alkaline and sodium-calcium varieties, are of minor importance. The grains of rocks were also subordinate and represented the fragments of light crystalline rocks (granitoids, fragments of gneisses, etc.). Additionally, there were fragments of carbonate rocks (limestones, etc.), macroscopically visible as white-gray grains. Such grains mainly consist of calcite. The grains of rocks observed in the composition represent the psammite fraction. A significant amount was also observed within this fraction of quartz grains and black and black-brown grains, which are clusters of opaque minerals (sulfides, oxides, oxyhydroxides) and/or being organic components. The composition of the grain skeleton is complemented by mineralogically varied and at the same time accessory components, mainly representing the so-called heavy minerals, as well as glauconite or mica. The pelitic fraction is definitely dominated by clay components. It is composed of rhombohedral carbonates dispersed within it. Furthermore, within the clay mass, similarly to carbonates, there are dispersed non-crystalline or weakly crystalline iron minerals in the form of oxyhydroxides (goethite, lepidocrocite). A small degree of crystallinity and a lower amount in relation to other components means that they have not been identified by diffraction methods; however, their presence is confirmed by thermal methods. They cause the clay mass to be yellow-orange in color.

These mineral phases can also build the above-mentioned black or large black and brown grains of the psammite fraction. Based on X-ray diffraction examination (Figure 7), we can state that the clay fraction has a mixed composition, although it is dominated by illite. Along with illite, the pelitic fraction also includes kaolinite and trace amounts of chlorite. The thermogram of the tested sample is shown in Figure 8. The sample is characterized by low-temperature weight loss, visible as a deflection of the DTG curve (derivative weight curve—green one), and a corresponding endothermic effect (derivative heat flow curve (DDSC)—turquoise one), visible up to 200 °C. In the initial phase (up to 100 °C), these effects should be interpreted as the release of free (hygroscopic) water by the sample. The maximum of this process is visible in the form of the inflection point of the DTG curve, which is below 100 °C. However, the DTG curve, although it returns to the baseline at about 200 °C, after exceeding 100 °C, still indicates a (decreasing) weight loss until reaching the subhorizontal course. Such behavior should be interpreted as the effect of thermal decomposition (dehydration) of clay minerals—illite/muscovite. In the range of 200–400 °C, clear weight and endothermic effects are visible. Maximum weight

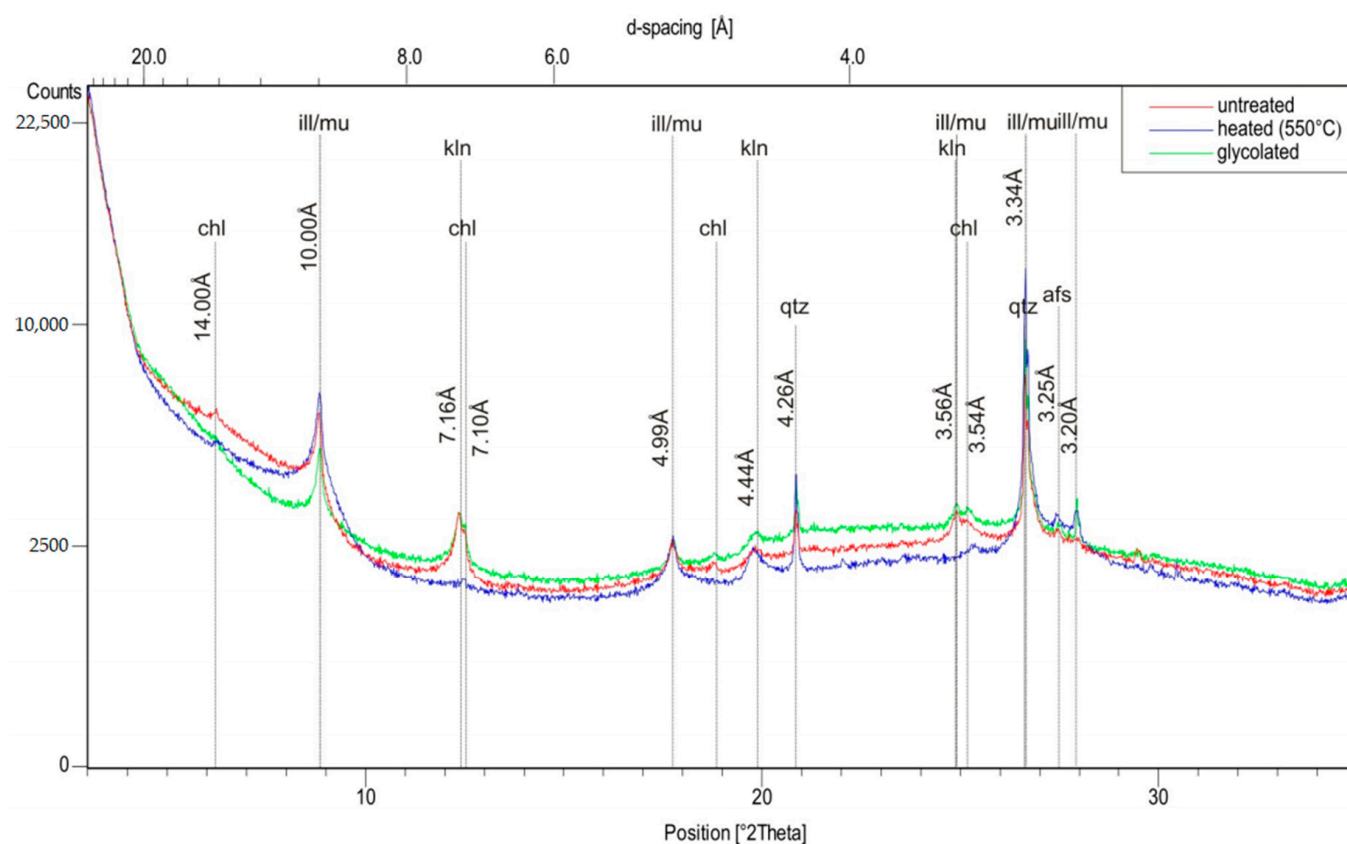
Figure 7. X-ray diffraction examination of clay fraction [40] (chl—chlorite, ill/mu—illite/muscovite, kln—kaolinite, qtz—quartz, afs—alkaline feldspar).

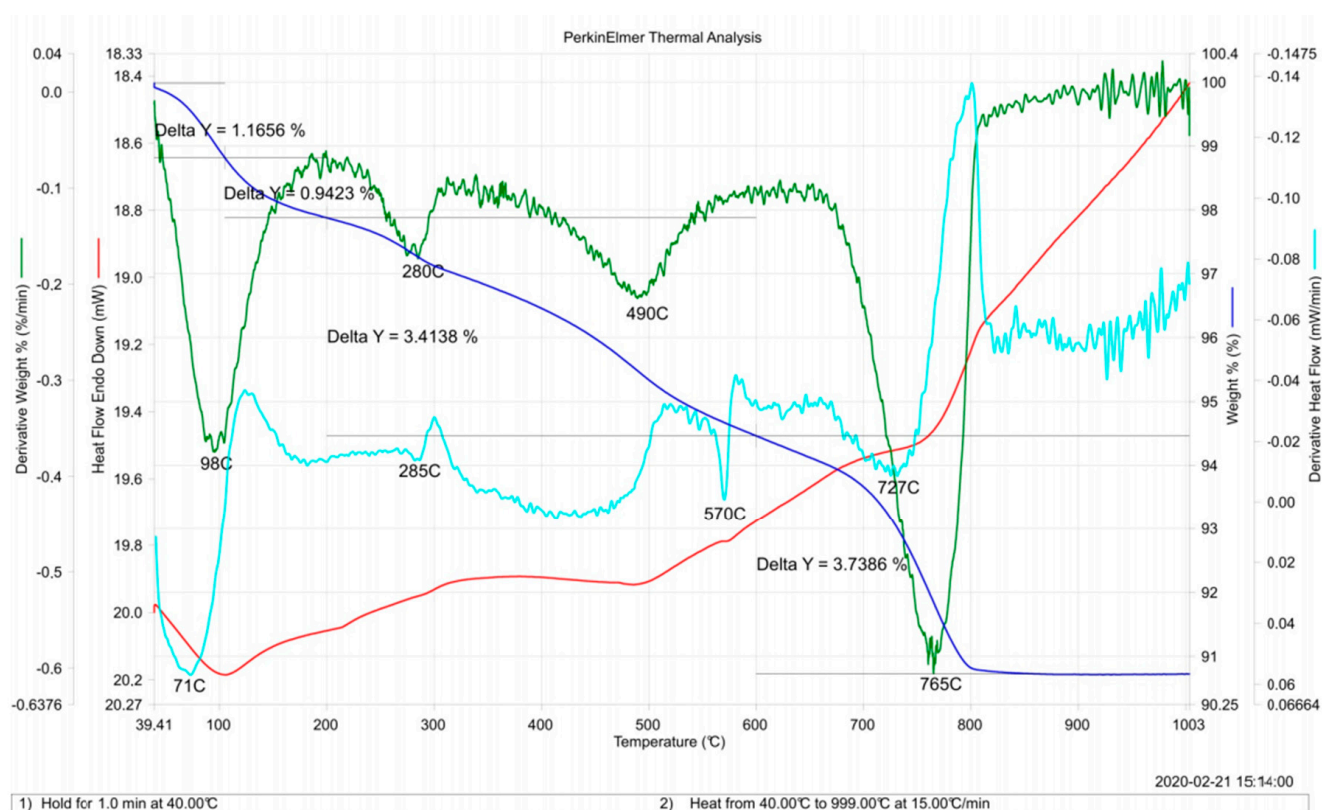
Figure 8. Thermogram of the sample [30] (the weight curve TG—navy blue; first derivative of the weight curve DTG—green; heat flow curve DSC—red; first derivative of heat flow curve DDSC—turquoise).

loss occurs at 280 °C and 277 °C. It is caused by the decomposition of iron oxides in the form of goethite (α -FeOOH) and lepidocrocite (γ -FeOOH). Other weight effects and slightly marked endothermic effects are visible at 490 °C. They result from the further breakdown (de-hydroxylation) of the structure of clay minerals—illite and kaolinite. At the temperature of 570 °C, the DDSC curve shows a well-marked endothermic effect; at the same time, it is not accompanied by any weight effect. It is related to the polymorphic transformation of low-temperature quartz into high-temperature ones. Above 600 °C, one very strong weight loss effect is visible on the DTG curve, with a maximum at 765 °C. It is accompanied by a clearly visible endothermic effect—the dissociation effect of calcium carbonate (calcite). At a similar temperature, a second endothermic de-hydroxylation of illite can also be observed. After the dissociation of the calcite is complete, no weight effects are observed, and the deviations of the DSC (heat flow curve—red one) and DDSC curve are the result of uneven heat flow between the sample and the thermocouple.

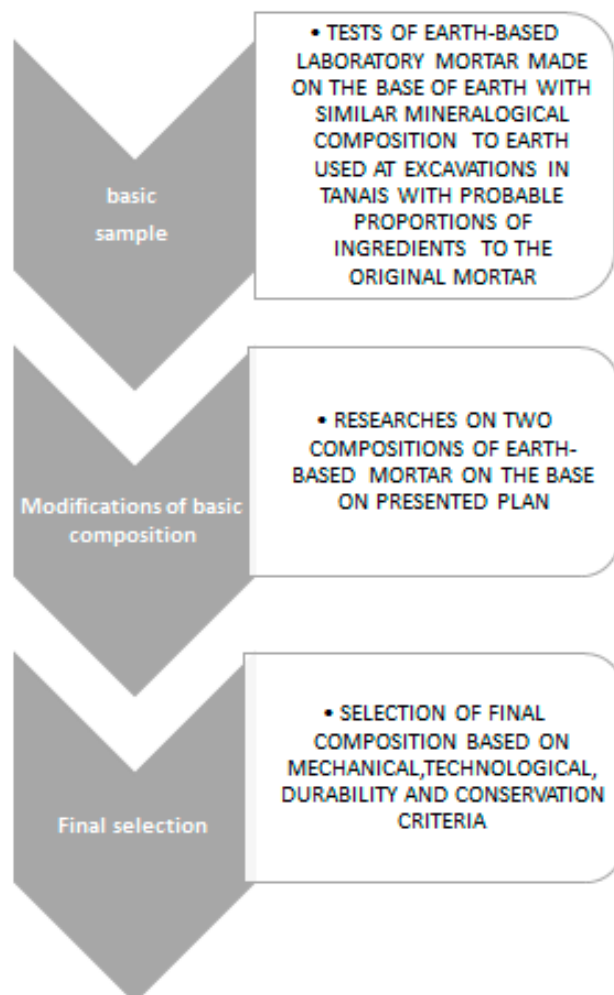
Figure 9. Steps to get the final composition of earth-based mortar for reconstructions of stone masonry walls.

The whole process to get the final composition of repair mortar, which can be used in the conservation works of stone masonry structures, is shown in Figure 9. As already mentioned, the earth is the main binder on the basis of which mortars used in irregular stone constructions in Tanais were made. Therefore, research to determine the properties of earth-based mortars used in masonry structures had to be carried out to determine the best way to strengthen it, using cement (creating an earth-based mortar stabilized with cement with the most appropriate recipe) and other substances available in regions where conservation works are carried out not only to improve the durability, physical and mechanical parameters but also to achieve the desired esthetic effect in the form of a suitable color (color combination in the wall) and compatibility of the repair mortar with the substrate. As a next step, the properties of earth-based mortar made on the base of substitutive material were tested. Since the exact proportions of ingredients in restored masonry walls were not specified, some test proportions were made for the research. Moreover, having in mind that tested mortar will be used in specific conditions of the archeological site, only volumetric dosing of ingredients can be used in this case.

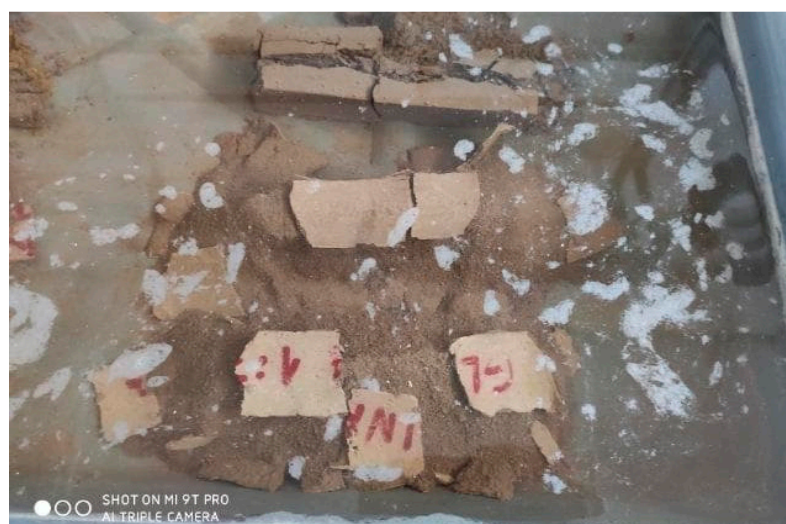
Figure 10. Clay mortar sample after the first cycle of freeze–thaw test.

mortar sample, despite the use of the hydrophobizing agent, disintegrates already after placing it in a container with water for the first time (Figure 10), which proves its very low durability and resistance to weather conditions.

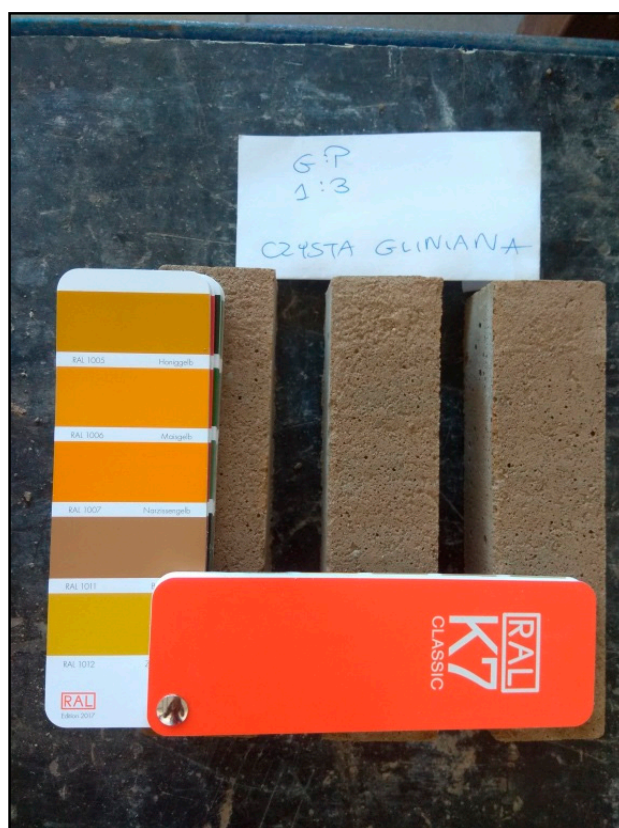
**Figure 11.** Color analysis of clay mortar sample using RAL K7 palette.

Earth-based mortar samples were also subjected to the test for determination of shrinkage and color analysis. In the case of mortar with sand: earth ratio of 3:1, the shrinkage was about 4.0%, which in practice led to cracks and the ingress of water into the wall, which largely contributed to the current state of the mortar. According to the new German standard [44], the maximum linear shrinkage should be equal to 2.5%. The color of the original mortar was assessed as RAL 1011 brown beige (Figure 11).

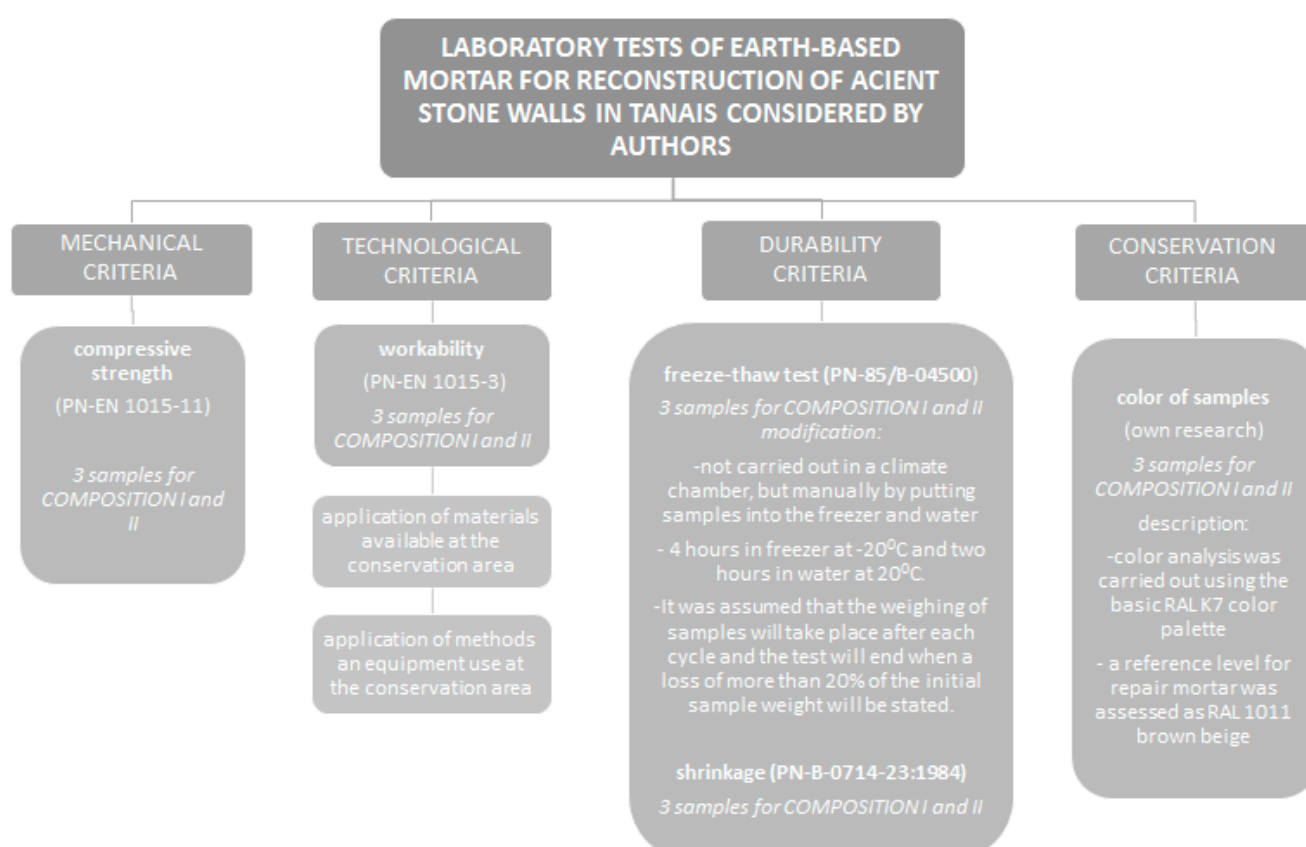
Figure 12. Plan of research for the final selection of clay mortar.

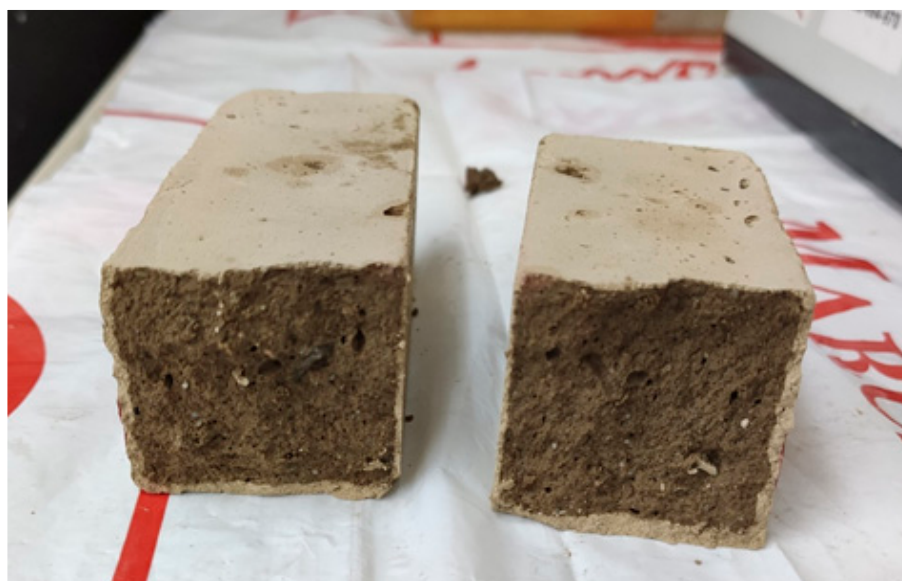
Figure 13. Composition I after eight freeze–thaw cycle.

The next comparison was the frost resistance of new compositions. As already mentioned, earth-based samples not stabilized with cement were destroyed in the first cycle of the test. All new samples with the addition of cement survived eight freeze–thaw cycles. In all cases, the samples stabilized with cement were destroyed by the fracturing of the sample (Figure 13). It can be easily noticed that the surface layer of the sample is covered with a layer of a hydrophobizing agent. Due to the fact that also in the case of clay samples, this layer was intact, there is a presumption that water penetrated inside through leaks in the coating. It is recommended to perform these tests with an increase in the number of layers used, as well as to perform a durability test more suited to the actual situation of using the material. Comparing the shrinkage, the samples stabilized with cement showed smaller linear shrinkage than pure clay samples (about 3.0% for all compositions), but its value seems to be still too high for a repair mortar for stone structures exposed to changing atmospheric conditions. As was discussed in the introduction of this article, all materials used in the conservation activities should be original or compatible. In order to restore the original view of analyzed structures, the last comparison was color analysis. As in the case of clay mortar, the RAL K7 palette was used. The results of this test are presented in Figure 14. For all samples containing cement (compositions I and II), the color obtained is No. 7044 silk grey while for clay mortar No. 1011 brown–beige. It can therefore be concluded that the obtained color of mortar containing cement differs a little bit from the desired one, acquiring a grayish tone. Of course, the color of the earth will also have an influence on the final tone of composition, but it would be beneficial to limit the color change with the cement content or try to achieve the color in a different way.

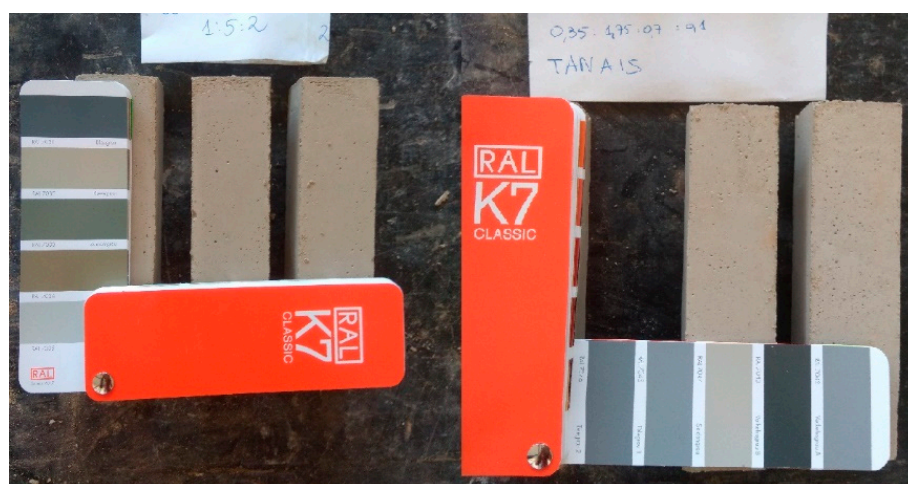
Figure 14. Color analysis of composition I and II using RAL K7 palette.

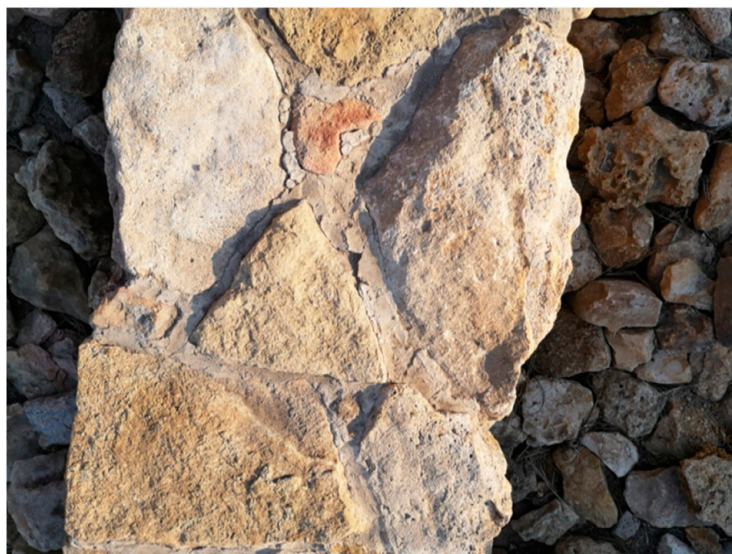
Figure 15. Cracks in earth-based mortar applied in 2017.

During the conservation actions at the Tanais site in 2017, the chosen earth-based mortar seem to fulfill the requirements both in the case of consistency and strength. In the next excavation season in 2018, the verification of applied treatment was also satisfactory since only the formation of small, superficial scratches and detachment of approximately 10 wall elements (stones) were observed. Damages and condition of restored masonry walls are shown in Figure 15. The resulting shrinkage cracks were secured and bonded by grouting with earth-based mortar stabilized with cement and plasticized with lime. During drying, the repaired joints were properly cared for to prevent further cracks, and the detached stones were rebuilt (after removing the previous mortar) and reintegrated with the wall. The view of the structure after repair works in 2018 is shown in Figure 16. After the restoration activities in 2017–2018, in 2019, no significant damage, superficial scratches or detachment of the wall elements (stones) were observed. There was also no visible destruction of the wall by atmospheric conditions and salt efflorescence on the face of the wall. Therefore, the properties of earth-based mortar in terms of mechanical, technological and durability issues may be assessed as satisfactory.

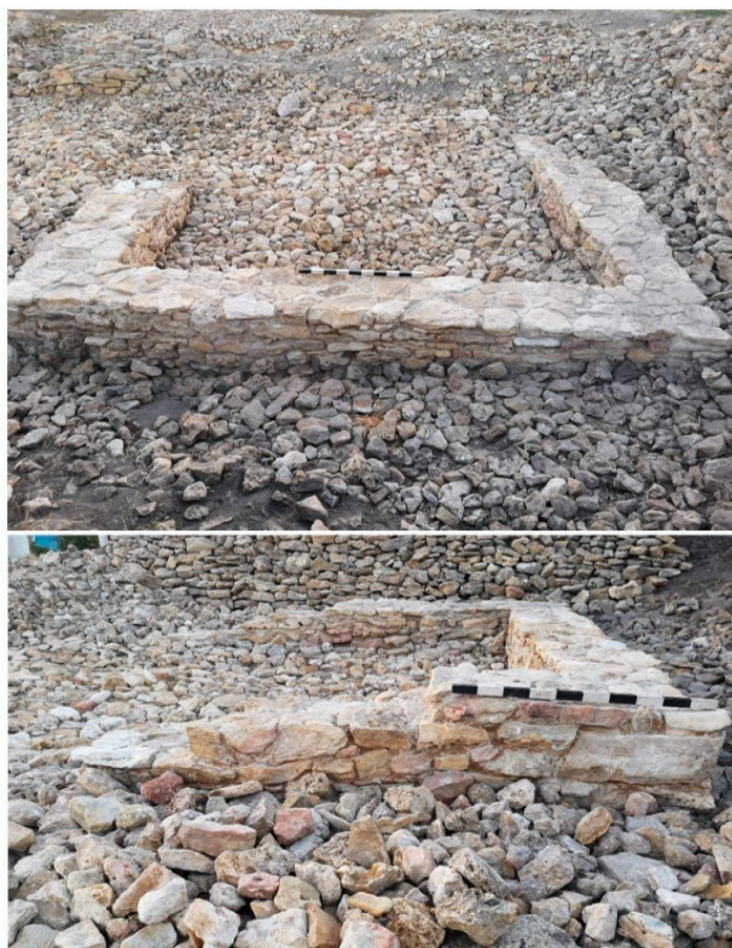
Figure 16. View of the wall after conservation, 2018.
